**YEW CLOSE GARAGES,  
MERTHYR TYDFIL**

**BUILDING INSPECTION  
REPORT**

APRIL 2025

Document Ref: E25132001/DOC 01 – APRIL 2025

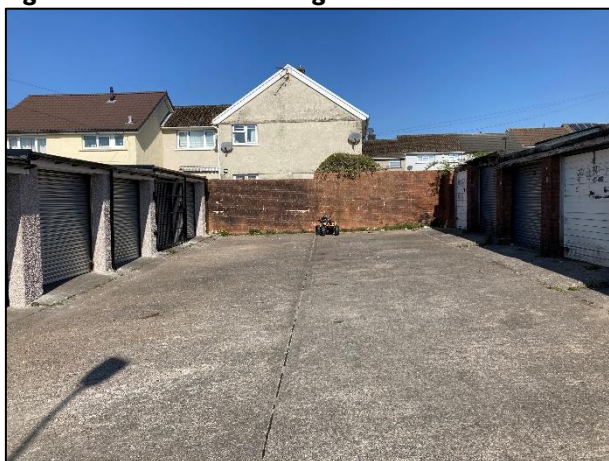
**Figure 1 – Yew Close Garages**

- 3.4 The PRA and walkover survey identified that the site entirely comprises of hardstanding and the existing garage blocks (see cover image and Figure 1). The areas of hardstanding and paving do support occasional annual weed species e.g., Annual Meadow Grass *Poa annua*, Common Dandelion *taraxacum officinale* and Herb Robert *Geranium robertianum*. There are no other ecological features and the habitats were considered to be of negligible ecological value (see Figure 1 and Cover Image).

- 3.5 The site supports three linear blocks of garage units. Two of which have recently been refurbished (units 1-7 and 22-27) and were not included in the assessment. The middle block, containing garage units 8-21, comprise of brick, pebble dash, metal doors, a combination of wooden and metal frames and felt roofing. The garage units are in a poor condition and in a general state of disrepair. For example, many of the wooden door frames are rotten, doors damaged and the roof to the rear of units 21-18 has collapsed.

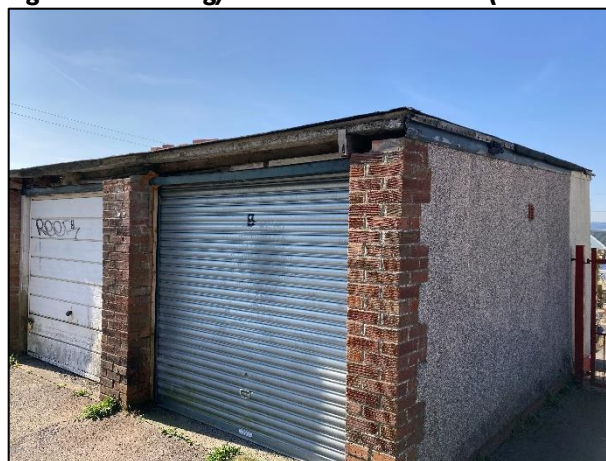
**Figure 2 – Missing/rotten wooden frame (units 8 & 9)**

- 3.6 The survey only identified minor potential roost features (PRFs) associated with the external elevations. This included gaps associated with rotten wood around the door frames of units 8 and 9, and missing pebble dash and mortar on unit 16, which provide small access points into the internal garage space (see Figures 2 & 3). There were also a small gap between the door frames associated with unit 19. No other PRFs were identified during the survey.

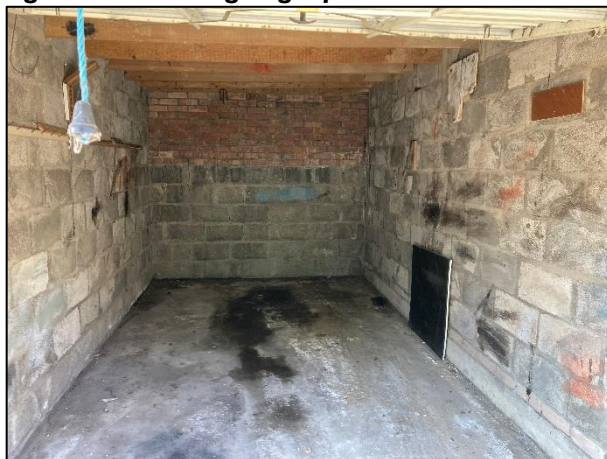
**Figure 4 – Internal garage space**

- 3.7 An internal inspection of garage units 9, 10, 11, 12, 14, 15, 16, 17, 20 and 21 was undertaken during the current survey. As discussed in paragraph 2.7, units 8, 13, 18 and 19 were not inspected internally due to health and safety concerns or seized locks. Internally the garages do not support a cavity wall, with the walls consisting of brick and breezeblock (Figure 4). Inside the garage roof comprises of stramit board (wood wool board), bitumen felt and timber beams. The only PRF associated with the internal aspect of the garage units is a small gap (3-4cm) to the rear of units 9-15 between the timber beam and wall (Figure 5). Other gaps have been filled in with spray/foam insulation. Apart from the external gaps to units 8, 9, 16 and 19 there are no other access points for bats. In addition, those with collapsed or partly collapsed roofs (Figure 6) were considered unsuitable to support roosting bats as they are likely open, well-lit and exposed to weather conditions.

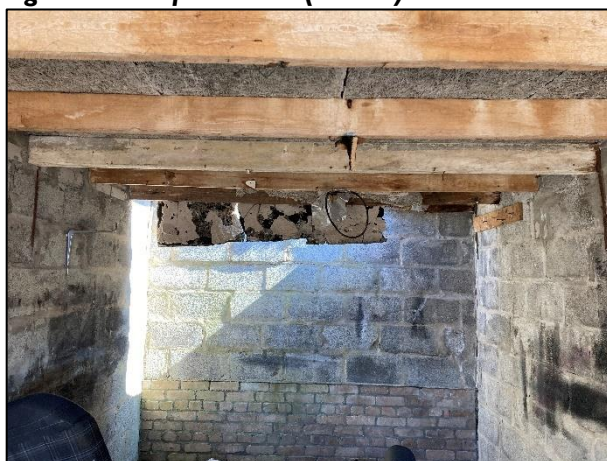
**Figure 6 – Collapsed roof (unit 20)**

2.7 Although keys were made available for the internal inspections of garage blocks 8 – 21, internal inspections of units 8, 13, 18 and 19 were not undertaken due to either health and safety reasons (collapsed roof) or a seized lock. This was not considered to impact the overall findings of the survey given an internal/external inspection of all other connected units was possible.

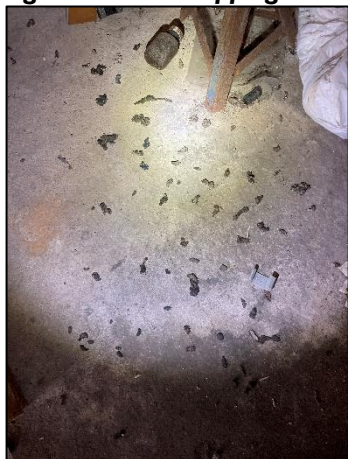
**Figure 7 – Rat droppings**

- 3.8 No evidence of roosting bats (or nesting birds) was found during the internal inspection e.g., droppings or feeding remains. Rat droppings were noted within units 9 and 10 (Figure 7). In combination with the lack of ecological features at the site, well-lit environment and lack of ecological connectivity (built-up residential area), the garage units were assessed to be of Negligible potential to support roosting bats.
