## BAT TOWER REQUIREMENTS

- BAT-ESA-XX-XX-DR-A-061000\_P02 - Planning Drawings  
Proposed Masonry Tower Option - Sheet 1

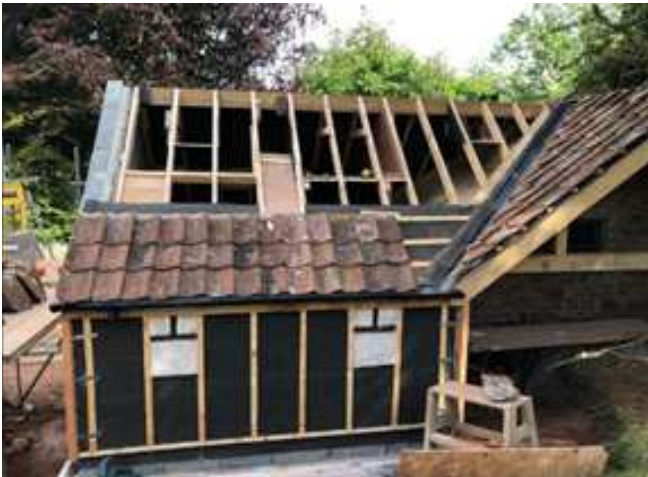
Wildwood Ecology example above of a new-build roost (mid-construction) with a loft for free-hanging lesser horseshoe bats and internal crevices for crevice-dwelling bats. This loft will be accessed by a hopper entrance in the middle of the roof pitch (seen partially constructed).

On the north elevation the bat loft structure will be built into a slope, to provide a hibernation wall (seen in the photo). This comprises hessian roofing felt wall (covered by weather boarding once finished) and slot access ports under the weather boarding leading into passively controlled interior roosting area. Note the two examples of hibernation crevices – additional crevices were created after this photo was taken, branching off horizontally at various heights. The crevices will not be visible once the weather boarding is installed.

The hibernacula built here is a great precedent however the timber clad building is not a suitable construction for our scheme due to it not being completely secure, fire proof, or not at an adequate height.

South facing roof areas help heat the interior with a dark, draught free but vented interior which has a recommended ambient temperature range. Additional interior features such as triangular baffles are installed to partition the loft area and to create varied thermal regimes. Internal crevices are provided in the loft, made from short sections of battens, and roosting surfaces are provided for free-hanging bats in the form of wooden ridge boards. Wooden sarking or hessian roofing felt are installed under the tiles. Access points for crevice-dwelling bats are provided under tiles and ridge tiles by installing modified tiles.

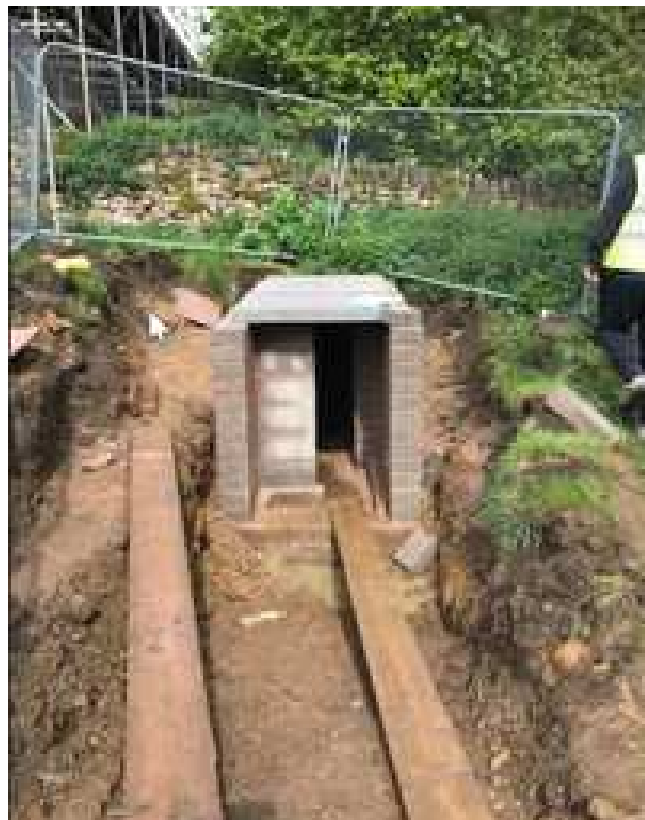
A buried linear hibernaculum, (photo above, mid-construction) to provide winter hibernation opportunities. The opening with a lockable gridded gate (13cm - 15cm air space between bars) should face north or north-east and feature insect attracting planting to the surround to provide linear connectivity from existing habitats to the new bat roost. This 'linear- cellar' roost features a dark roosting internal space that has ambient temperatures stabilized (aiming for 8 – 13C and very high humidity). The hibernaculum is dug c. 1.5m-2 deep and covered with soil (grassed over once completed). It is built from breeze blocks, with internal features such as alcoves and fake chimney breasts to provide very dark locations, hessian roofing felt sections and battens to provide gripping surfaces/ crevices, and bat tubes built into the walls.

Linear bat roosts that would be built horizontally and have an underground structure. This proposal must provide a 3 to 5m high access point. The space inside for free-hanging bats is usually 4m x 4m, with c.2.8m apex height to provide sufficient volume for bats to fly in. Internal features and access features as described in the option bat roost above.

Landing /access points cannot be built of steel or plastic as bats cannot cling to the smooth surface; they need rough natural surfaces to cling to for landing and entry such as wood, stone, and brick. Any steel used as walls would need to be carefully designed to afford good landing areas for the bats, perhaps incorporating render, stone, brick, so that bats can climb up these surfaces to the roosts.
