## Technical Note

| Subject | P/22/0175- Garages at Tramroad Side, Merthyr Tydfil | | Date | 12.10.22 |

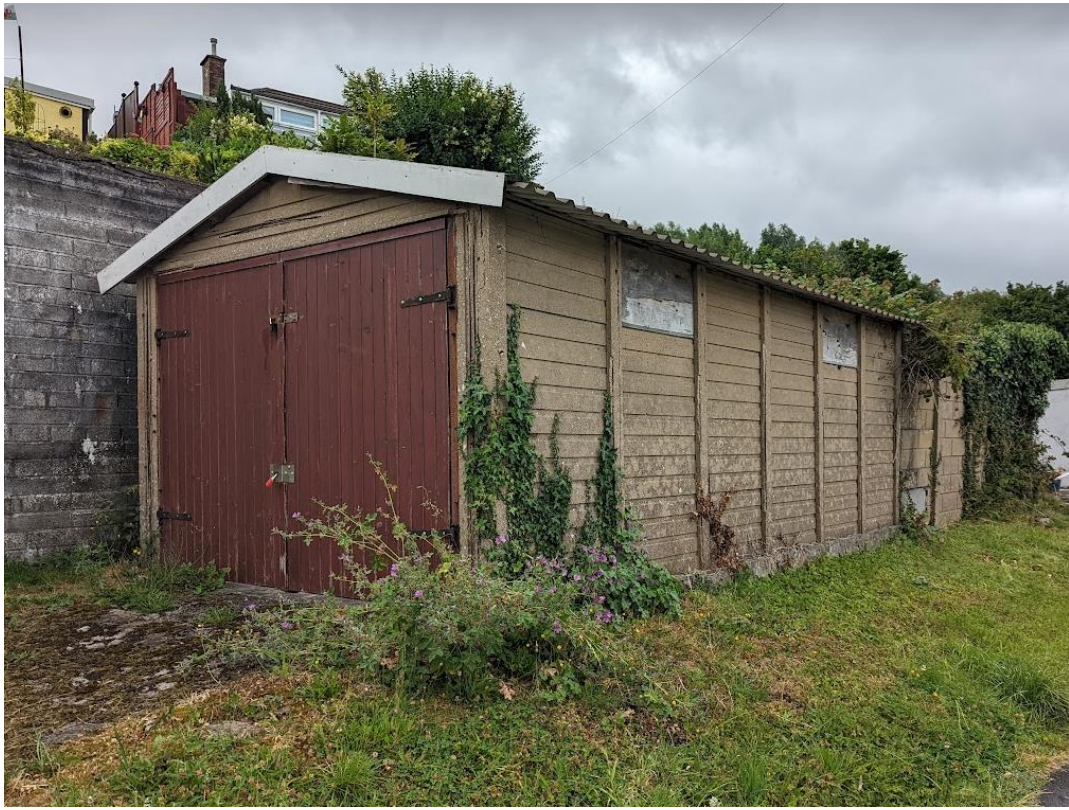
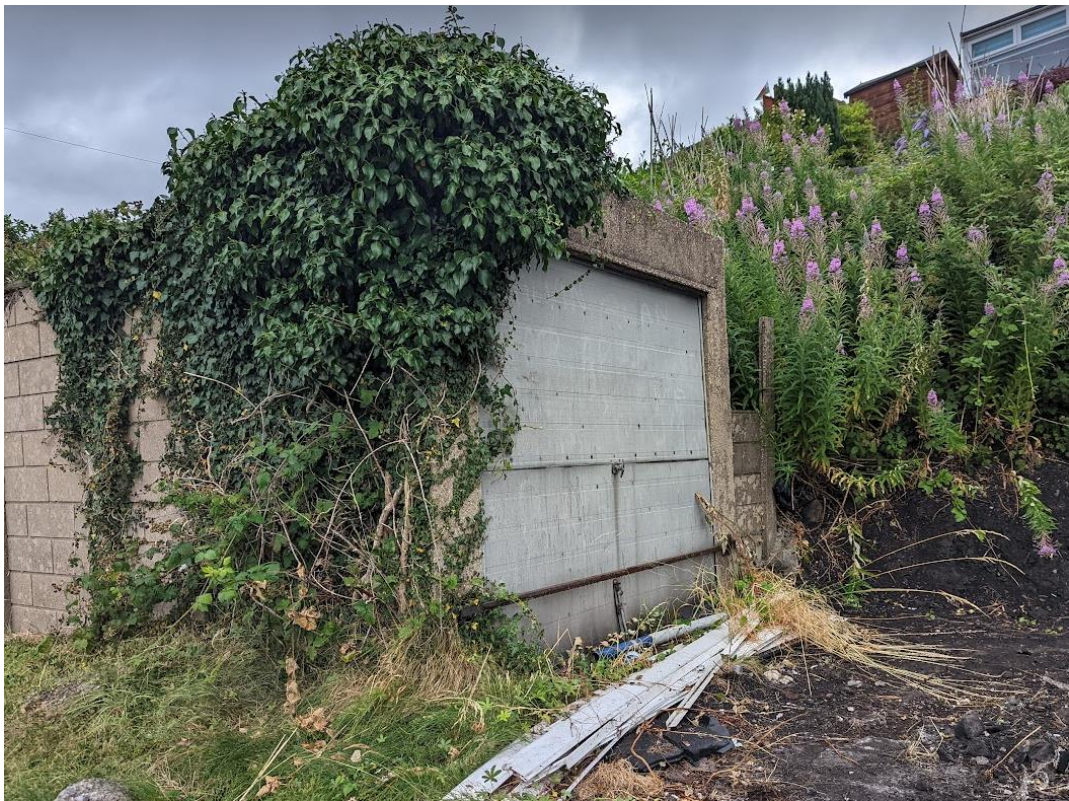
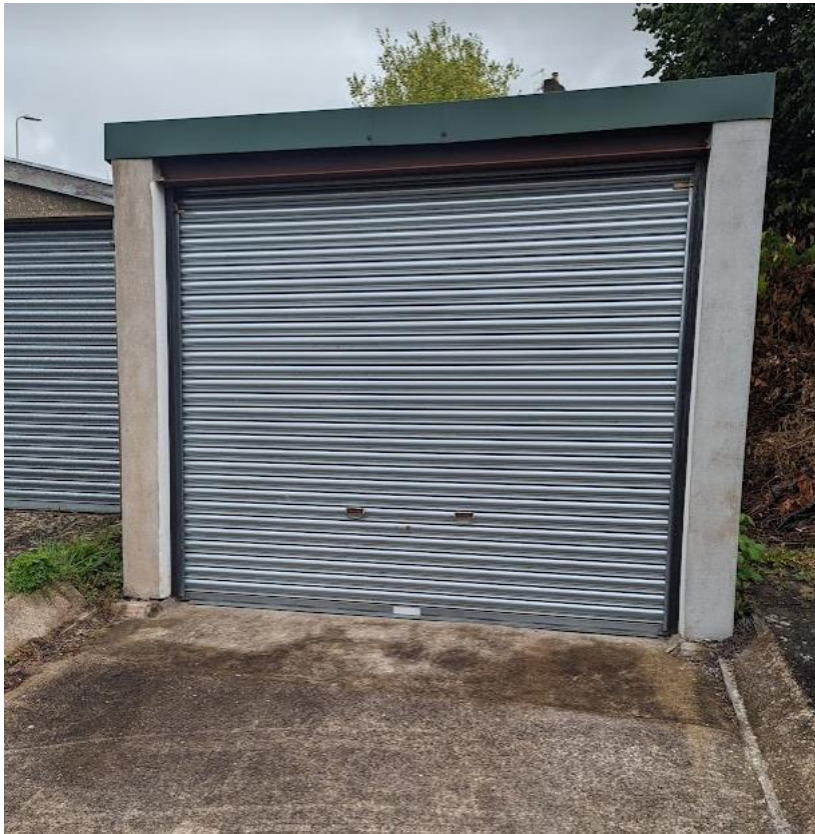
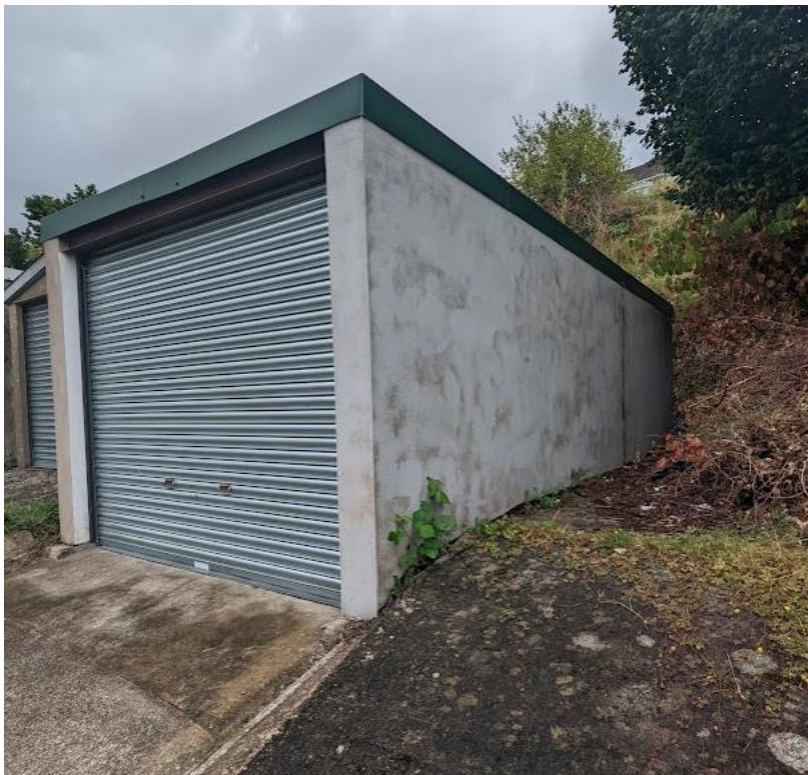
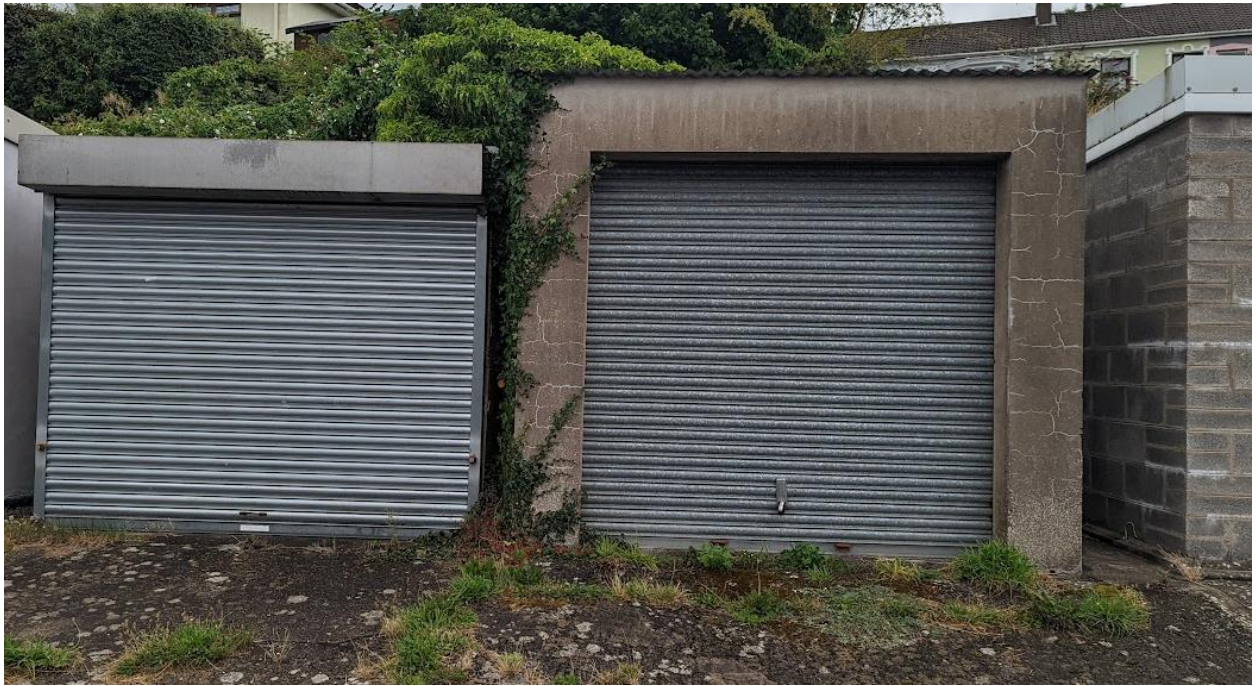
A bargeboard will be added to the elevations of the new garages as per Appendix 1 below. A small gap (15-20mm) will be left between the bargeboard and the wall to provide roosting opportunities for bats. These elevations will not be illuminated.

A Schwegler 1SP Sparrow Terrace or the following <https://www.nhbs.com/sparrow-terrace-nest-box> will be attached to each garage as per Appendix 1 below.
