**Former Howfield Bakery, 39–42 High Street,  
Merthyr Tydfil, CF47 8DP**  
**Bat Survey Report for Mr R. Powell, RWP Properties**

| <b>Report type</b> | Bat Survey Report |
| <b>Report reference</b> | IG2020FormerHowfieldBakery |

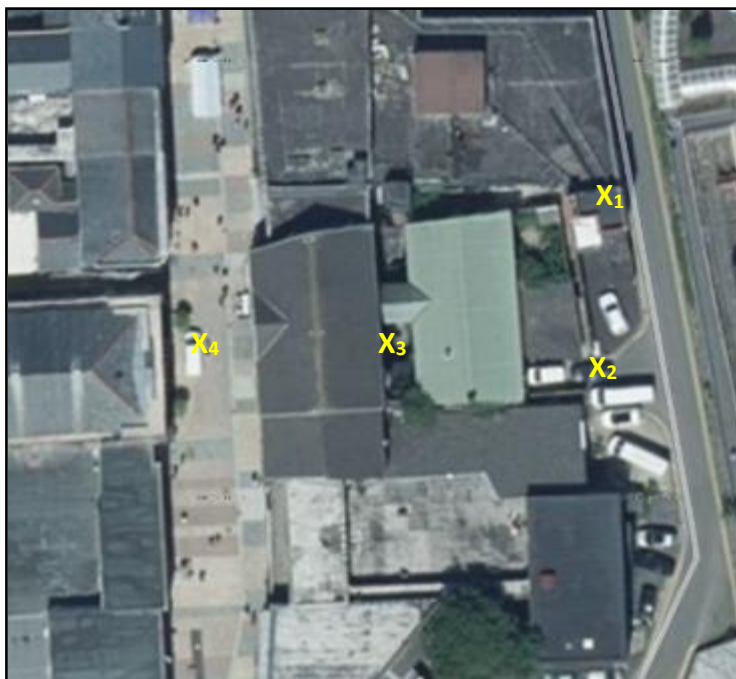
3.1.6 Figure 4 shows the position of surveyors during the activity survey. Each surveyor had a Magenta 5 or an Elekon Batscanner bat detector to assist in identification and detection of bats and their behaviour.

**Figure 4:** Surveyor positions during the activity survey (from Apple® Maps)

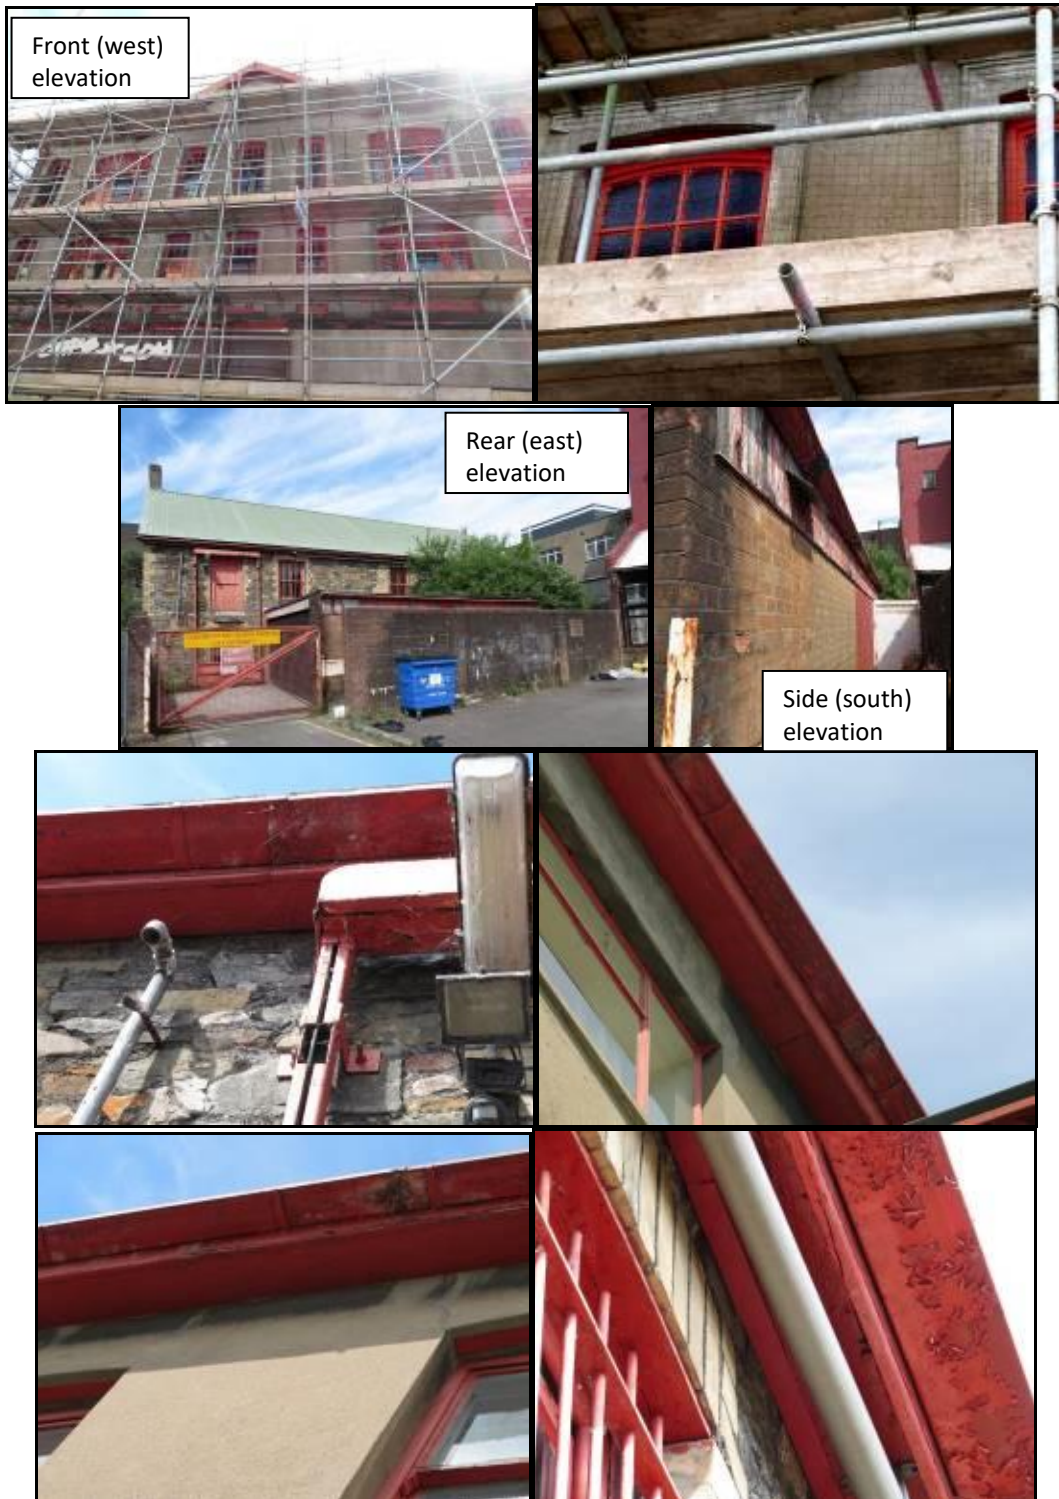
The property is a large west facing period former commercial property comprising two buildings joined together. The section to the west is three storey stone/brick which is part rendered and covered by mesh to prevent pigeon access. To the rear is a two storey stone/brick building with a single storey extension to the rear. The walls are in good condition and there are only minor gaps under the timber soffits/fascias while the metal framed windows and timber doors are intact and remain closed when not in use. The 5th image shows two lights in the one location!

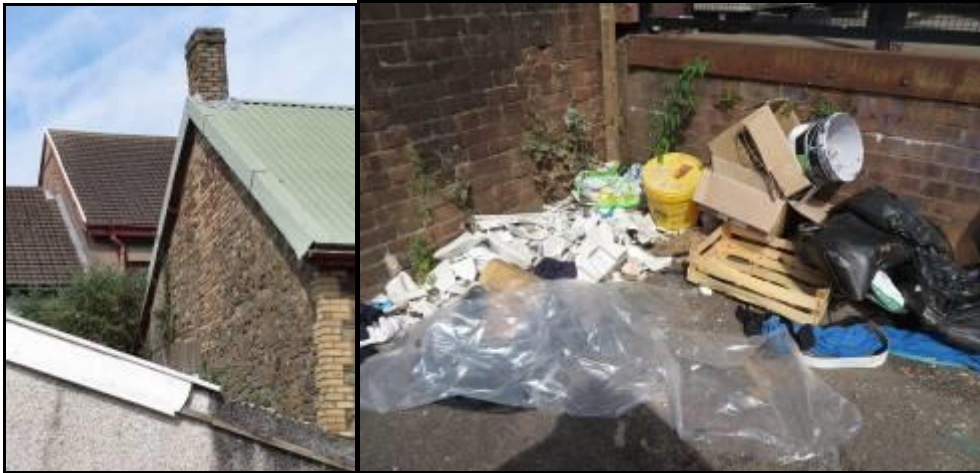
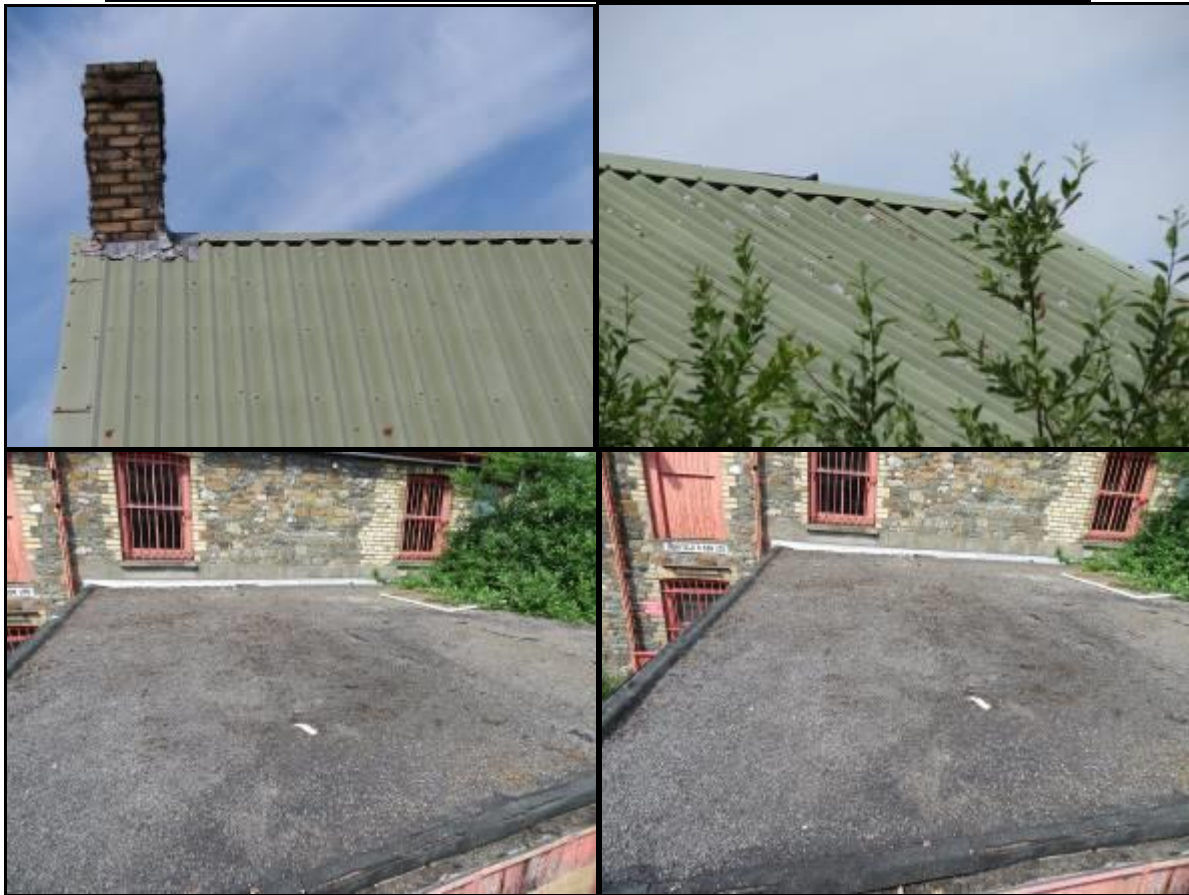
The tile roof on the front section is in good condition with no damaged/slipped/missing tiles while the unlined corrugated metal sheet roof is in very good condition with no damage. The adjoining section in the middle has a flat felt roof which also has no damage. The lead flashing around the chimney is also in good condition with no gaps, and no bats or their signs were found externally.

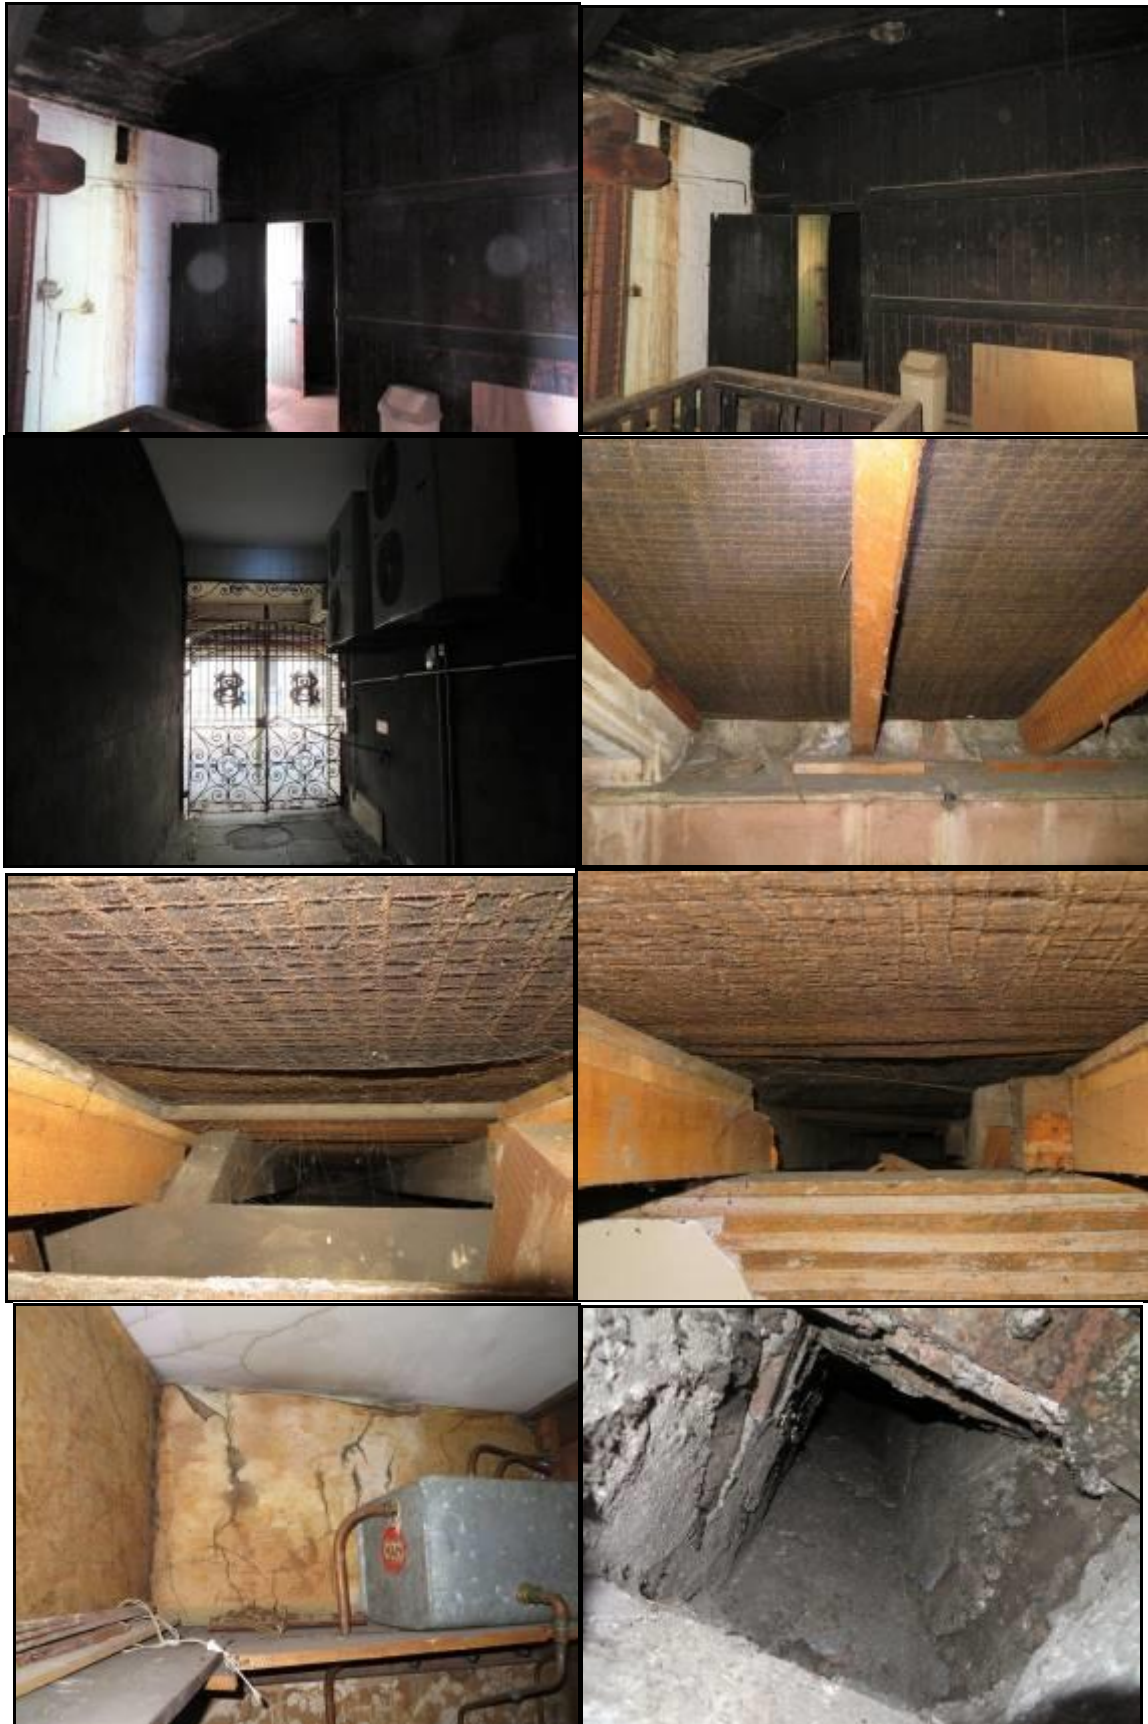
Additional interior images above the timber lining to the roof and up chimneys

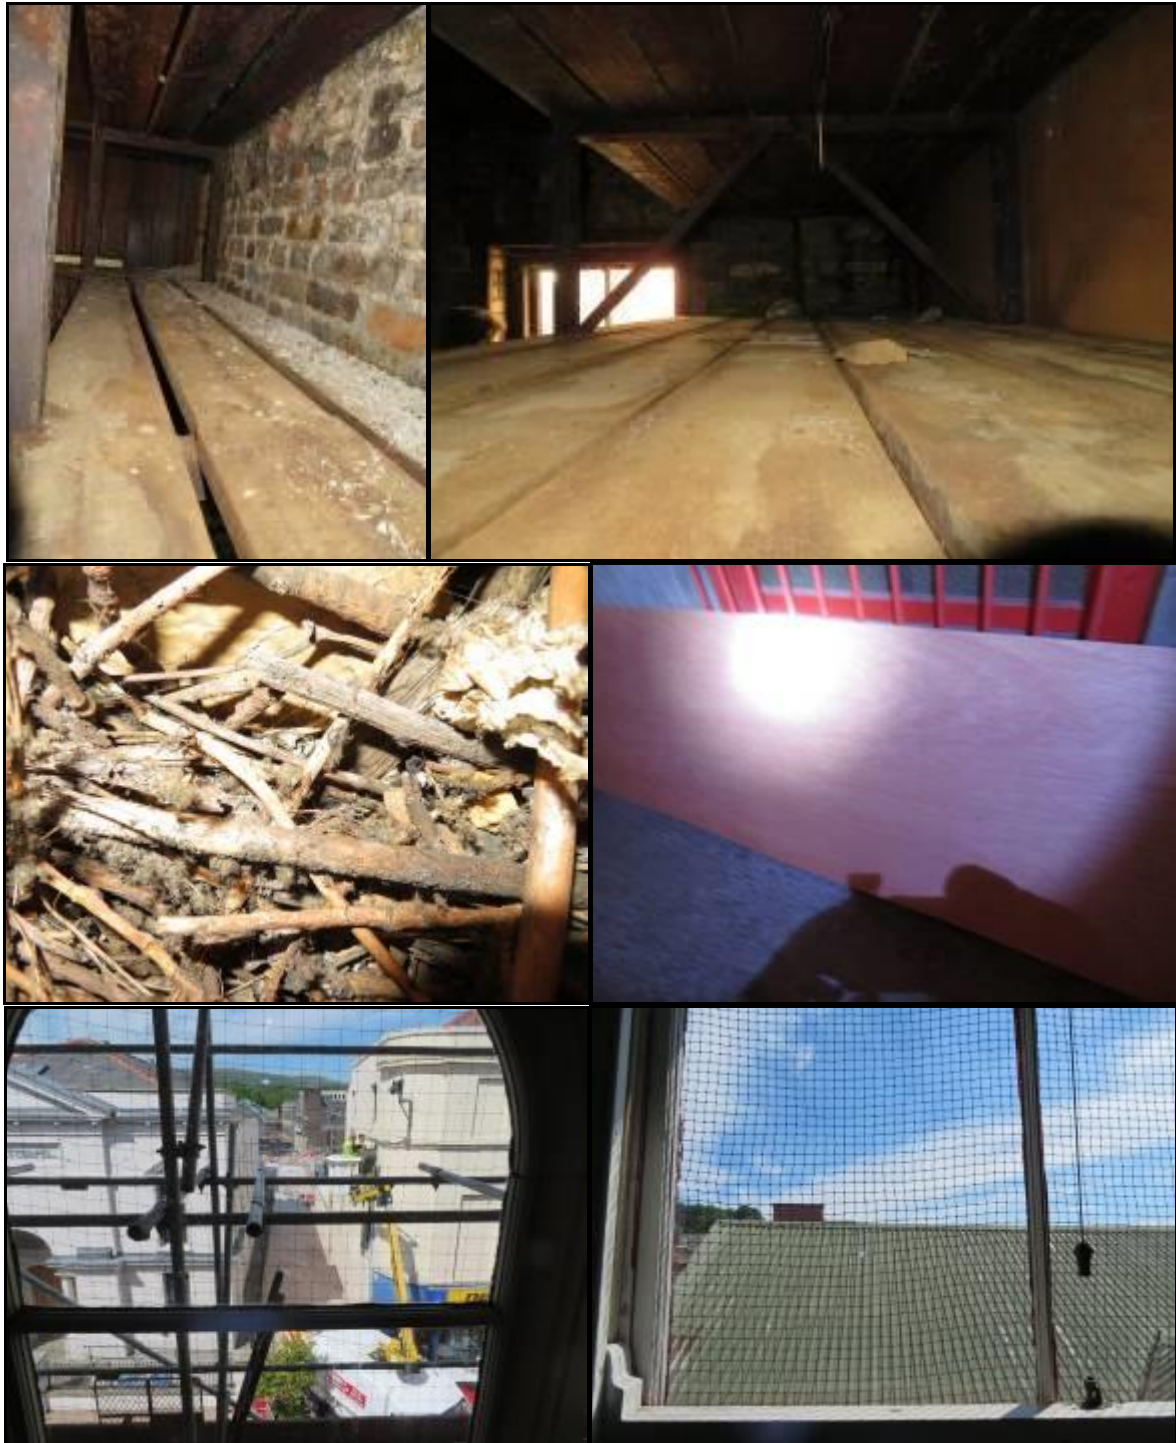
Additional interior images showing some of the surfaces and items within the property. There was a lot of dust and many undisturbed cobwebs, and there were also signs of older rat traps and other measures due to having baking flour on premises when it was operational. However, no bats or their signs were found.

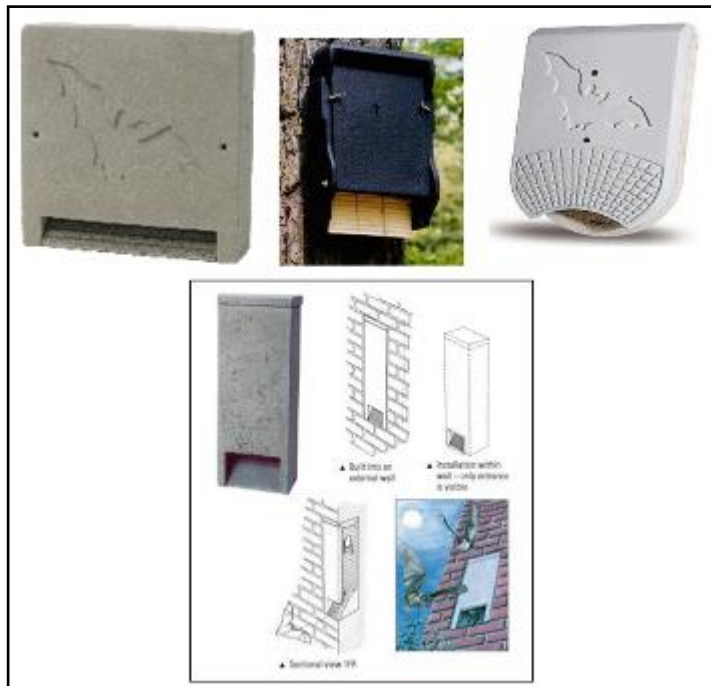
**Top:** From left to right, the in-wall Schwegler 1FR, the tree mounted 1FF and the multi season 1WQ. The bottom image shows the 1FR in situ.

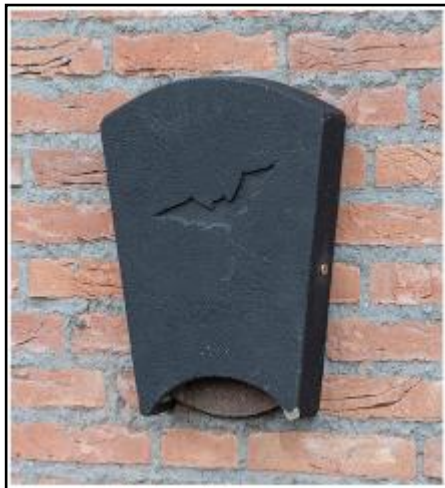
**Middle:** The Beaumaris bat box is made entirely from Woodstone, a robust material comprising concrete and wood fibres. This means that, not only does the box have excellent insulating properties maintaining a more consistent temperature throughout the year, it also provides excellent protection from predators. The Beaumaris box has a single narrow cavity which makes it suitable for crevice roosting bats. The interior of the box has a rough surface for bats to cling to and the front of the box features a subtle but attractive imprint of a bat in flight. It is suitable for attaching to external walls and available in two sizes: Midi and Maxi.
