## **ECOLOGICAL IMPACT ASSESSMENT**

### **FORMER YMCA IN MERTHYR TYDFIL**

### **MERTHYR TYDFIL COUNTY BOROUGH COUNCIL**

DOCUMENT REF: WWE19143 BAS REV A | 27/07/2020

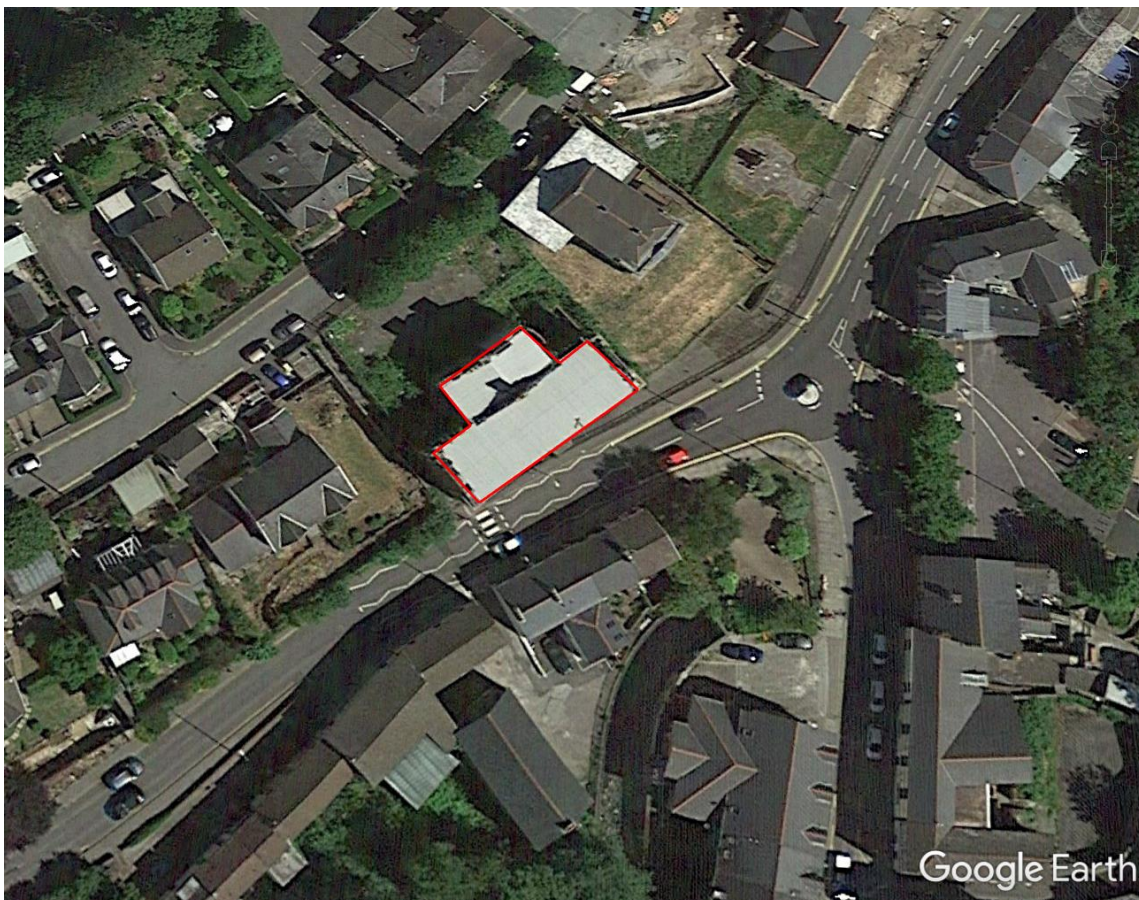
Figure 1 – Aerial image of the site (red line shows the site boundary). Image used under licence (©2019 Google). Imagery date 25/06/2018.

- 1.4 The aerial image of the site (Figure 1) shows the site to consist of a grade II listed building located within an urban setting in Merthyr Tydfil, with some scattered mature trees to the north. The building is vacant and in a state of disrepair, the building was made safe in 2014 when a temporary roof was installed to try and keep the building watertight until works on the building could commence.

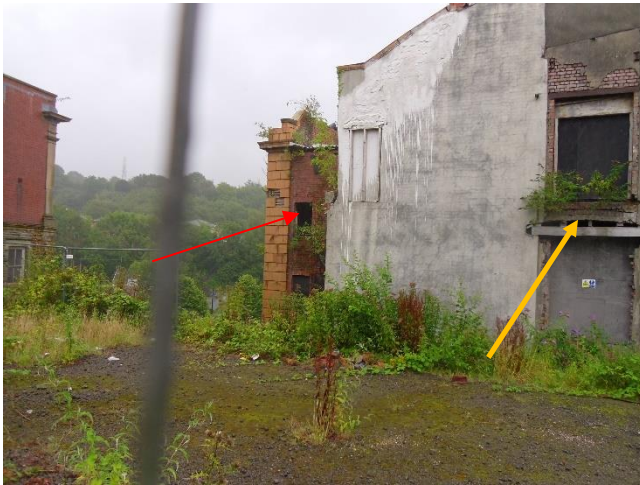
| Date | Species (number) | Roost type (number) | Roost location | Access points |
|---|---|---|---|---|
| 02/08/2019 | Lesser Horseshoe Bat | Night/feeding perch – transitional roost | Unknown | Through un-boarded window on the north eastern corner of the building (rear of building) |

Figure 4 - Un-boarded window that lesser horseshoe bat accessed the building at the rear of the property (red arrow), suitable bat access feature (orange arrow)

- The structure will incorporate a chimney/chute feature allowing bats to gain access to both upper and lower floors.
  - The bat access will be located on the north eastern aspect of the site where the lesser horseshoe bat was observed entering the building. The access will be 200mm x 400mm inside.

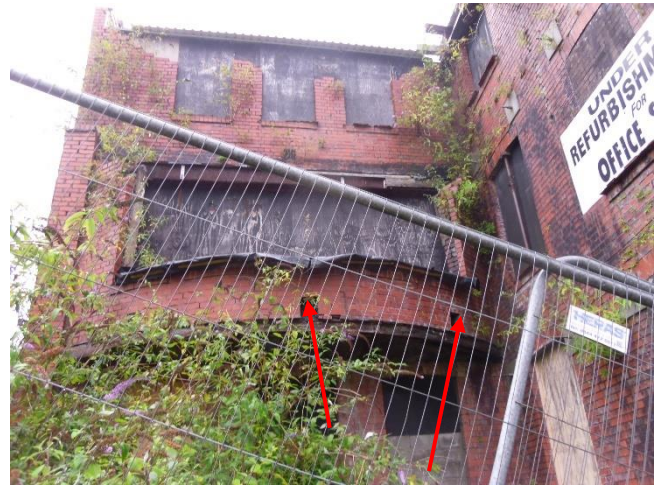
Figure 5 - Western aspect of the building. Arrows highlight suitable bat access and nesting bird features

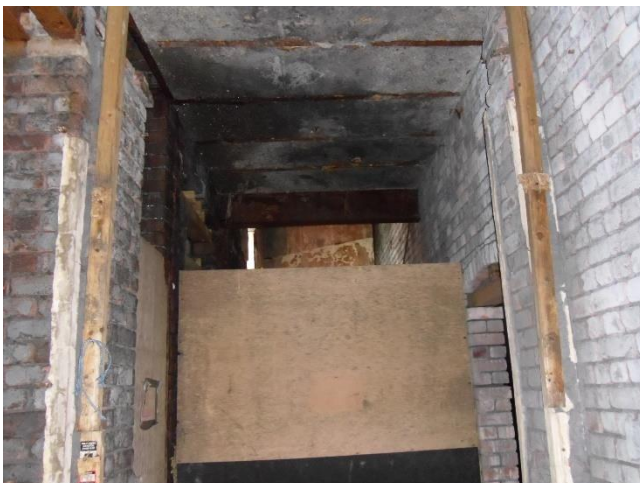
Figure 6 - North eastern corner of the building (Internal), location of where lesser horseshoe bat entered the building, blocking off human access into lift shaft.

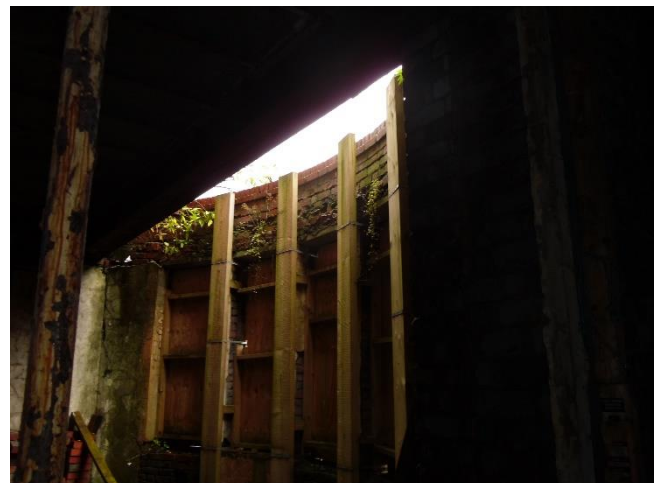
Figure 7 - Top floor at the rear of the building (internal image) - suitable bat access feature into the building

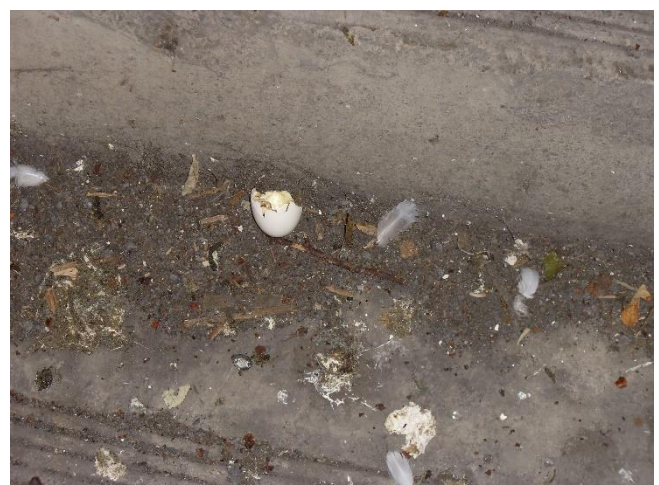
- 4.7 Several dead birds, broken birds eggs and large amounts of bird droppings were recorded within the building during the PRA.
- 4.8 Pigeons and jackdaw were recorded nesting within the building during the PRA and the bat activity survey.

Figure 9 - Broken birds egg within the building

- 5.15 In the event that work have to be undertaken during the nesting season (generally from 1st March until 31st August, although birds are known to nest outside of these dates in suitable conditions), a breeding bird survey will be required and must be carried out by a suitably qualified person. Any active nests identified should be protected until the young have fledged. Where a Schedule 1 species (as defined in the Wildlife and Countryside Act - <http://www.jncc.gov.uk/page-3614> is involved, compensation for impacts, e.g., loss of nesting sites, should be devised and implemented.

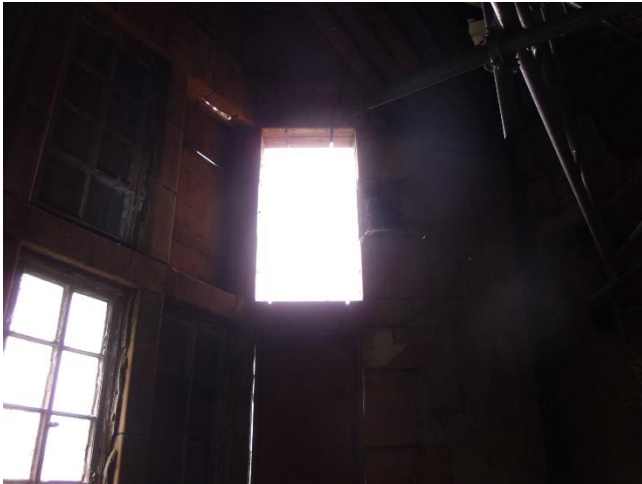
Figure 10: Broken window on top floor of building allow bird and bat access

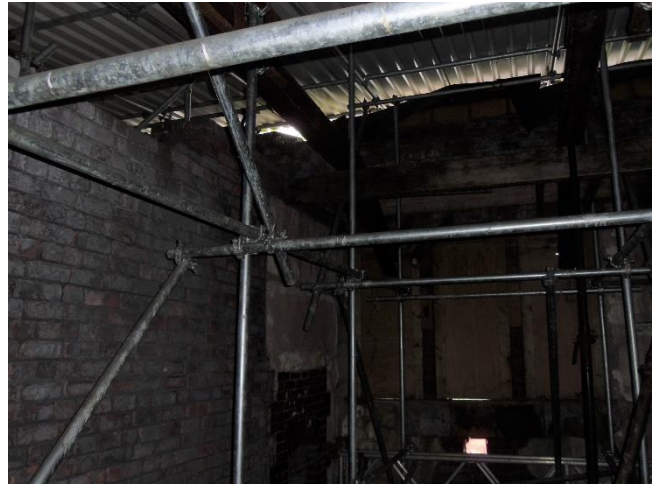
Figure 11 - Temporary roof to the rear of the building

- 5.10 Only BS747 Type 1F bitumen roofing felt or wooden sarking will be used to line the roof. Breathable membranes will not be used as they are detrimental to the welfare of bats and when used in bat roosts are known to lose their functionality over time.

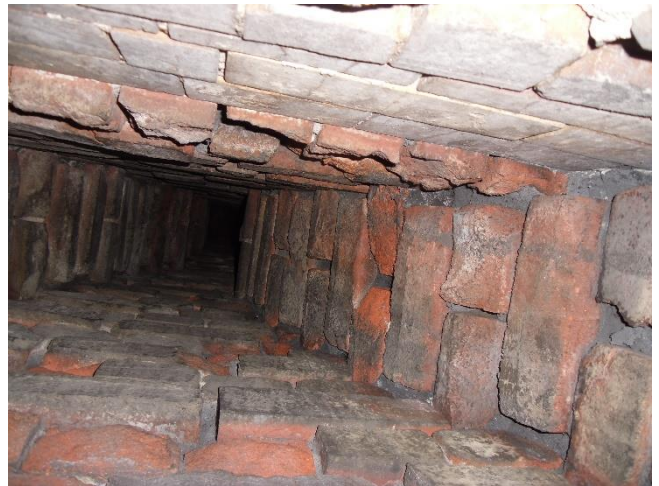
Figure 13 - Flue inside one of the many fireplaces within the building, suitable to support roosting bats

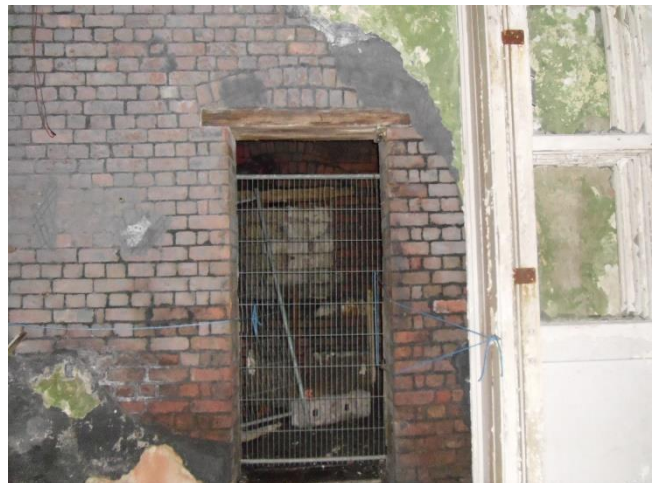
Figure 15 - Fenced off door at rear of building
