**Smart Electrical Systems,  
3-4 Phoenix Industrial Estate  
Goat Mill Road,  
Dowlais,  
Merthyr Tydfil**

**Preliminary Roost Assessment**

**August 2025 (V2)**

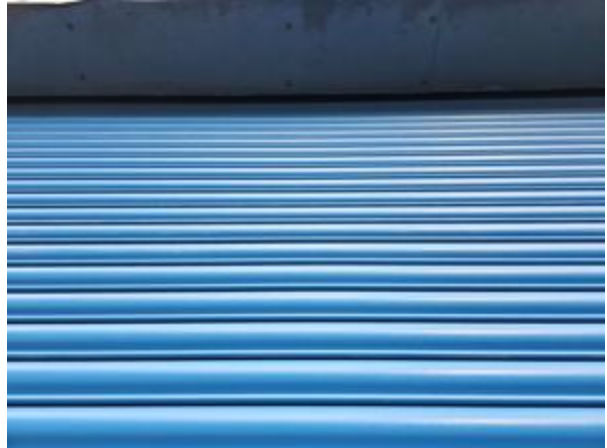
Photo 4: Shutter Door at the Southern Elevation

| Doors | The shutter door to the building is found on the southern front and is constructed of metal. The shutter door is in good condition with no gaps around it (Photo 4). |

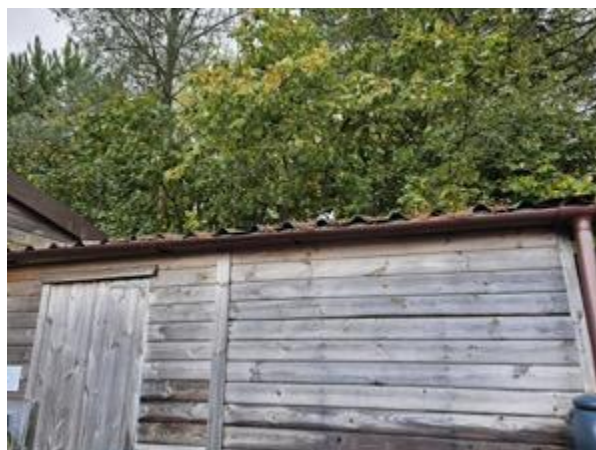
Photo 9: Roof at the North-Western Elevation

| External Walls | The walls are constructed of timber boards which are in good condition (Photo 9). |

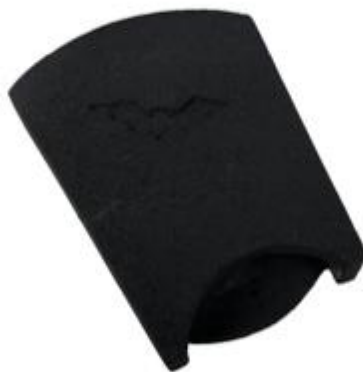
This bat box is made entirely from WoodStone, a robust material comprising concrete and wood fibres. This means that the box has excellent insulating properties maintaining a more consistent temperature throughout the year and provides excellent protection from predators. The Beaumaris box has a single narrow entrance, making it suitable for crevice roosting bats such as the common pipistrelle, soprano pipistrelle, Nathusius' pipistrelle, Brandt's bat and whiskered bat. The box's interior has a rough surface for bats to cling to and the front of the box features a subtle but attractive imprint of a bat in flight.

Suitable for attaching to external walls and should be sited as high up on the façade as possible, at a height of at least 3m from the ground. Avoid siting under artificial lights. Bats prefer to change roosts to benefit from varying ambient temperatures, so bat boxes should ideally be clustered in small groups.

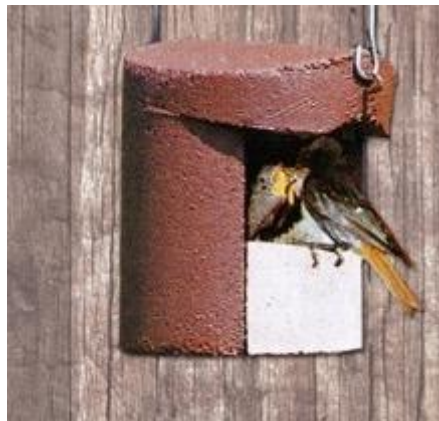
### Schwegler Bird Home

These should never be hung on trees or bushes as this could allow small predators to access the interior and predate nesting birds.

This nest box should always be installed on the external walls of houses, barns, garden sheds etc. It is designed to be hung so that the entrance is to one side (90° angle to wall).
