**CYFARTHFA DENTAL PRACTICE, ROOKWOOD HOUSE,  
GWAELODYGARTH LN, MERTHYR TYDFIL**

**INITIAL BAT INSPECTION SURVEY**

**SEPTEMBER 2020**

**Bat Survey Report**

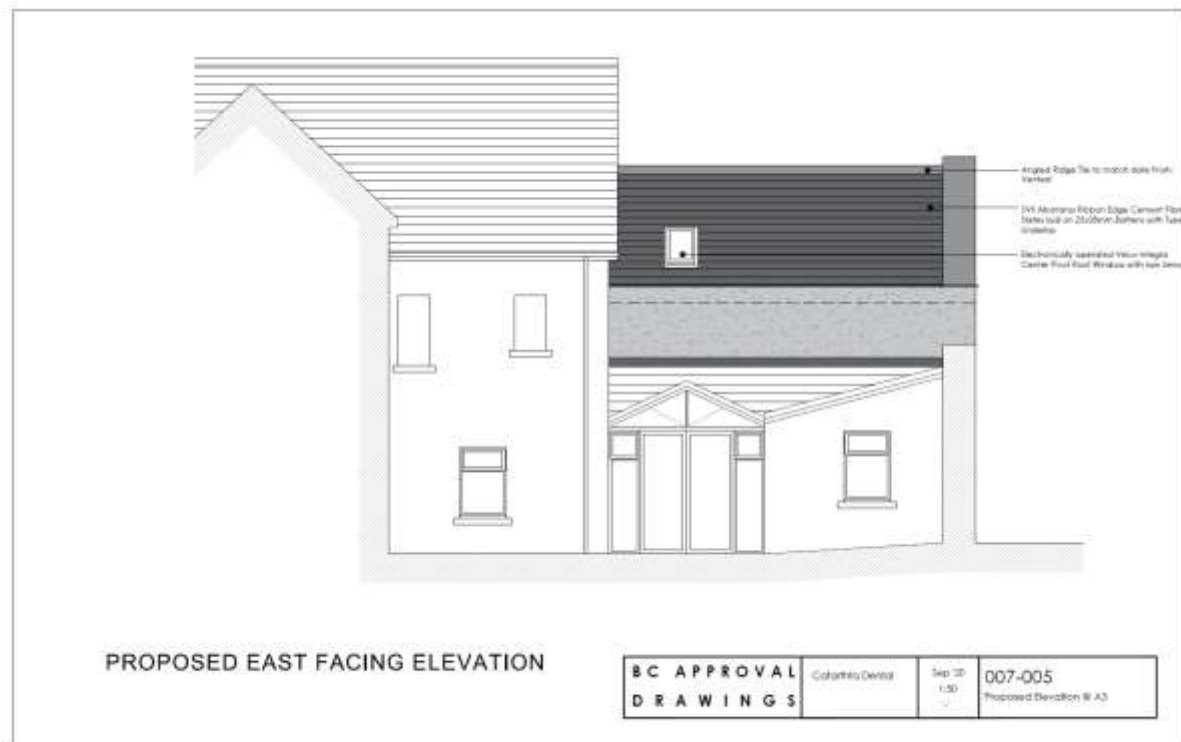
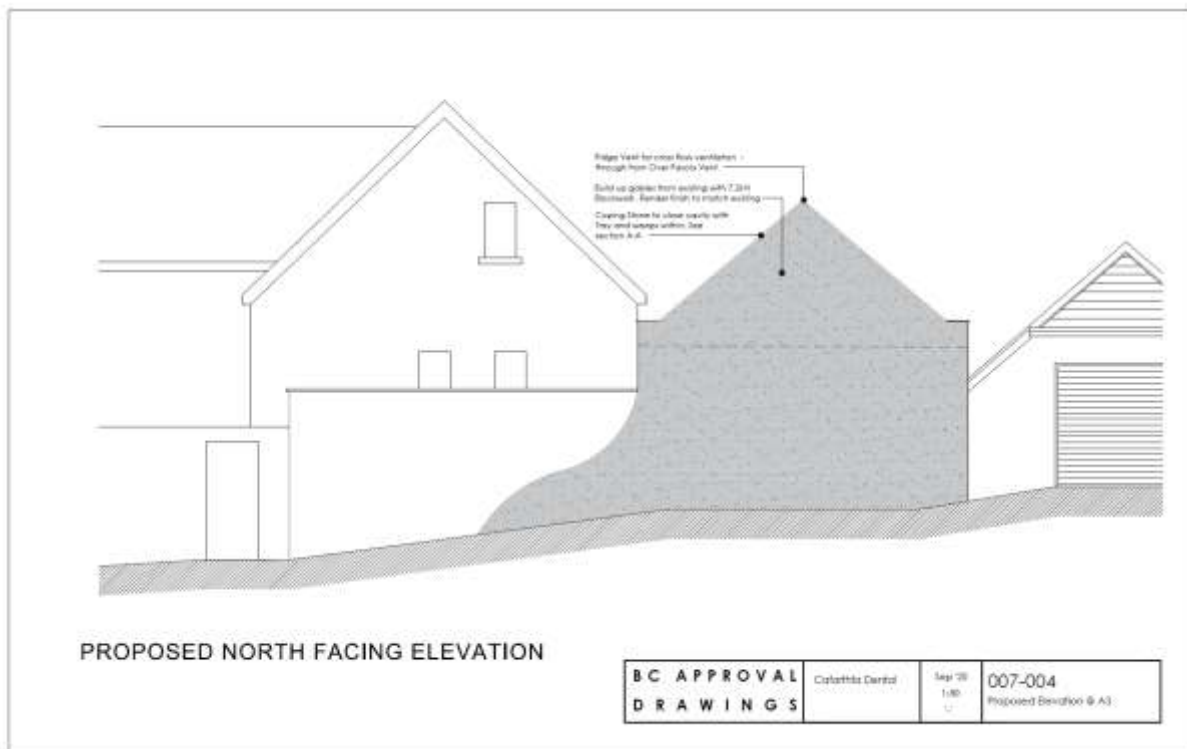
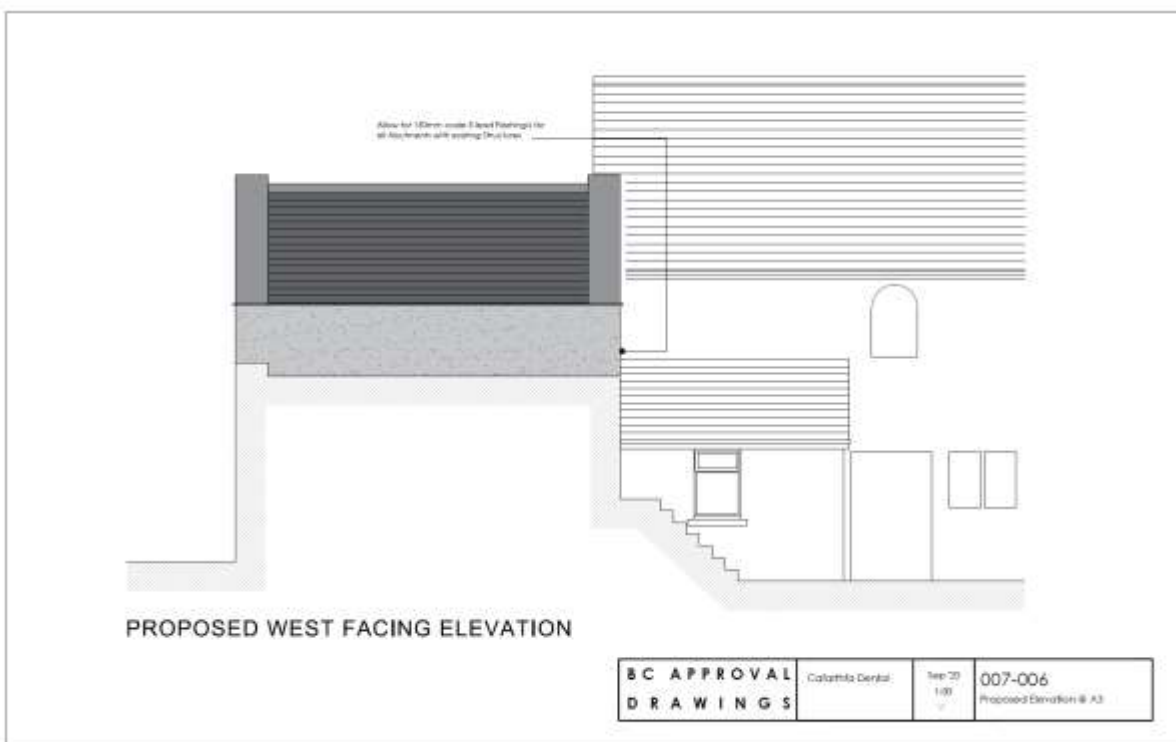
It is proposed to remove the flat roof and replace it with a new pitched roof along with other alterations and refurbishment.

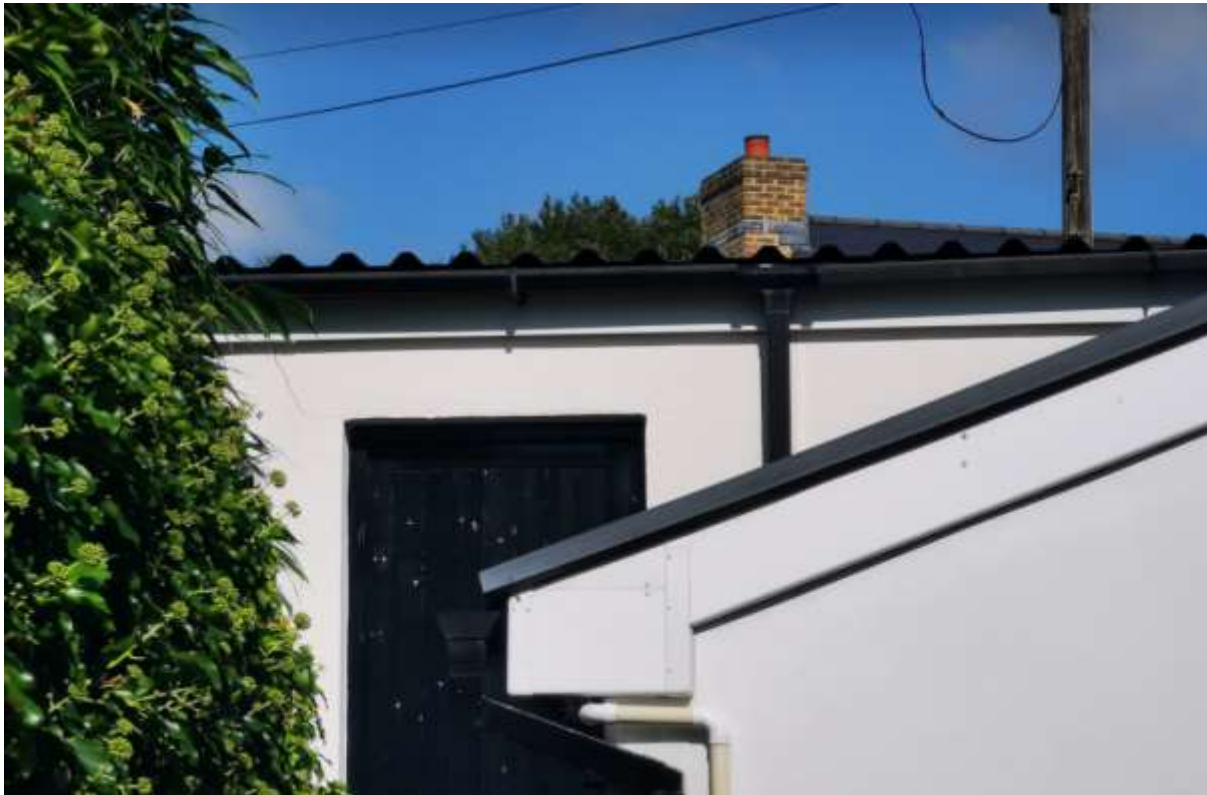
**Plate 1- Photograph of southern elevation**

There does not appear to be any access into the garage. It is possible that bats may fly through the gaps of the wiggly tin metal, however, this is considered unlikely. The fascia board on the southern elevation is tightly sealed to the wall. There is potentially a small gap above the roller shutter door, however, it is considered unlikely that it is a suitable access point for bats..

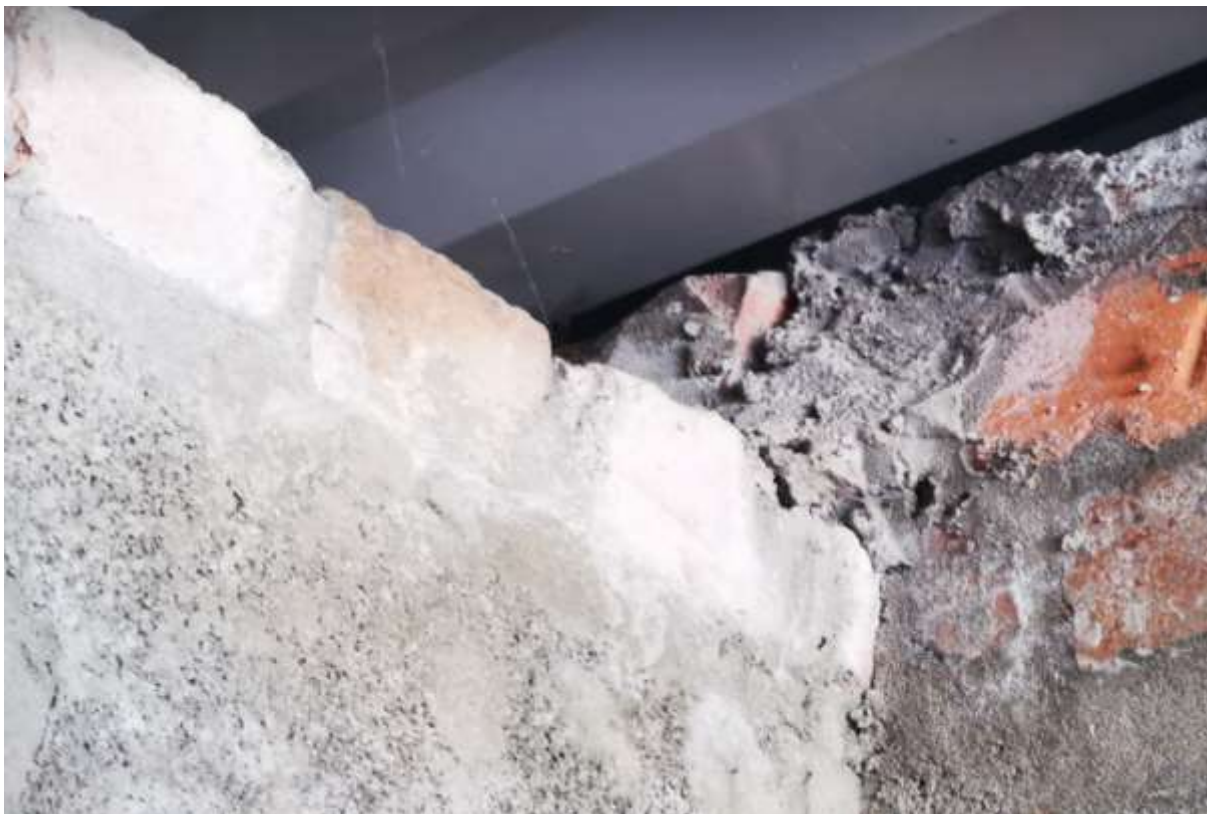
The wall plates are visible on the interior, however, there are no light ingress' within the building at wall plate level.

**Plate 2- Gaps at wall plate level with no light ingress'**

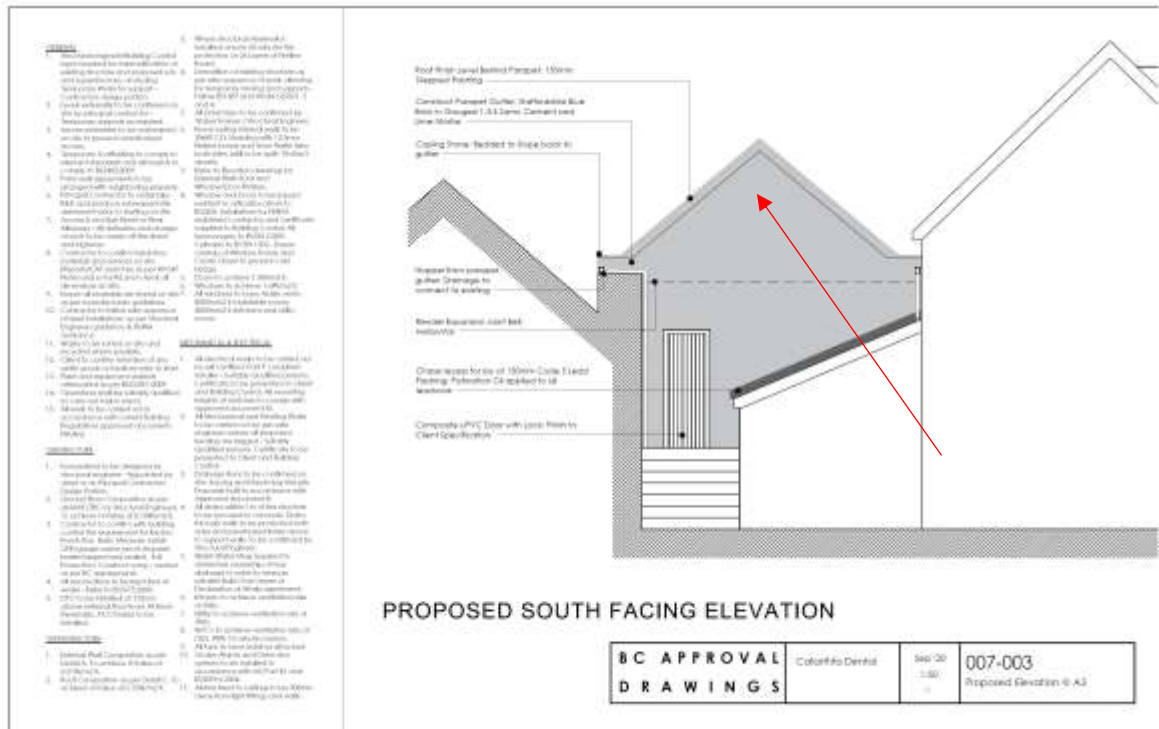
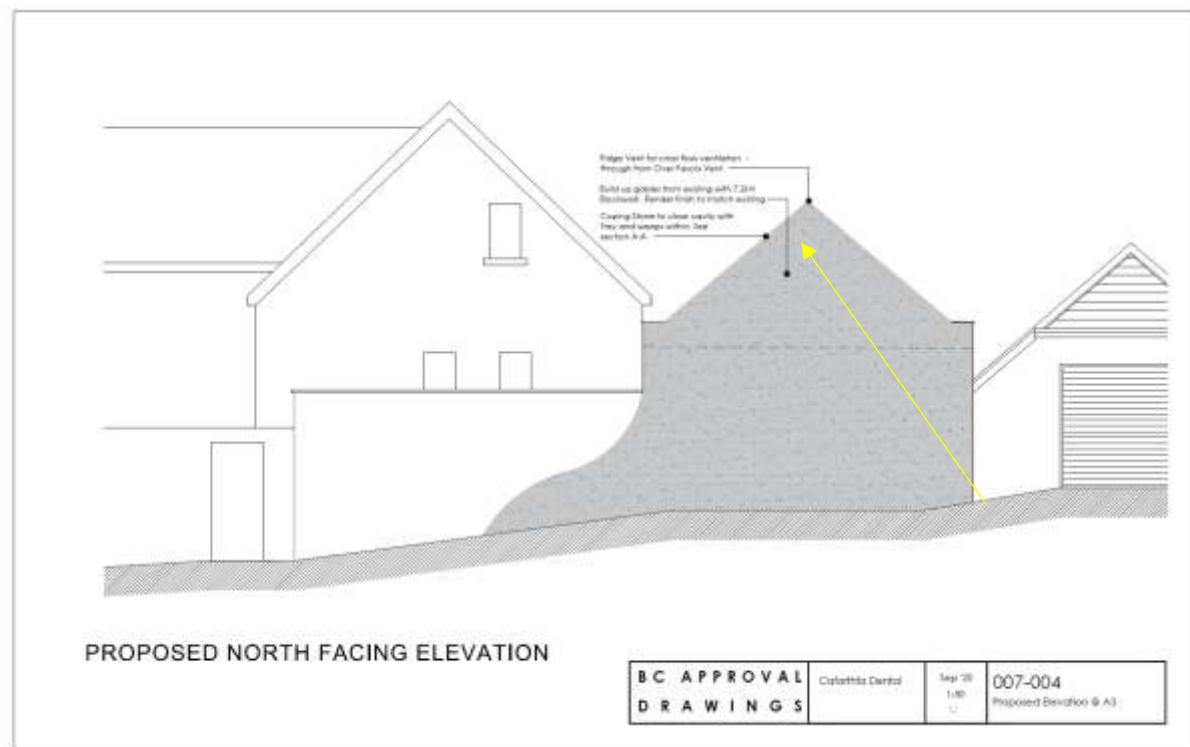
## APPENDIX B- SITE PLAN DETAILING ENHANCEMENTS (bat box arrowed red, bird box arrowed yellow)

A Schwegler 1FF bat box will be attached to the southern elevations of the property. Should the 1FF prove difficult to source, an eco bat box (crevice box) <https://www.nhbs.com/title?slug=eco-bat-box> will be installed in its place.

A Schwegler 1SP Sparrow Terrace or the following <https://www.nhbs.com/sparrow-terrace-nest-box> will be attached to the northern elevation of the property.
