# East Street, Merthyr Tydfil

**Title** Ground Conditions Assessment Report

Merthyr Tydfil Housing Association are proposing to redevelop a vacant plot of land off East Street, Dowlais, Merthyr Tydfil with the construction of one and two storey residences. To assist with the development of the site proposals, Jubb Consulting Engineers (Jubb) have been appointed to undertake a geotechnical and geo-environmental assessment of the ground conditions.

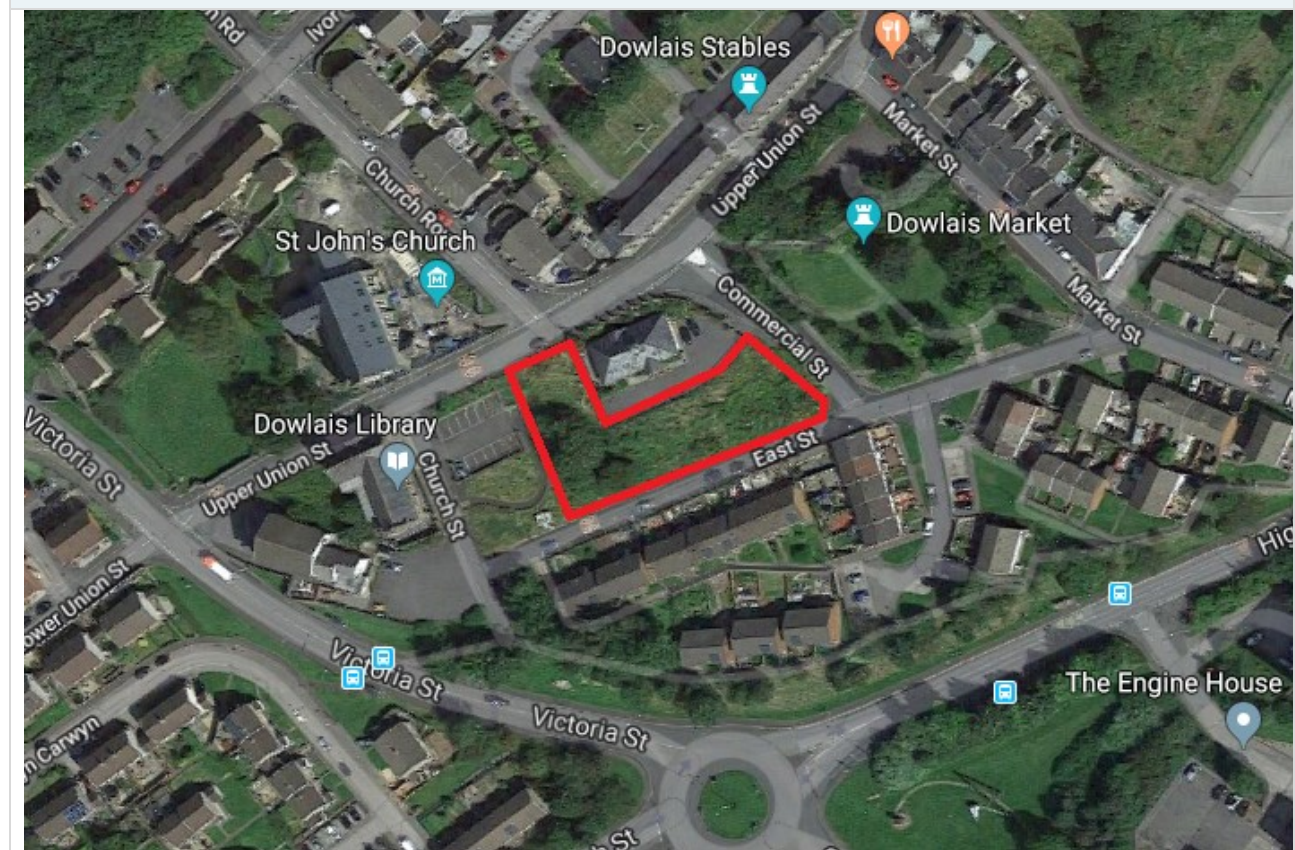
Figure 1: Site Location

The site is located on a patch of open grassed land off East Street in the village of Dowlais situated approximately 2.5km to the north east of Merthyr Tydfil town centre.

The Ordnance Survey (Landranger) grid reference at the centre of the site is SO 0671 0781.
