**TREHARRIS LIBRARY, TREHARRIS, MERTHYR TYDFIL**

**BAT SURVEY  
ISSUE 1, VERSION A**

**TREHARRIS LIBRARY****Bat Survey Report**

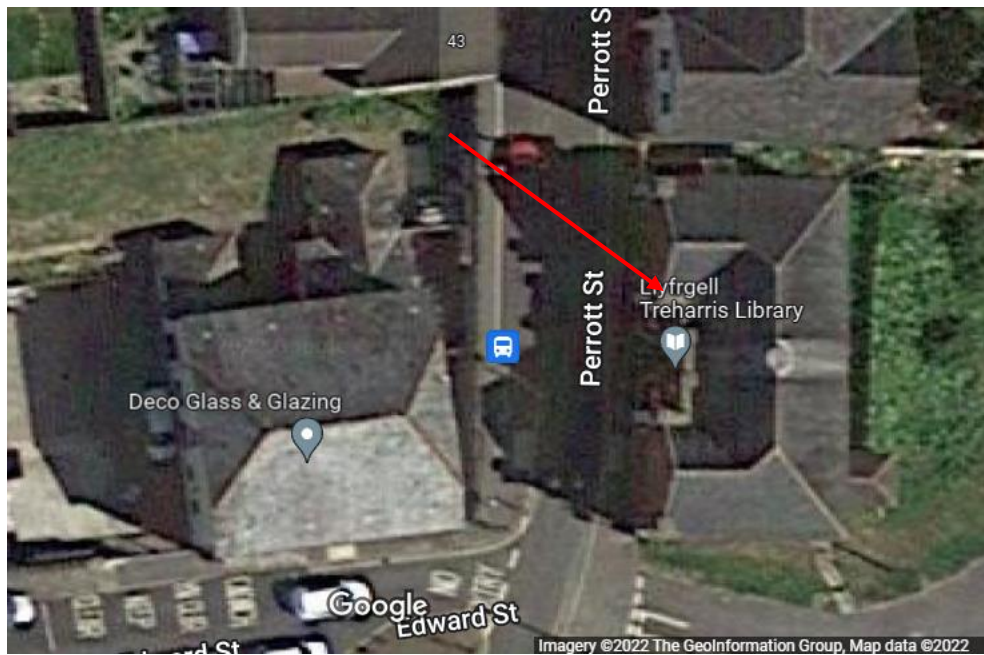
**Figure 1: Building (arrowed red) (Google Maps 2022)**

The property subject of this survey is located at Treharris Library, Treharris, Merthyr Tydfil (Figure 1).

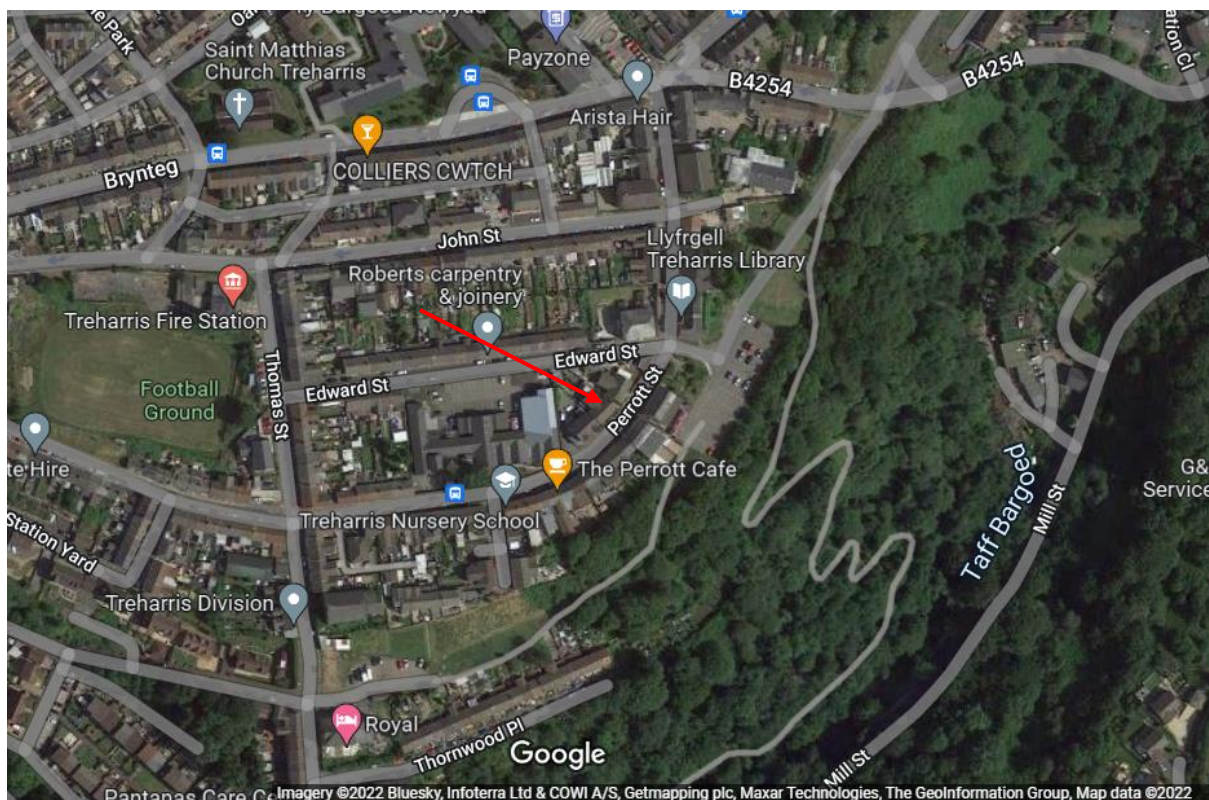
**Figure 2: Detailed view of property (Image courtesy of Google 2022)**

The property is a Grade II Listed Building that is comprised of brick beneath a pitched slate roof. The property is a U-shaped building with the main ridge running from north to south, there are various hips running from the main ridge. Generally the brick work is well pointed with a number of pillars attached to it. There are gutters present but no fascias or barge boards as such. There are two gables on the property that face west.

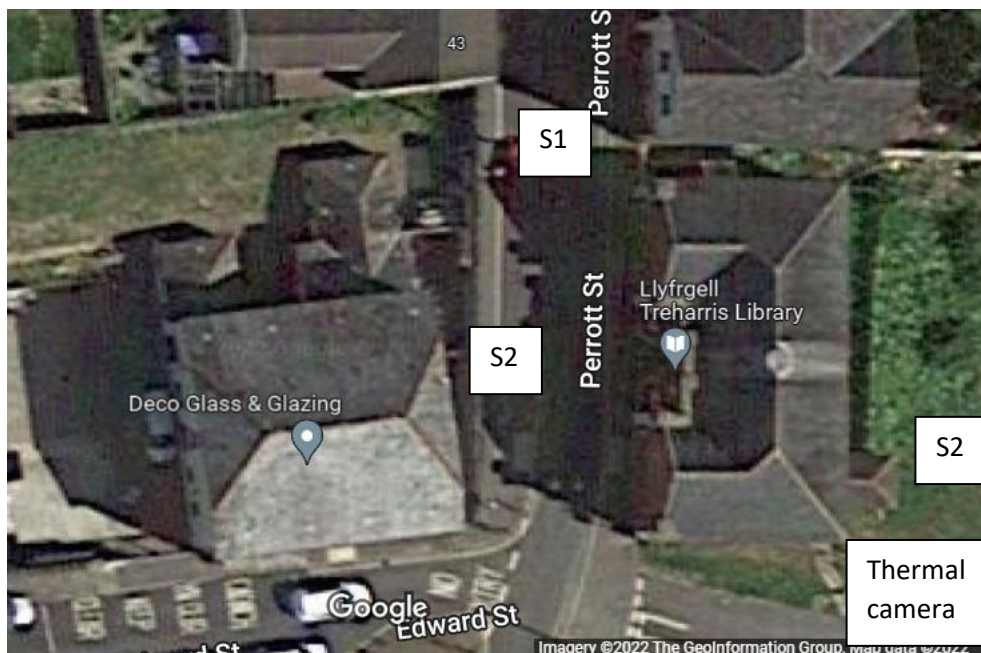
Figure 3: Approximate surveyor locations

A dusk survey was carried out on 6<sup>th</sup> June 2022 using surveyors and a thermal imaging camera, positioned in such a way that as much of the building was visible to surveyors as possible. Surveyors and cameras were equipped with Batlogger M detectors.
