**68 High Street,  
Merthyr Tydfil**

**Preliminary Roost Assessment**

**July 2024**

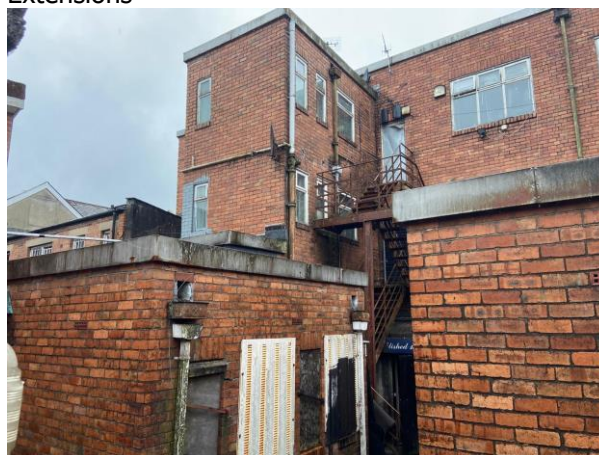
Photo 2: Eastern Rear Showing Single-storey Extensions

| Soffits, Fascias and Bargeboards | The metal trim on all elevations is generally in good condition, however, it is lifted in some areas (Photos 2, 4 & 13). There is a gap in the soffit on the eastern rear of the main section of B1 (Photo 7). Additionally, there is a large area of lifted trim on the ground floor of the rear (Photo 13). However, this not considered suitable for roosting bats due to its open nature and lack of protection from the elements. |
| External Walls | The external walls are in good condition and are free of cracks or crevices that could be utilised by roosting bats (Photo 2). |

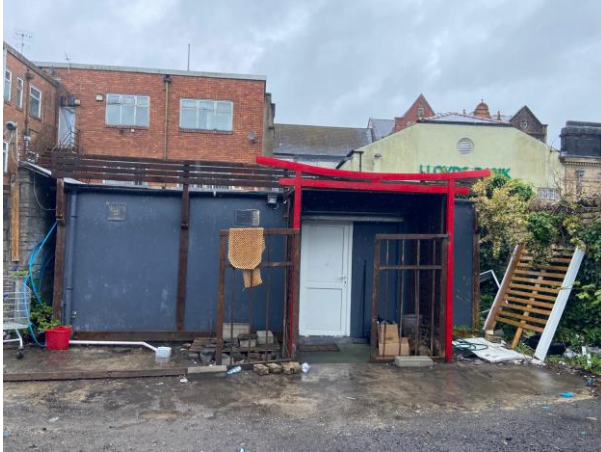
Photo 3: Additional Single-storey Extension to the Rear

| Roof | The main three-storey section of B1 and the single-storey extension which adjoins the eastern rear have flat, concrete roofs with a metal trim around the edge (Photo 4). An additional single-storey extension exists on the northernmost side of the rear. The roof of this extension is comprised of bitumen felt (Photo 6). There are no obvious gaps or holes within any of the roof areas which could be utilised by roosting bats. |

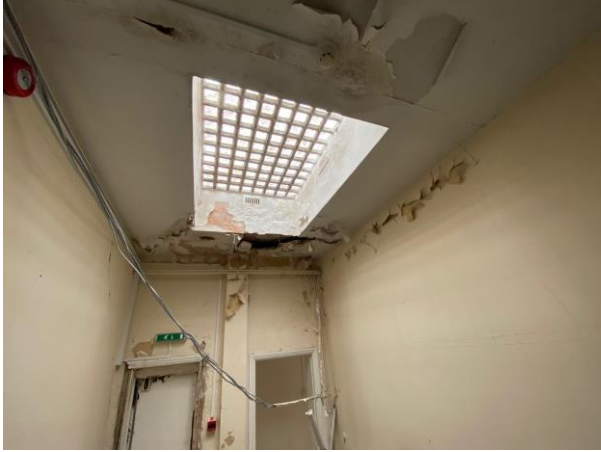
Photo 5: Internal View Showing Stairwell Open to the Ceiling

| Roof Void | There is no roof void present. The upper floor is open to the ceiling (Photo 5). |
| Roof Lining | There is no lining present (Photo 5). |

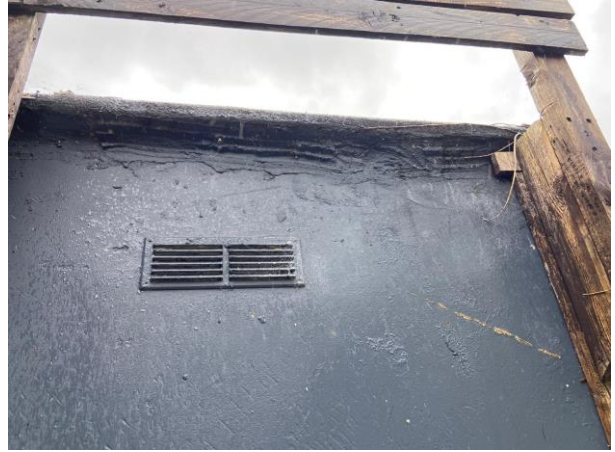
Photo 6: Easternmost Single-storey Extension Showing Vent Bitumen Felt Roof

| Vents | Vents are present on the eastern, southern, and western elevations of the single-storey extensions (Photos 6 & 8). These gaps could be utilised by roosting bats. There is a broken vent guard revealing a deep hole on the eastern rear (Photo 13). |

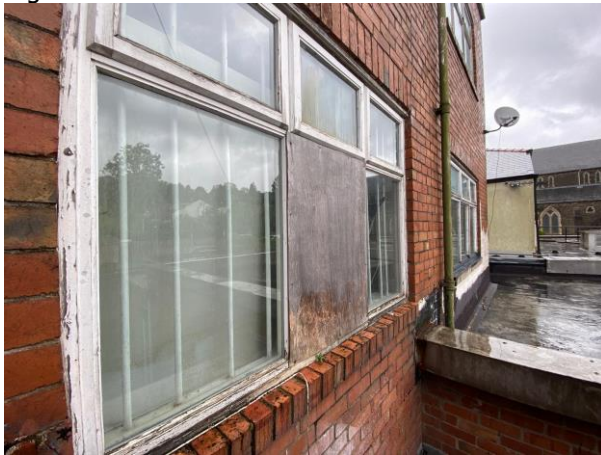
Photo 9: Example of Windows With Timber Frames Tight to the Exterior Wall

| Windows | The windows have timber frames, are well-sealed and tight to the external wall on all elevations (Photo 9). Some of the window frames are damaged where the timber has rotted away (Photo 10), however, there are no gaps that are suitable for use by bats for roosting. The doors have metal frames, these are in good condition and well-sealed (Photo 11). The metal trim above the door on the eastern rear is damaged with a large open gap (Photo 11) this could potentially be used by bats for roosting, however, it is considered to be a sub-optimal feature. |

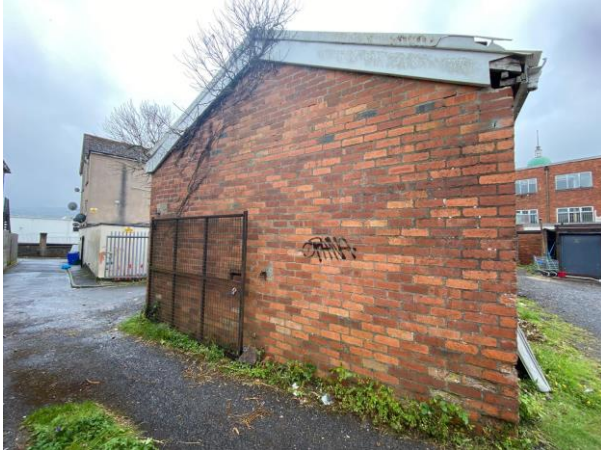
Photo 14: Eastern Elevation

| Building Type | B2 comprises a single-storey brick and mortar storage building that is attached to B1 by an extension between the two buildings (Photos 14-17). Sections of the eastern elevation are of breezeblock construction (Photo 16) and a section of the western elevation that encompasses the extension joining B1 and B2 together is rendered (Photo 17). |

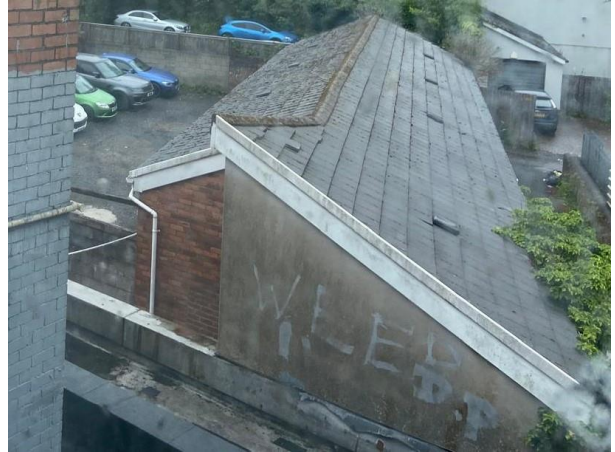
Photo 17: Western Elevation and View of the Roof

| Roof | B2 has a dual-pitched roof, with the central ridge running along an east to west axis, and is constructed from concrete roof tiles with concrete ridge tiles (Photo 17). The roof is in good condition, with well aligned tiles absent of gaps. The edge tiles at the gable ends are capped with a uPVC trim (Photo 14 & 17). The uPVC trim is broken on the northeastern and southeastern corners of B2 exposing gaps that could potentially be used by bats to gain entry into the interior of the building (Photo 18). |

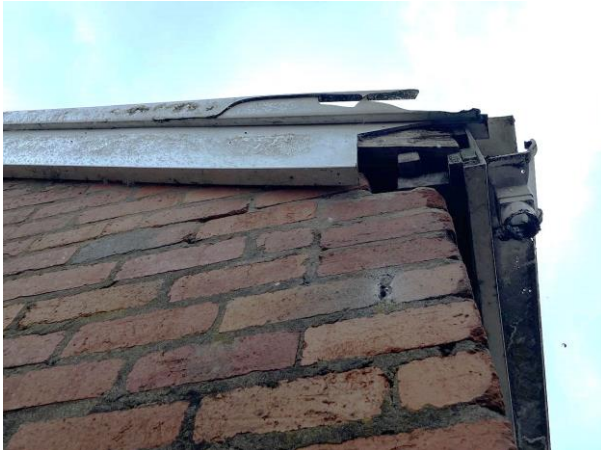
Photo 18: Broken uPVC Plastic Trim on the Eastern Elevation

There are numerous potential access points for bats to gain entry into the interior of B2. Bats could gain entry through the raised fascia on the northern elevation, the broken uPVC plastic trim on the eastern elevation (Photo 18), the lifted uPVC bargeboard on the eastern elevation (Photo 19), and the vents on the northern and southern elevations (Photo 20).

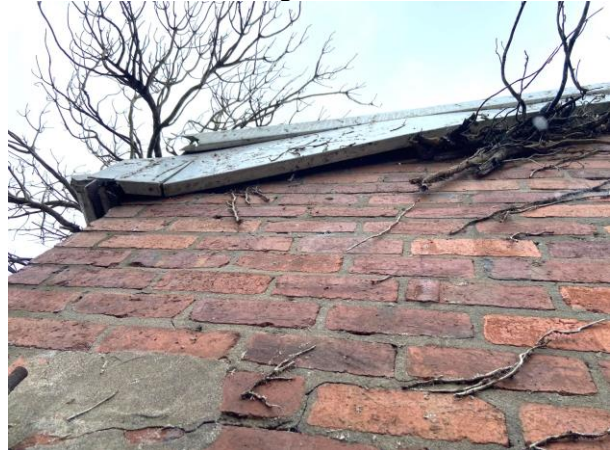
Photo 19: Lifted Upvc Bargeboard on the Eastern Elevation of the Building

| Soffits, Fascias and Bargeboards | The uPVC bargeboard on the eastern elevation is in poor condition with large gaps on the eastern end and is lifted from the external wall in its entirety creating gaps that could be used by bats to gain entry into the interior of B2 (Photo 18). The uPVC plastic fascia on the northern elevation is also lifted from the external wall along much of the length of the building, creating large gaps that could be used by bats to gain entry into the voids within B2 (Photo 20). |

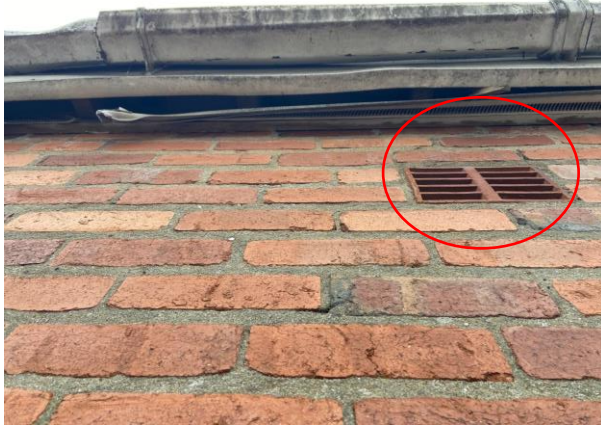
Photo 20: Lifted Fascia on Northern Elevation Showing Example of Vents (Circled)

21), gaps behind the lifted fascia on the northern elevation (Photo 20), the broken uPVC plastic trim on the eastern elevation, and the lifted bargeboard and fascia providing access to the multiple voids;

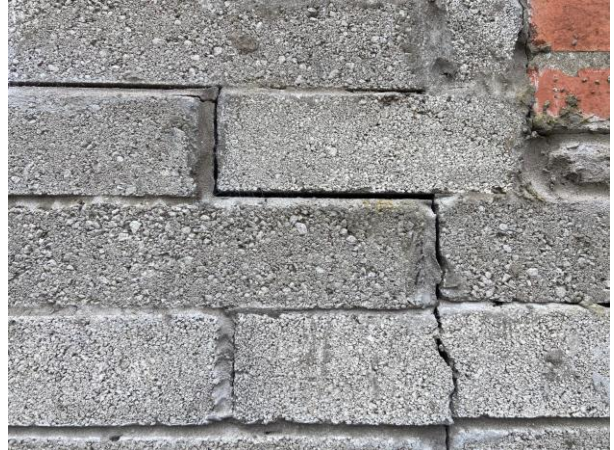
Photo 21: Large Crack in Breezeblock Section on Northern Elevation

| External Walls | The external walls are generally in good condition (Photo 14-17), however, there is a large crack in the breezeblock section on the northern elevation (Photo 21). |

- PRF 1 – The large crack in the breezeblock section of the northern elevation (Photo 21);
- PRF 2 – The eastern interior section of the building (Photos 25 & 26); and
- PRF 3 – Within the voids.

The large crack in the breezeblock section of the northern elevation of B2 creates a crevice that could potentially provide a hibernation site for bats. However, a full assessment of the potential for winter use (i.e. hibernation) will be undertaken after the completion of further dusk emergence surveys.

The following work could have an impact on bats and should not take place until the surveys recommended above have been completed and/or an ecologist has been consulted: The demolition of B2 and any works affecting the PRFs identified on B1.

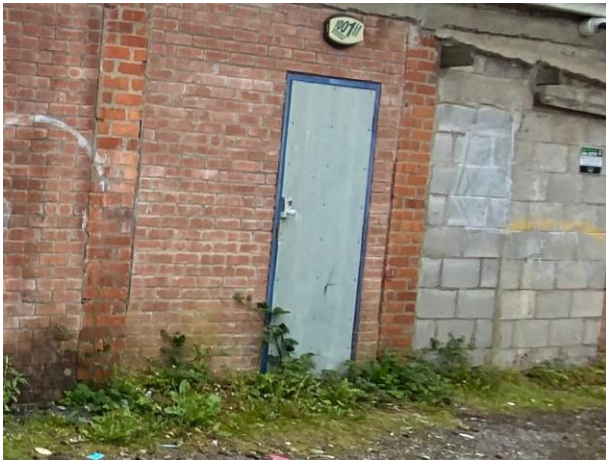
Photo 22: Door on Northern Elevation

| Windows and Doors | No windows are present on B2. There is a door on the northern elevation, it is well sealed and sits tight to its frame (Photo 22). There are roller shutter doors to the front, these are well sealed and tight to their frames. |

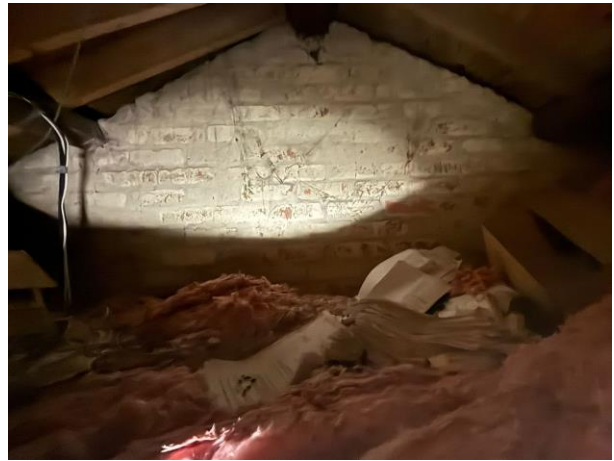
Photo 23: Internal View of Void Showing Dividing Wall

| Roof Void | There are four voids present in B2 separated by three dividing walls (Photo 23). Light was emanating from the eaves on the northern side of both loft voids (Photo 24), this correlated with the lifted fascia seen externally on the northern elevation and it is assumed that this would be consistent through the easternmost loft void that could not be inspected due to restricted access. These gaps could potentially be used by bats to gain entry into the void. The easternmost section of the building does not have a void, with the single-storey structure open to the roof (Photo 25). |

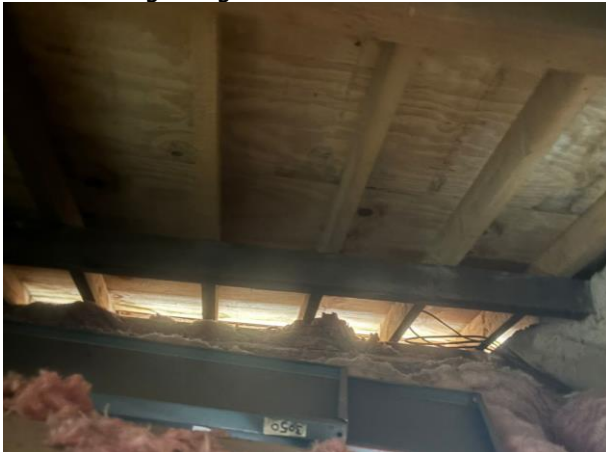
Photo 24: Light Ingress

| Roof Construction | The roof is supported on traditional, rough sawn timbers with associated timber purlins and rafters (Photo 24 & 25). |
