**From:** denis.canney@sky.com  
**Sent:** 29 September 2023 15:36  
**To:** Chard, Nia  
**Cc:** Denis Canney  
**Subject:** Planning reference P/22/0119 Roof Extension, Pontygwaith Farm, Treharris  
**Attachments:** 1136 Pontygwaith Farm, Treharris Bat Survey v2 - Sept 2023.pdf

**PONTYGWAITH FARM, TREHARRIS**

**BAT SURVEY REPORT**

**September 2023**

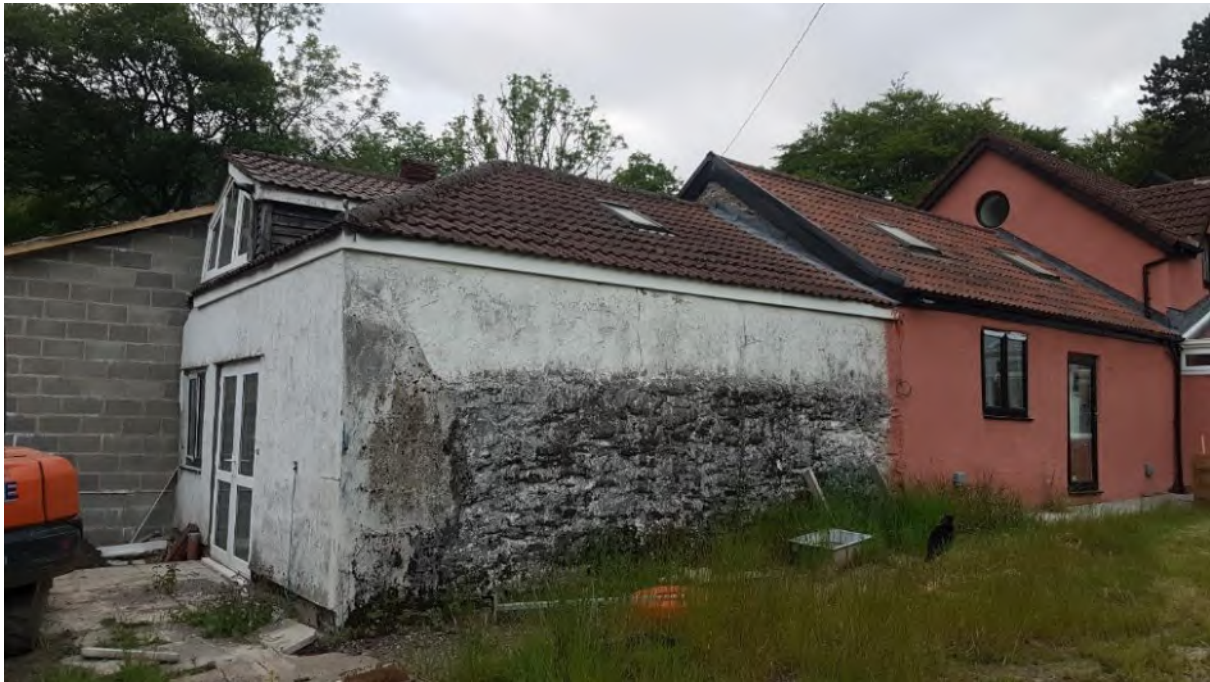
1) Southeast elevation – showing gym (white building) and family room (reddish building)

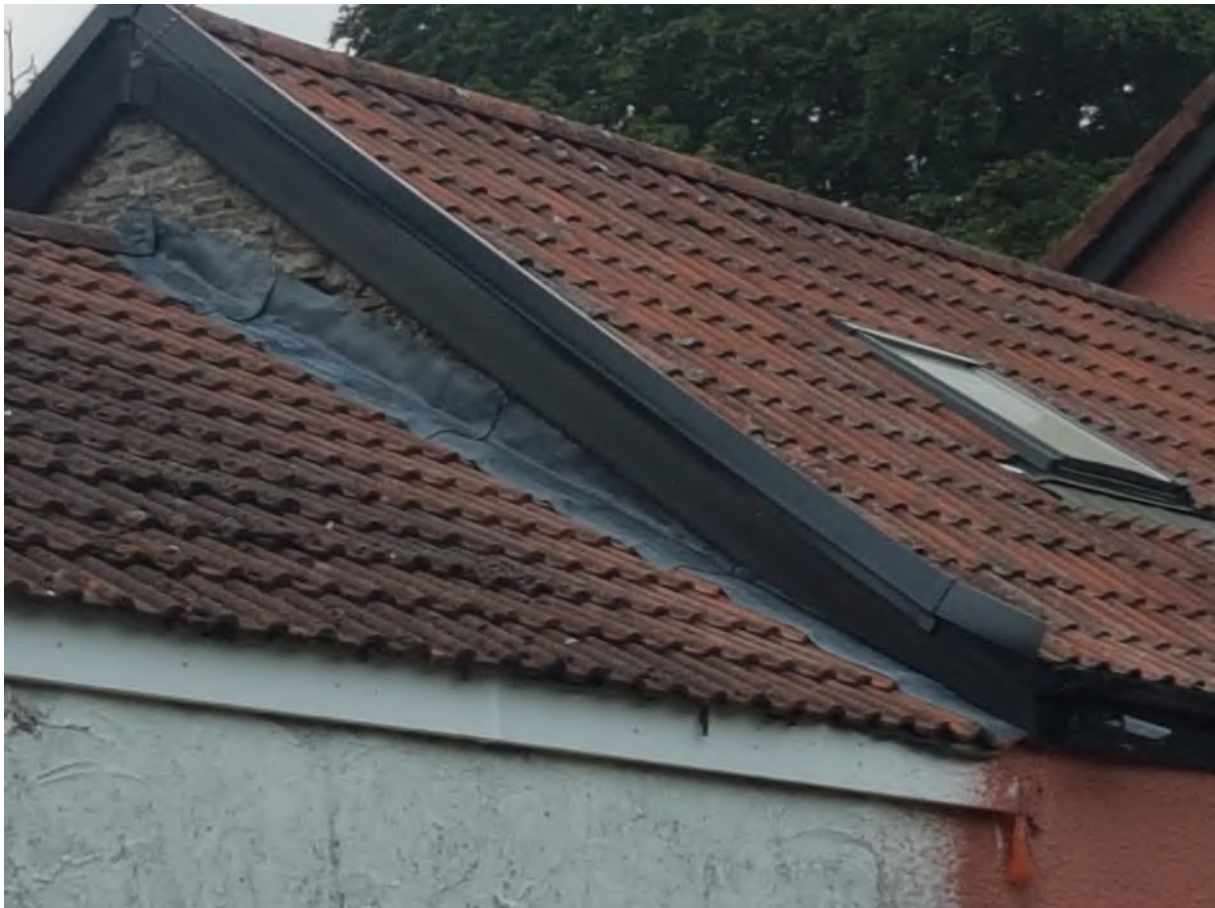
2) Gable end of family room section

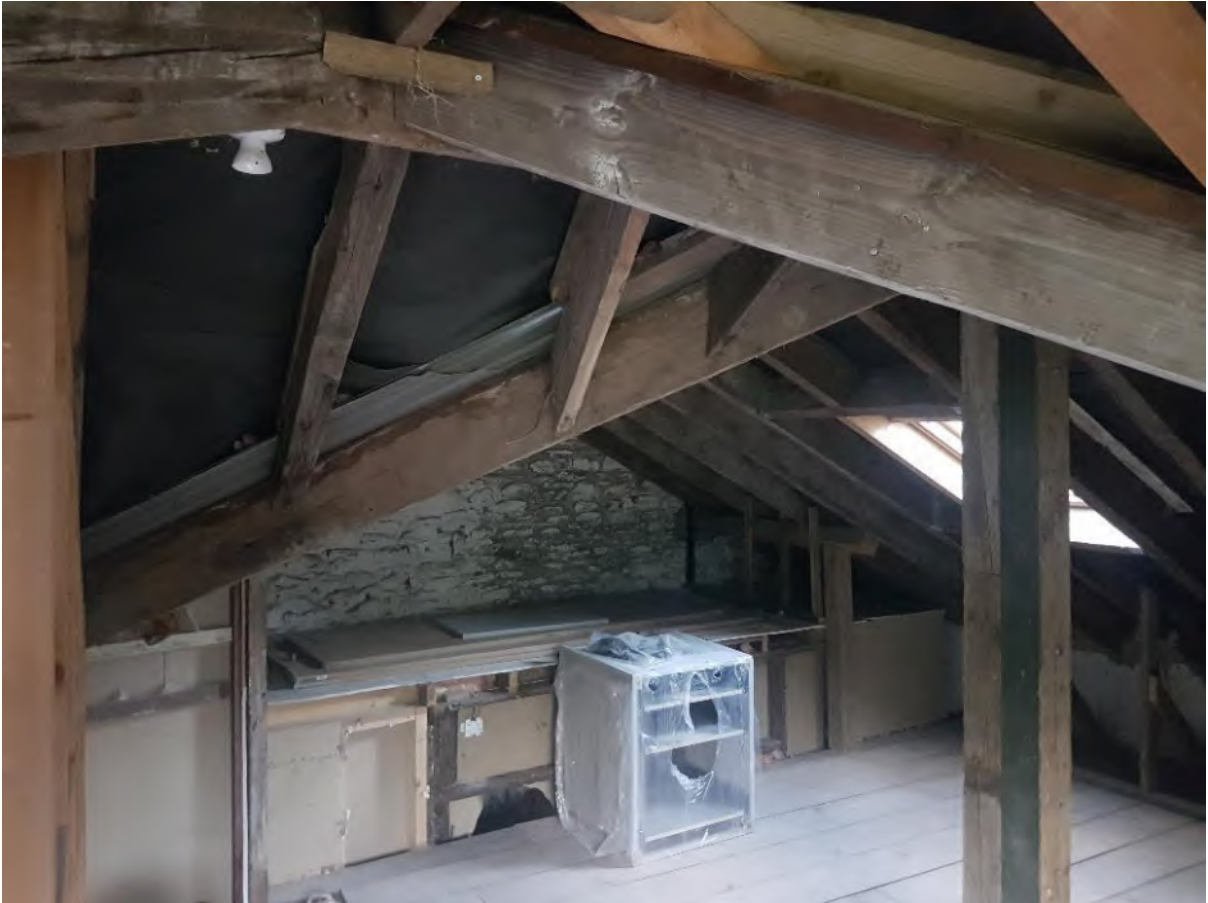
*Photos of the attic space above the gym – Photo number 3 in the original report was mislabelled, sorry. This shows the attic space above the gym, which is currently used as a study. The family room is open to the roof, so there is no attic above this room. Table 1: Building Inspection results has been adjusted to clarify this. Appendix 2 has been added to show the existing ground floor and 1st floor building layout.*

3) Study in loft above gym

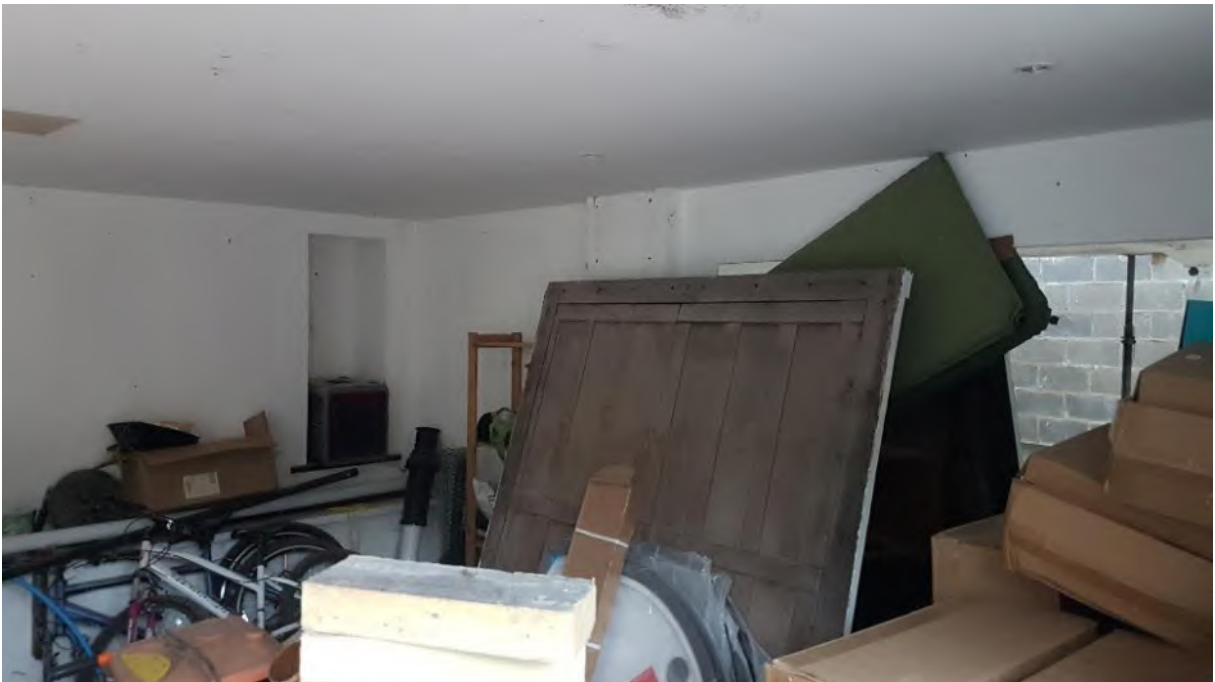
4) Internal area of gym

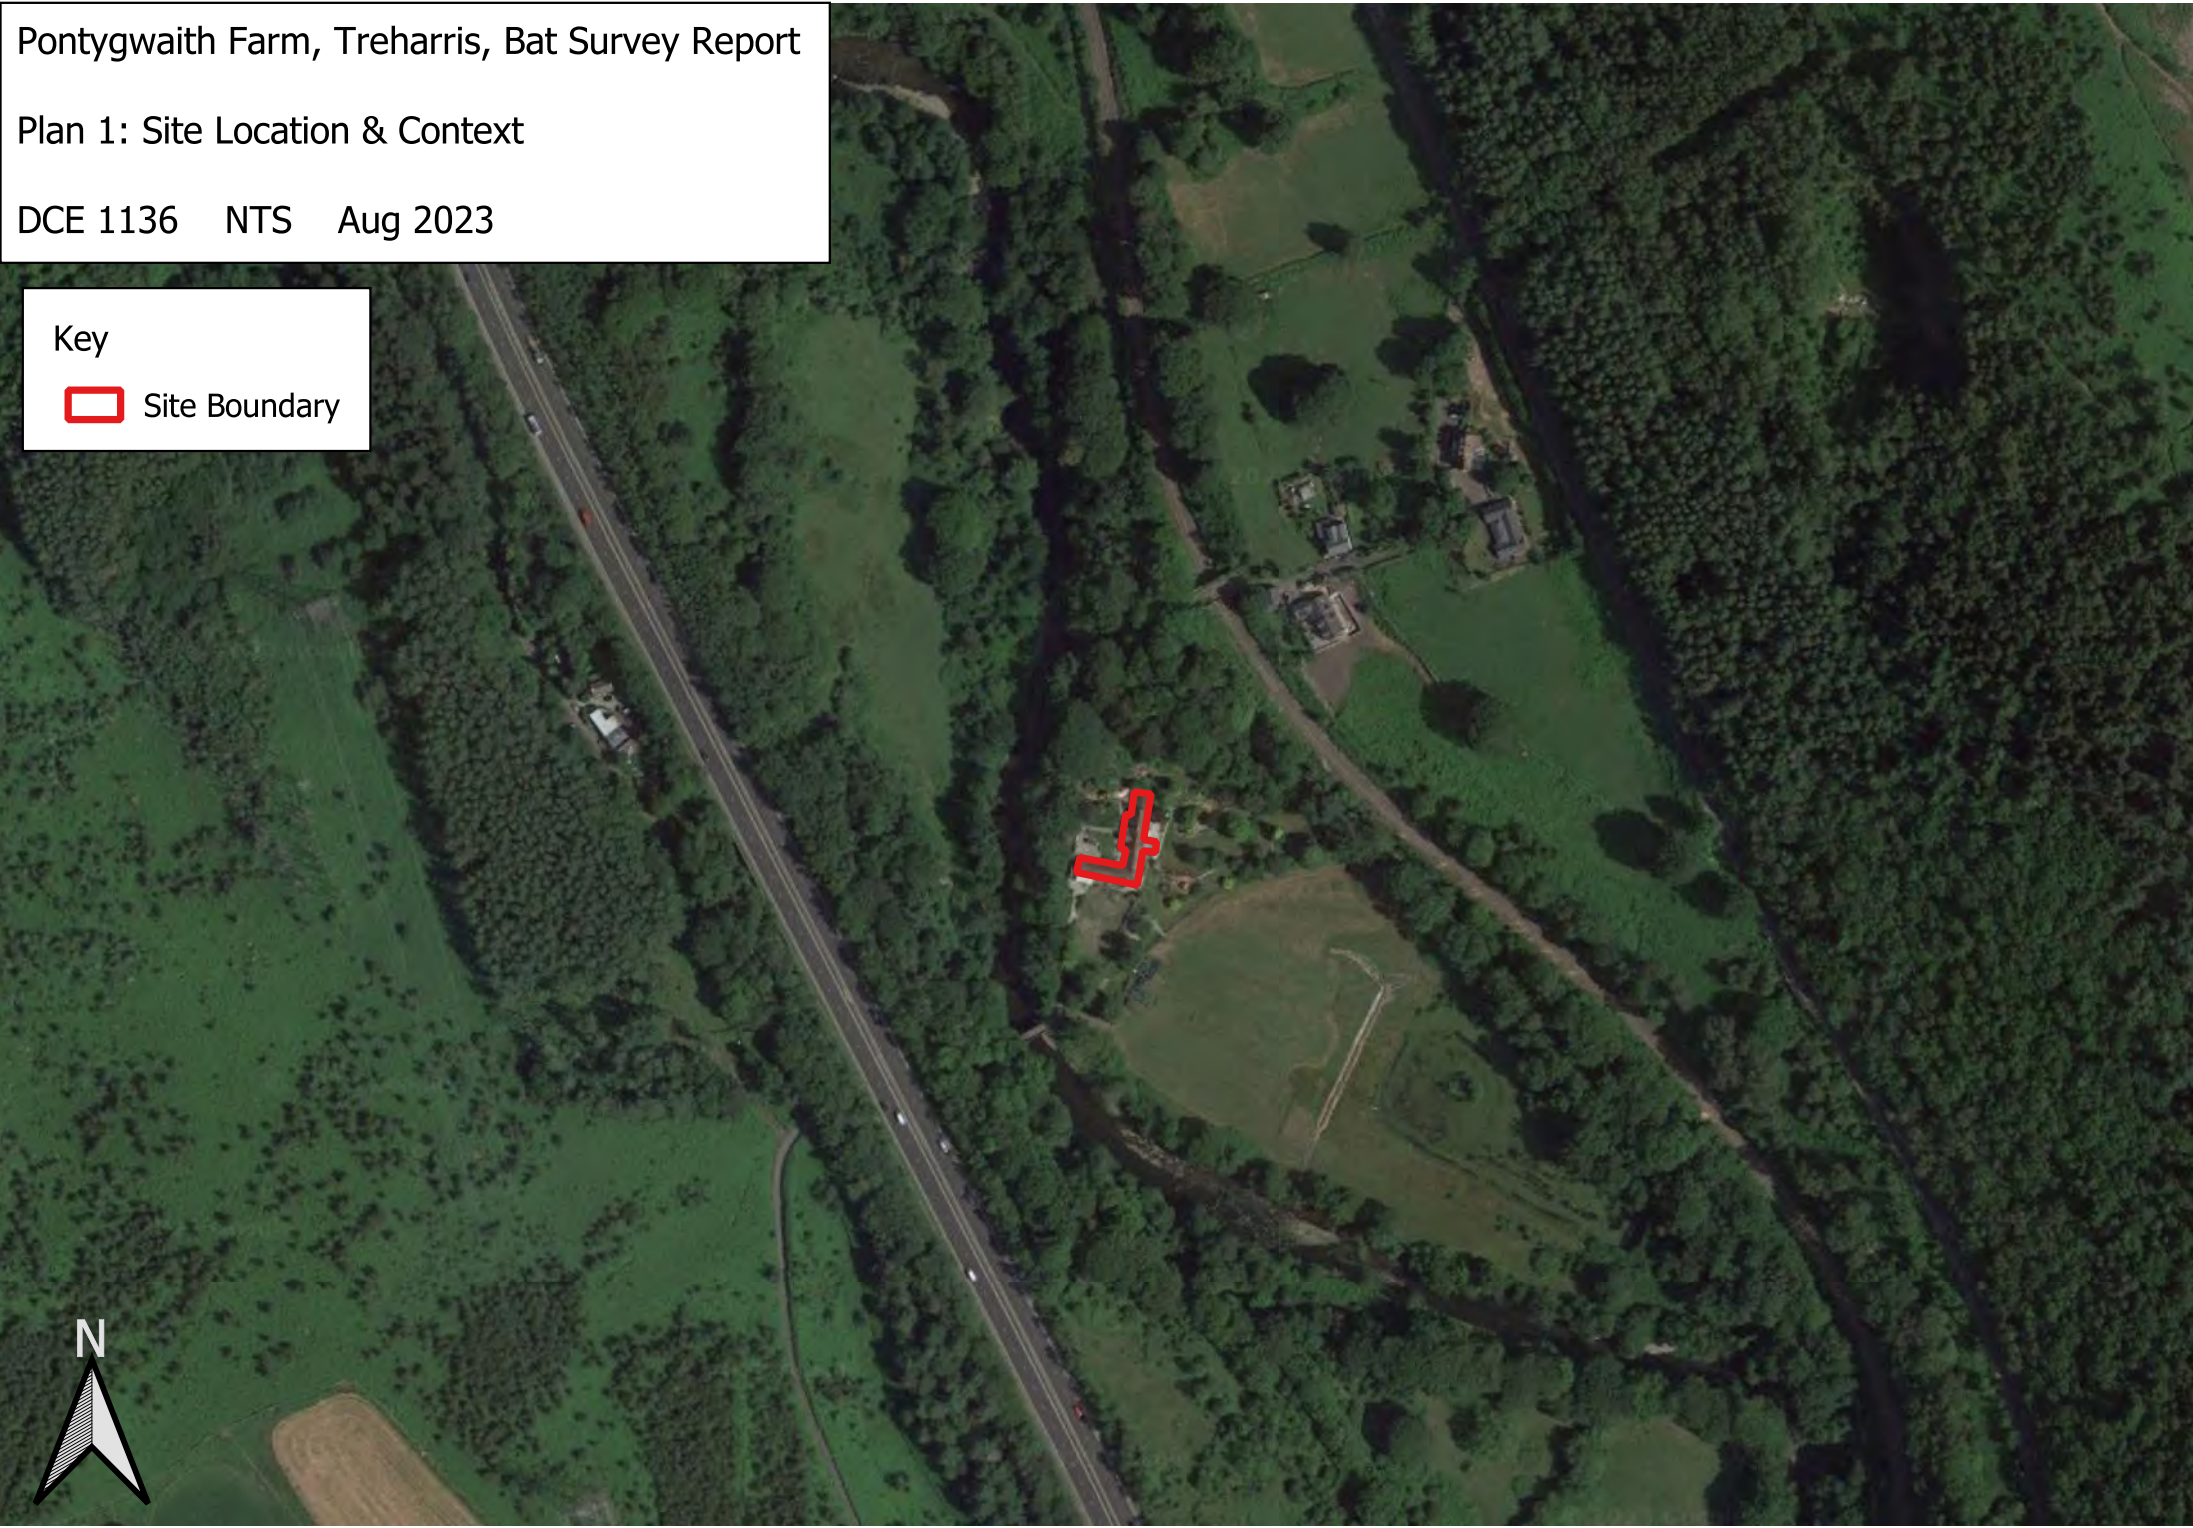
Plan 2: Site Plan

- 3.2.1 The two southern-most sections of the main farmhouse building (the gym and family room areas) will be affected by the currently proposed development. (See Plan 2). Only these sections were surveyed on this occasion. The gym is adjacent to the stables which was subject to previous surveys for bats and nesting birds (DCE 2021; Acer 2021). The potential attractiveness of these sections for bats and nesting birds was assessed and the results described in Table 1 below.
- 3.2.2 The building has been assessed as having some potential for roosting bats during the spring, summer and autumn months. However, the building does not appear to be suitable for hibernating bats, lacking the thermally stable conditions required for hibernation.

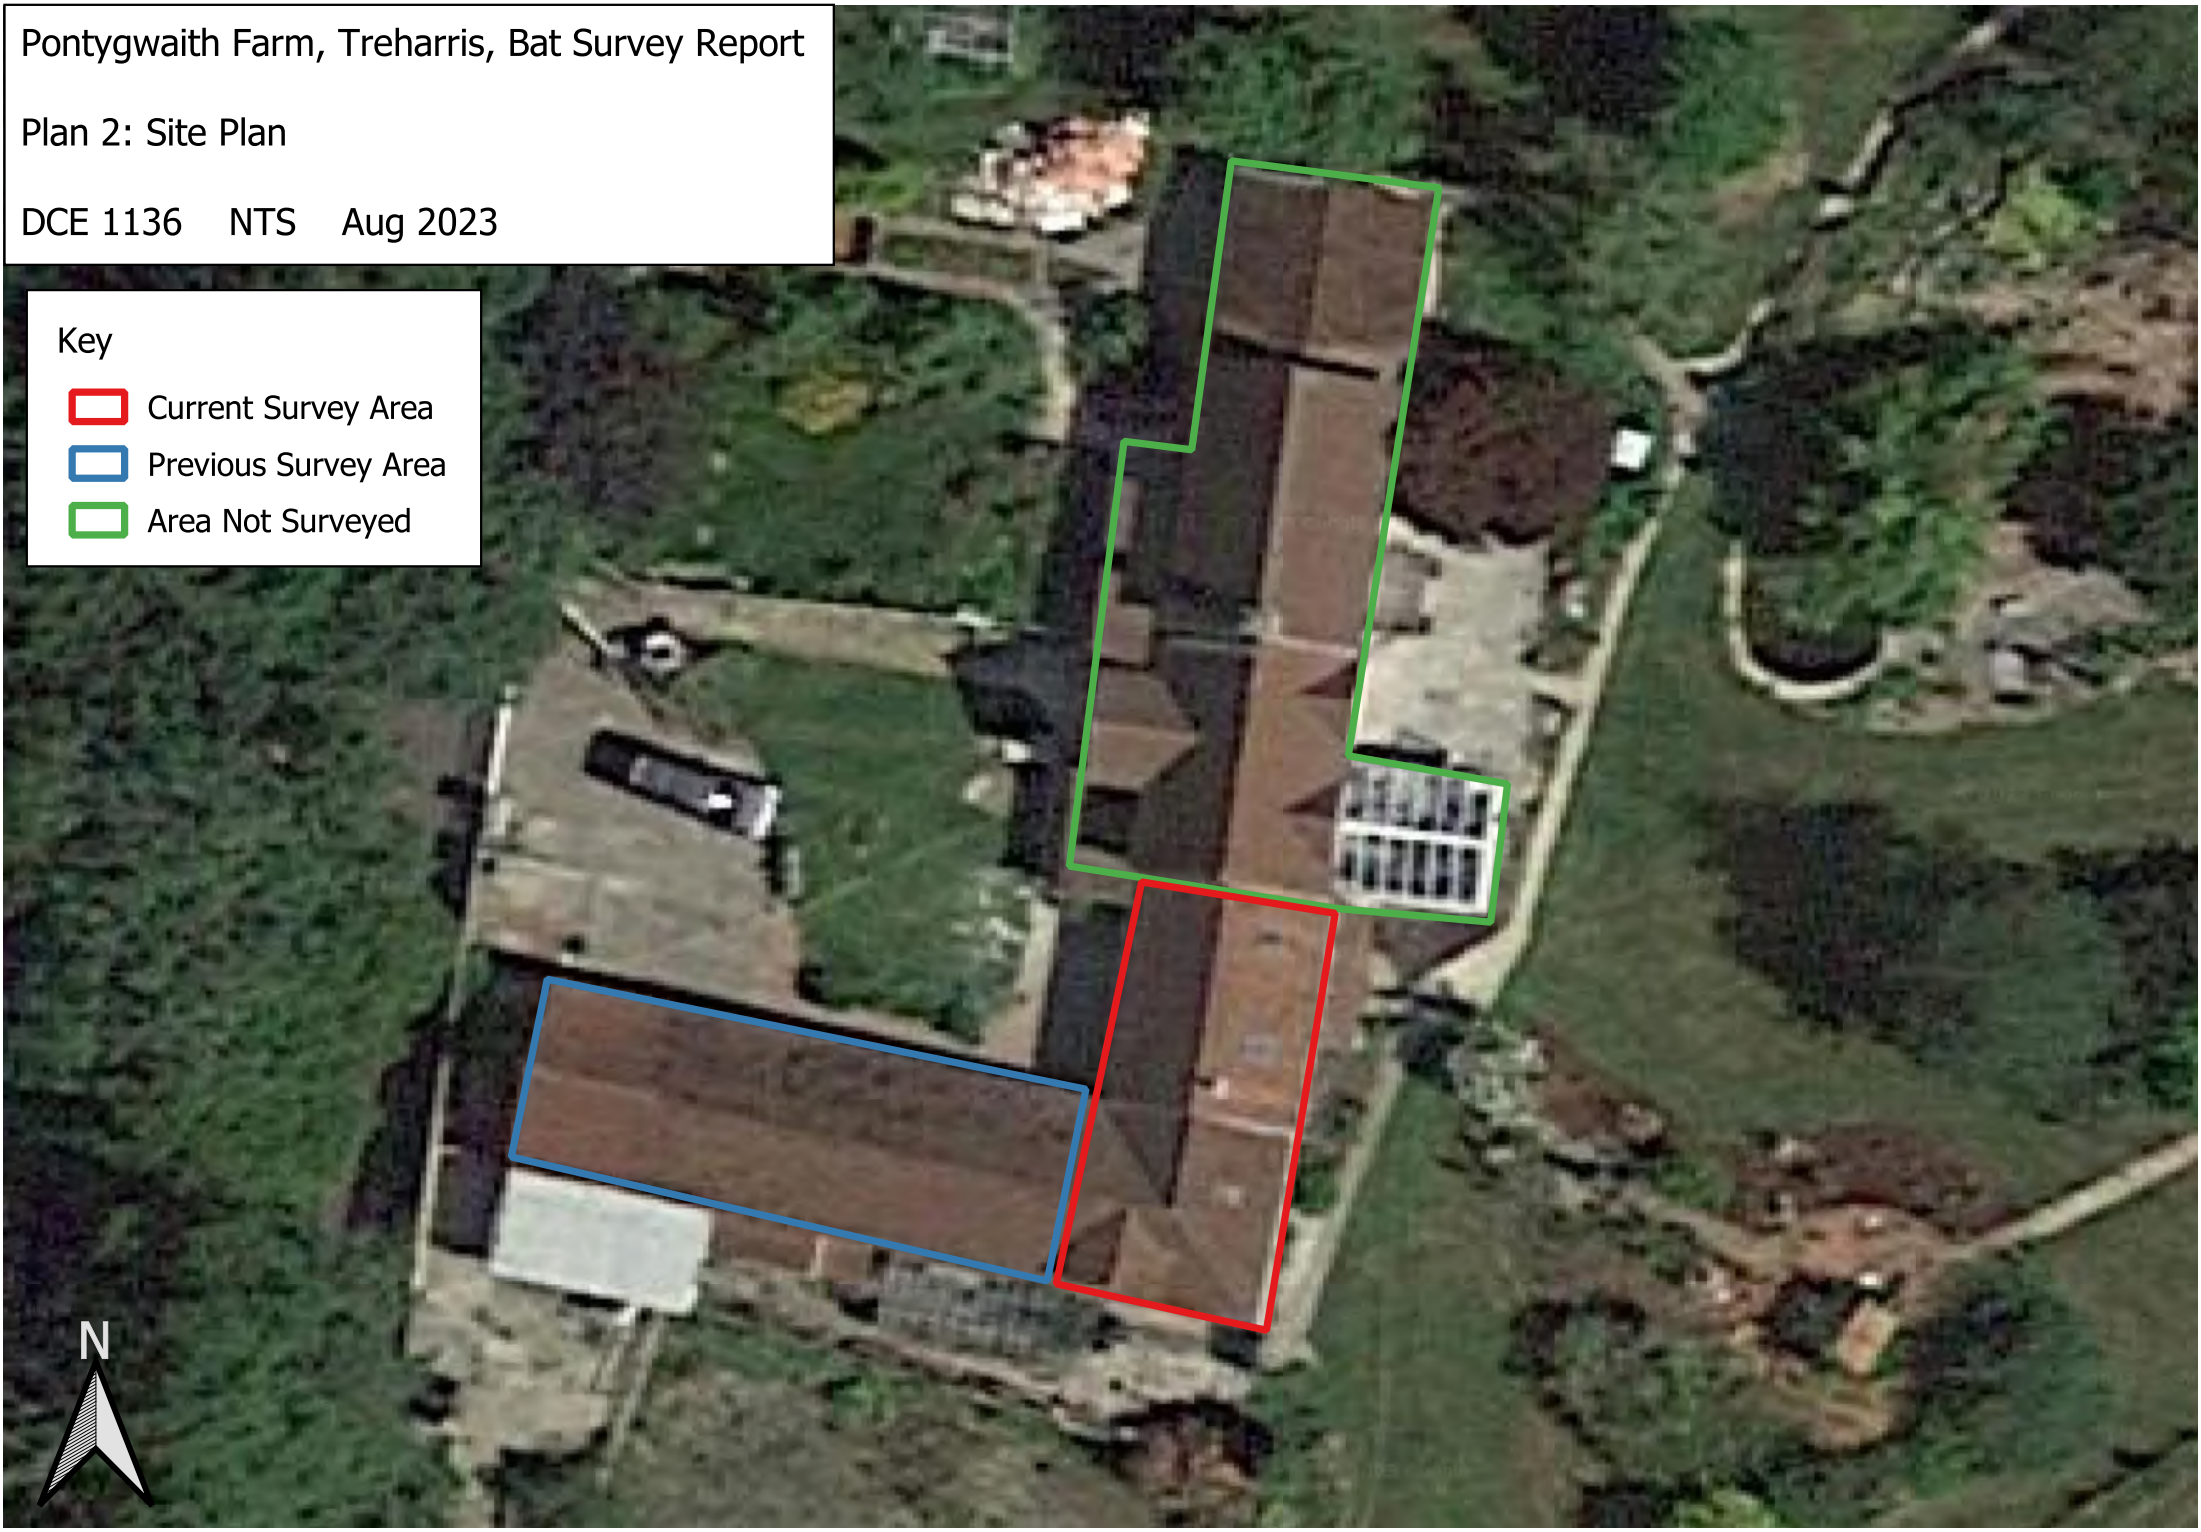
Plan 3: Bat Flight Paths

*"Plan showing surveyor positions and general bat activity requested – Plan 3 added.*

- 3.3.1 A dusk emergence survey was completed on 25<sup>th</sup> May 2023 between 21:00 and 22:45. Two surveyors were utilised to survey each elevation of the building. The weather conditions were dry and cloudy, with a light wind. Temperatures were approximately 15.5°C at the start of the survey and sunset was at 21:13.
- 3.3.2 No bats were seen emerging from the building. Very high activity levels of noctules were recorded commuting overhead with some foraging. There were also high activity levels of soprano pipistrelles commuting, with lots of foraging and social calls recorded. There were very low activity levels of common pips recorded commuting. A Myotis species was also recorded occasionally commuting.

- 3.3.3 A second dusk emergence survey was completed on 5<sup>th</sup> July 2023 between 21:15 and 23:00. Two surveyors were utilised to survey each elevation of the building. The weather conditions were dry, calm and cloudy. Temperatures were approximately 13°C at the start of the survey and sunset was at 21:33.
- 3.3.4 No bats were seen emerging from the building. High activity levels of noctules were recorded commuting overhead, with some foraging. Unusual, rapid social calls were recorded while two noctules were observed being chased by a bird of prey (probably a hobby). Low activity levels of soprano pipistrelles were recorded commuting. A single Myotis species and a single common pipistrelle were also recorded commuting.

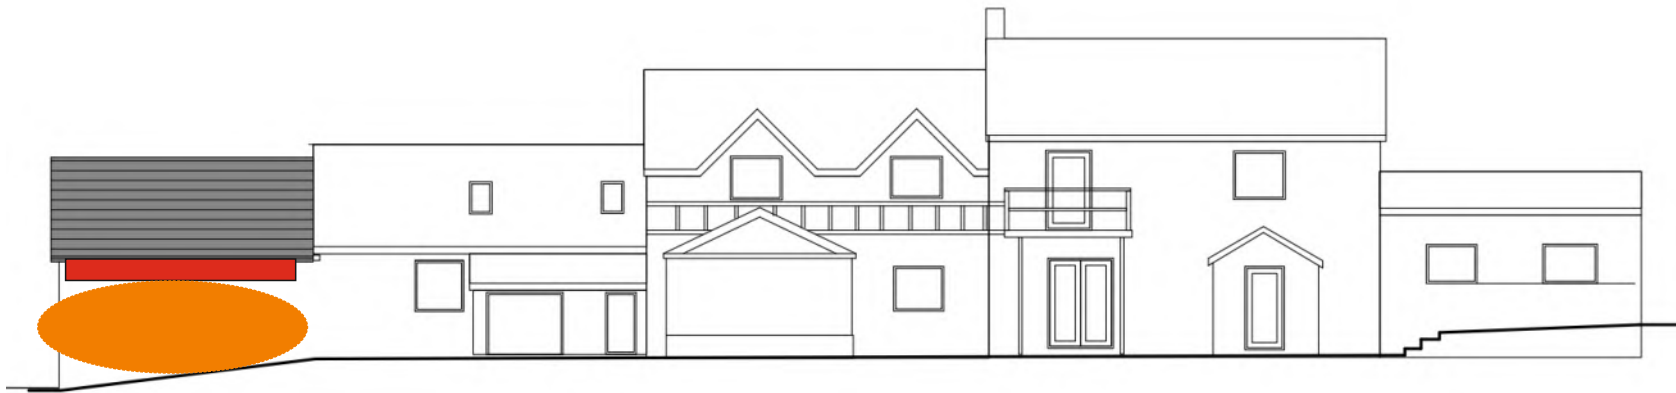
Plan 4a: Bat Mitigation Plan (Rear Elevation)

- 5.1.6 Existing gaps under fascia boards on the eastern elevation will be retained within the renovated building or recreated if replacement materials are used. These gaps will continue to allow access to wall-tops, potentially providing opportunities for hibernating bats (see Plan 4a).

- 5.1.7 No additional lighting will be installed as part of this development and dark corridors will be maintained, allowing bat access to the new bat box on the south elevation and under fascia boards on the eastern elevation (see Plans 4a and 4b).
