## St. Luke's Church, Gellideg

## Bat Activity Survey Report

August 2020

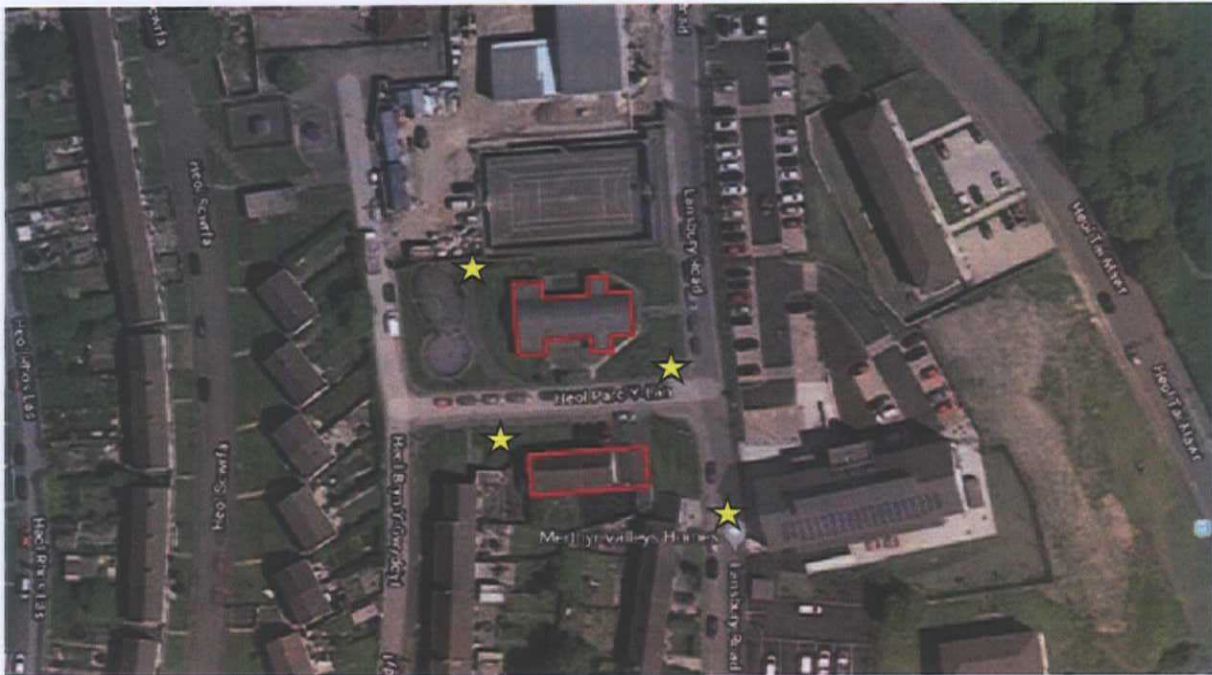
This survey was undertaken at dusk, with sunset being recorded at 21:08. During this survey, no bats were seen to emerge from the surveyed structure. In addition to this, no foraging and commuting bats were witnessed on site at all.

**Figure 3:** An aerial photograph of the surveyed site (red outline), the surveyor locations (yellow stars) and the identified bat flight paths (blue arrows).

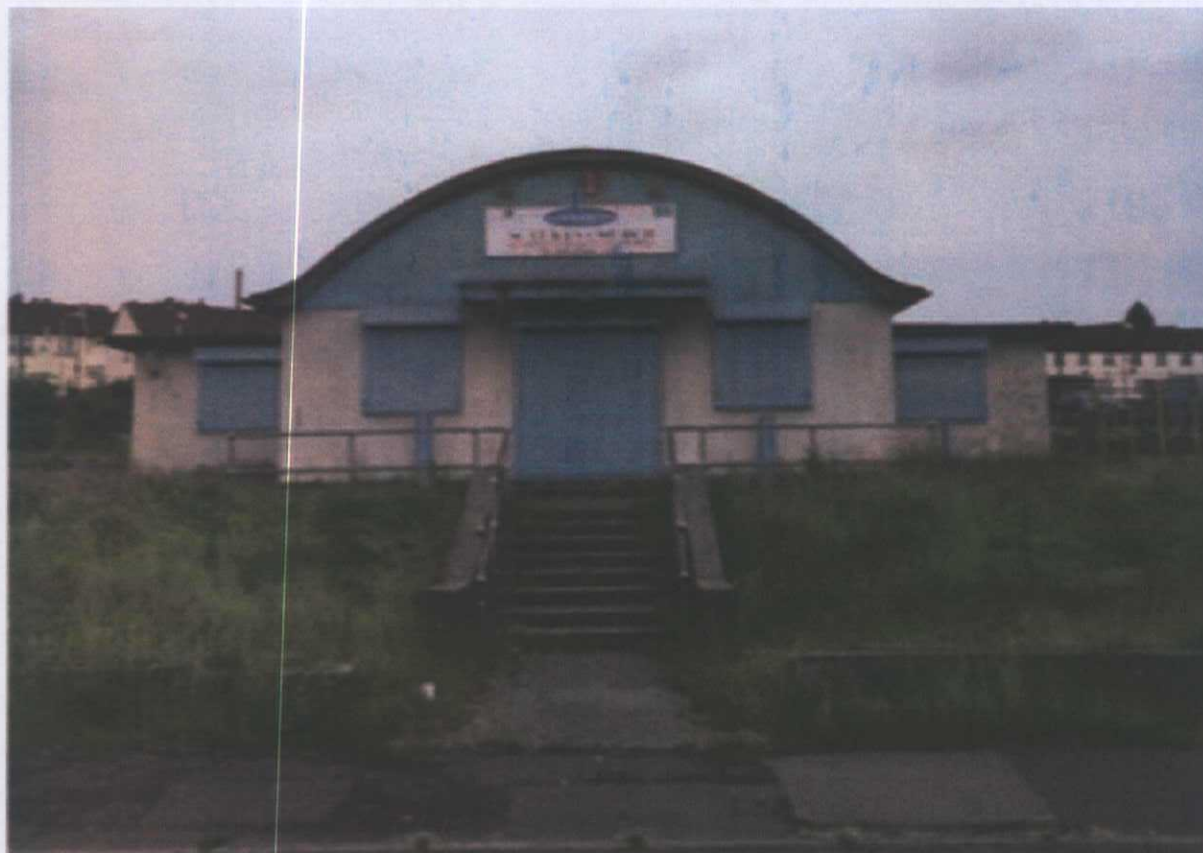
**Plate 1:** Front elevation of the surveyed church.

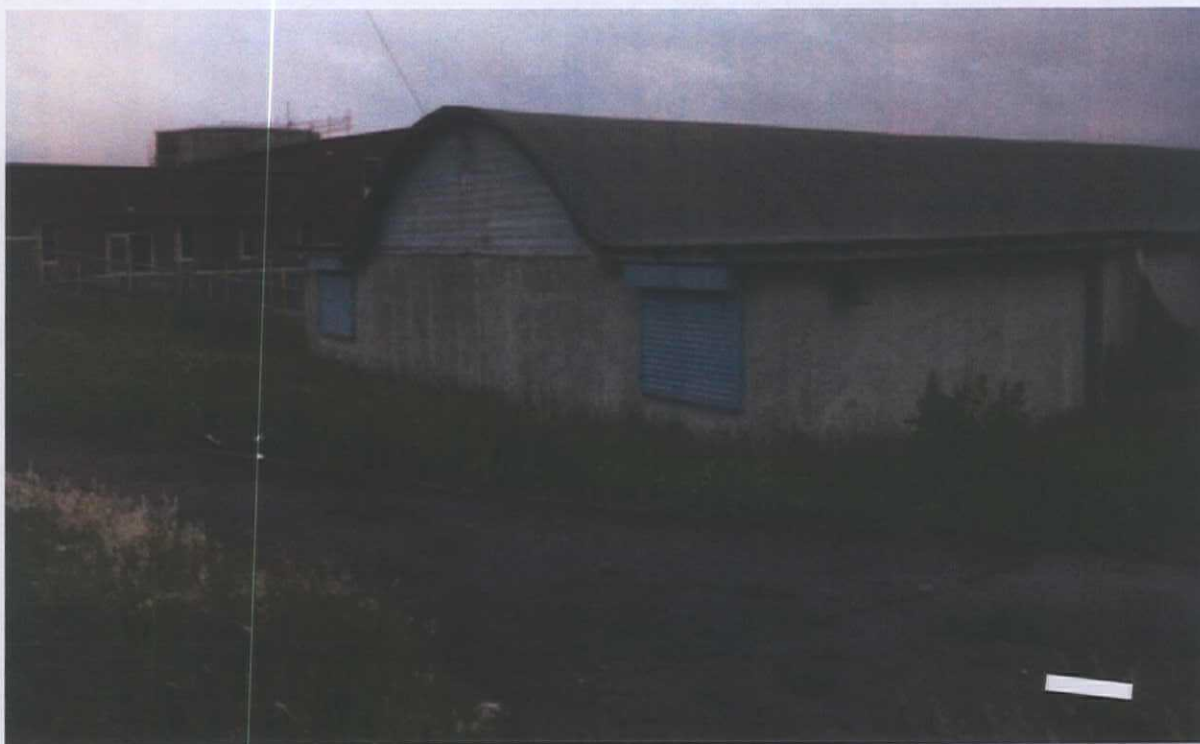
**Plate 2:** Rear elevation of the surveyed church.

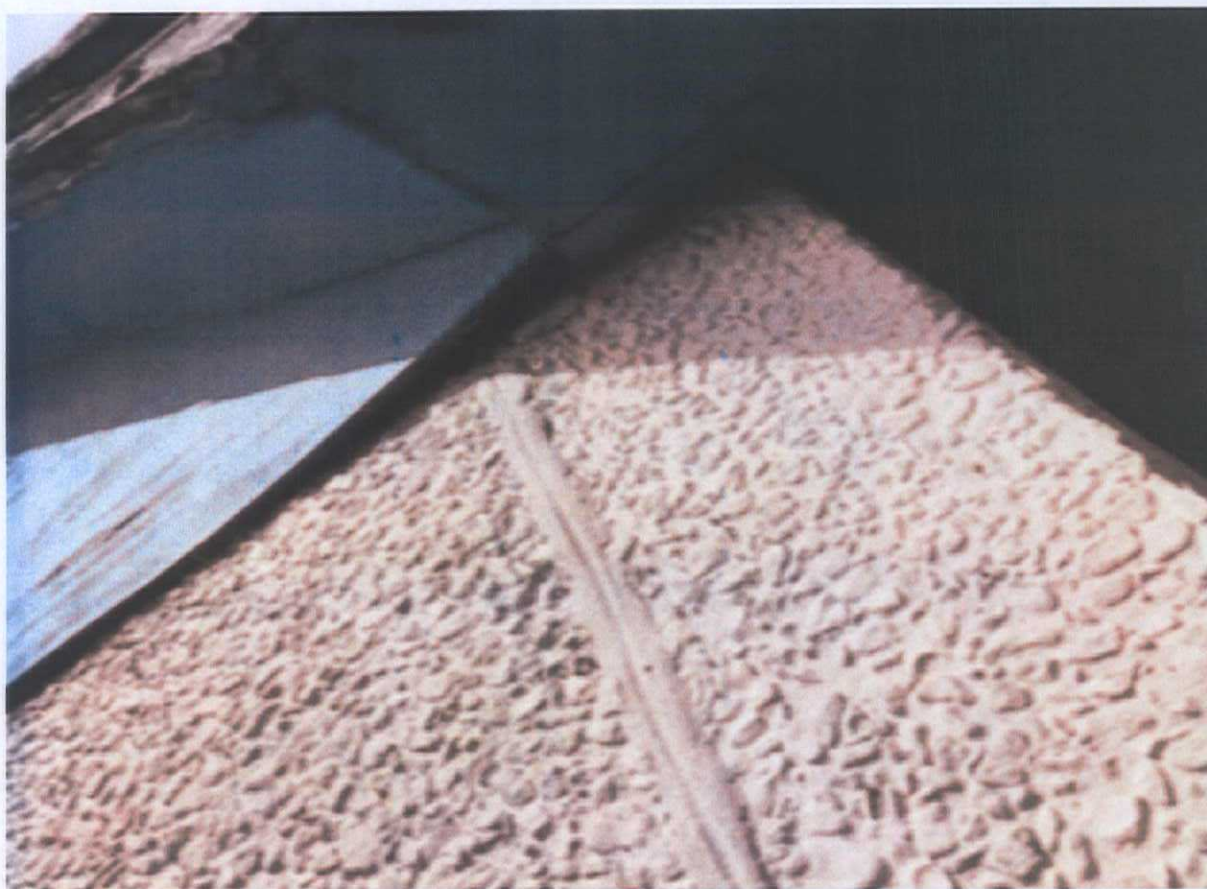
The church has a unique, dome like roof. The roof is felted and in a good condition. The soffit boards are in poor condition with several large holes. The limited amount of cladding present has some small cracks or has come away from the building. However, the windows are covered with metal rollers, meaning that the lintels are not exposed and as such, do not provide an area for bats to enter. The building itself is not clad in any material and, therefore, presents no opportunity for bats to roost. No evidence of bats or birds was identified externally.

**Plate 3:** Detail of gap around the soffit of the church.

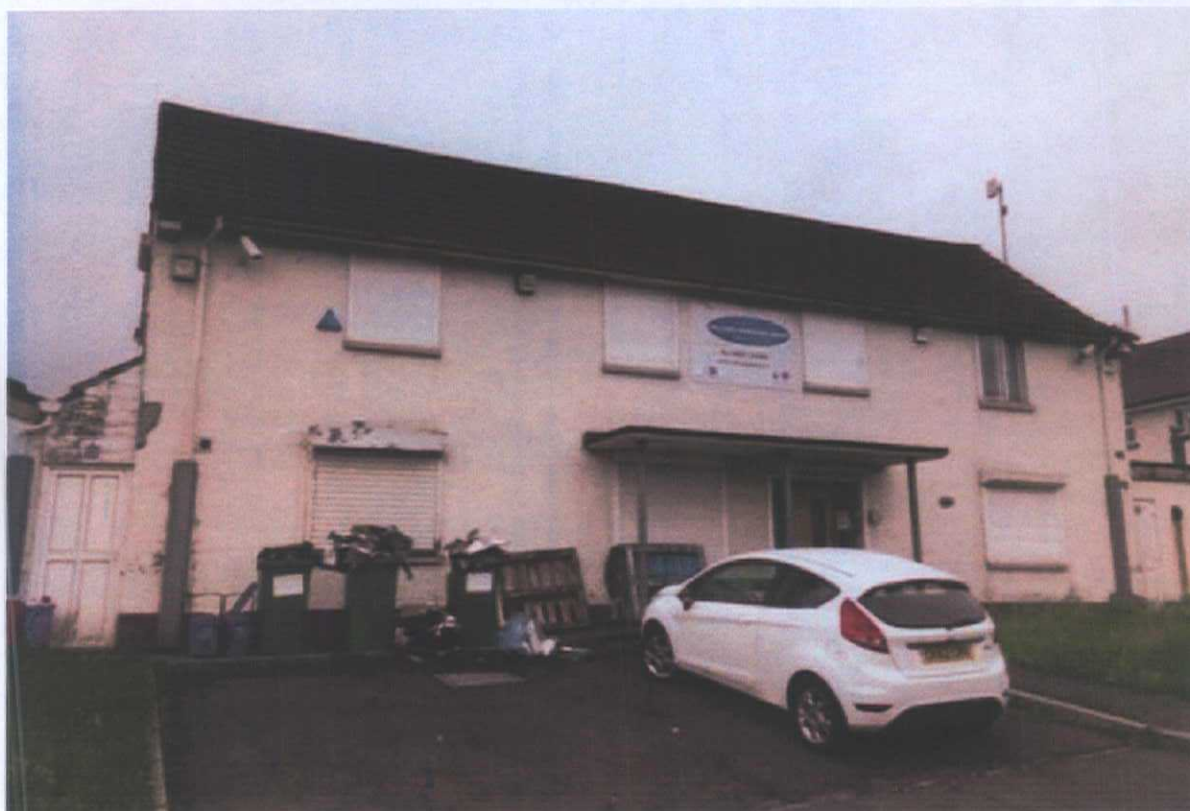
**Plate 4:** Front elevation of the surveyed office building.

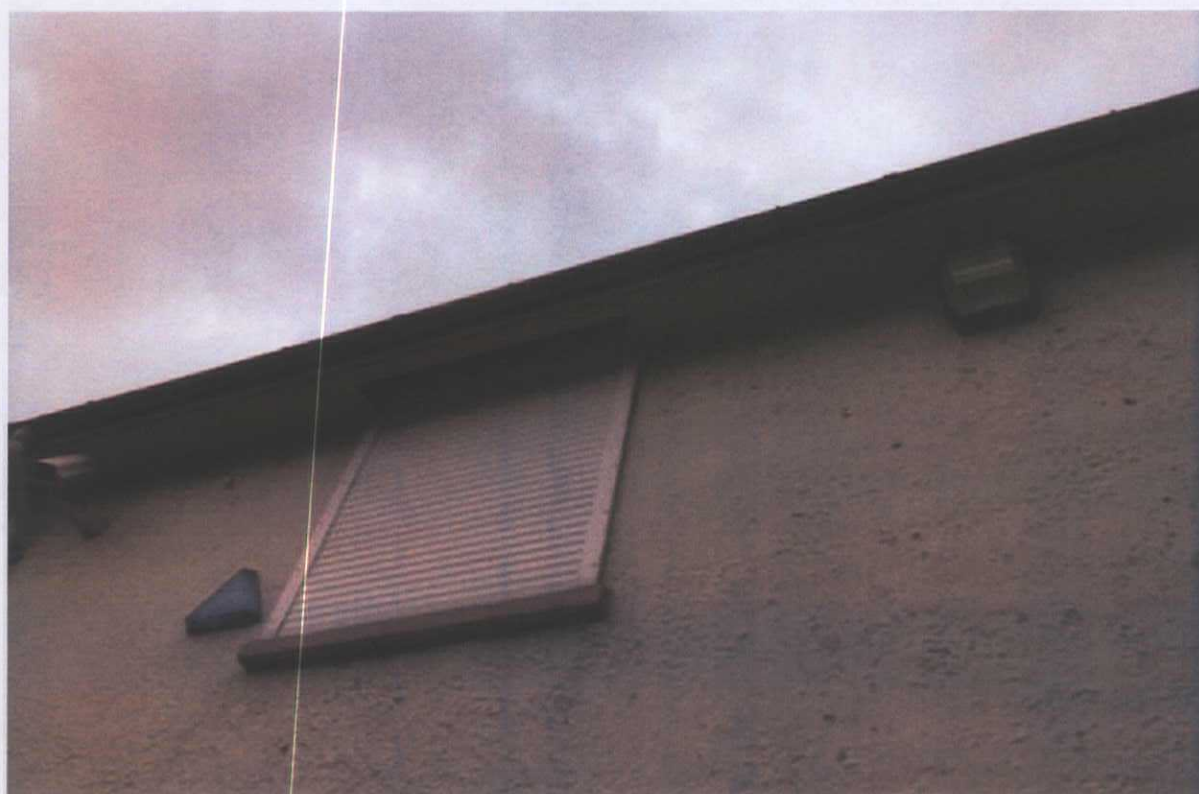
This structure has a pitched roof with clay tiles which seems to be in an adequate state. There is, however, room under some of the tiles for access as several small bird species were observed moving in and out of these. Again the lintels were covered by security rollers, however, in two areas these had fallen off and provided an area for bats to enter. Externally, the rest of the building was in good condition and the limited amount of cladding appeared to be good condition. No evidence of bats was identified externally.

**Plate 5:** Detail of the eaves of the office building.

Evidence of bird activity was observed within the office building. Therefore, the structure is deemed to be of **moderate** bird nesting potential. It is recommended that all works are undertaken outside of the breeding bird season (March to September, inclusive). If this timescale cannot be achieved, then an inspection by a suitably qualified ecologist is required no more than twenty-four hours prior to the commencement of the works. If active nests are located, appropriate exclusion zones are to be implemented until the nests become disused. An update nesting survey should be undertaken prior to commencement of any works and further compensatory measures will be devised following this additional survey.

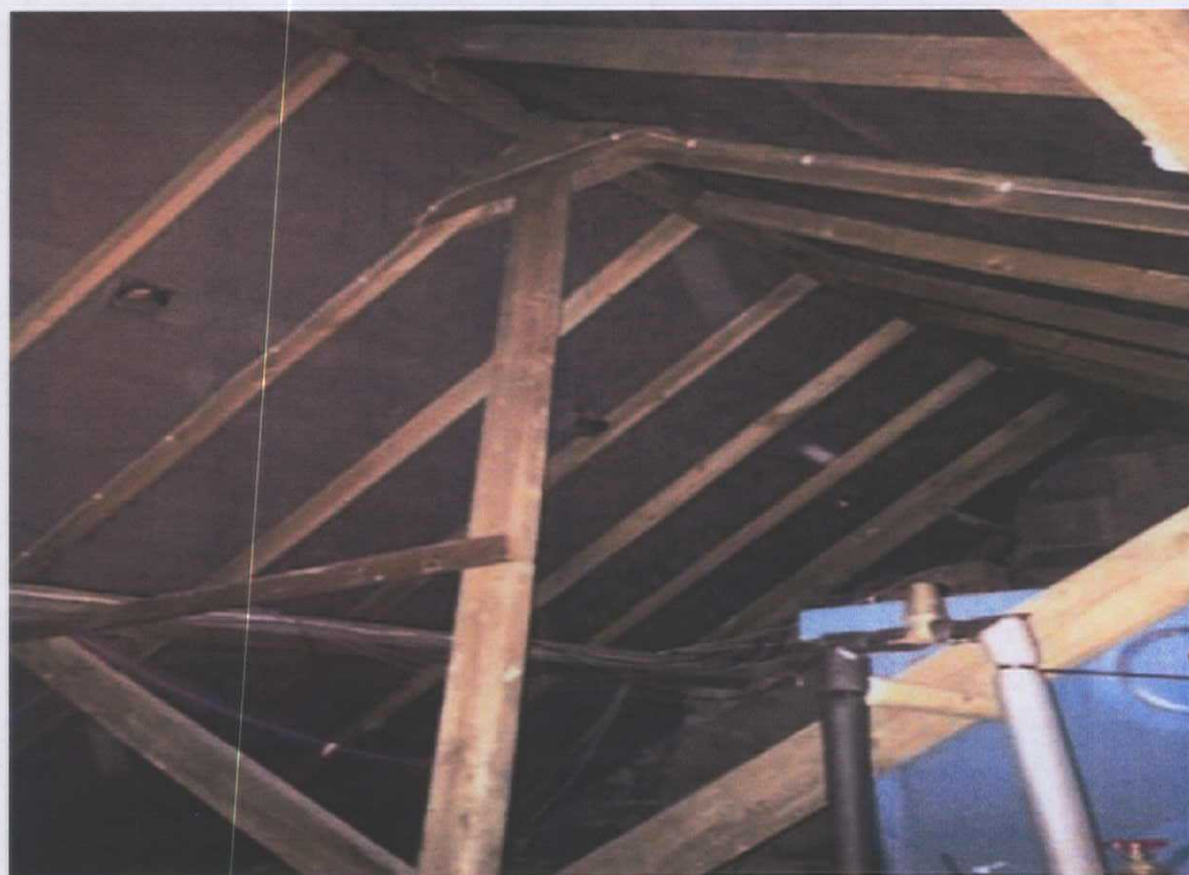
The building had one large attic space which ran most of the length of the building. Although this was lined, there was a hole which allowed access into the loft and potentially behind the lining. The space was generally uncluttered although there were a couple of support beams and a hot water tank in the middle of the room. There were some gaps where the beams met each other which could have provided crevices for bats to utilise. The attic had not been accessed for some time, however, it is likely there is regular traffic under the hatch from office workers. No evidence of bats or birds was identified internally.

**Plate 6:** Internal view of the office loft space.
