# MERTHYR VALLEY HOMES

## PROPOSED ROOFING REPAIRS AND IMPROVEMENTS, PROPERTIES AT COUNCIL STREET AND URBAN STREET, MERTHYR TYDFIL

### BUILDING INSPECTION REPORT (PROTECTED SPECIES)

Document Ref: E22108101 MARCH 2022

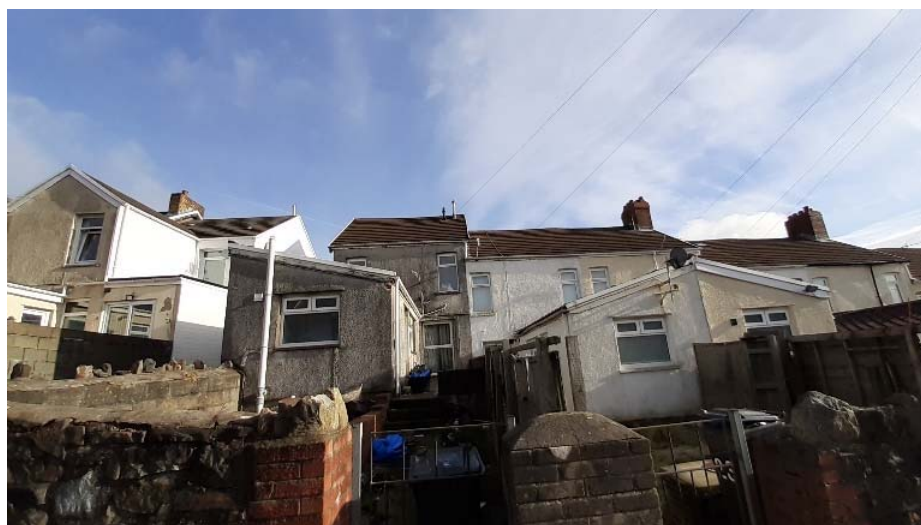
**Plate 1-View of the rear of the properties**

rendered and painted with no obvious gaps between the soffits and the walls. There are generally less PRF's present compared to the front of the properties (Plate 1).

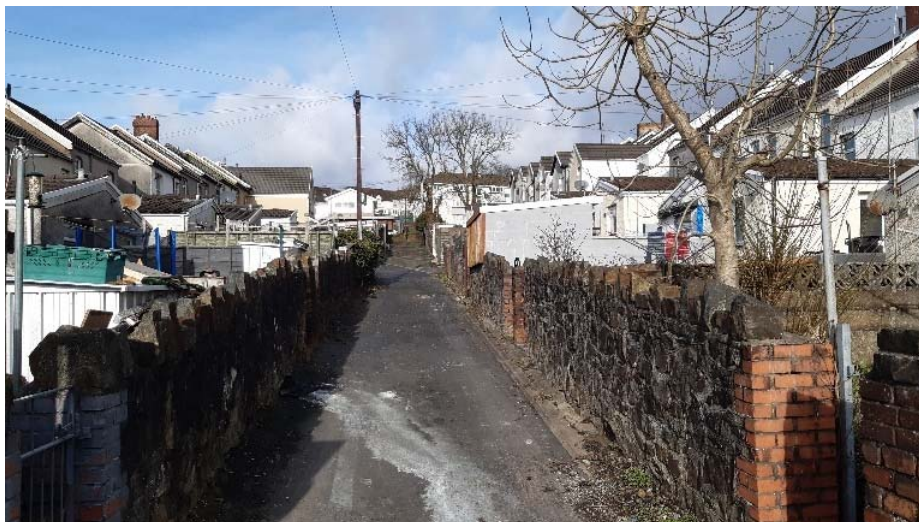
**Plate 2-View of rear garden gardens**

- 3.7 There is no semi/mature trees/vegetation present in the rear gardens however several of the properties had bird feeders/bird feeding stations whereby House Sparrows and Blackbirds were noted during the survey (Plate 2)

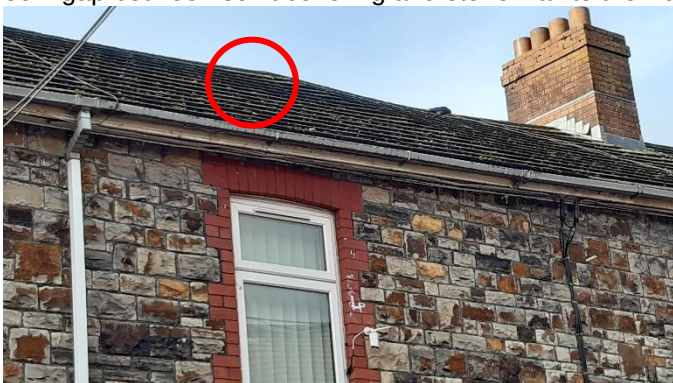
| Street | Property No. | Comments<br>Photos |
|---|---|---|
| | 14 | Slightly raised roof tile.<br>5cm gap between soffit covering and stone wall to the front of the property.<br> |

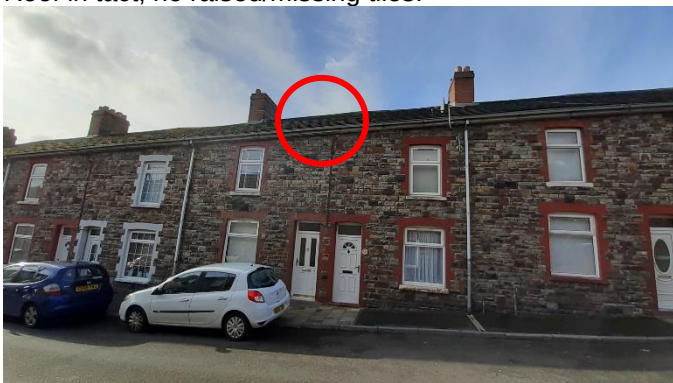
| Street | Property No. | Comments<br>Photos |
|---|---|---|
| | 16 & 17 | Fairly large gap in soffit to the front of the property between property 16 and 17.<br>5cm gap between soffit covering and stone wall to the front of the properties..<br>Roof in tact, no raised/missing tiles.<br> |

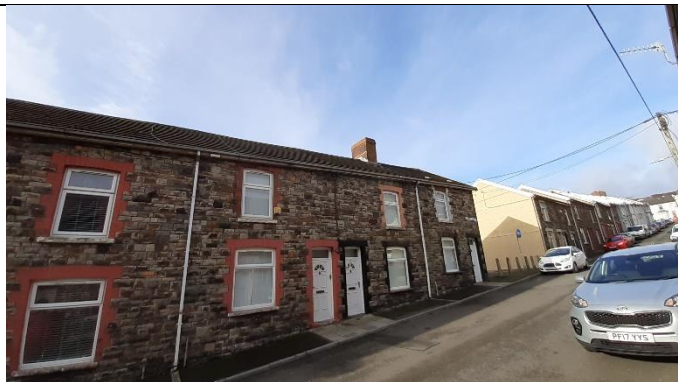
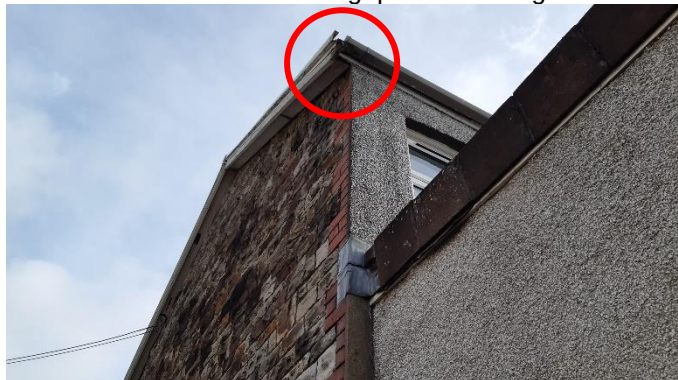
| | <p>Gable end of 22 has several gaps and damaged soffit.</p> |

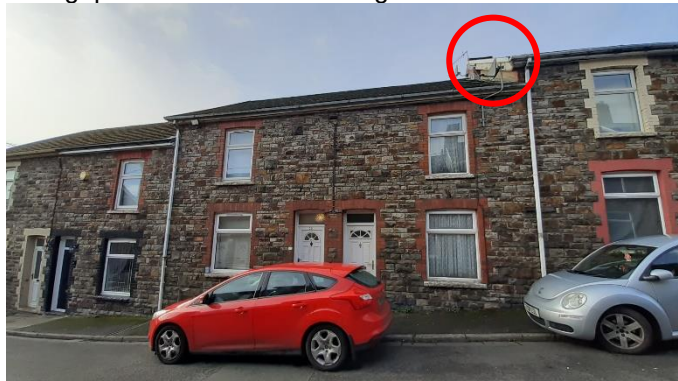
| 25 & 26 | <p>Slightly raised lead flashing between 26/27.<br/>5cm gap between soffit covering and stone wall to the front of the properties.</p> |

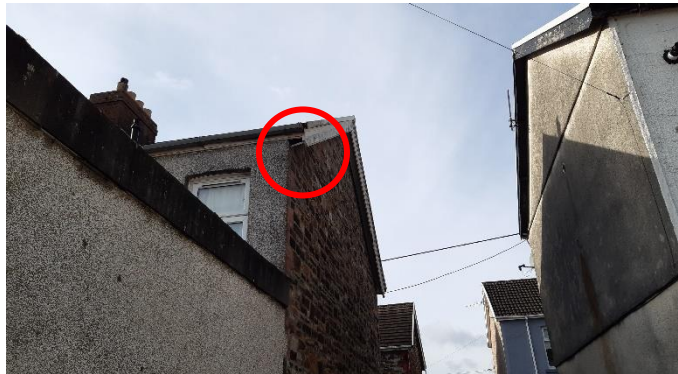
| 30 | <p>Fairly large gap on north eastern corner of the gable end.<br/>5cm gap between soffit covering and stone wall to the front of the property</p> |

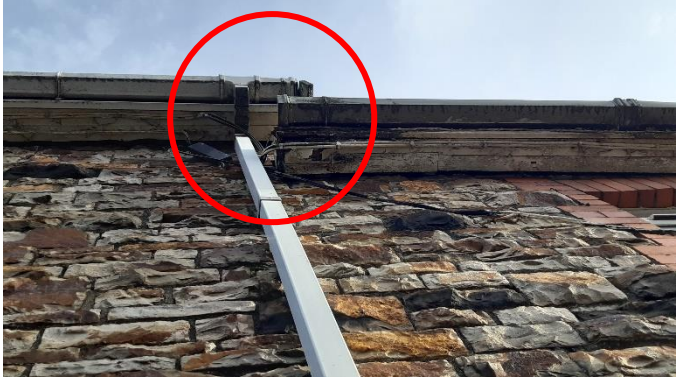
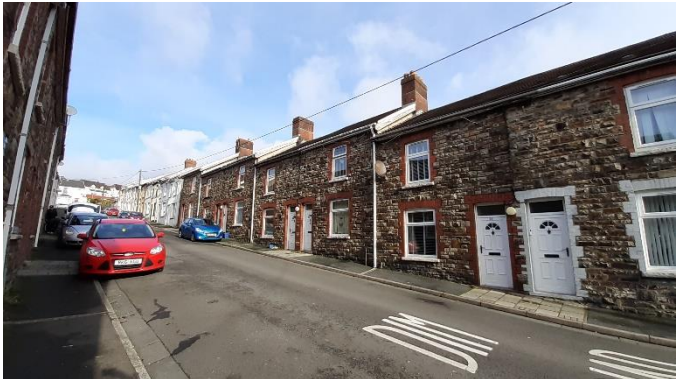
| 32, 33,<br>34, 35<br>&36 | <p>Damaged guttering/soffit between property 34 &amp;35.</p> <p>5cm gap between soffit covering and stone wall to the front of the properties.</p> |

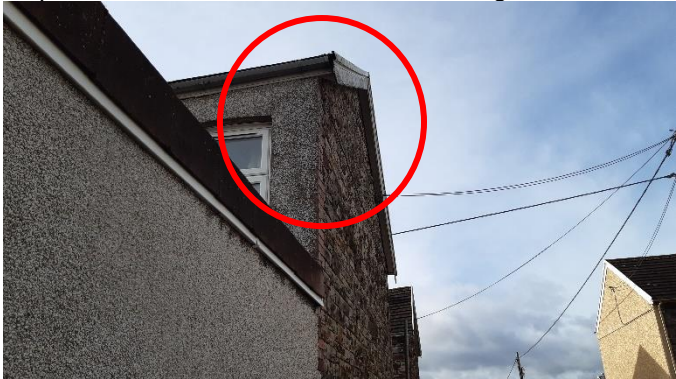
| 37 | <p>Gap between soffit and stone wall on the gable end.</p> |

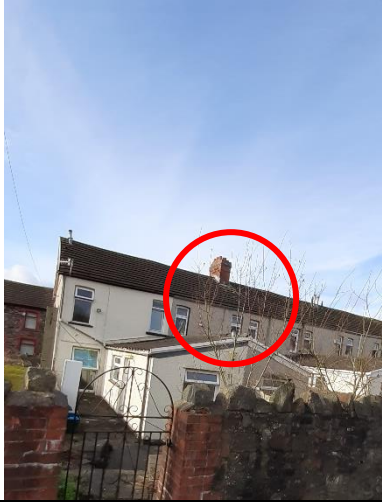
| 56 | <p>Slightly raised roof tile between 55/66 on the front of the property.<br/>5cm gap between soffit covering and stone wall to the front of the property</p> <p>To the rear of the property a damaged roof tile and raised lead flashing around chimney breast.</p> |

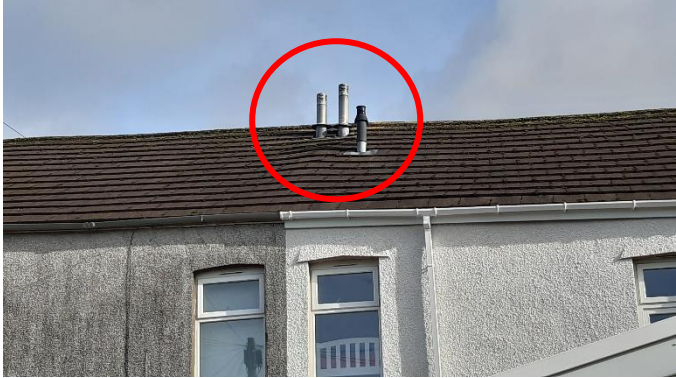
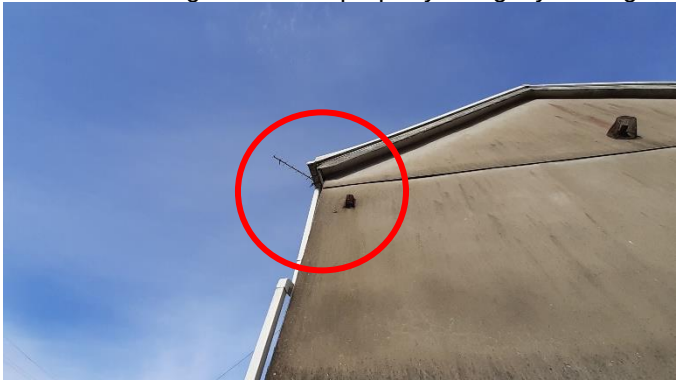
| Urban Street | 1,2,3,& 4 | <p>5cm gap between soffit covering and stone wall to the front of the properties. Slightly raised tiles on the rear roof between properties 2 and 3.</p> <p>Soffit/fascia on gable end of property 1 slightly damaged on SW corner.</p> | |

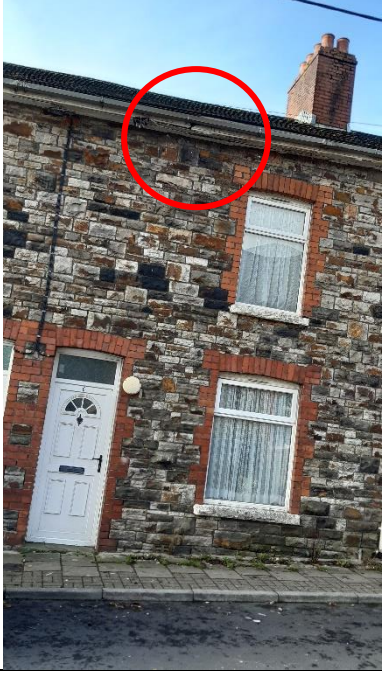
| | 6 | <p>5cm gap between soffit covering and stone wall to the front of the property. Damaged fascia covering to the front of the property. Dropped tiles present above fascia.</p> | |

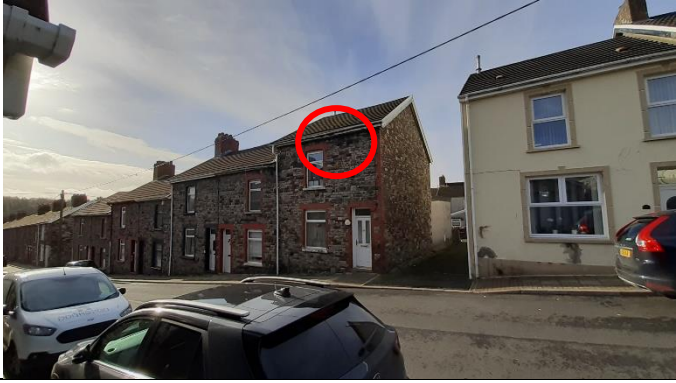
| 24 | | 5cm gap between soffit covering and stone wall to the front and gable end of the property<br>Slipped tiles above the guttering to the front of the property. | |

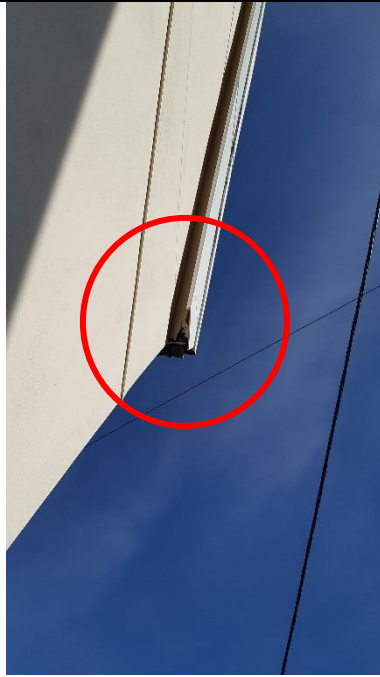
Fascia and soffit damaged on the front of property 30

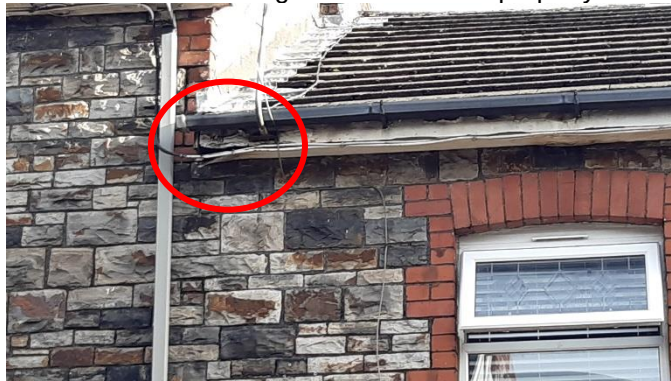
Damaged fascia and soffit covering on the NE corner of the gable end of property 32.

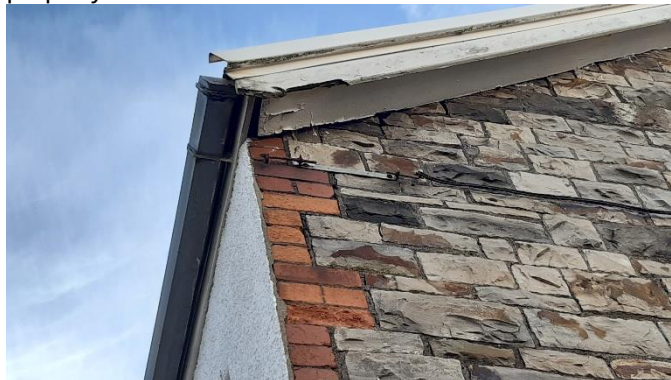
Damaged fascia and soffit covering on the NW corner of the gable end of property 32.

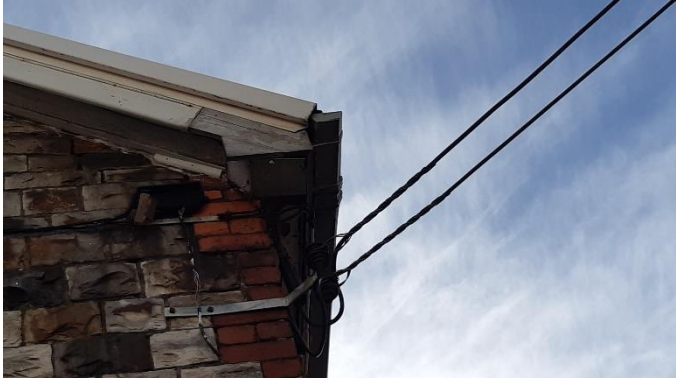
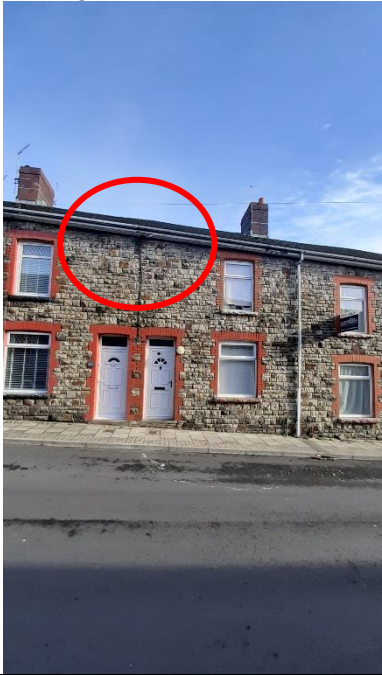
| 36 | <p>5cm gap between soffit covering and stone wall to the front of the property.<br/>Damaged fascia/soffit to the front of the property between 35 &amp; 36.</p> | |
