**CAEDRAW PRIMARY SCHOOL, 7 CAEDRAW ROAD, MERTHYR  
TYDFIL**

**BAT SURVEY  
ISSUE 1, VERSION A**

**AUGUST 2022**

### Bat Survey Report

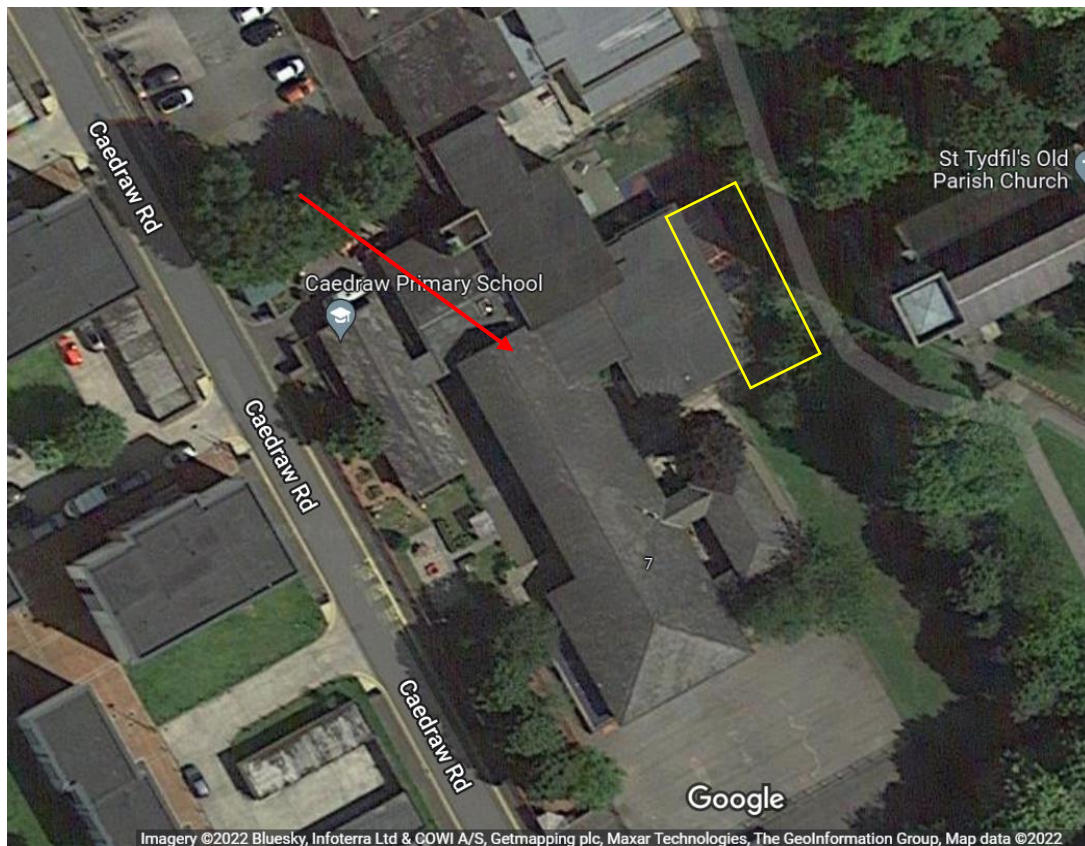
The area that will be affected by the proposed plans (boxed yellow) is to the north east of the school. Generally the building is in good order, fascias are of uPVC. There is currently an existing metal sheet add on to the school that is bolted to the wall at eaves level.

**Figure 1: Detailed view of the school (arrowed red) (area to be affected by development boxed yellow) (Google maps 2022)**

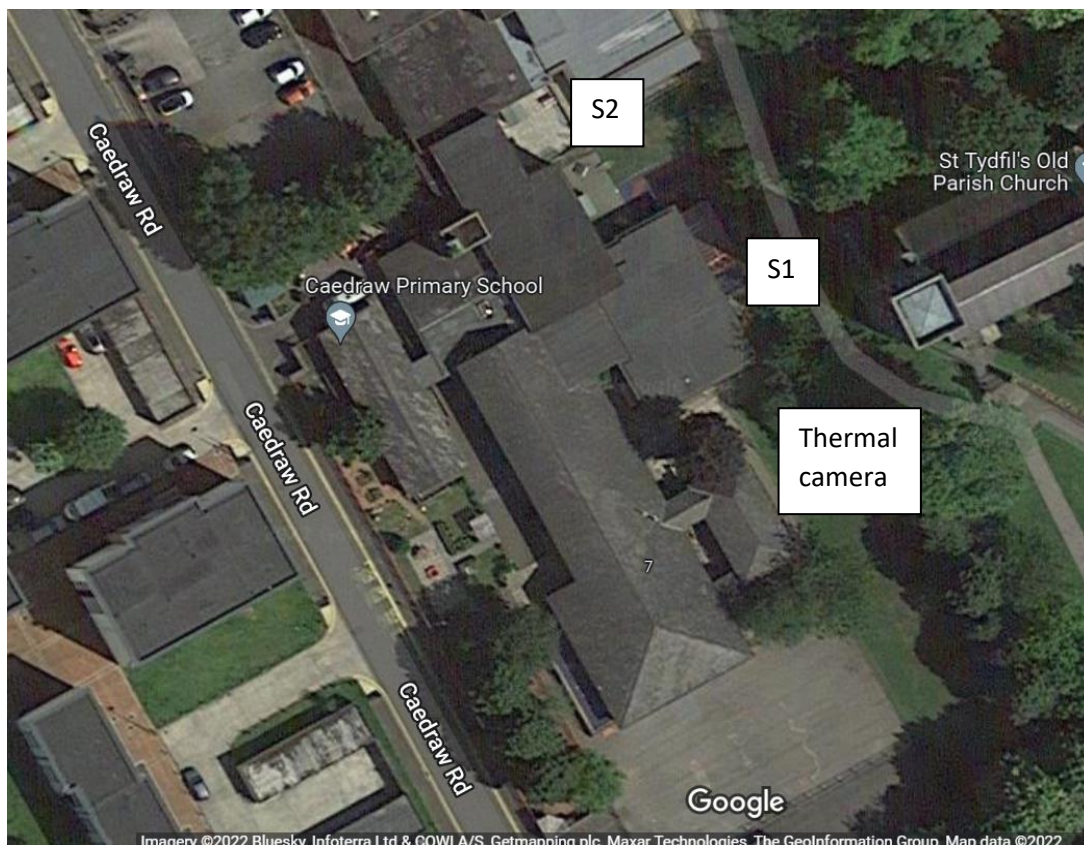
A dusk survey was carried out on 5<sup>th</sup> July 2022 using two surveyors ,positioned in such a way that as much of the building was visible to surveyors as possible. Surveyors were equipped with cameras and Batlogger M detectors.

Figure 3: Approximate surveyor locations

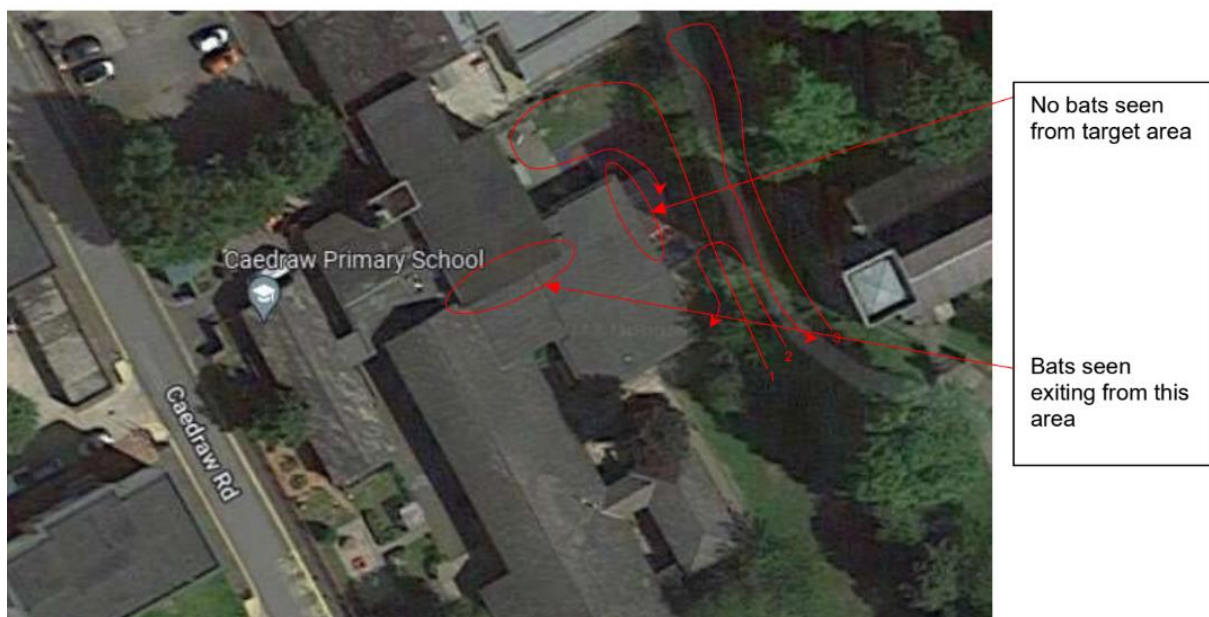
The first bat heard was a common pipistrelle, the bat was seen exiting from beneath the fascia of the flat roof, a level above the area that the proposed classroom will be tied in to. This was shortly followed by a further two common pipistrelles.

Figure 4: Location of identified common pipistrelle roost and flight lines

The school was identified as a roost for three common pipistrelles on this date. However, the area to be affected by the proposed works was not confirmed as a bat roost.

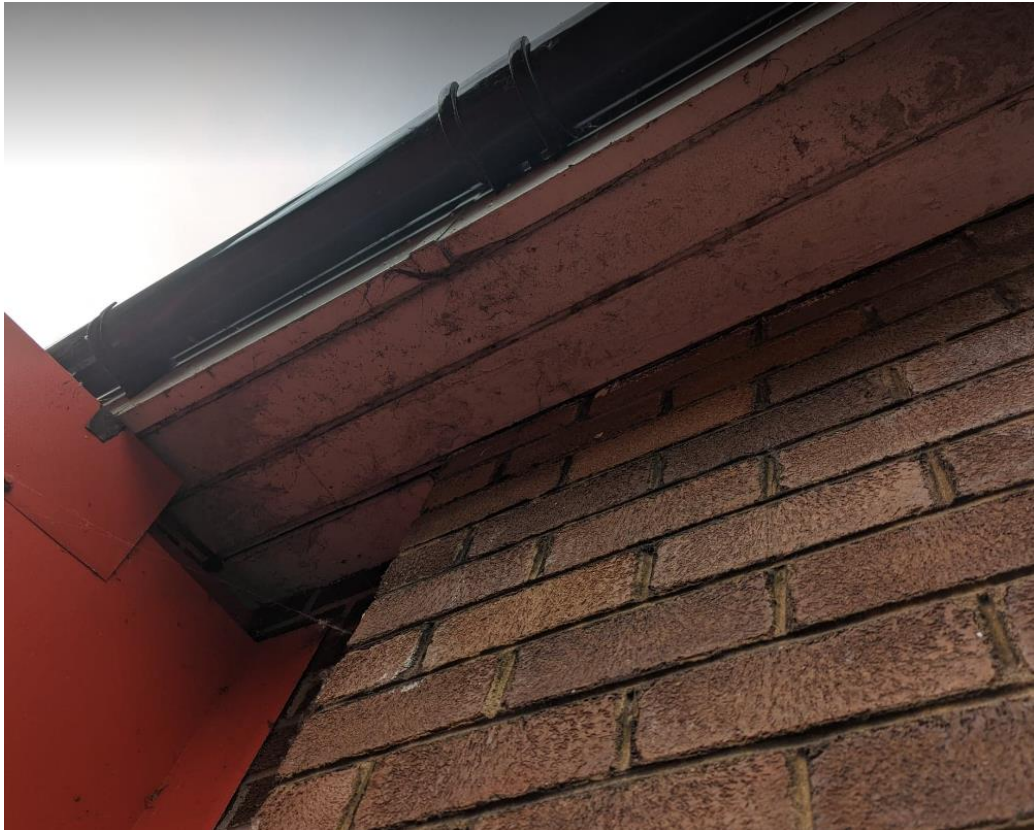
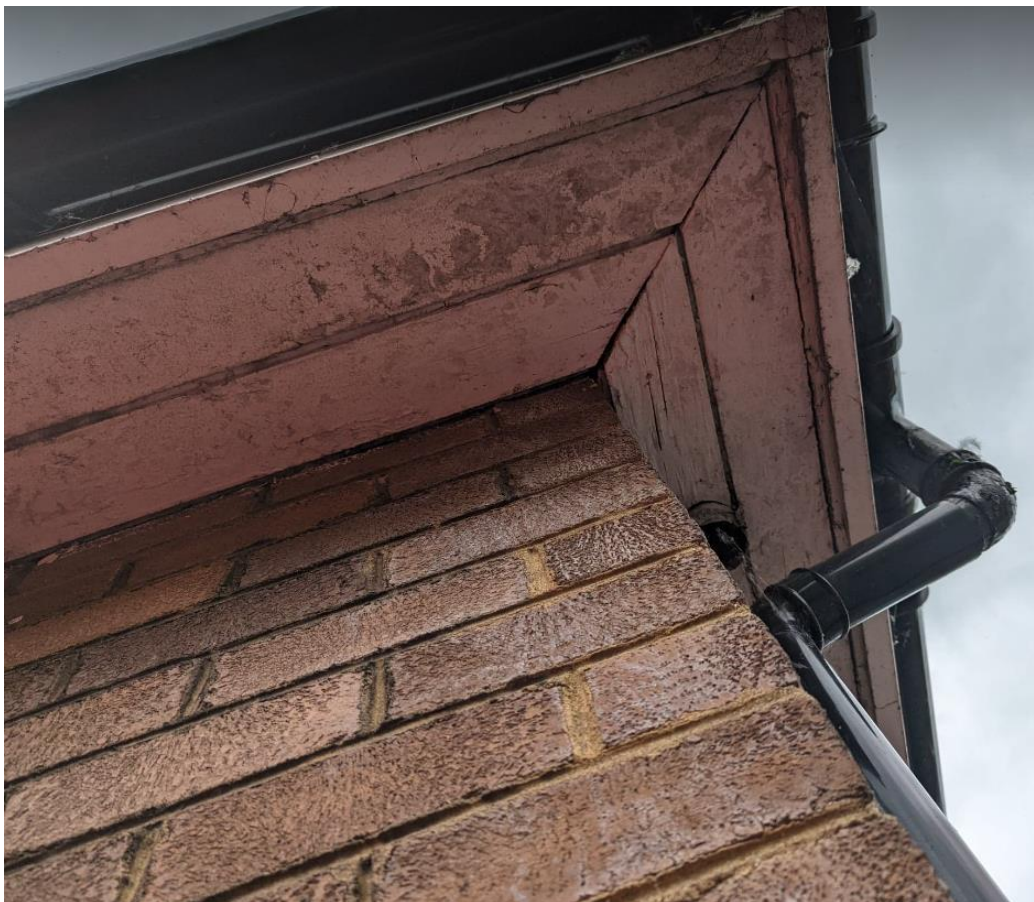
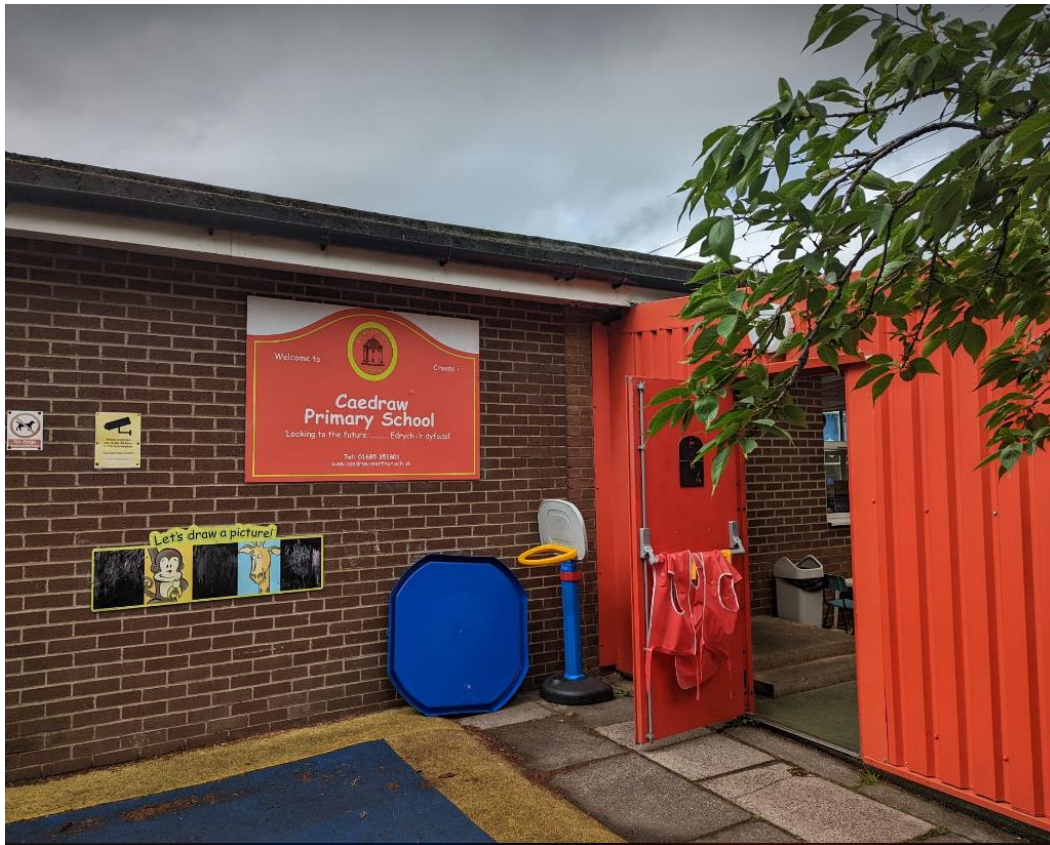
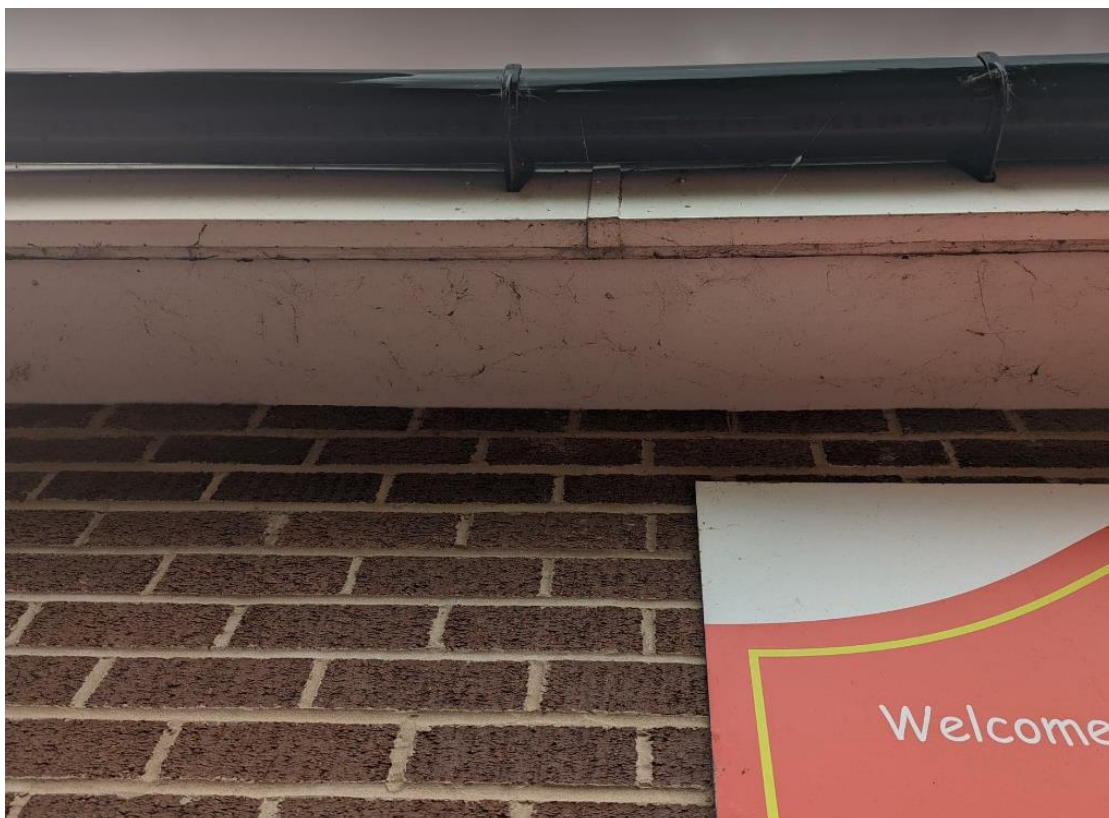
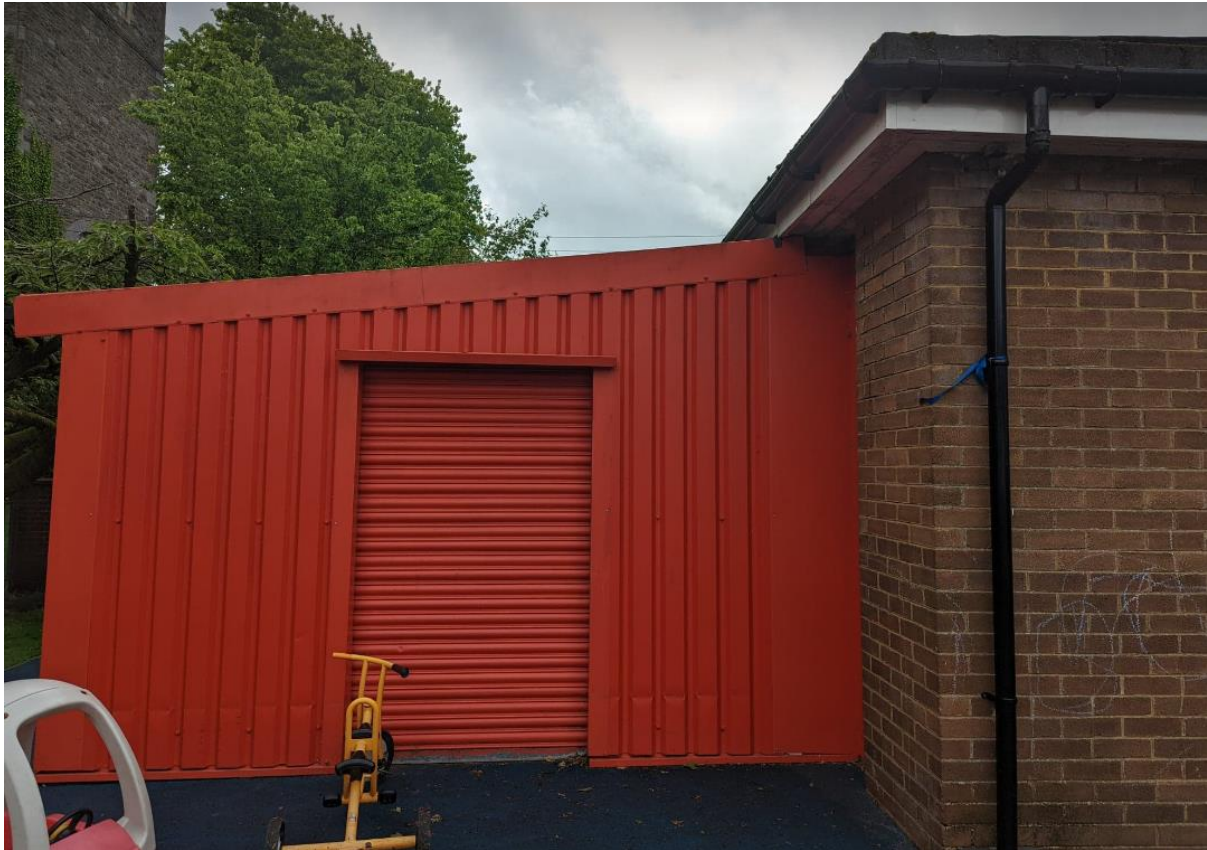
## APPENDIX A- SITE PHOTOGRAPHS

The survey carried out by BE Ecological Ltd revealed no droppings or evidence of bats on the exterior of the building, however, access and roosting potential for bats was identified in the form of:

- Potentially small gaps beneath fascia and felt overhang

Please see appended plates for photographs of the property exterior. Other than these areas, the building is well sealed with no obvious gaps. Please note whilst there are small gaps present, there is a timber batten beneath the felt and fascias at eaves level, preventing ingress into the building (area to be affected by the proposals) at the majority of locations. There were no suitable access points within the metal classroom to be dismantled.
