# PROTECTED SPP REPORT

BRYNTAF GARAGE

| Project: BRYNTAF GARAGE | | |
|---|---|---|
| Document Number | J022- Eco Report-V1.3 | |

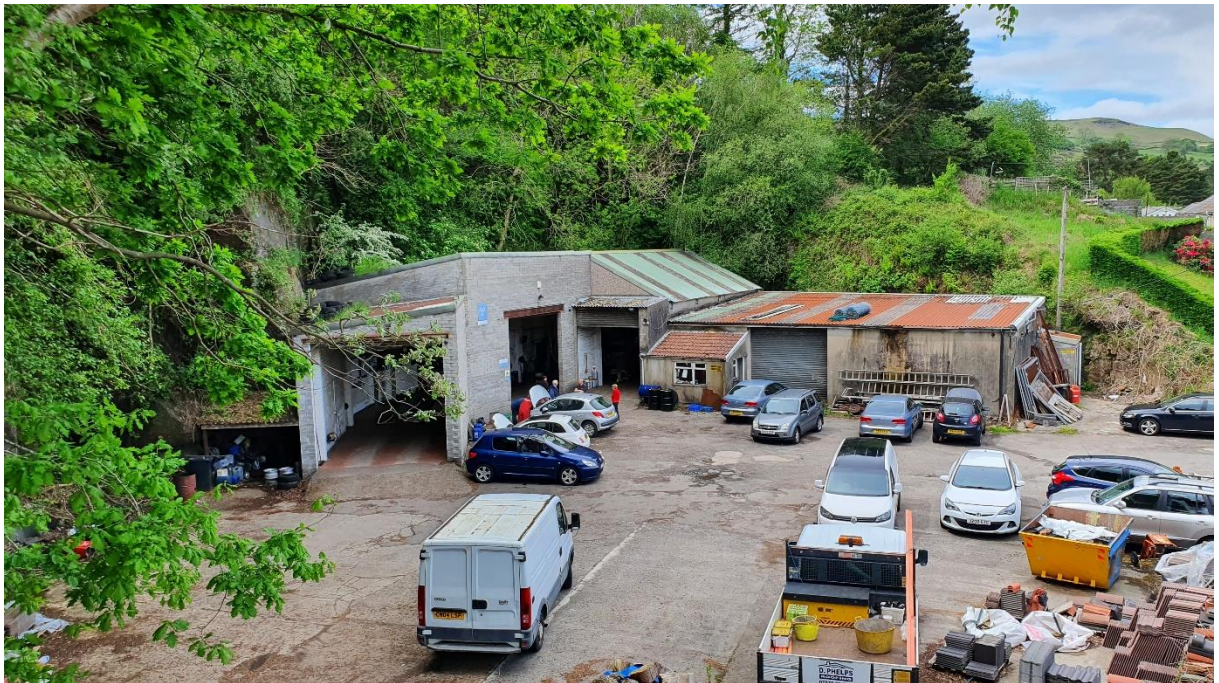
*Photo 1: Shows an overview of the buildings.*

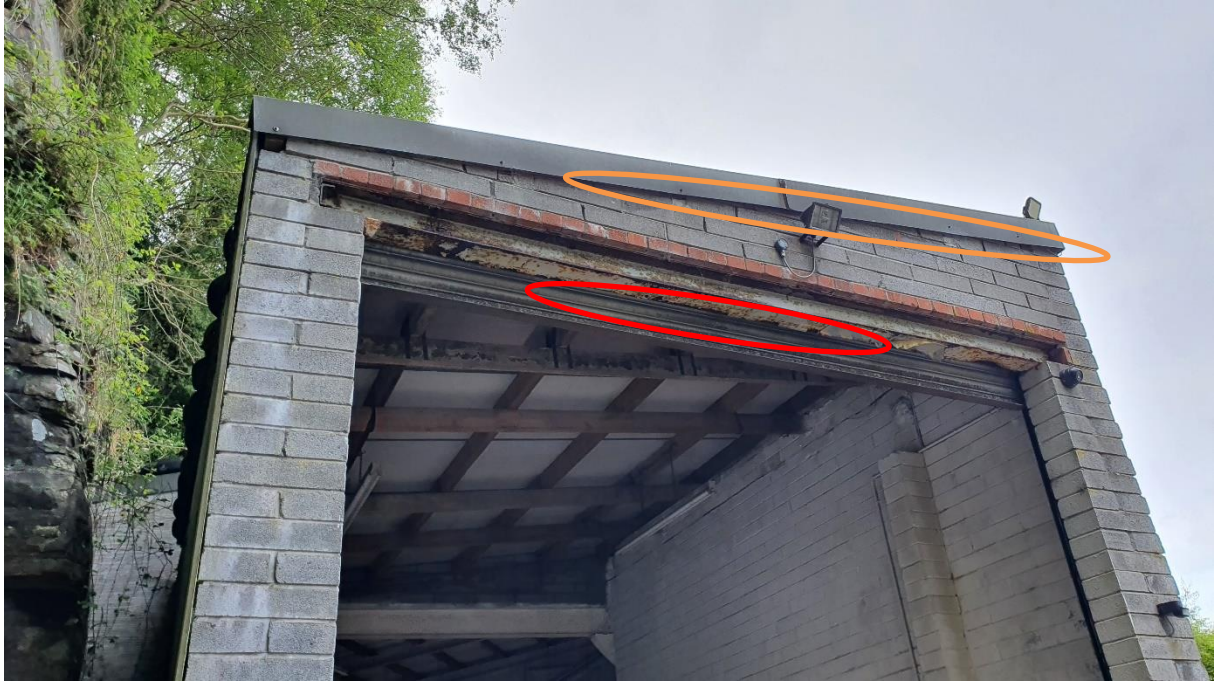
*Photo 2: Shows part of the southern aspect of the workshop, the orange circles highlight some roosting potential beneath the edge of the corrugated steel roof. The red circle highlights a gap along the top of the steel shutter.*

2.10 The lack of access points, the lack of internal activity, and the lack of any bat evidence; suggests the building and quarry face are not being used as a bat roost. However, the possibility exists that bats could access the space along the edge of the corrugated roof, or over a gap in the shutter doors, as a result, the building has been designated as having moderate suitability for bats.

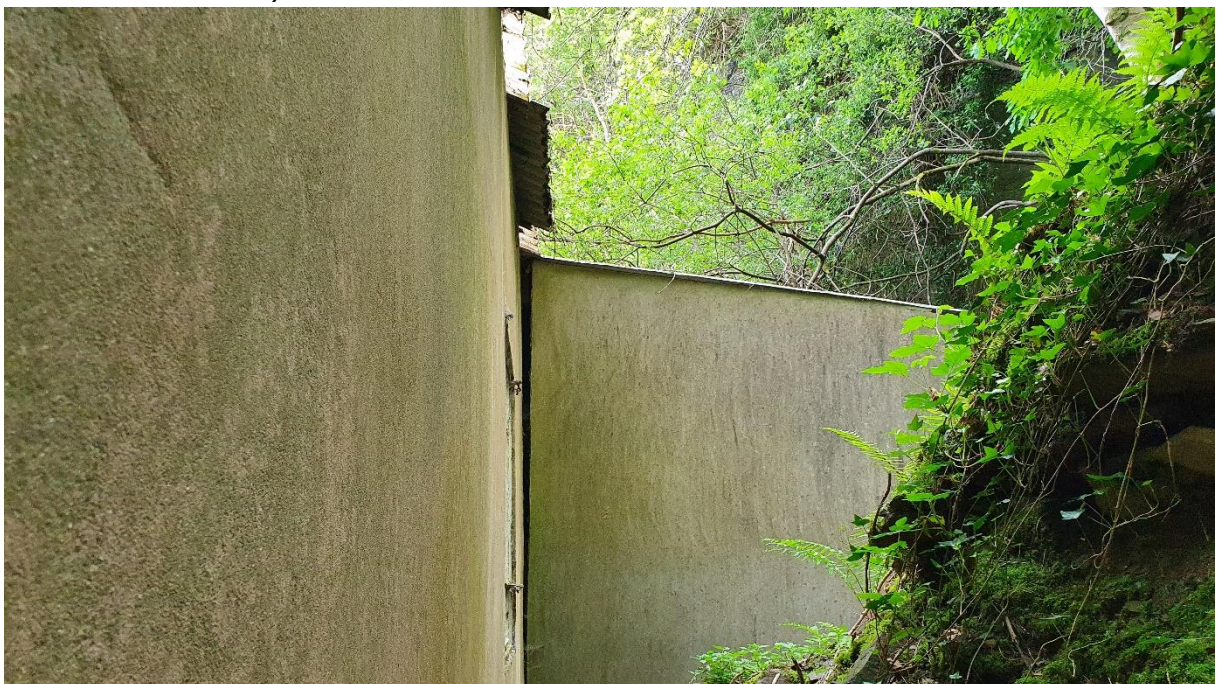
*Photo 7: There is a small lean-to storage room along the western aspect. The mortar along the joint is severely damaged and part of the building has pulled away from the wall. Light is clearly visible on the other side of the crack. The crack offers limited roosting potential for crevice dwelling bats. The space between the two walls was simple to inspect, it was heavily cobwebbed and no bats or evidence of bats was found.*

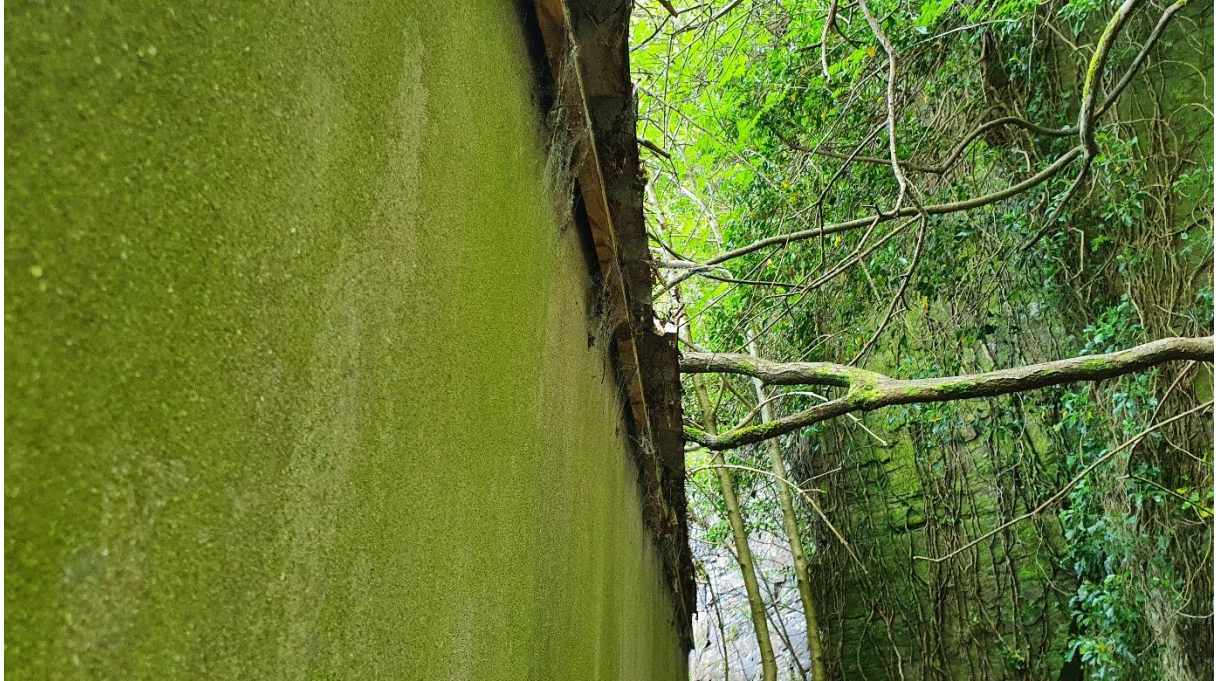
*Photo 8: There is a small wooden bargeboard around the small lean to, the potential roosting feature is shallow and heavily cobwebbed with no evidence of bats. There is low potential for bats to access to space beneath barge boards.*
