*Report No. BC/MB/10.18.01/2.*

# **Report on Drilling and Grouting: Plot 1, Greenacres, Heolgerrig, Merthyr Tydfil.**

and relates to a parcel of land in Heolgerrig, Merthyr Tydfil where it is proposed to erect a detached dwelling; it discusses the findings of a drilling and grouting programme carried out on the Site to stabilise shallow mine workings. Recommendations are made on appropriate foundation options.

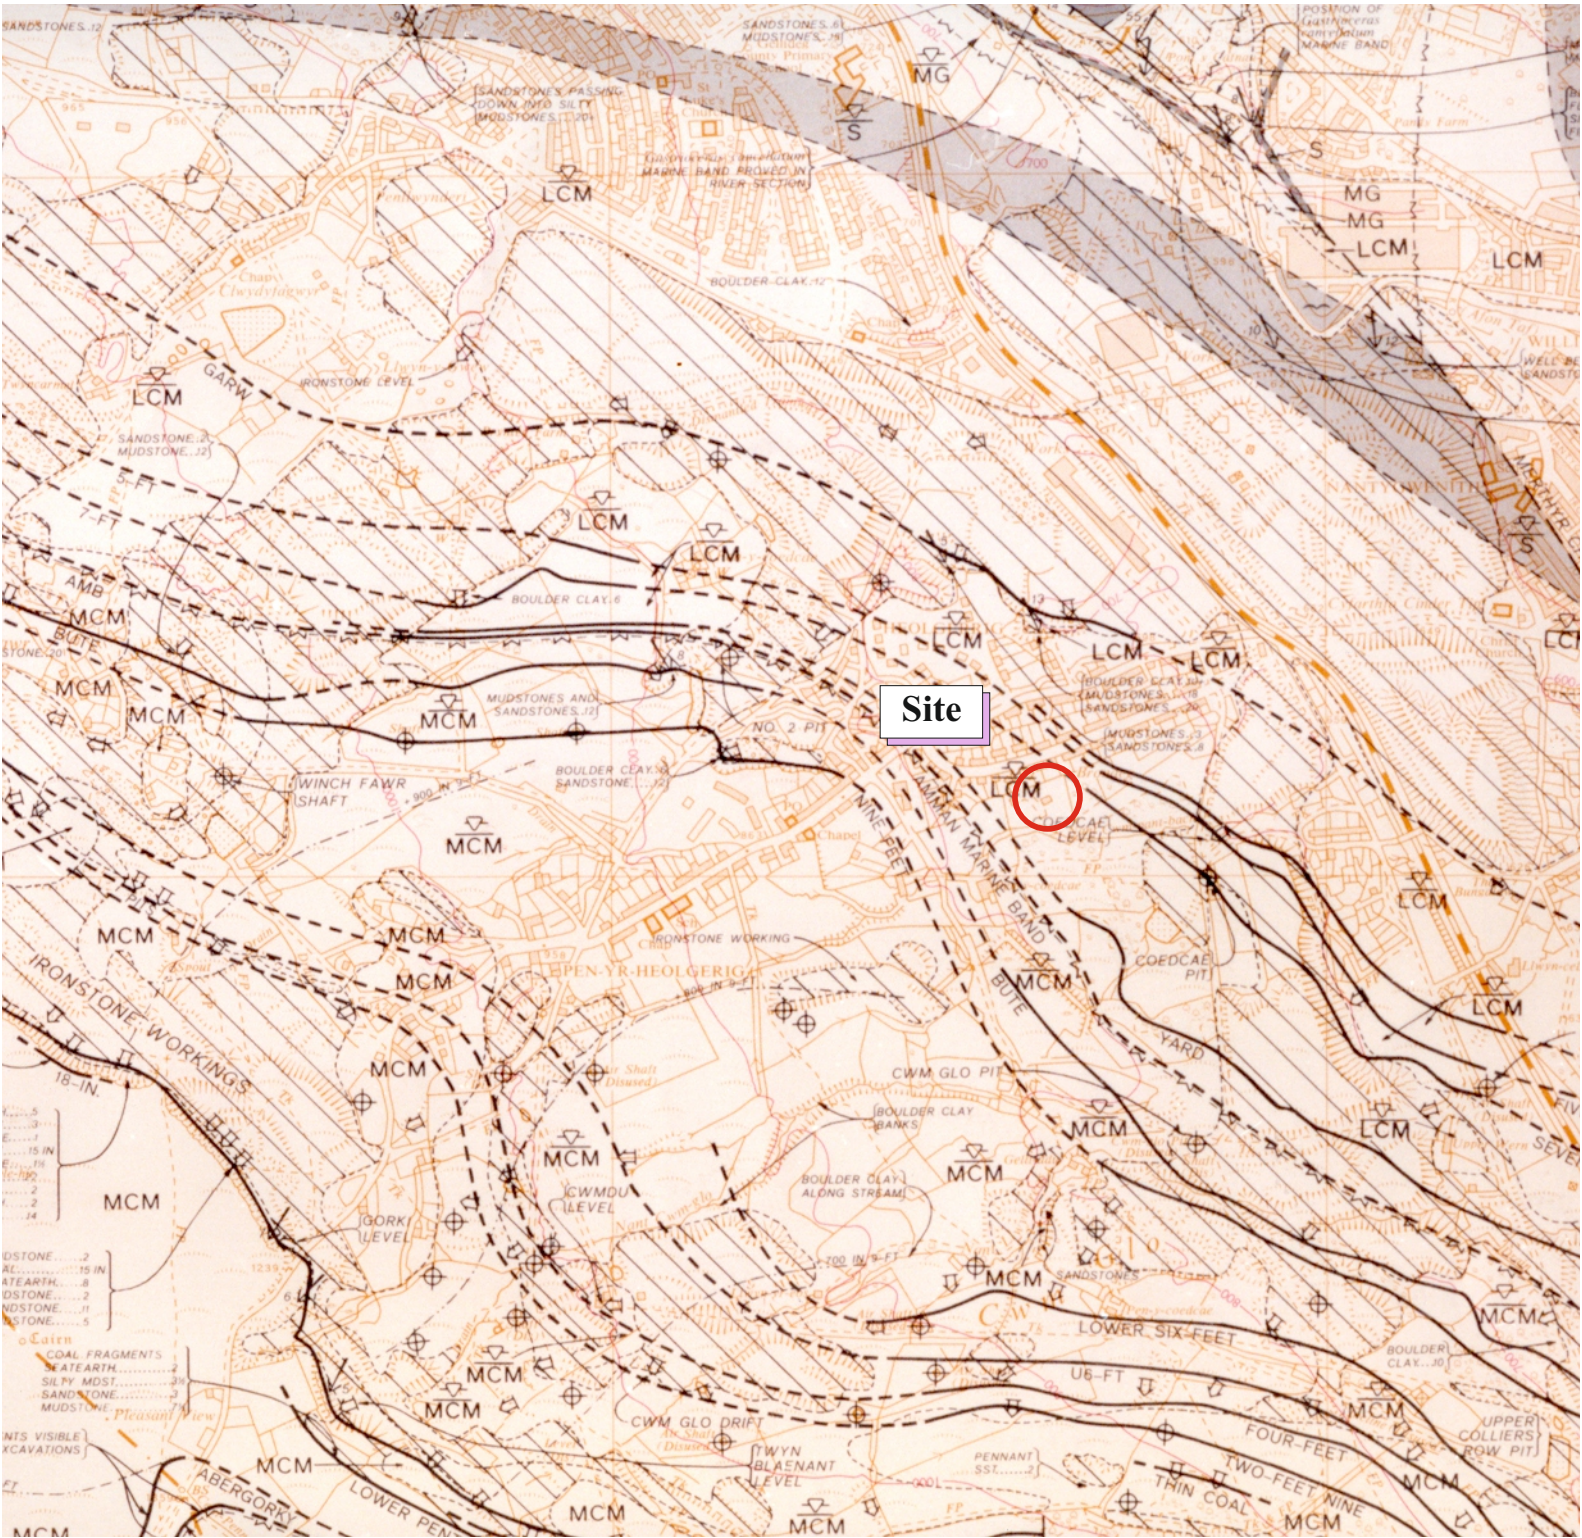
Drawing No: BC/MB/10.18.01.02.

*Geology Plan.*

The earlier site investigation report found the Site to be underlain at shallow depths by strata assigned to the Lower and Middle Coal Measures that include a number of coal seams, at

least some of which are thick enough to have supported underground mining operations. The earlier reports also identified that the Site is not affected by any large-scale faulting and the coal measures to be overlain with deposits of glacial till, Boulder Clay, and that the Site is not affected by landslip.
