**Rhydycar West  
Leisure Resort,  
Rhydycar West,  
Merthyr Tydfil**

**FINAL DRAFT**

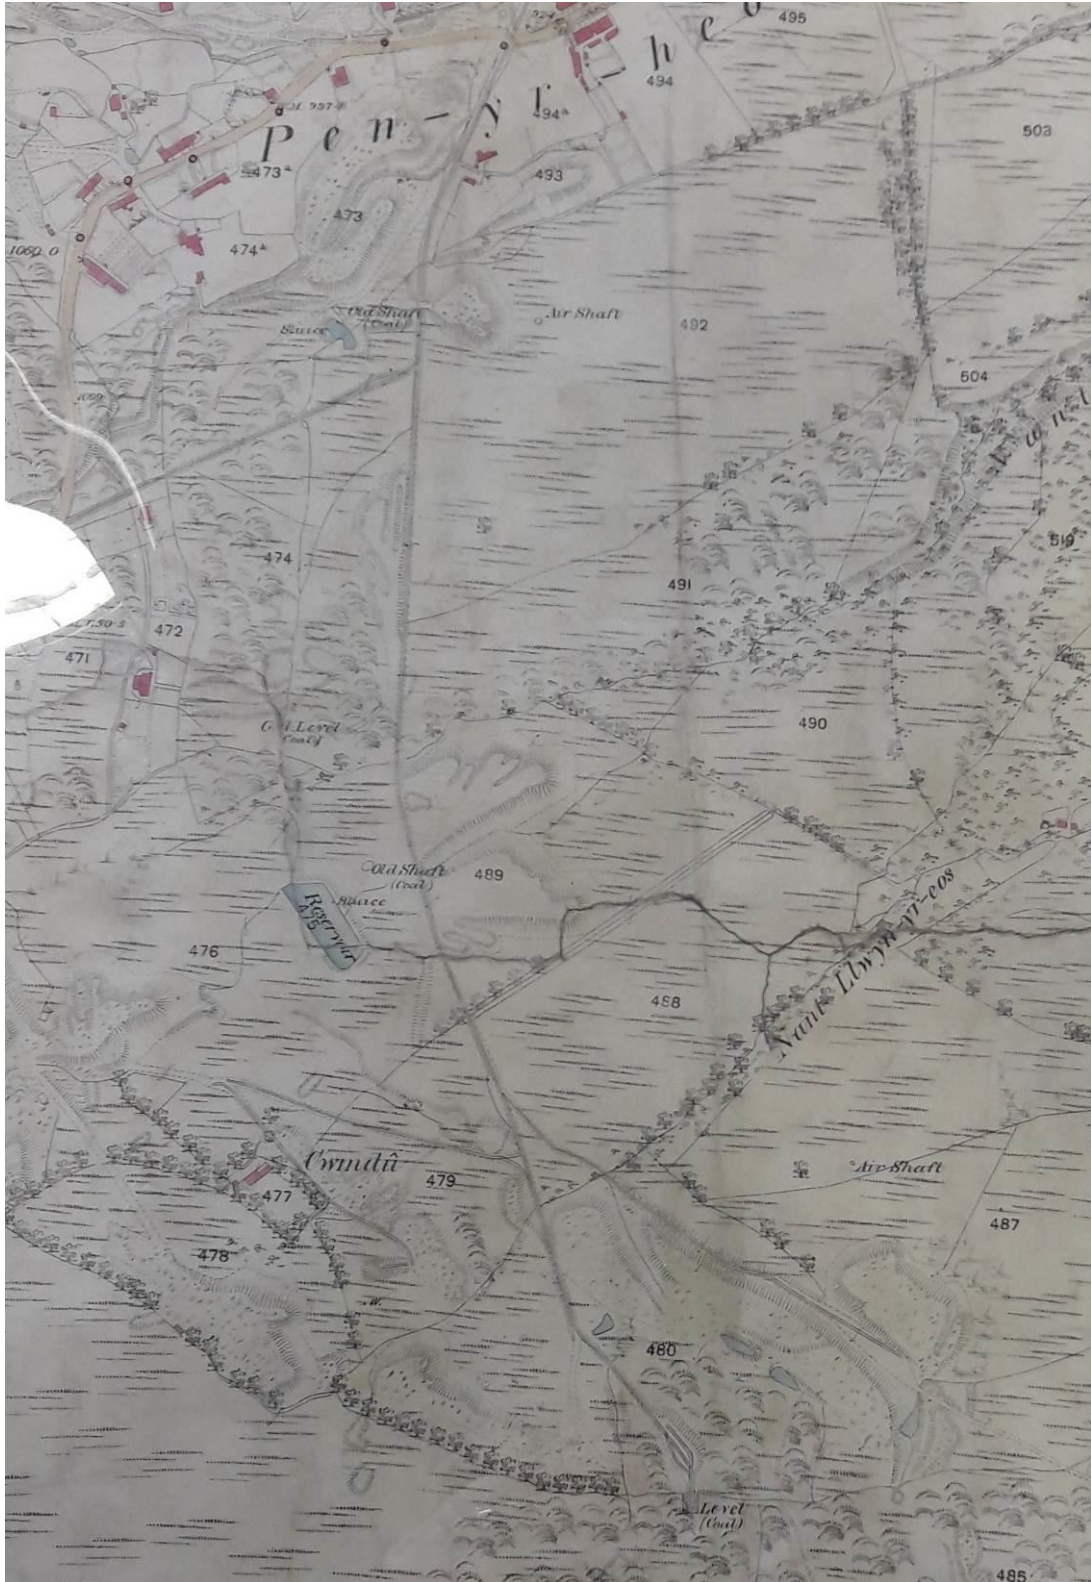
Figure EDP 6: The Cwm Du area on OS Map of 1876.

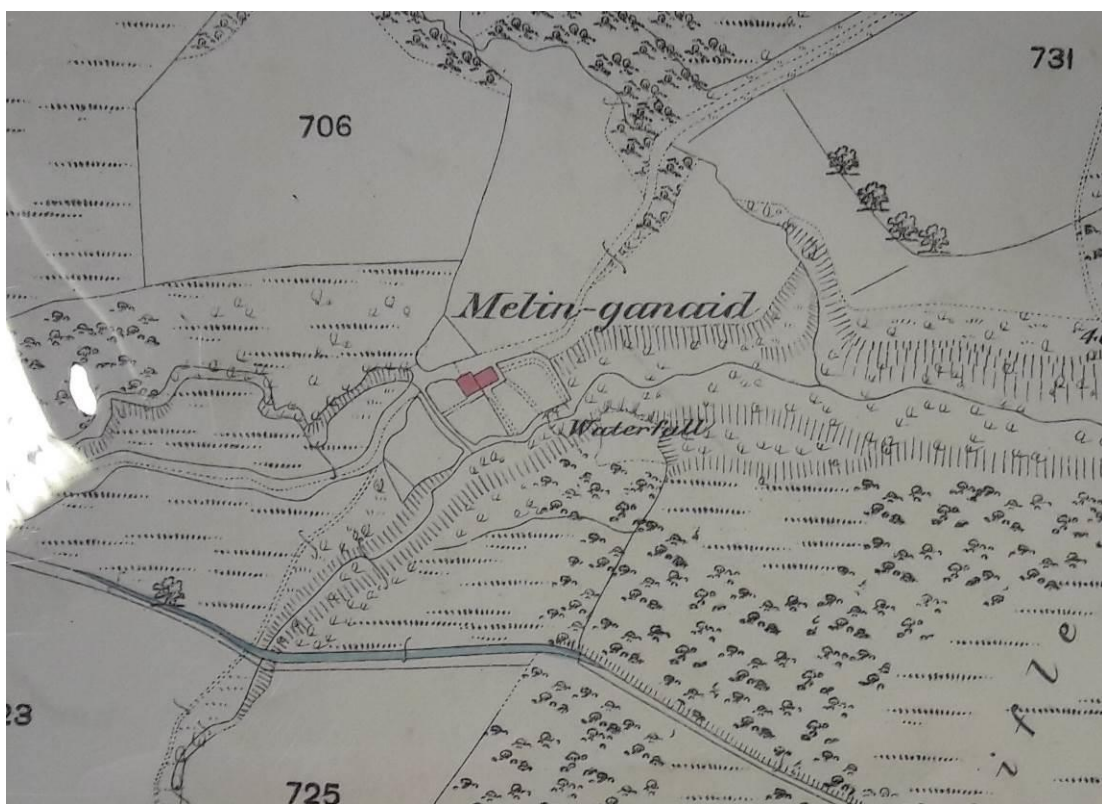
**Figure EDP 13:** Melin Ganacid as depicted in 1876.

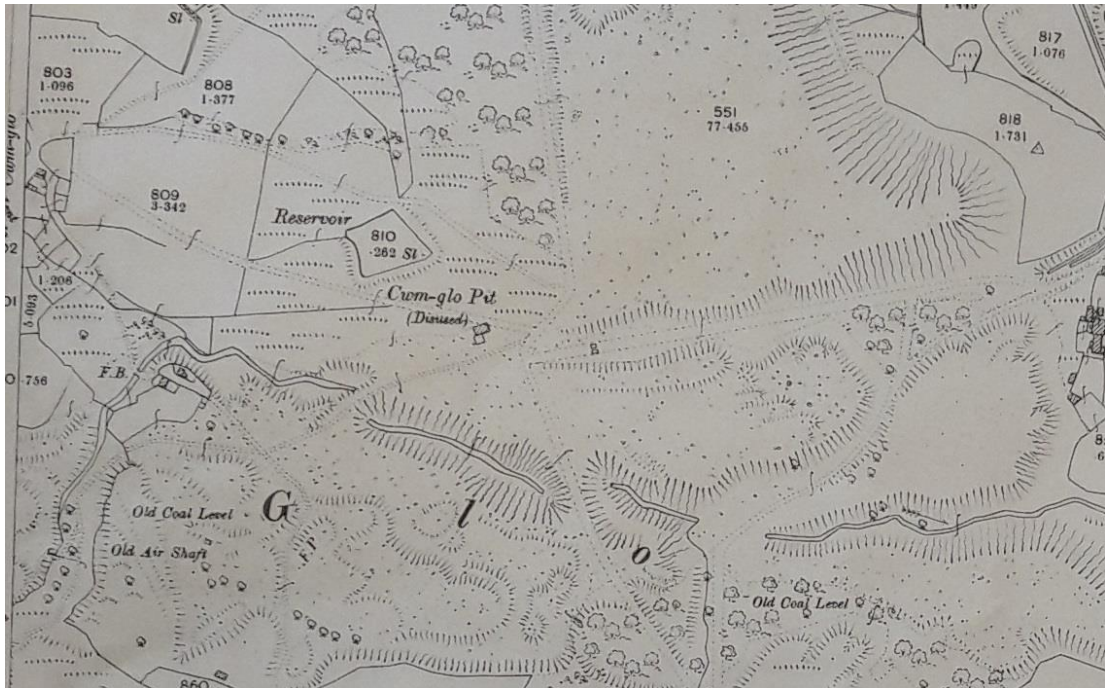
**Figure EDP 17:** Cwm Glo Pit as depicted in 1900.

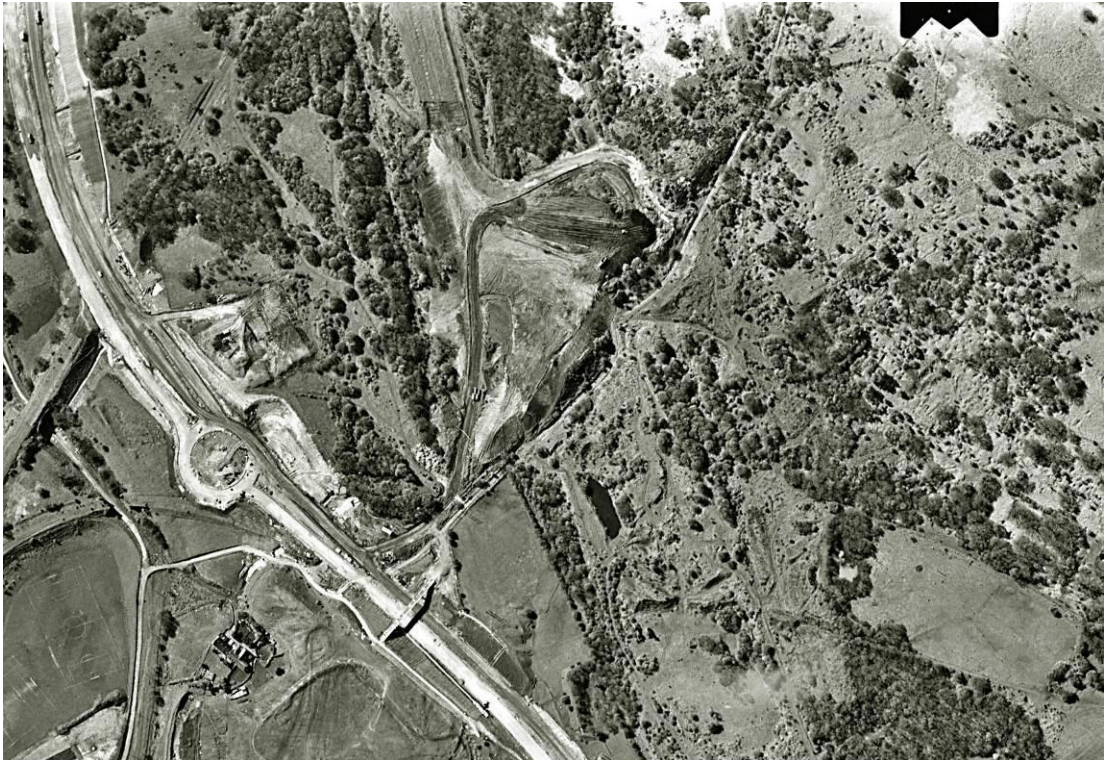
**Figure EDP 24:** Extract from aerial photograph of 1996 showing tipping within the site during the construction of the A470.
