# Rhydycar West

## Hydrogeology & Hydrology Assessment Desk Top Study

B023905

November, 2022

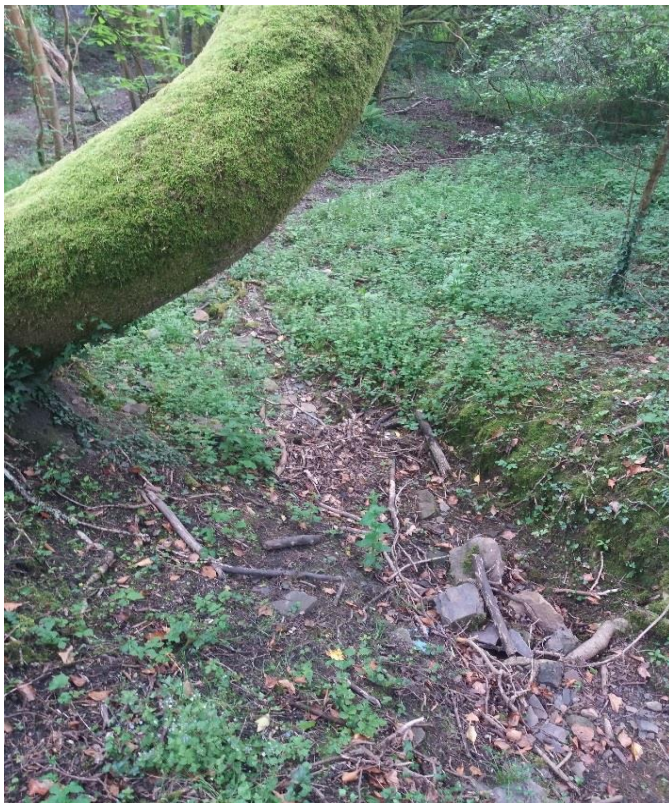
**Plate 14**

Locality 15: Possible adit tunnel/channel structure.

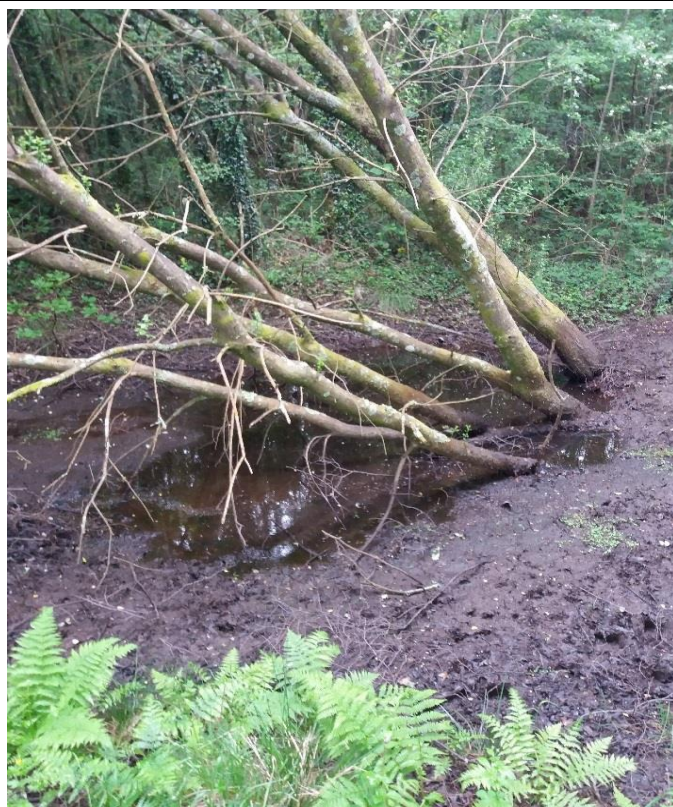
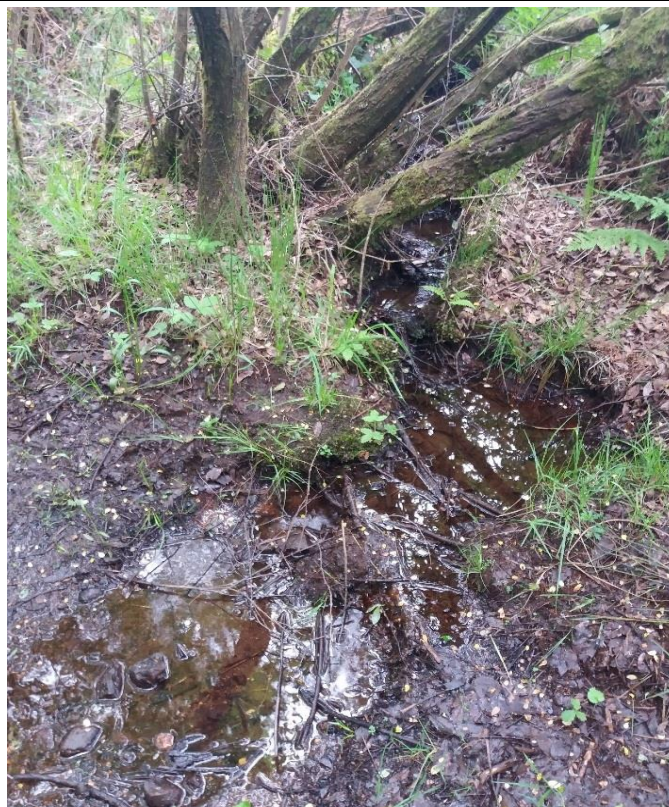
**Plate 16**

Locality 18: Small stream draining land to the north. Slight orange discolouration.

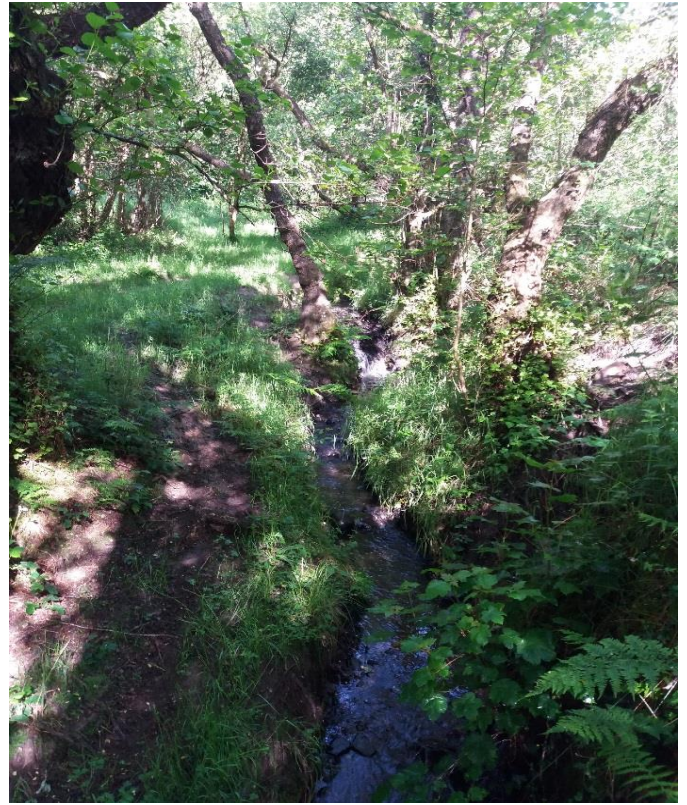
**Plate 17**

Locality 19: Tributary stream of the northern tributary of the Nant Cannaid stream.

Plate 17 shows water flowing within a stream onto the site close to the south-western boundary at an estimated flow rate of 1-2L/sec on the 15<sup>th</sup> June 2017. Water is channelled towards a concrete culvert which eventually discharges the water into the diverted stream of the Nant Canaid within the southern area of the site near Cwm Pit. The diverted stream of the Nant Canaid was viewed at the 'waterfalls' in the south-western point of the site, with the flow of the water over the waterfalls estimated to be 20-40L/sec. The channel was noted to be as wide as 3m in some places with numerous cobble and boulder sized mudstone and sandstones in the bed of the stream. The water was observed to be clear and transparent as it flowed over a 1.5m thick, blocky sandstone bed which is also exposed along the southern side of the valley at this locality.

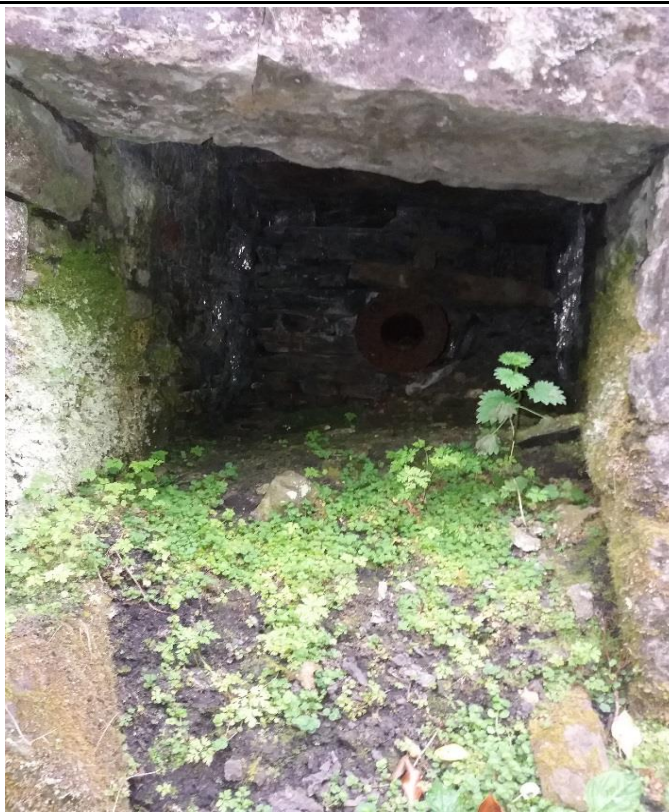
**Plate 19**

Locality 21: Pipe noted in stone wall structure viewing south. No evidence of recent discharge from the pipe.

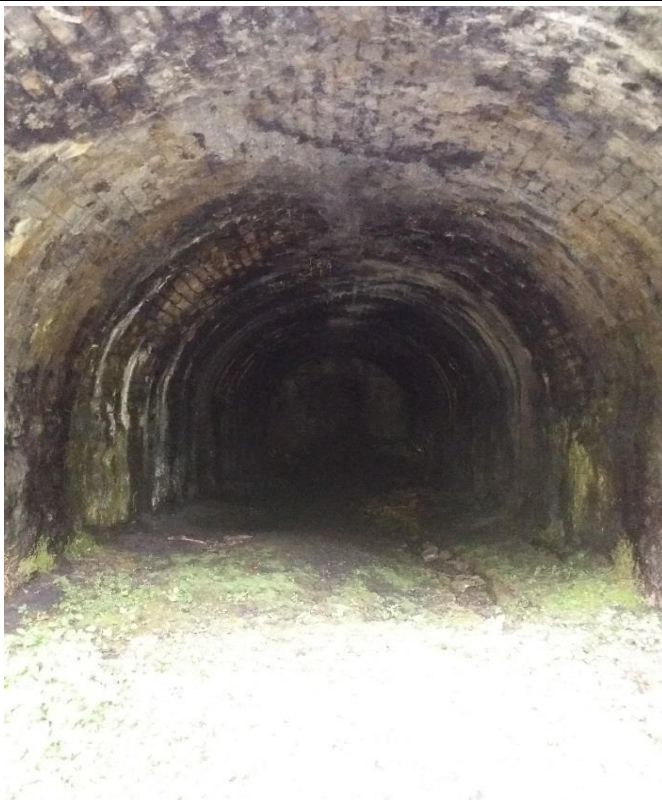
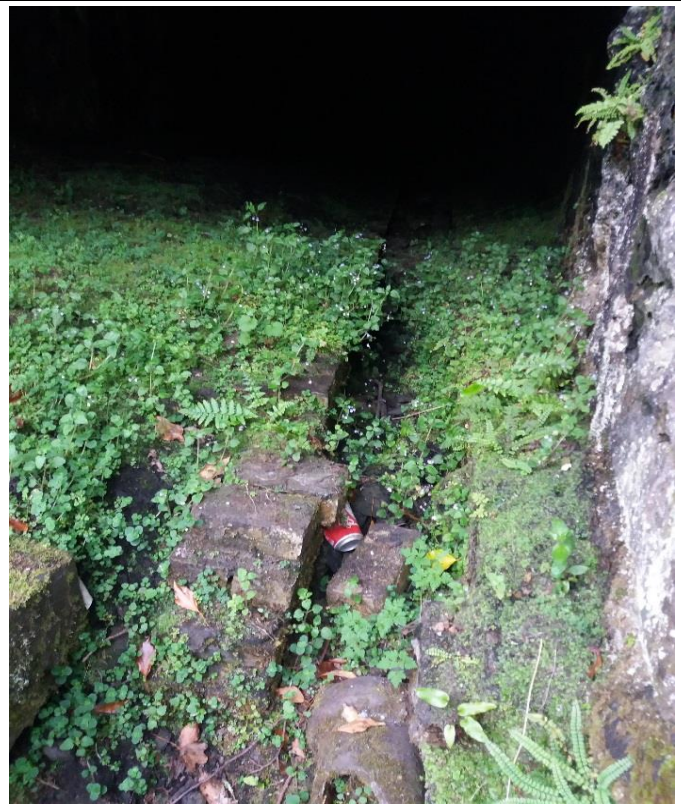
**Plate 20**

Locality 21: Second mine entrance at Cwm Pit. Appears to be blocked up by bricks.

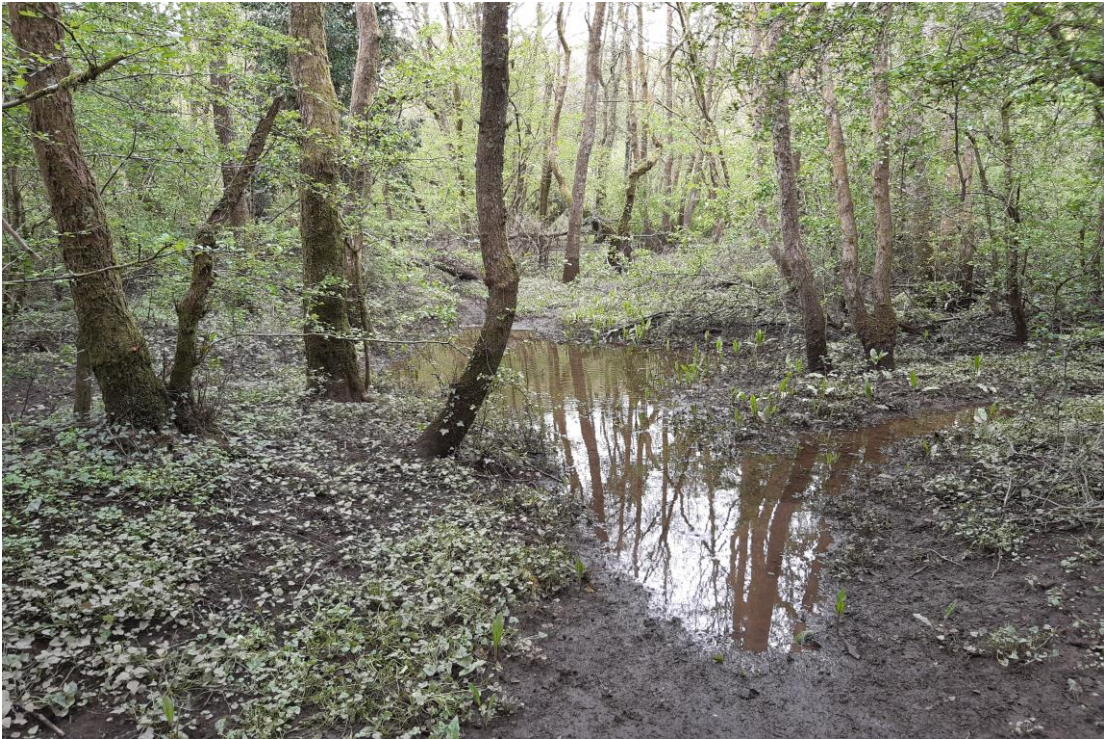
**Plate 1**                      Photos showing evidence of recent flooding from the ‘hollow’ and a storm event in c. 2020 - 2

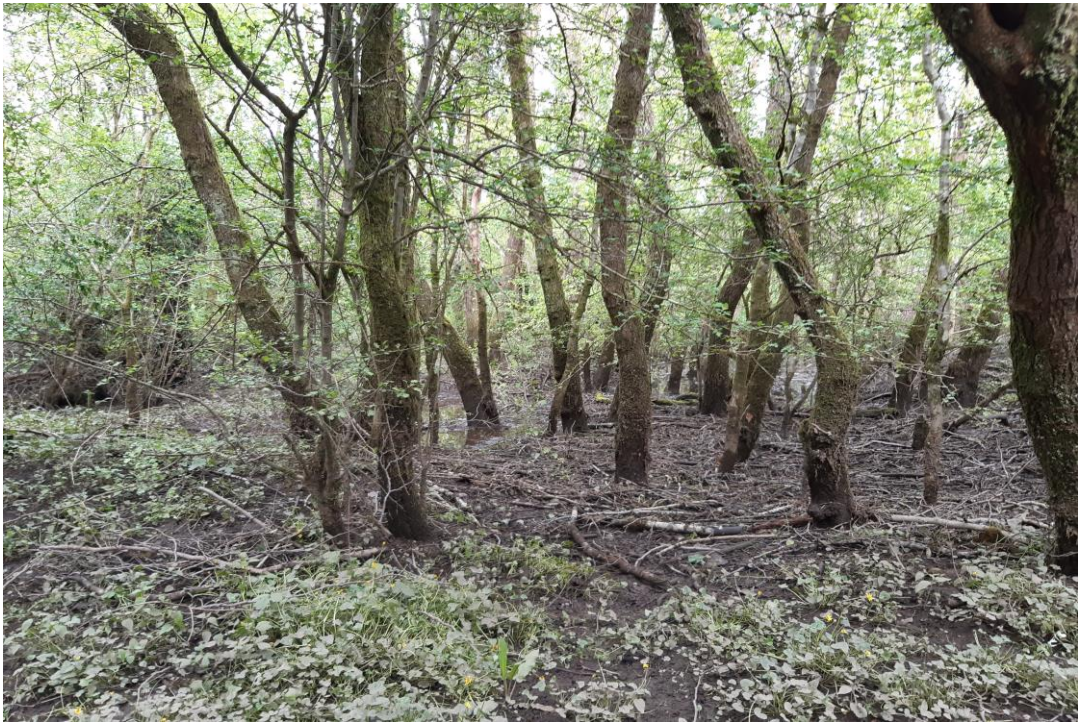
**Plate 2**                      Photos showing evidence of recent flooding from the ‘hollow’ and a storm event in c. 2020 - 2

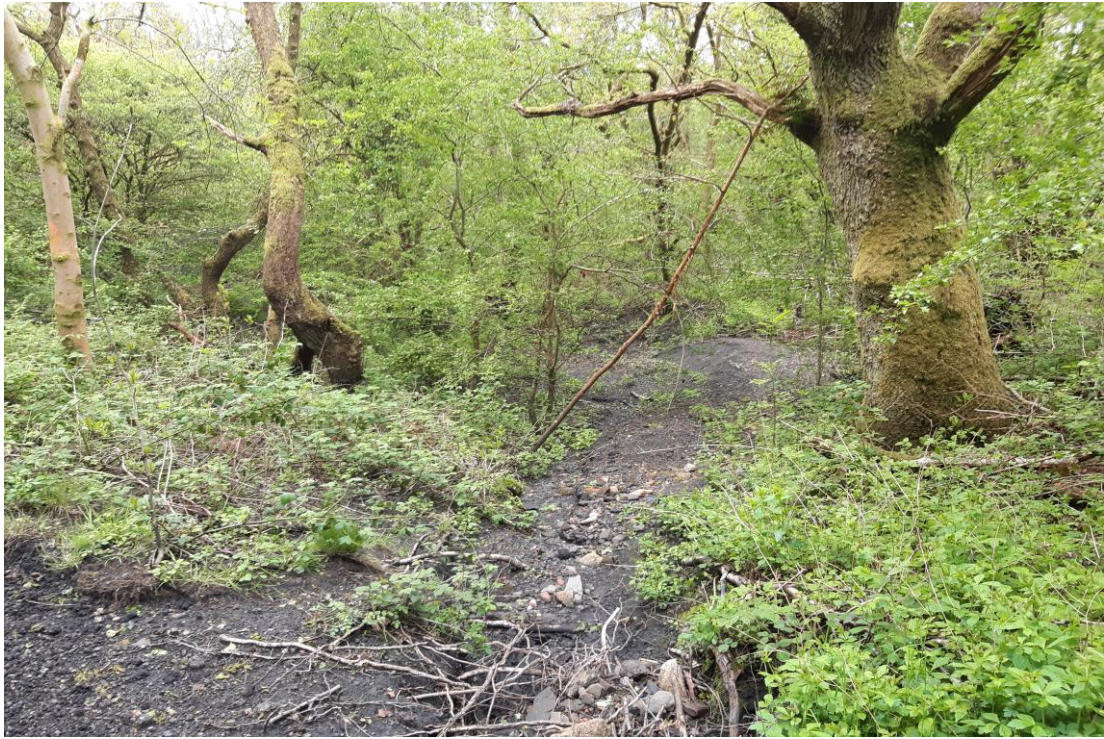
Plate 3

Photos showing evidence of recent flooding from the ‘hollow’ and a storm event in c. 2020 - 2

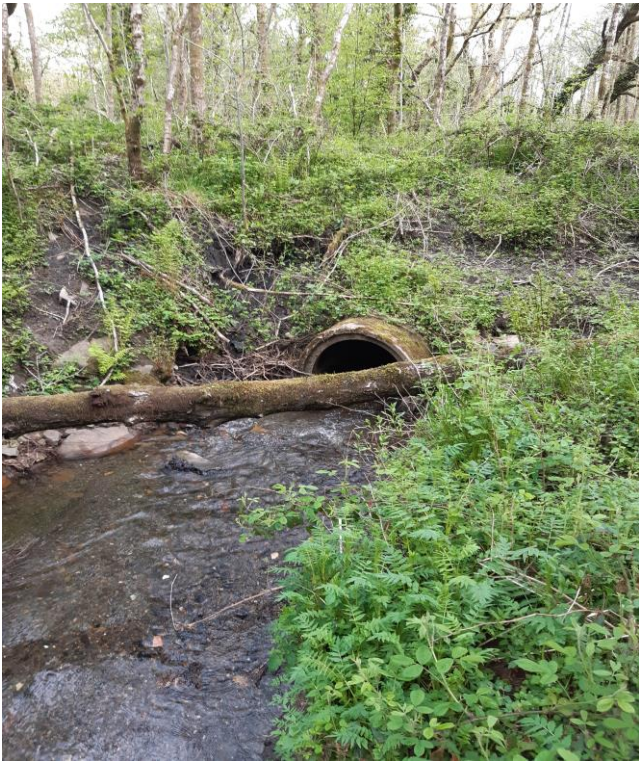
Plate 4

Photo of culvert beneath access track at edge of site boundary - 3

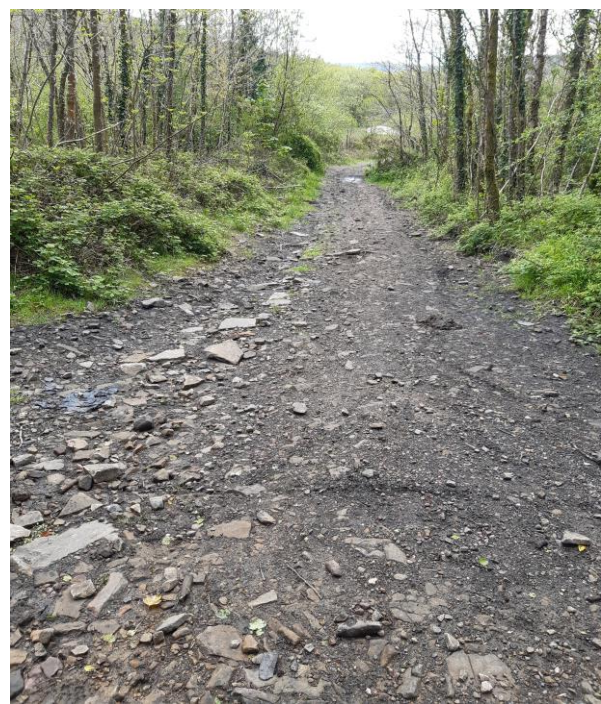
**Plate 5** Photo looking eastwards along vehicle access track at damage which is the result of flood water overtopping from the ‘hollow’. - 4

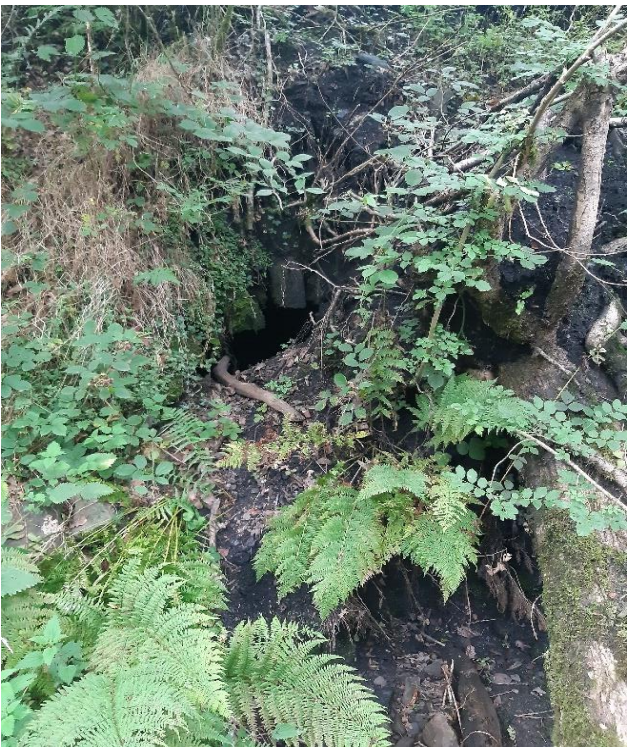
**Plate 6** Photo viewing culvert outfall within the northern bank of the Nant Melin Cannaid Stream - 5

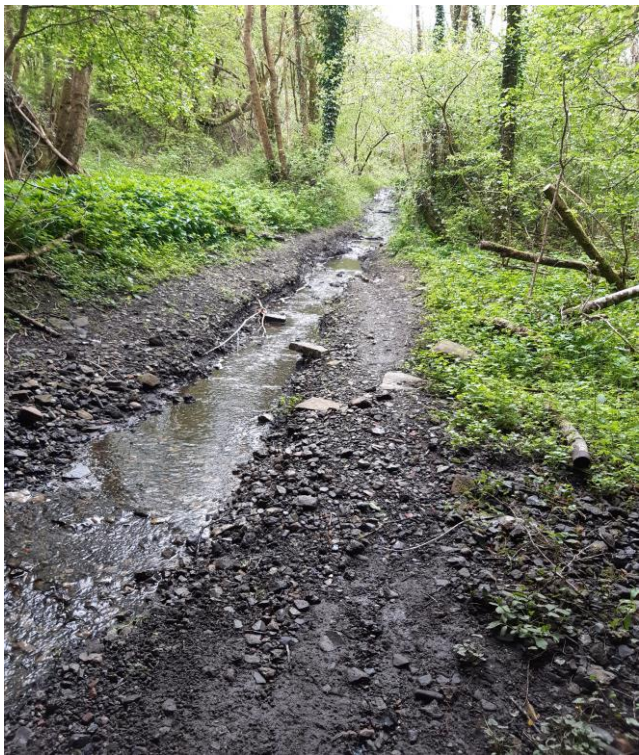
**Plate 7**                      Photo viewing water flowing along the former Aberdare to Merthyr Railway line - 6

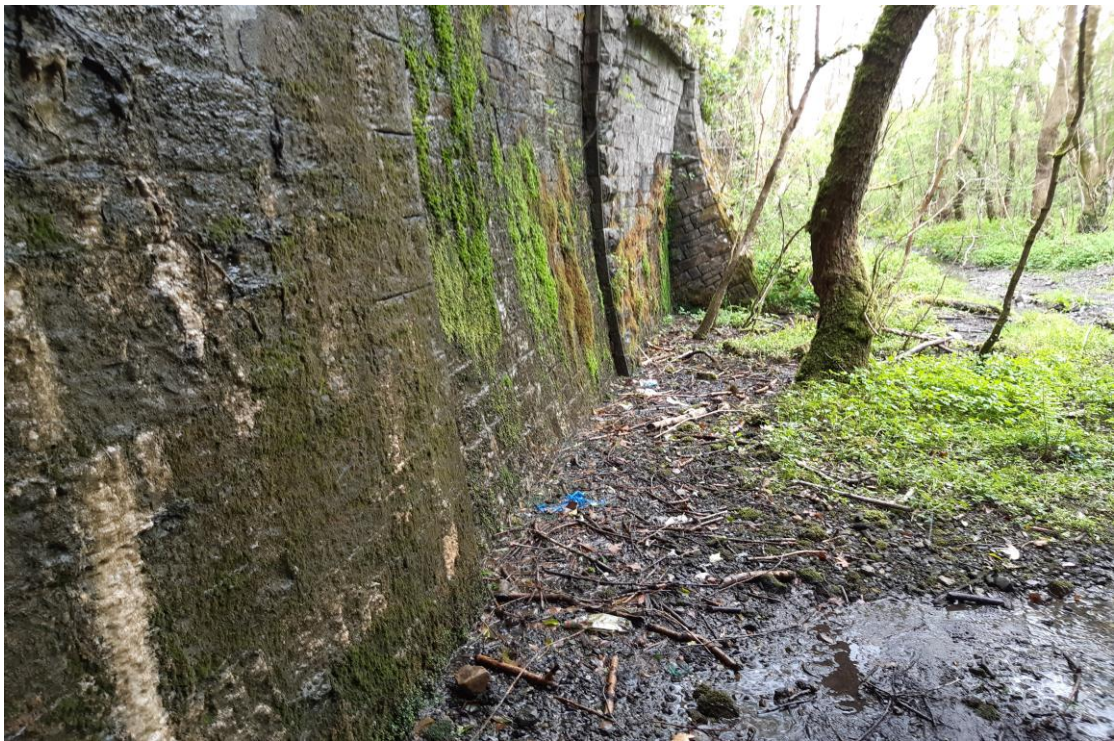
**Plate 8**                      Photos viewing groundwater seepage through the masonry of the bridge which crosses over the former Aberdare to Merthyr railway line - 7.

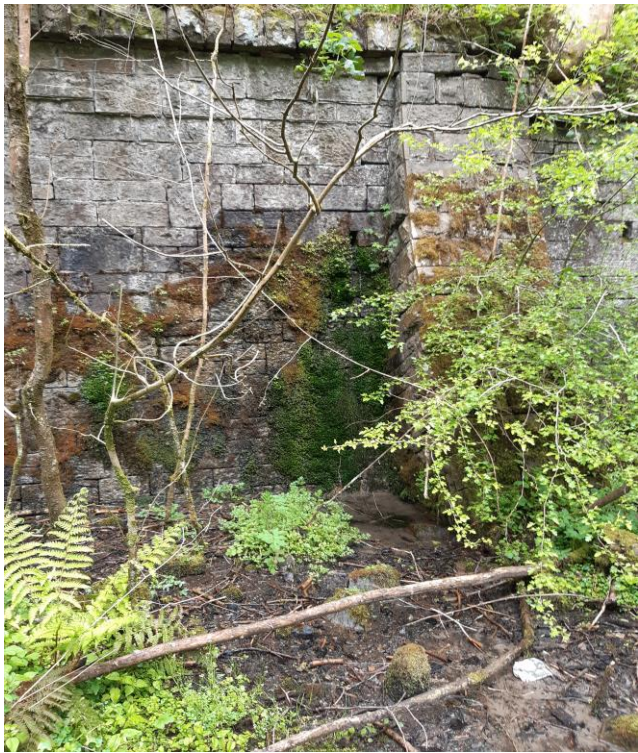
**Plate 9**                      Photos viewing groundwater seepage through the masonry of the bridge which crosses over the former Aberdare to Merthyr railway line - 7.

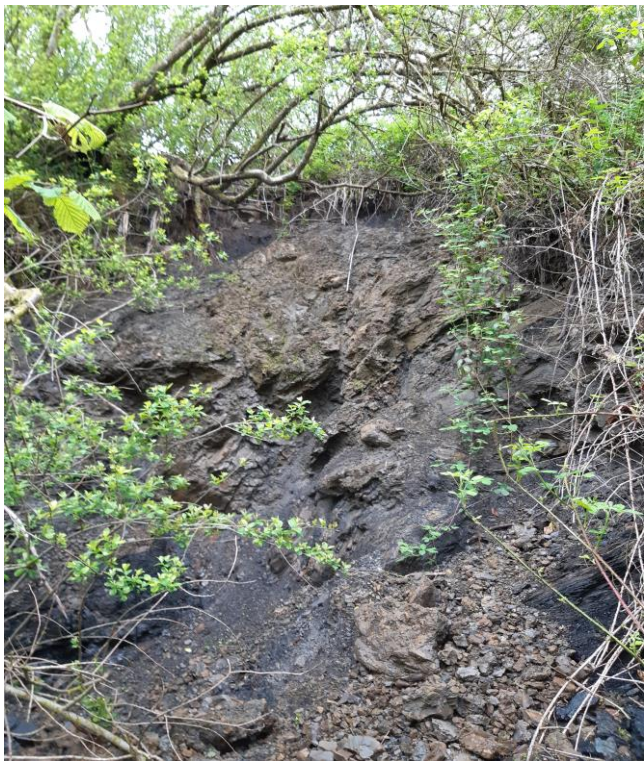
**Plate 10**                      Photo showing exposed coal seam within cutting of the railway line. - 8

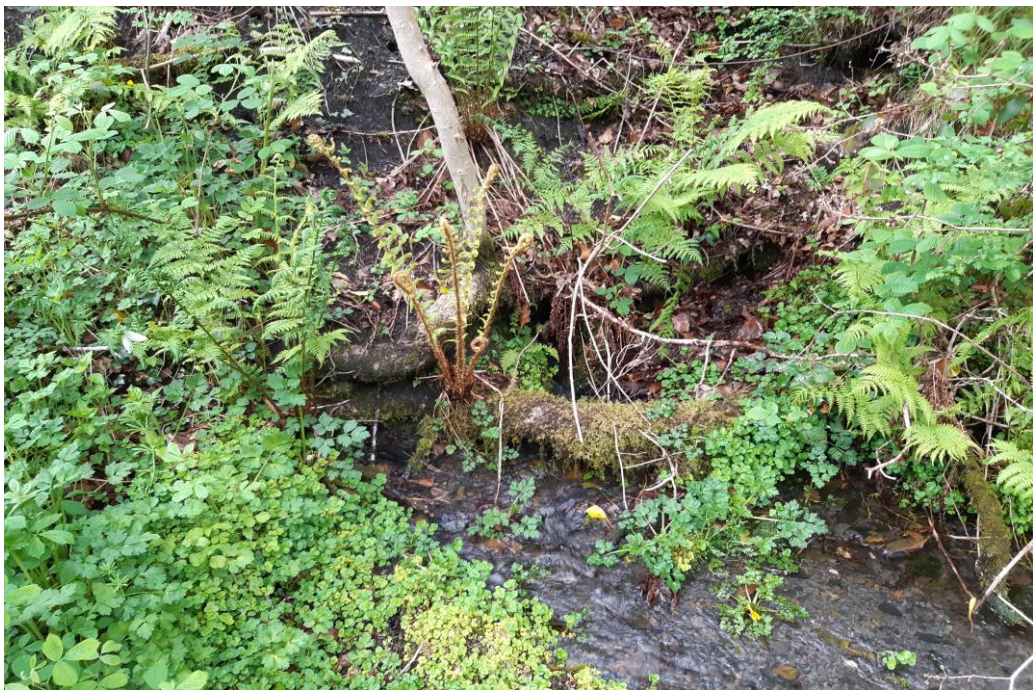
**Plate 11**                      Photos showing springs emerging at the base of the Glyndyrys Tips - 9

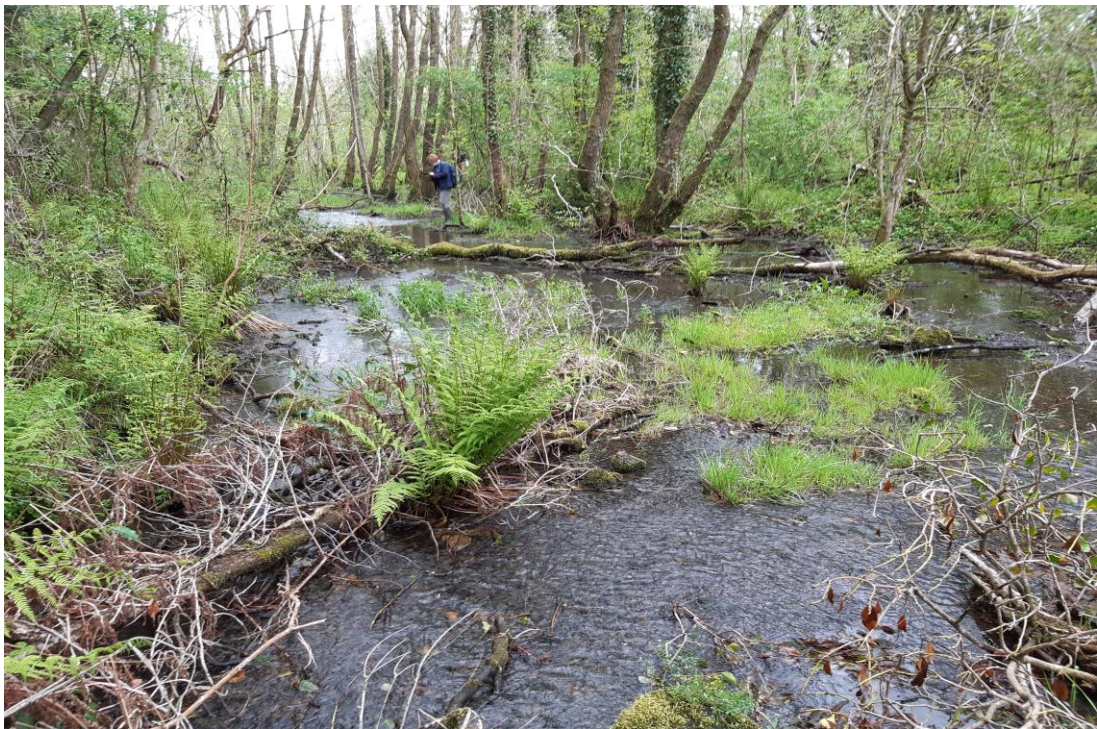
**Plate 12**                      Water which flows along the former Aberdare to Merthyr railway line, joins spring water from beneath the Glyndyrys Tip and is directed towards a ponded area at Locality 26. - 9

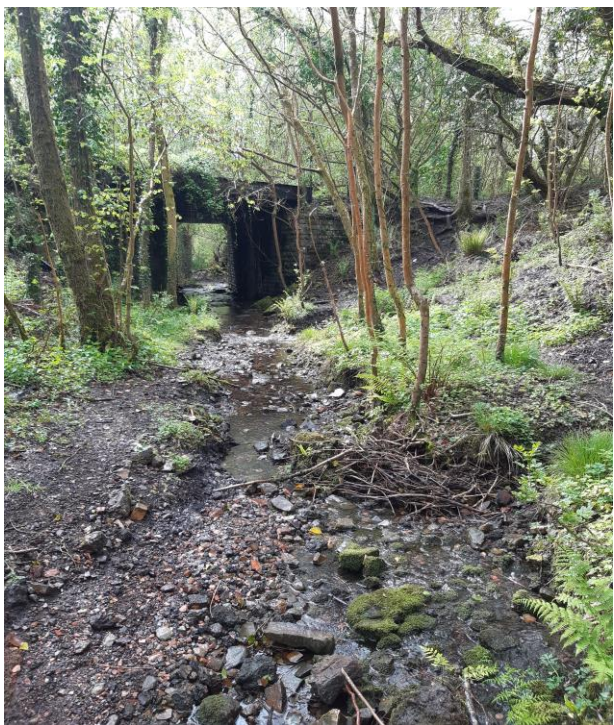
Plate 13

Photo viewing spring water emerging at the base of the Glyndyrus Tip flowing along the former railway track beneath the Cyfartha Junction heading in a south, south-east direction.- 10

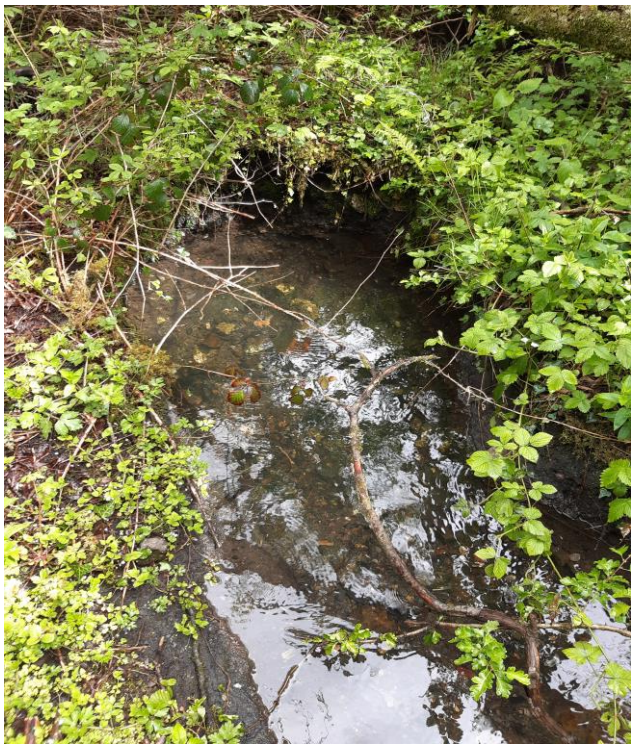
Plate 14

Water up-welling from the base of the Glyndyrus Tip. - 11

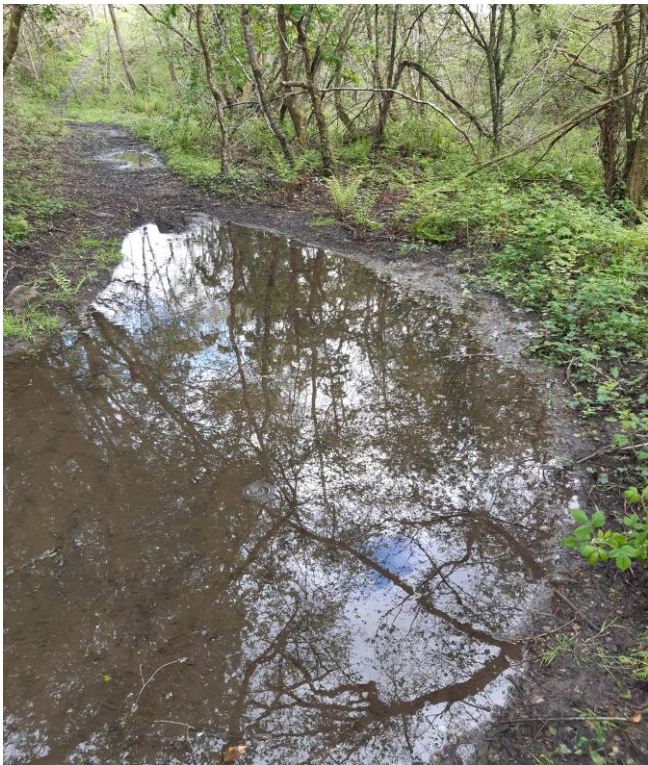
**Plate 15** Stagnant water within the ‘Leat’ of the Cyfartha Tub Boat Canal and water found to be seeping from the leat and into the ‘hollow’ -12

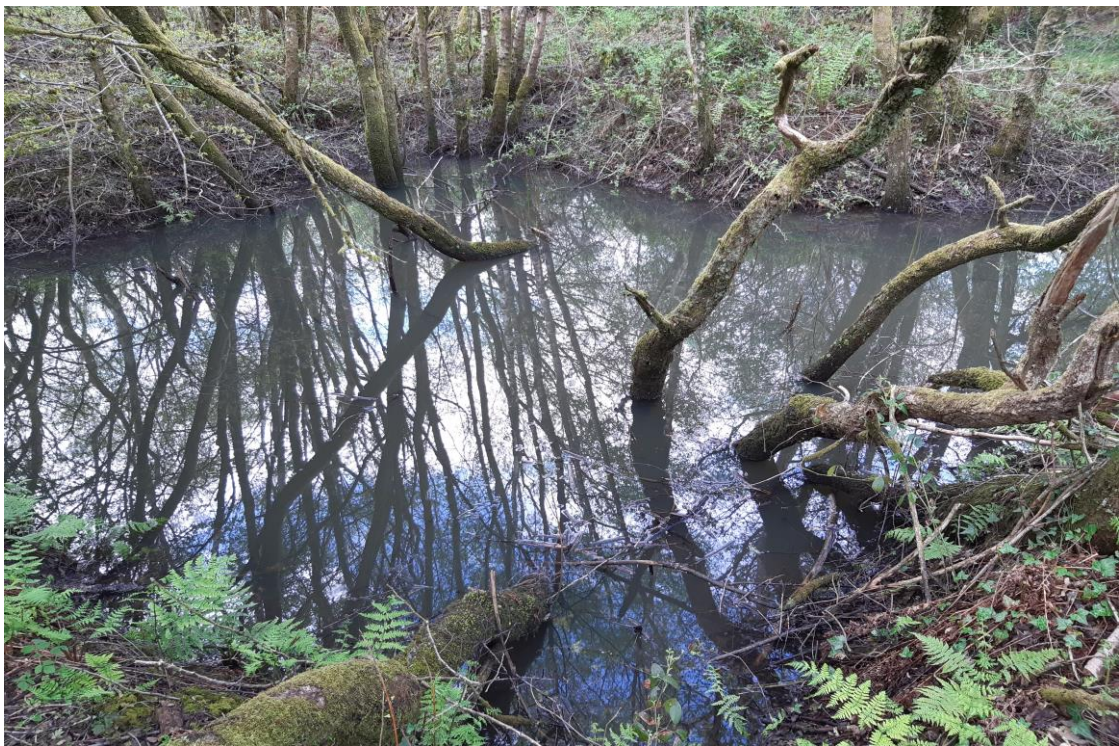
**Plate 16** Stagnant water within the ‘Leat’ of the Cyfartha Tub Boat Canal and water found to be seeping from the leat and into the ‘hollow’ -12

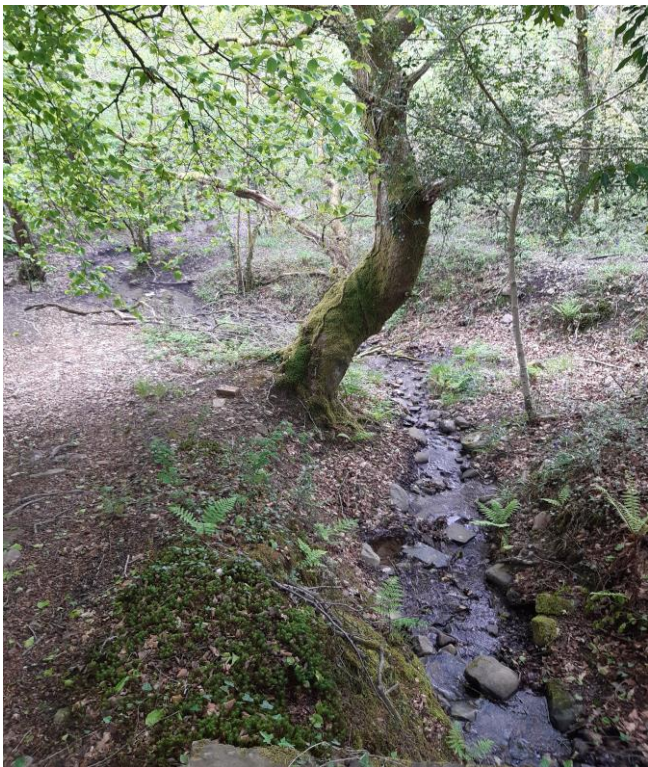
**Plate 17**                      Water draining away from a break in the ‘Leat’ and discharging into the ‘hollow’ - 13

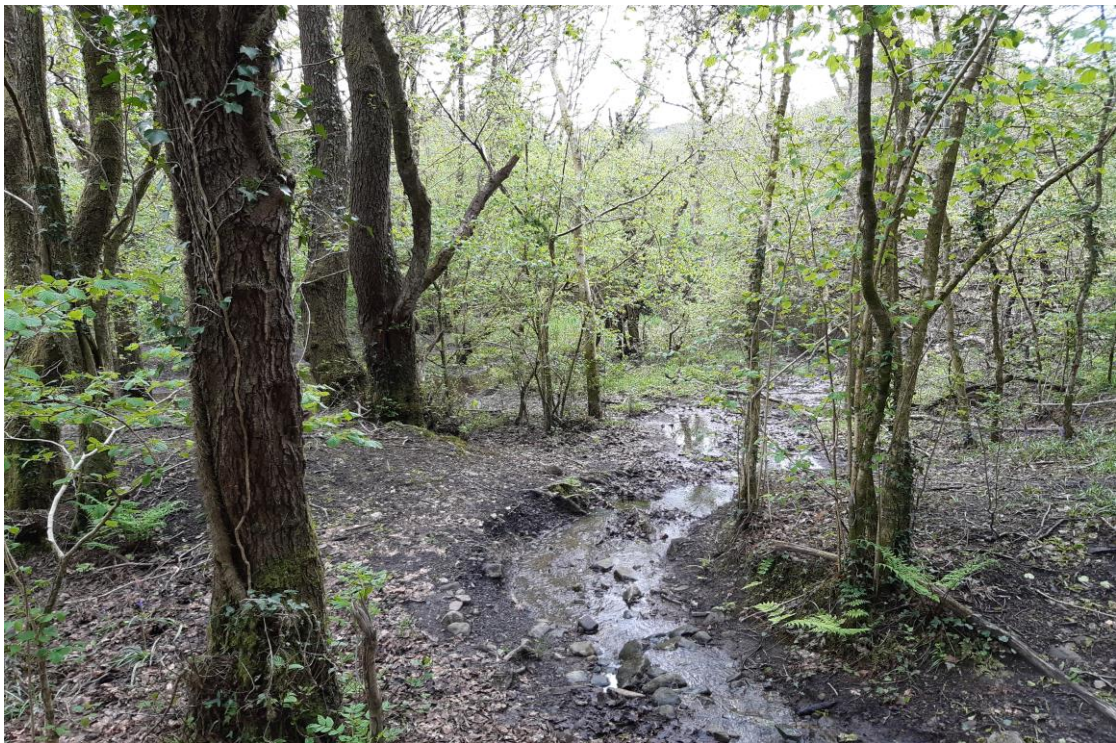
**Plate 18**                      Water draining away from a break in the ‘Leat’ and discharging into the ‘hollow’ - 13

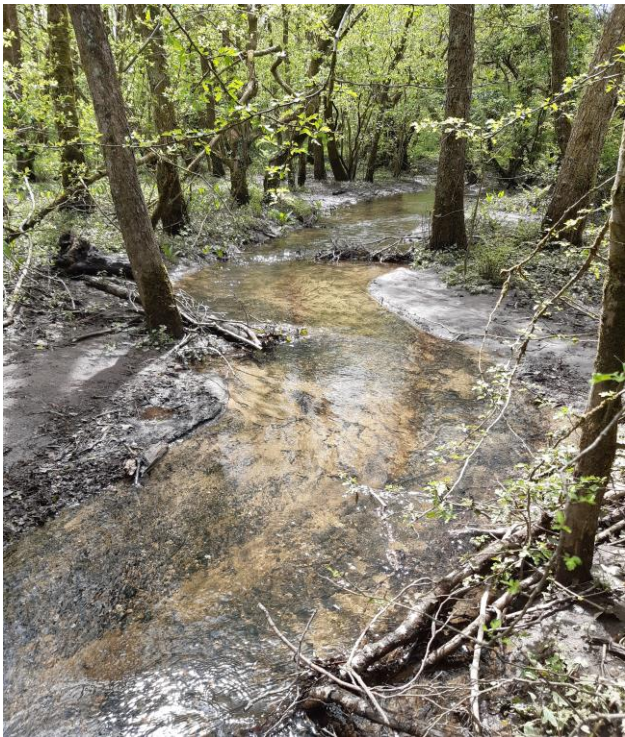
**Plate 19** Observed water flowing and ponding within the ‘hollow’ area of the site. - 14

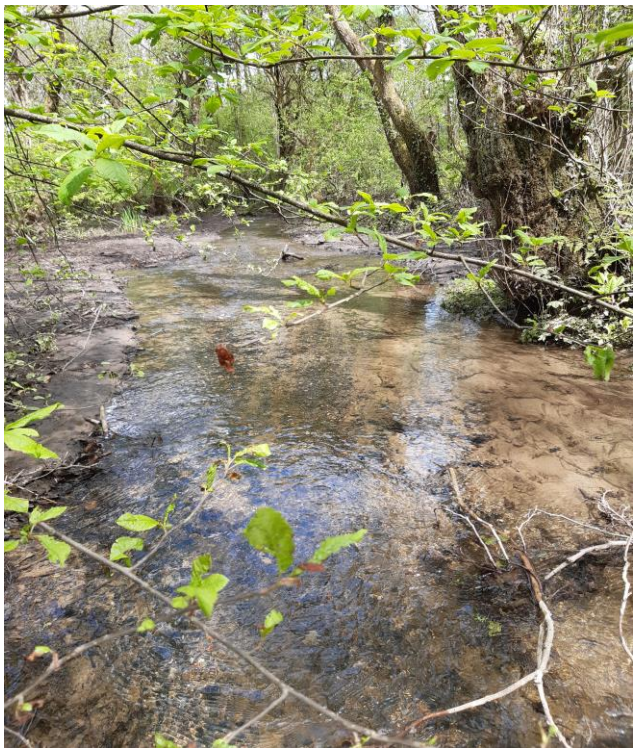
**Plate 20** Observed water flowing and ponding within the ‘hollow’ area of the site. - 14

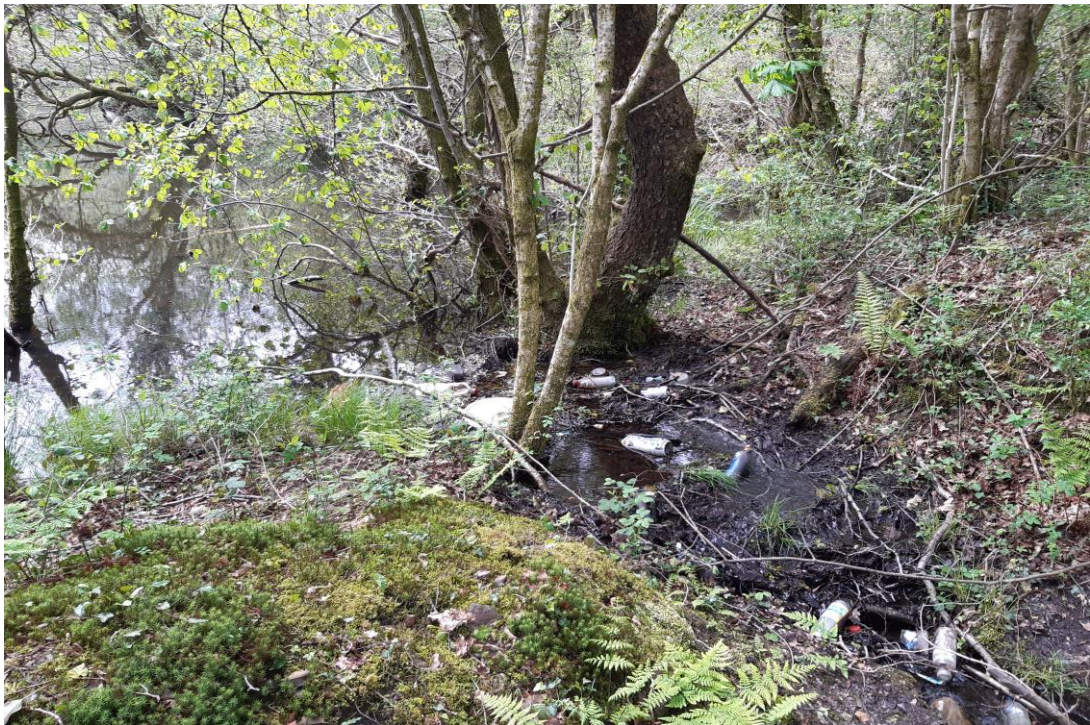
**Plate 21**                      Water observed to overtop from the pond on the northern extent and flow into the ‘leat’. - 15

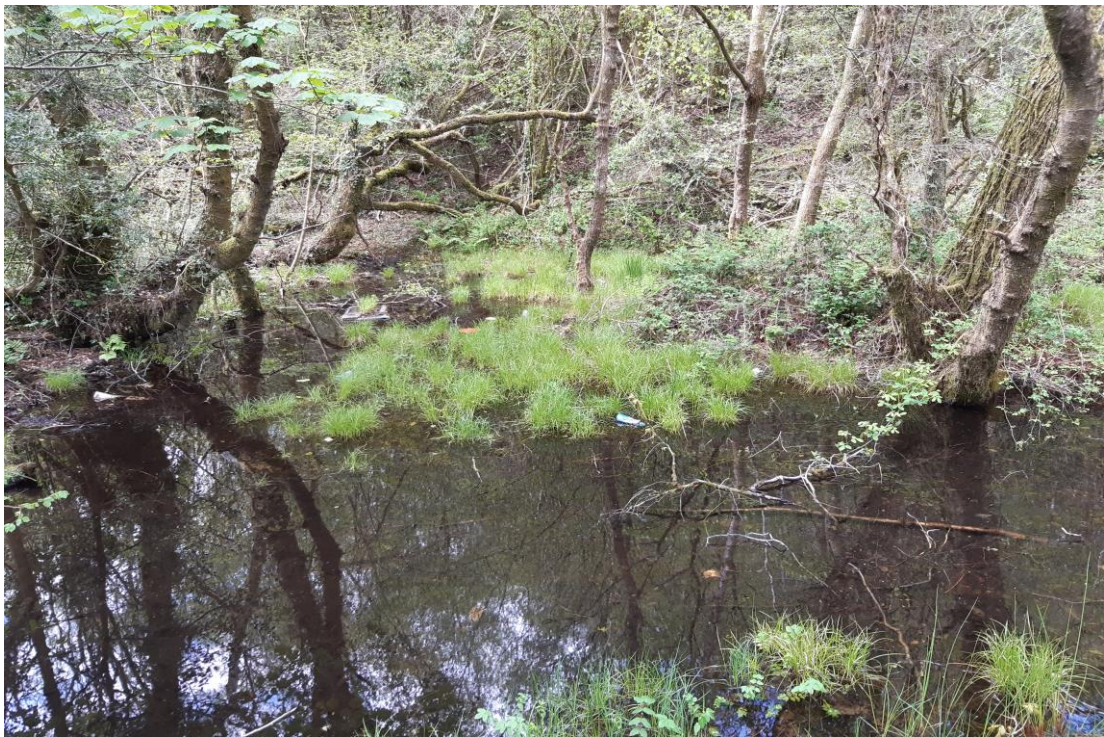
**Plate 22**                      Water pooling at the base of the adjacent tip in the south-western extent of the Cyfartha Pond. - 16

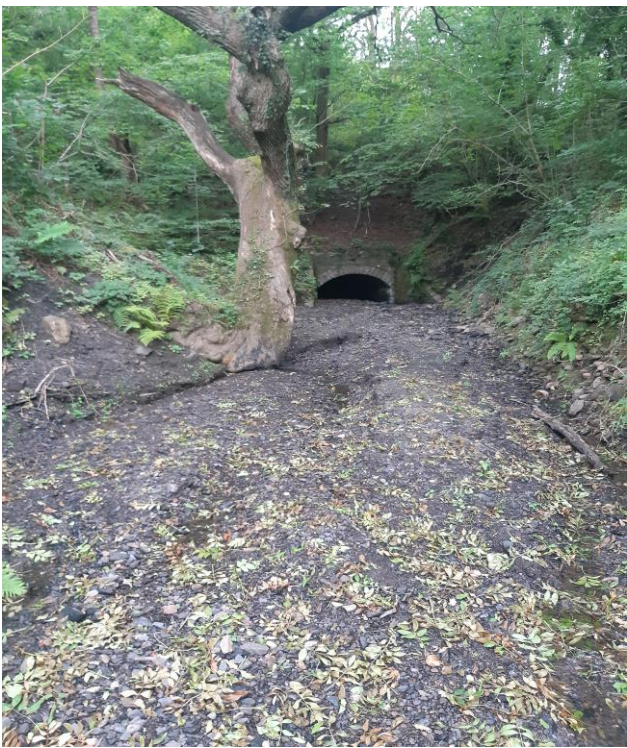
**Plate 23**                      Photo showing heavily silted Nant Cannaid and the culvert beneath the A470 - 17

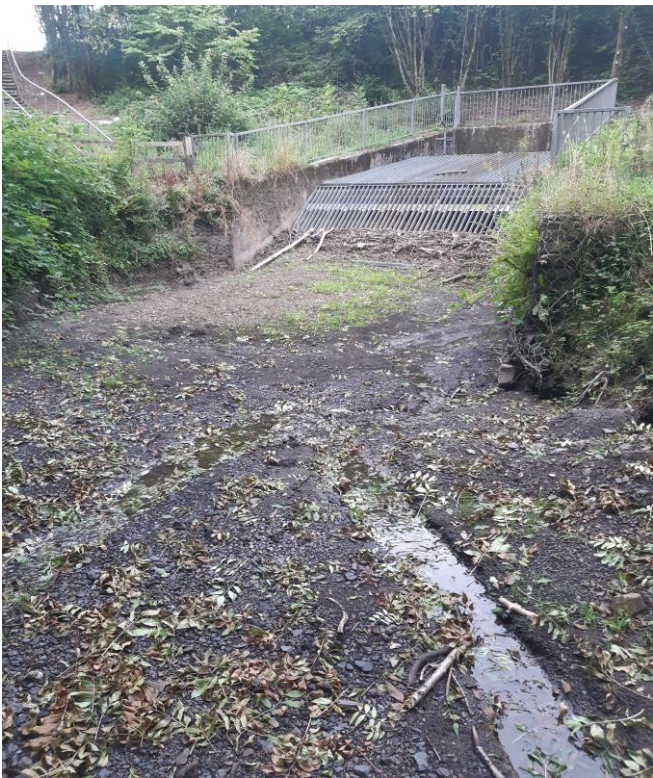
**Plate 24**                      Photo showing heavily silted Nant Cannaid and the culvert beneath the A470 - 17

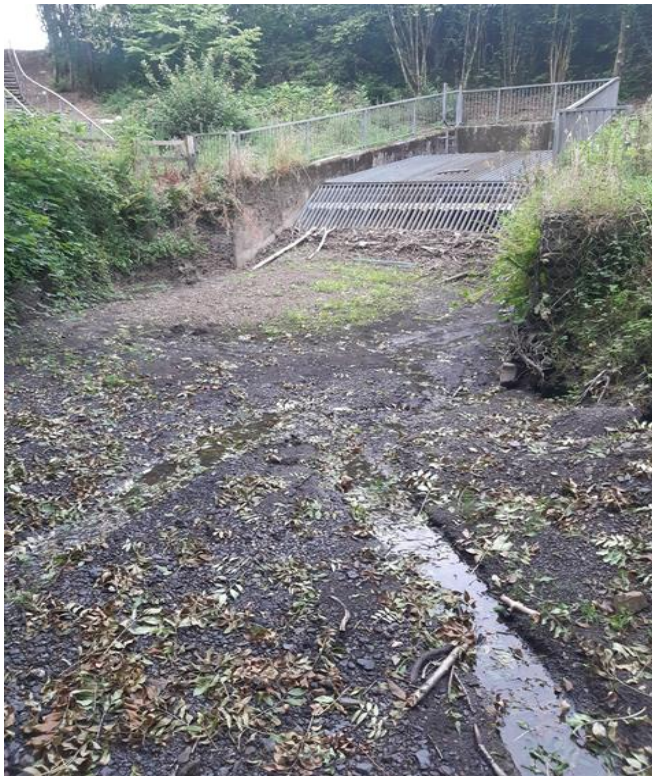
**Plate 25**                      Photo of the Nant Cannaid culvert beneath the former Aberdare to Merthyr railway line - 18

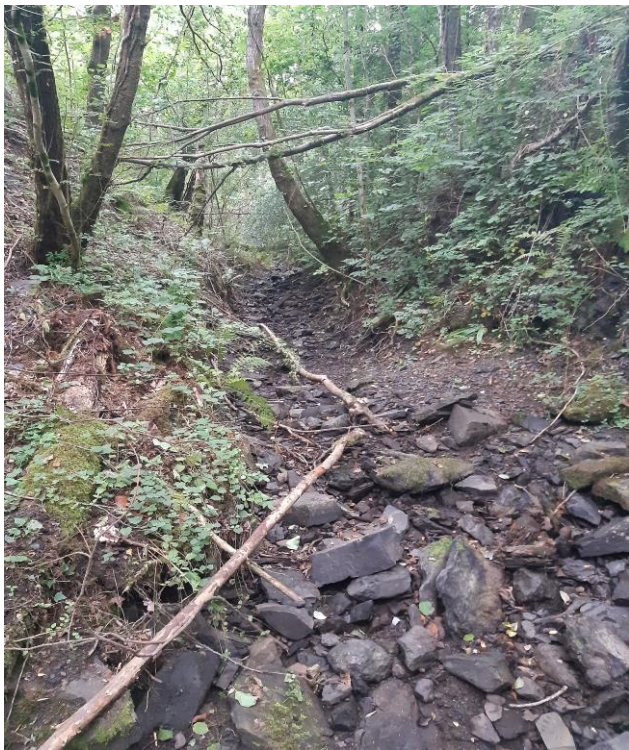
**Plate 26**                      Photo of the dry Nant Cannaid stream - 19

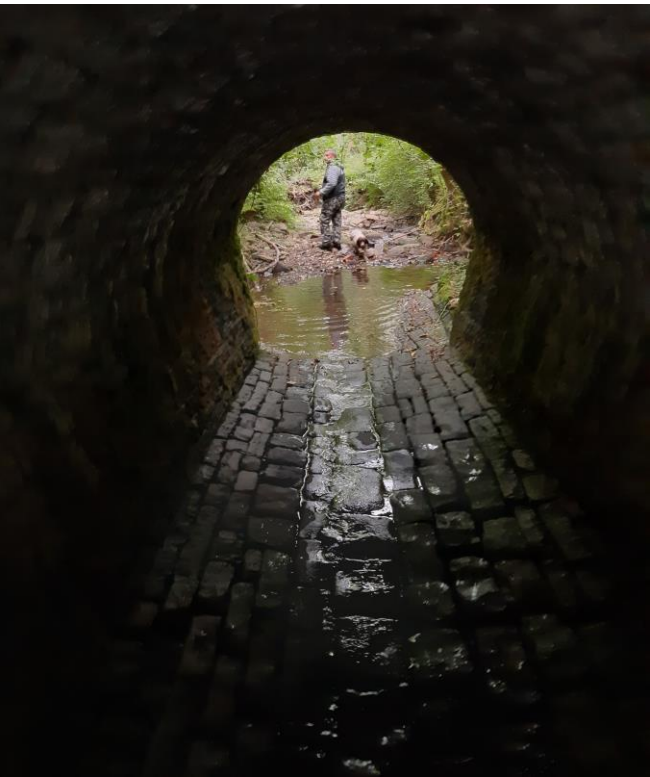
**Plate 27**                      Photo showing the culvert for the Nant Cannaid beneath track crossing - 20

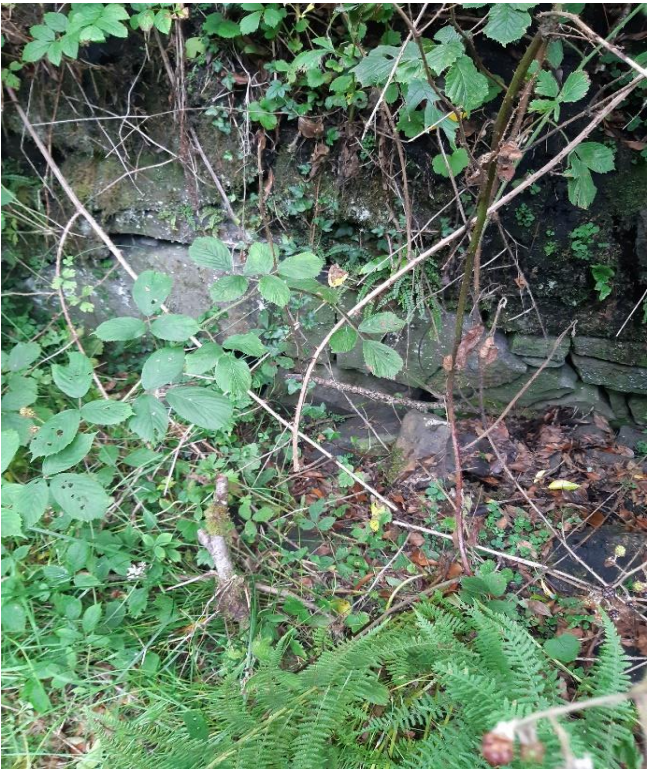
**Plate 28**                      Photo showing a buried culvert outfall point on the bend of the Nant Cannaid prior to the culvert beneath the former Aberdare to Merthyr railway line. - 21

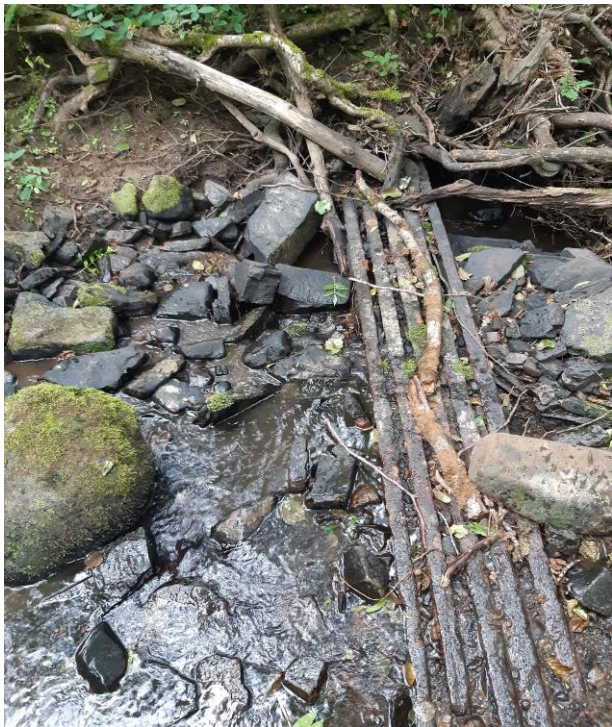
**Plate 29**                      Photo showing metal tram lines within the bed of the Nant Canaid Stream - 22

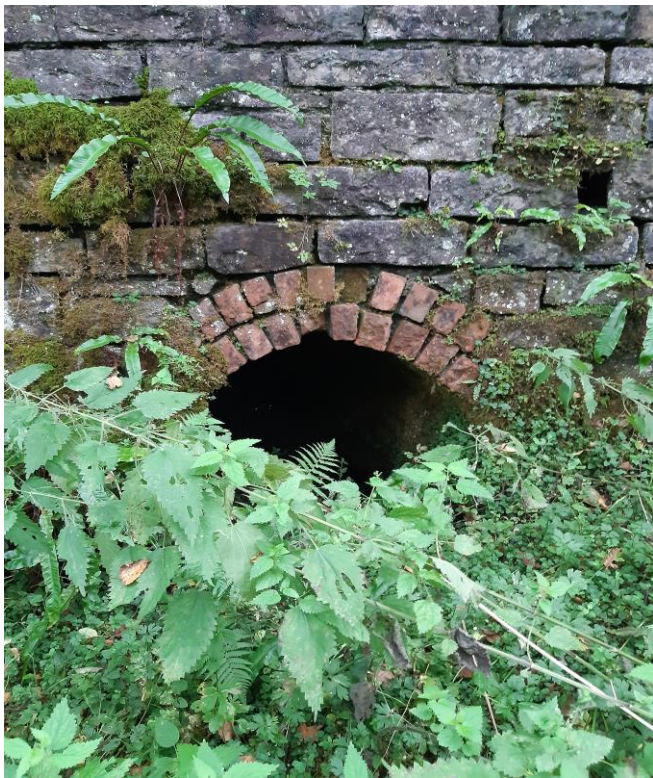
**Plate 30**                      Photo of a brick lined culvert entrance within the base of the stone masonry wall of Cwm Pit - 23
