# Rhydycar West

## Hydrogeology & Hydrology Assessment Desk Top Study

B023905

November, 2022

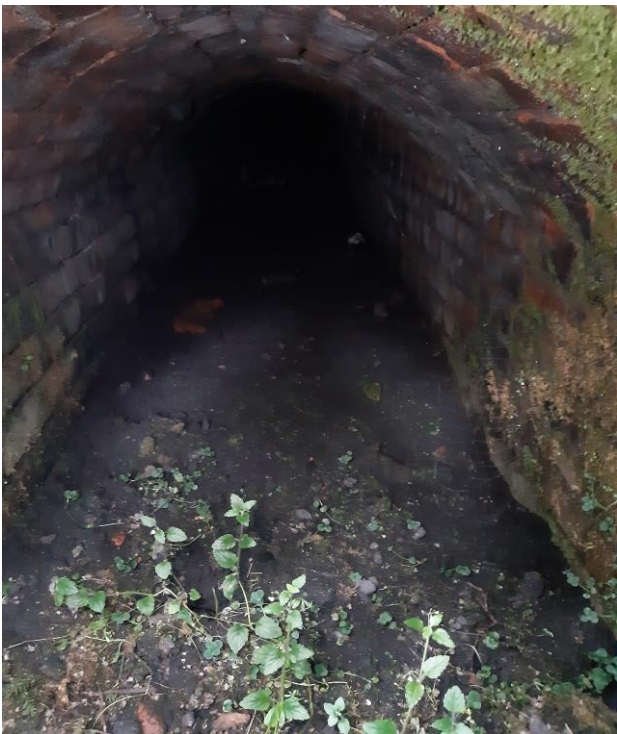
Plate 31

Photo of a brick lined culvert entrance within the base of the stone masonry wall of Cwm Pit - 23

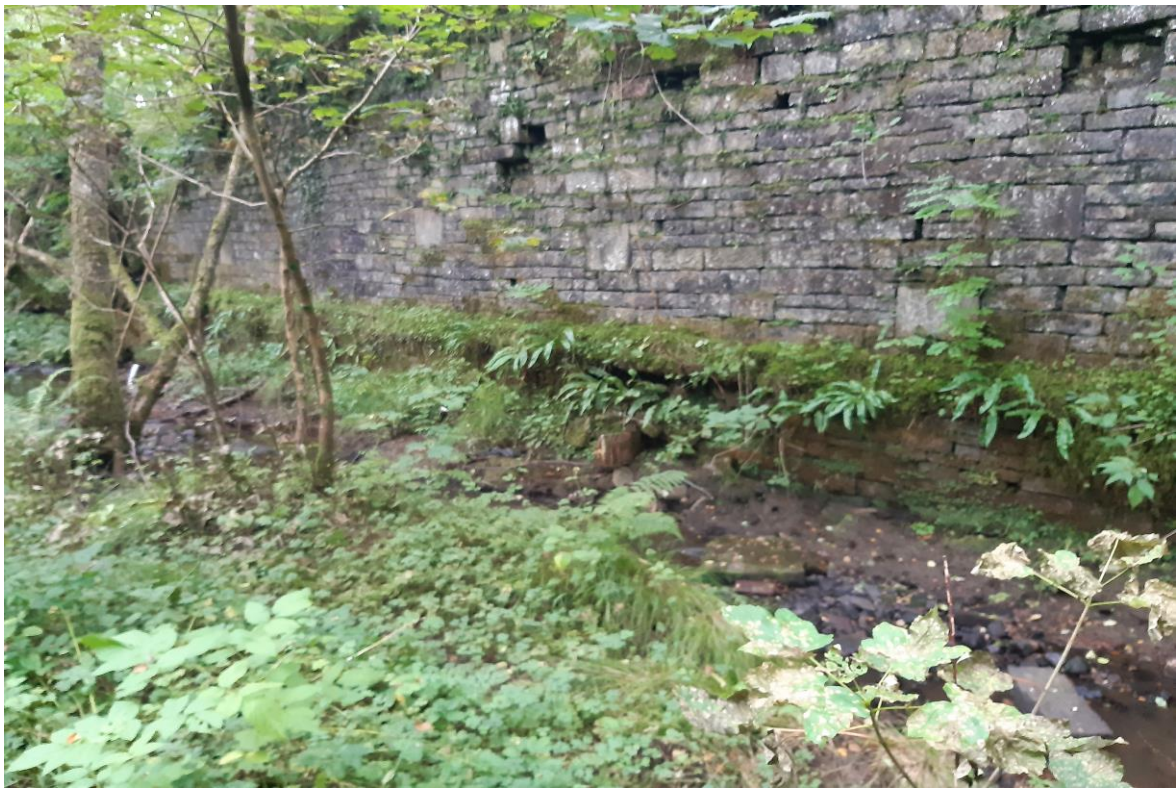
Plate 32

Photo viewing the Cwm Pit Masonry Wall and the difference in levels between current stream level and the previous ground level, as well evidence of erosion - 24

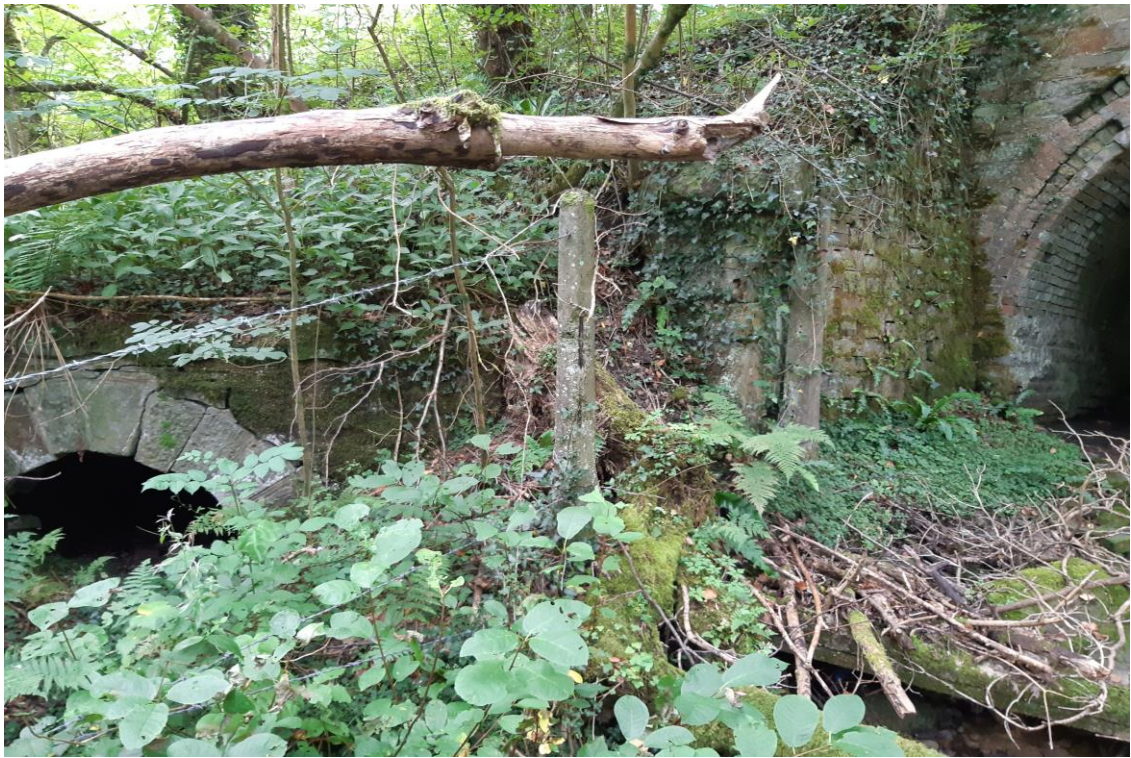
**Plate 33** Photo showing a small culvert emerging adjacent to a much larger culvert beneath a railway line - 25

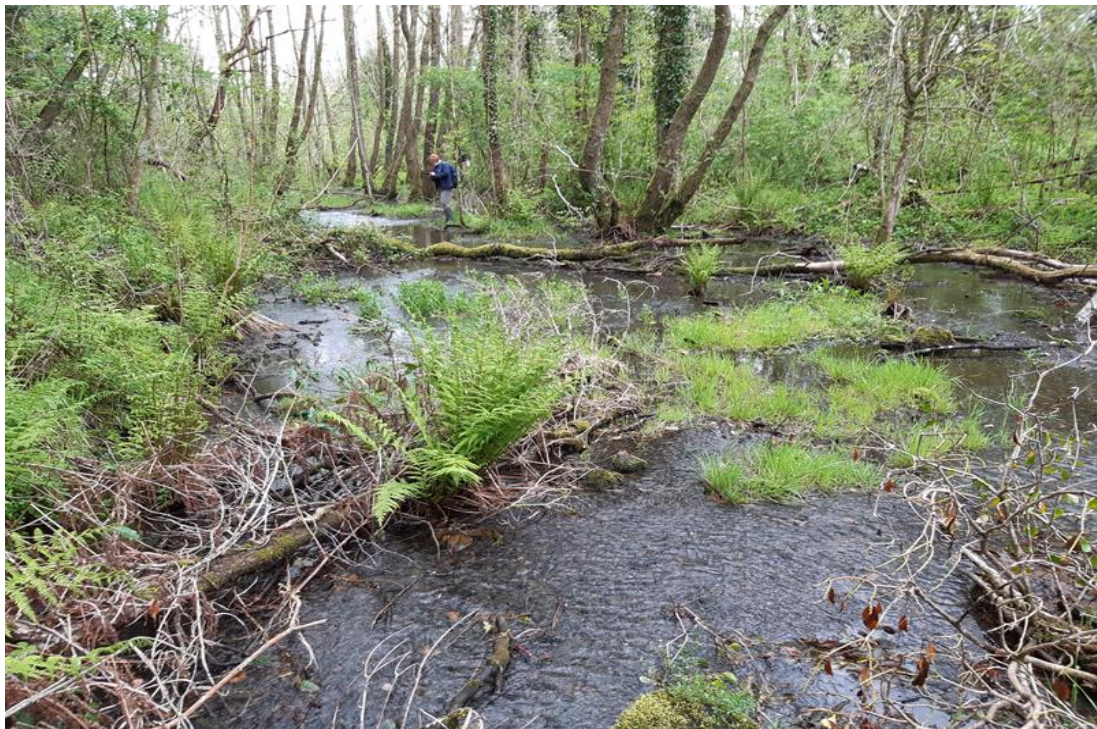
**Plate 34** Photo showing water flowing through the culvert during the visit in May 2021 which is sourced from water emerging at the base of the Glyndyrus Tip - 26

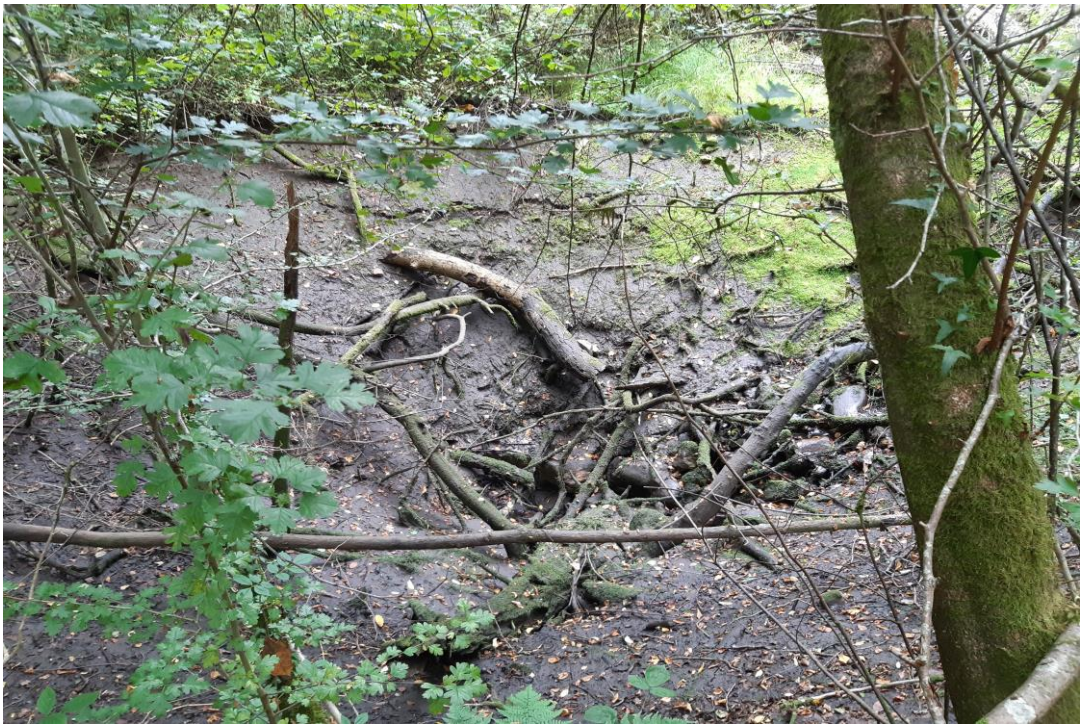
**Plate 35**                      Photo showing an area of collapse - 27

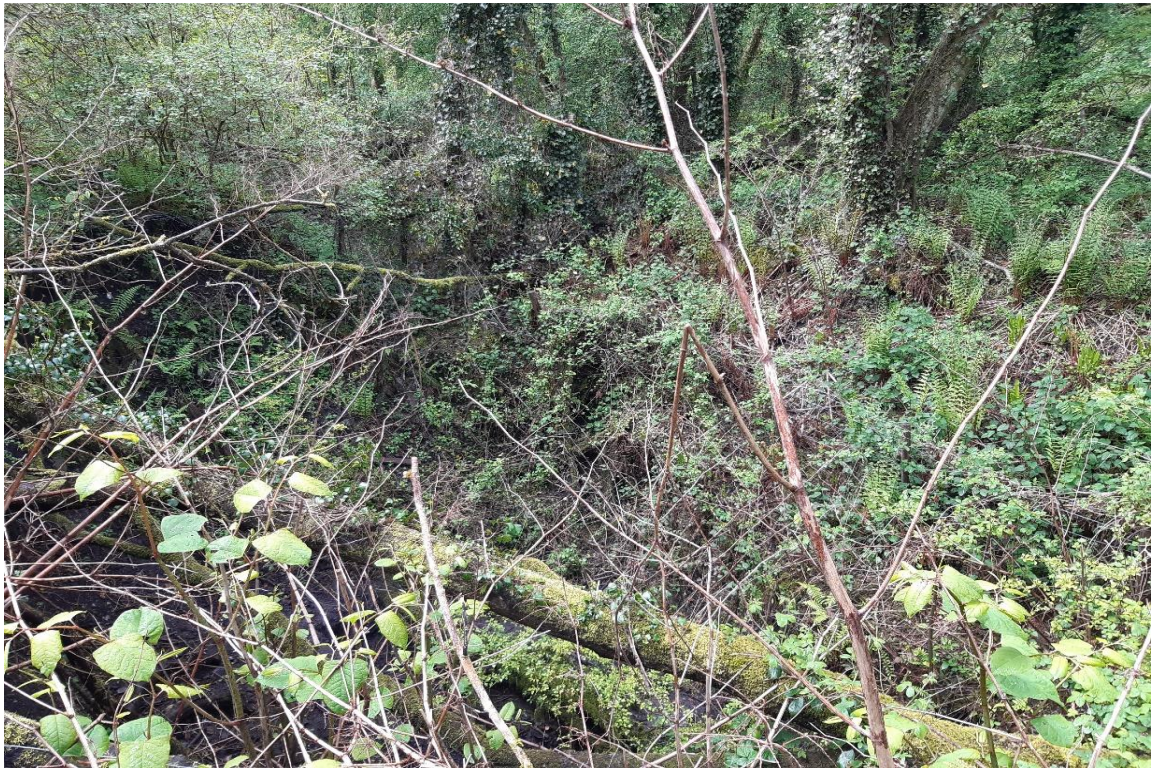
Plate 37

Photo viewing a large area of collapse which was dry at the time of the visit - 30

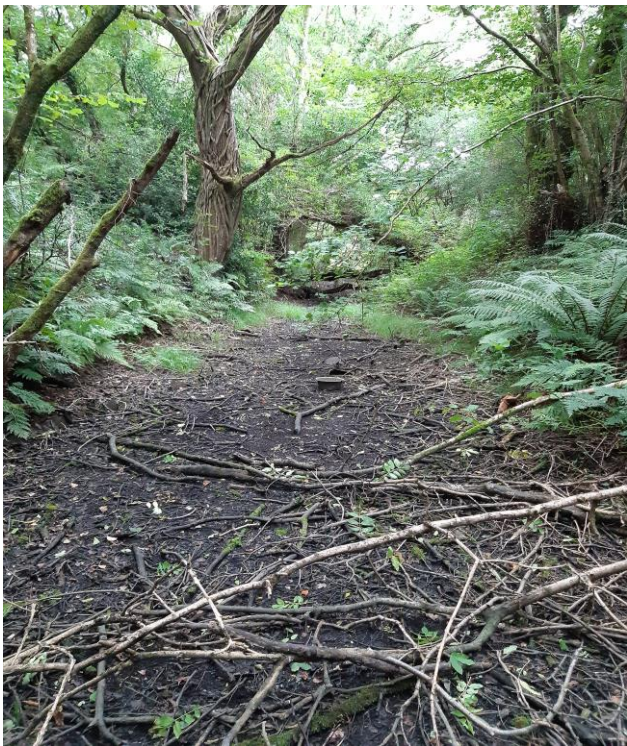
Plate 38

Photo viewing dry channel within a cutting - 32

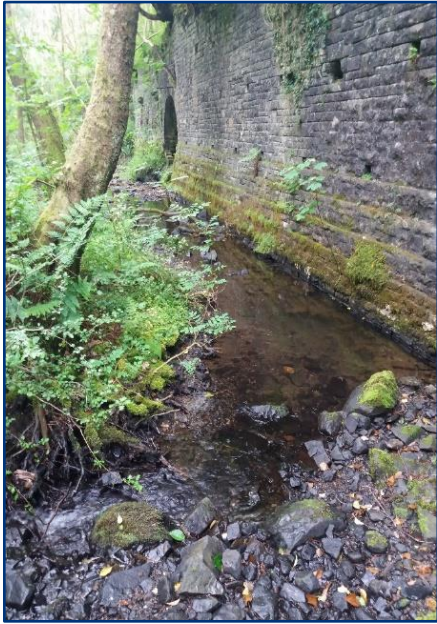
| Map Locality | Description | Photo Plate / Further Comment | Map Extract / Further Photo Plate |
|---|---|---|---|
| 1d | Diverted channel of the Nant Melin Cannaid is shown on the adjacent mapping to flow towards Cwm Pit but then is shown to stop and possibly enter underground. | <p>The Nant Melin Cannaid flow through Cwm Pit along the former tramways / railway lines (photo taken during 2017 survey)</p> | |

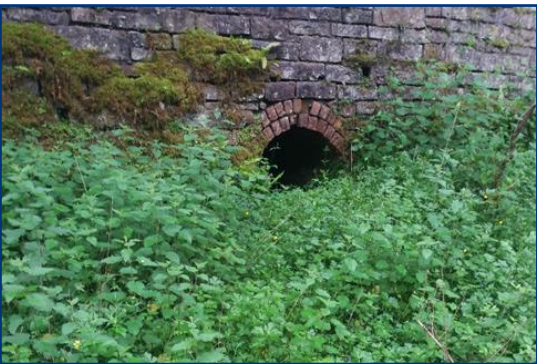
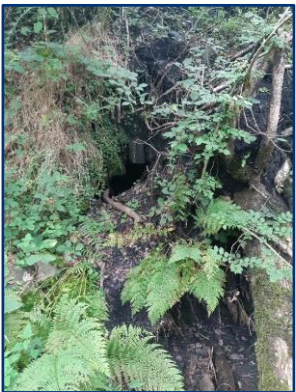
| Map Locality | Description | Photo Plate / Further Comment | Map Extract / Further Photo Plate |
|---|---|---|---|
| 1e | <p>The remains of Cwm Pit were observed at Locality 21 (2017) where the Nant Melin Cannaid flows through following the former tramways and railway line. The stream is generally 2m wide here, 3m in some parts, with the bed of the channel comprising numerous cobbles and boulders of sandstone and mudstone.</p> <p>At Locality 22 (2017) and 23 (2021), a brick lined culvert was observed within the stone wall at Grid Reference 04405,04346. This culvert is approximately 1m higher in elevation compared to the water level in the stream. It is likely that water from the stream was directed for use at the mine or it was used to drain the area, with discharge to the Nant Cannaid. A culvert was observed at Locality 5 within the northern bank of the Nant Cannaid which could have potentially connect with the culvert a Cwm Pit.</p> | <p>1e<sub>i</sub></p> <p>1e<sub>ii</sub></p> | <p>(Map extract has been sourced from Lle.gov.wales – copyright and database right 2021. Ordnance Survey 100021874)</p> |

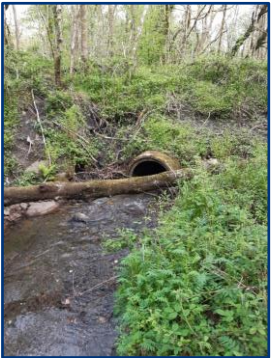
| Map Locality | Description | Photo Plate / Further Comment | Map Extract / Further Photo Plate |
|---|---|---|---|
| 1h | Stream is culverted beneath a trackway. During the May 2021 visit, Tetra Tech observed evidence of past flooding which was the result of the culvert becoming blocked last year (c.2020) during a storm. Flood waters are understood to have damaged the path and flowed along this path and down towards the former Great Western railway line (Aberdare to Merthyr line), exposing a coal seam in the cutting. | | The route of this stream passed the area marked as 'sinks' is not shown on historical or present-day OS mapping. |

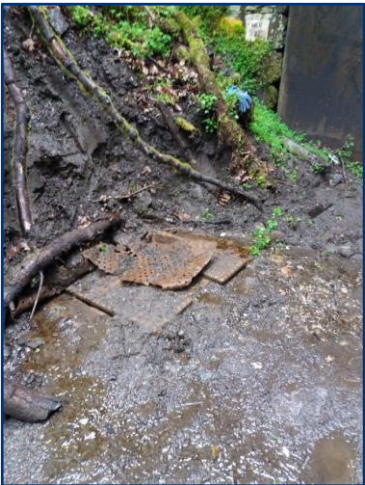
| Map Locality | Description | Photo Plate / Further Comment | Map Extract / Further Photo Plate |
|---|---|---|---|
| 2a | <p>Clear running water was noted to be emerging from a manhole chamber close to the entrance of the railway tunnel (Locality 29 c.2017) as shown in the adjacent photo. A pipe can be seen extending from the tunnel entrance and heading towards the manhole chamber, and therefore is likely to be draining water collecting inside the tunnel.</p> <p>It should be noted that a cut-off drain has now been installed and discharges this water into the Nant Cannaid Stream. The manhole lid adjacent to the tunnel entrance has been removed which shows a cast iron pipe entering and leaving the chamber. Further details are provided within the Tetra Tech 2022 report (Appendix G).</p> | | |

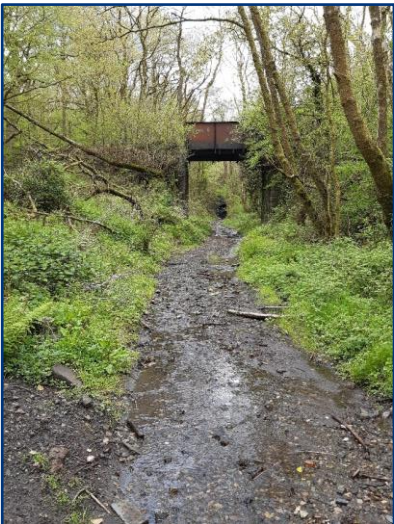
| Map Locality | Description | Photo Plate / Further Comment | Map Extract / Further Photo Plate |
|---|---|---|---|
| 2b | <p>Water is flowing along the former Aberdare to Merthyr railway line. This is thought to be combination of groundwater discharge and surface water run-off, as well as from tributary watercourses along the route which are discharging water emerging from springs up on the hillside, to the south-west.</p> <p>The watercourse has been eroding the former railway track, most likely during storm events. Groundwater seepage through the stone masonry wall of the bridge is occurring on the western side of the bridge.</p> | | Watercourse is not shown on historical or present-day mapping. |

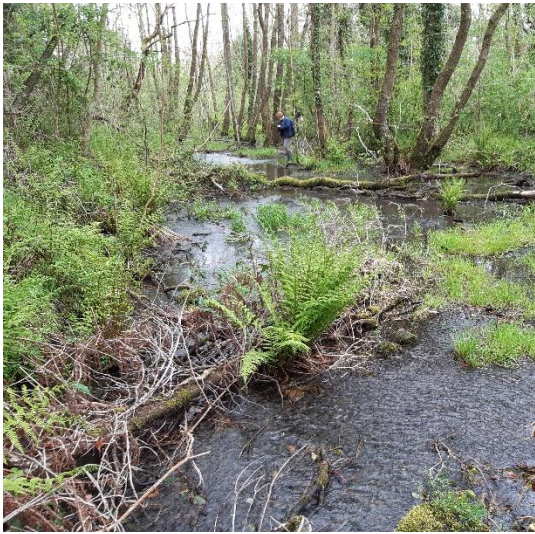
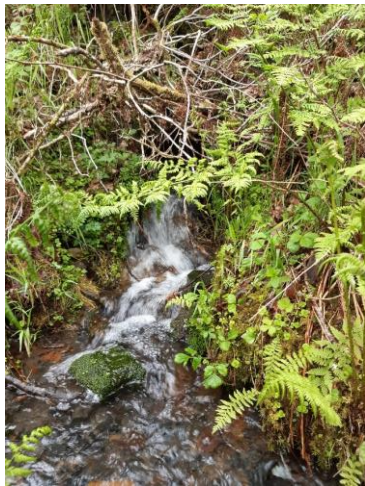
| Map Locality | Description | Photo Plate / Further Comment | Map Extract / Further Photo Plate |
|---|---|---|---|
| 2c | <p>There are circa 7 springs that were observed to emerge at the base of the Glyndyrus tip (this was 'Locality 31' in the previous WYG DTS) during the visit by Tetra Tech in May 2021. It should be noted that only three springs were observed last time (c.2017).</p> <p>The source of the water is thought to be a combination of groundwater discharge emerging from the adjacent tip (potentially sourced from the 'Hollow' area and/or natural upwelling of groundwater from mine-workings. Water floods western area of the former railway track and flows northwards to a culvert which goes underneath the track flows eastwards (see Locality 2d below)</p> | <p>Photo taken during the Tetra Tech visit in May 2021.</p> | <p>Springs/ resultant watercourse is not shown on contemporary OS Mapping.</p> <p>Photo of a spring that was observed during the Tetra Tech site visit in May 2021.</p> |

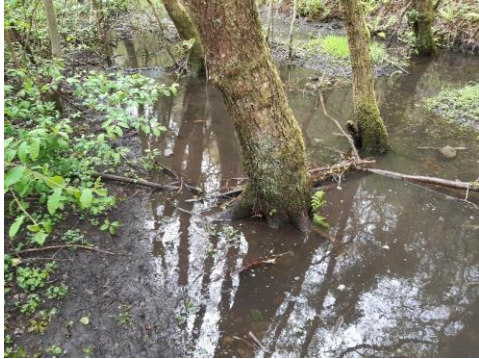
| Map Locality | Description | Photo Plate / Further Comment | Map Extract / Further Photo Plate |
|---|---|---|---|
| 2d | <p>Water collects adjacent to the former railway line and flows in a north-east direction before draining to a culvert close to the rail track. The culvert on the western side of the former track has been silted up and is no longer visible. It is worth noting that this was visible during last survey visit in May 2017. Water was observed to emerge on the eastern side of the track where it is also joined by water flowing along the former track, from the railway tunnel (<b>Map Locality 9</b>).</p> <p>Council drainage works did not extend to this locality before they were put on hold. As a result, water continues to discharge as shown on the adjacent map.</p> | | <p>Map extract obtained from Lle.gov.wales – copyright and database right 2021. Ordnance Survey 100021874</p> |

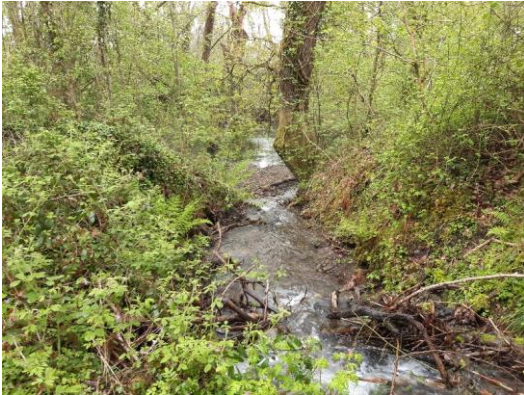
| Map Locality | Description | Photo Plate / Further Comment | Map Extract / Further Photo Plate |
|---|---|---|---|
| 2e | <p>Water flows away from Map Locality 12 and collects in a ponded area which eventually flows beneath a former railway track (<b>Map Locality 15</b>). Note that no water was observed to flowing on the previous site visits in c.2017 (see 'Locality 33' in the previous WYG DTS).</p> <p>Note that the adjacent mapping shows that water 'sinks' although no evidence for this could be seen during the visit in May 2021. Potential that water was culverted beneath the railway track and discharged into the Glyndyrus Pond.</p> <p>As reported the Tetra Tech site report (2022) at Appendix G, the are shown as 'sinks' was observed to be a collapse which had been fenced off by the Coal Authority.</p> | | <p>Map extract obtained from Lle.gov.wales – copyright and database right 2021. Ordnance Survey 100021874</p> |

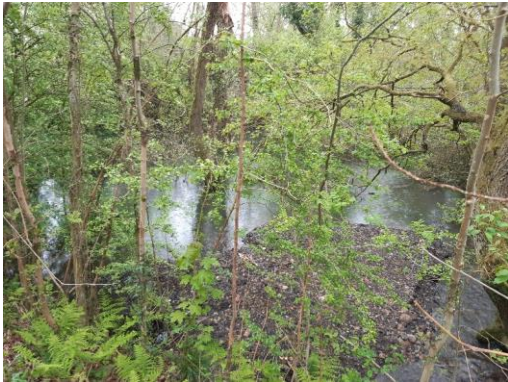
| Map Locality | Description | Photo Plate / Further Comment | Map Extract / Further Photo Plate |
|---|---|---|---|
| 2f | <p>Photo shows the pond (see adjacent map) which is not shown on the ESI World Topo basemap but is shown on the Ordnance Survey mapping on the Lle.gov.wales website.</p> <p>Photograph taken during the Tetra Tech visit to site in May 2021.</p> <p>Ponds first marked on historical OS Maps in c. 1962. However, a culvert feature beneath former railway (Locality 2d) is first shown in c.1875 mapping.</p> | | <p>Map extract obtained from Lle.gov.wales – copyright and database right 2021. Ordnance Survey 100021874</p> |

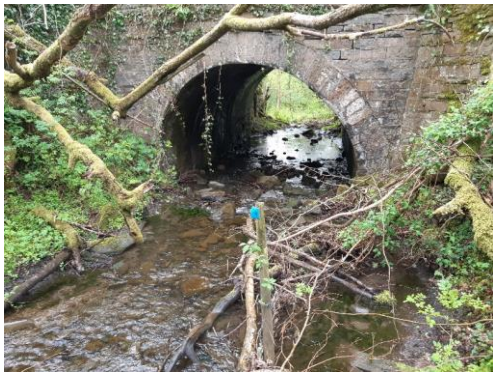
| Map Locality | Description | Photo Plate / Further Comment | Map Extract / Further Photo Plate |
|---|---|---|---|
| 2g | <p>Water outflow from ponds (Map Locality 2e and 2f) flows beneath the former railway eastwards into the former Glyndyrys Pond (infilled).</p> | | <p>Map extract obtained from Lle.gov.wales – copyright and database right 2021. Ordnance Survey 100021874</p> |

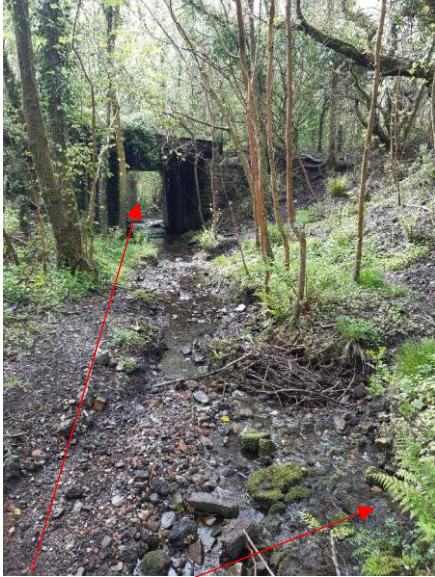
| Map Locality | Description | Photo Plate / Further Comment | Map Extract / Further Photo Plate |
|---|---|---|---|
| 3a | <p>Evidence of flooding was observed in the area of the site known as the 'Cyfarthfa Junction' where there would have been a number of railway lines crossing at this point. Springs were noted to emerge (this was 'Locality 37' in the previous 2017 visit); with water flowing along the former track, heading southwards ('Locality 34' in the 2017 visit).</p> <p>It is understood that the area close to the junction and track (base of the Glyndyrys &amp; A470 Tips) was used as a tipping ground by the pits, where slag and waste materials would have been tipped. Likely springs are emerging within tipped waste from the up-gradient Glyndyrys Tip and/ or groundwater up-welling from saturated former mine workings.</p> <p>The spring observed by WYG/ Tetra Tech in 2017 and 2021 at this locality is marked on OS Maps (1875). A second spring was observed (and shown on historic mapping) to the south of this locality, on the eastern side of the former railway line.</p> <p>A large stone lined channel has been constructed at this locality which cascades down towards the former Aberdare to Merthyr railway line/ widened track. Further information is provided in Appendix G.</p> | <p><b>Springs</b></p> | |

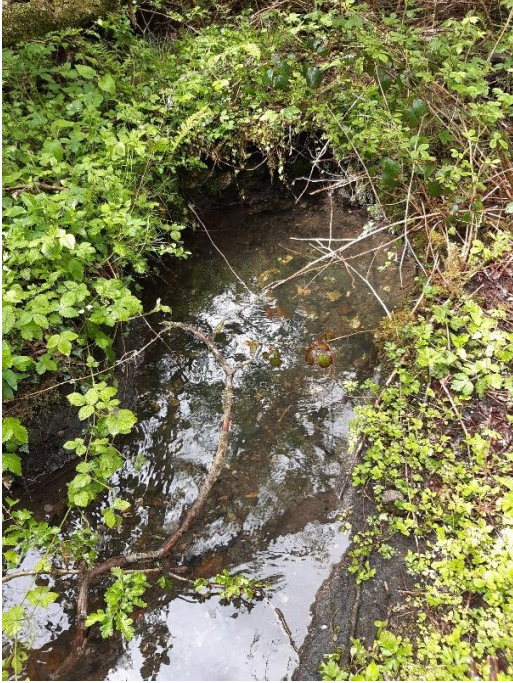
| Map Locality | Description | Photo Plate / Further Comment | Map Extract / Further Photo Plate |
|---|---|---|---|
| 3b | <p>A spring was observed further north, within a densely vegetated area with brick and slag materials/ cobbles scattered along the ground. Groundwater observed to slowly up-well at this point. Visual observation of this spring (see adjacent photo) did not appear that much water was emerging from this point. However, a considerable amount of water was noted to be discharging locally from this this area. As such, it is likely to be several, diffuse springs and/ or groundwater emerging in this area (most likely from the 'Marshy Area' which is located behind the tips at a higher elevation).</p> <p>Much evidence of flooding and washout of materials (brick, slag etc) which was also observed in the previous walkover (see 'Locality 45' in the previous WYG DTS). Water is thought to discharge towards an area noted to be "Glyndyrus Pond" ('Locality 35' in previous WYG DTS) before discharging from site at 'Locality 36' in the former WYG DTS.</p> <p><i>Note – exact location of the spring not known.</i></p> <p>A capture drain has been installed along the base of the tip as reported in Appendix G.</p> | | Not shown on current OS Mapping. |

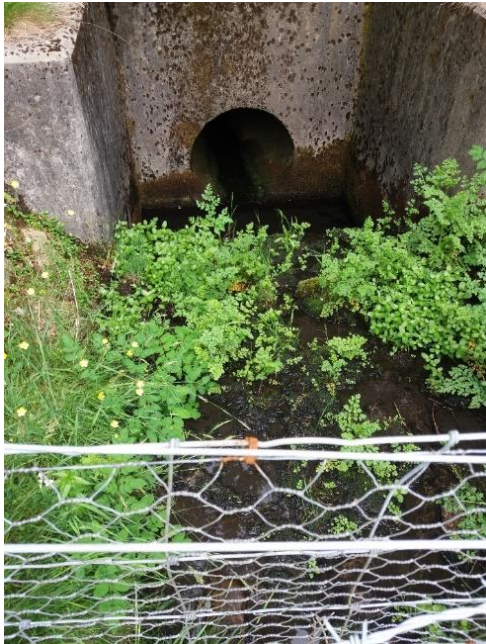
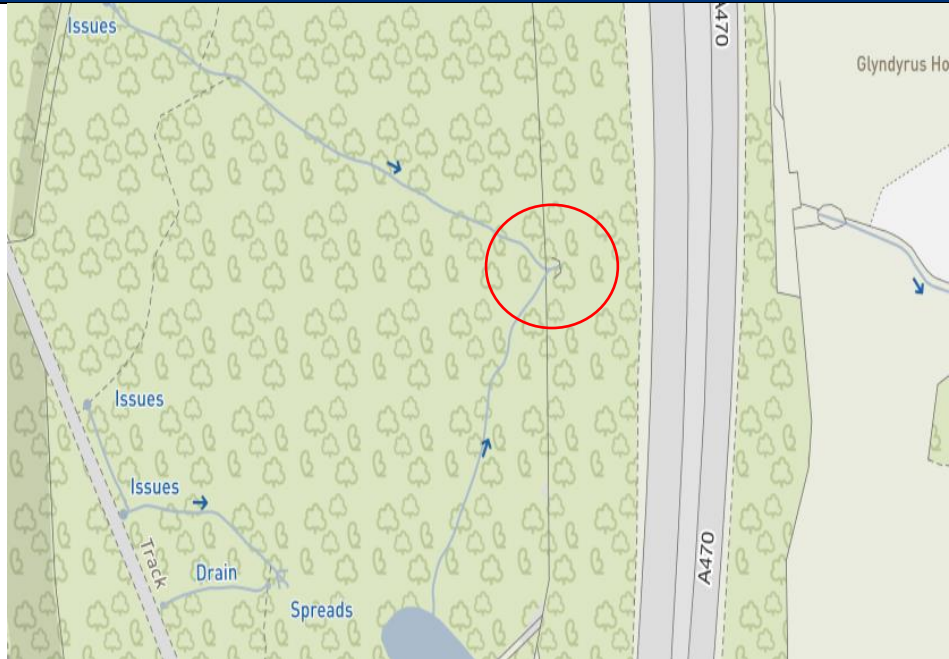
| Map Locality | Description | Photo Plate / Further Comment | Map Extract / Further Photo Plate |
|---|---|---|---|
| 3e | <p>Confluence of two streams which flows across the former Glyndyrus Pond, with water leaving the site via a culvert beneath the A470.</p> <p><i>This is shown as 'Surface Water Discharge Point No. 3' on the main Hydrological Map above.</i></p> | | <p>Map extract obtained from Lle.gov.wales – copyright and database right 2021. Ordnance Survey 100021874</p> |

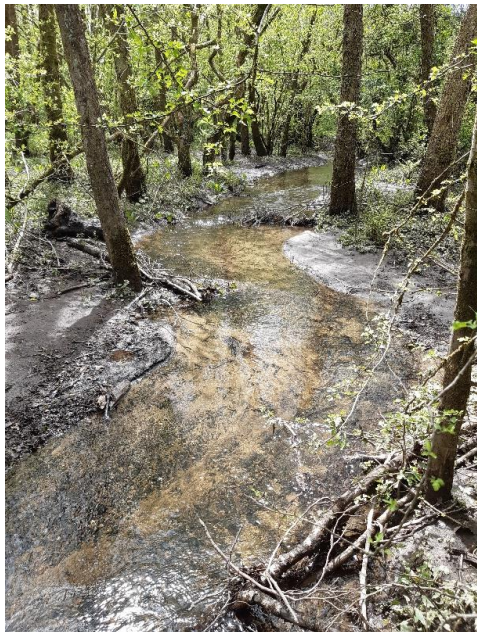
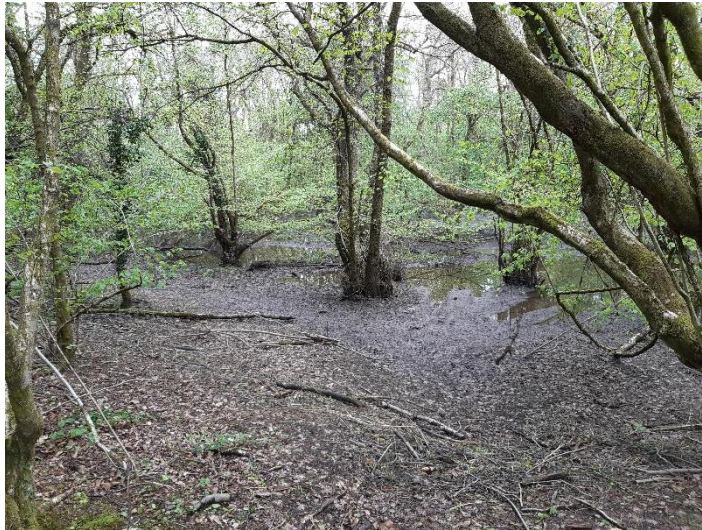
| Map Locality | Description | Photo Plate / Further Comment | Map Extract / Further Photo Plate |
|---|---|---|---|
| <b>5a</b> | <p>The "Hollow" area was found to be flooded during one of the visits in 2017 with ponded water observed throughout the basin. This area is fed by the watercourse (Nant Melin Cannaid) that flows through Cwm Pit, following the former railway line through this area although a number of ponds and flooded areas have been observed either side of the watercourse within the basin area.</p> <p>This area likely acts as a flood water overflow area following periods of heavy rainfall. We understand that during heavy rainfall periods last year (c.2020) flood waters had eroded trackways to the south-east and damaged the former railway line near the 'CyfarthfaJunction'.</p> <p>Attempts have been made to find an outlet for the water ponding in this marshy area. No obvious outlet has been found and therefore, it is considered likely the water is draining through one of the following pathways or through a combination of all three: fissures within the underlying natural boulder clay material; fissures (cavities) within the Glyndryys tip material opening due to subsidence, or; through mining related features such as through former mine entrances (adits) or tunnelways.</p> <p>The client representative explained during the visit in May 2021 that the 'hollow' was full of water the week prior and</p> | <p>See photos taken at Locality 41 to 44 in the previous WYG DTS Report.</p> <p>Photos below were taken by Tetra Tech during the visit in May 2021:</p> | <p>Not shown on current or historic OS Mapping. Approximate extent has been shown on the main hydrological mapping above.</p> <p>Photo viewing eastwards into the marshy basin from near leat. Perry had remarked that this area was completely flooded following a period of heavy rain.</p> |

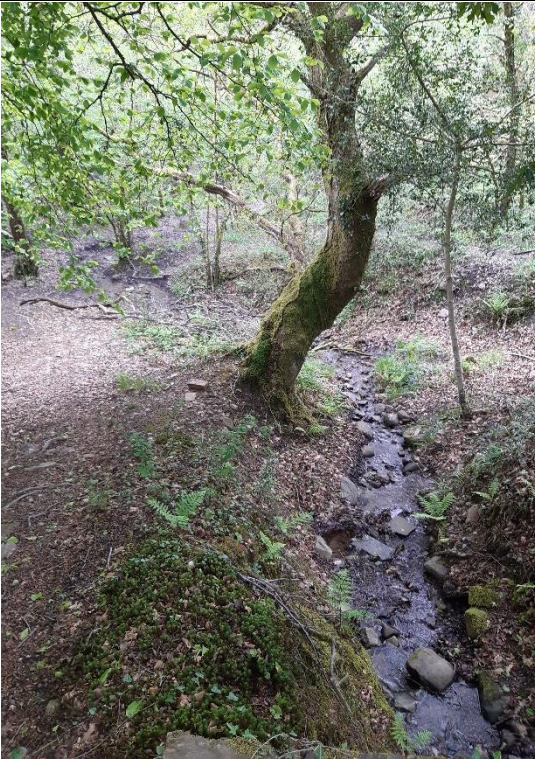
| Map Locality | Description | Photo Plate / Further Comment | Map Extract / Further Photo Plate |
|---|---|---|---|
| 5b | <p>Small, incised channel which flows between a break in the former tub boat canal (leat) which is draining water that is overtopping the Cyfarthfa reservoir and flowing northwards within the leat. Water flows eastwards down hill into the 'hollow' area.</p> <p>Potential for groundwater to be emerging from a former coal level which is located nearby to the west of this position.</p> | <p>Photo taken during the Tetra Tech visit in May 2021</p> | Not shown on current or historic OS Mapping. |

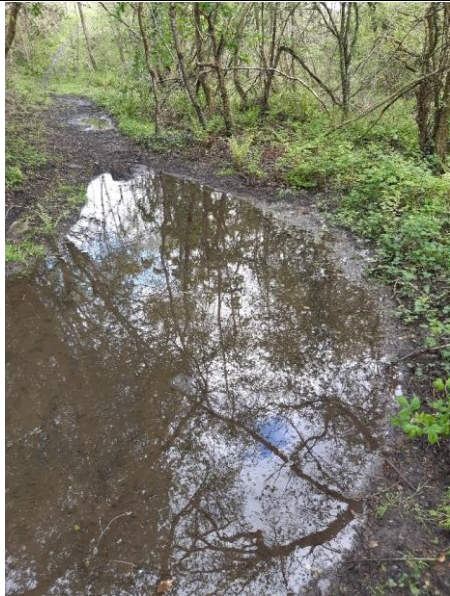
| Map Locality | Description | Photo Plate / Further Comment | Map Extract / Further Photo Plate |
|---|---|---|---|
| 5c | <p>Stagnant water was observed in the leat and evidence of groundwater seepage observed to be draining the canal and discharging into the adjacent 'Marshy Area'.</p> <p>During the WYG visit in c. 2017, A second break in the canal wall (likely due to subsidence) was noted at Locality 40 in the previous 2017 visit; with water found to emerge from beneath the eastern side of the footpath into a channel which discharges into the marsh area eastwards of this locality.</p> | <p>Photo taken during the Tetra Tech visit in May 2021</p> | Not shown on current OS Mapping. |

| Map Locality | Description | Photo Plate / Further Comment | Map Extract / Further Photo Plate |
|---|---|---|---|
| | The slow flowing water was observed to be stained an orange/red colour (Plate 40 – see Appendix E which is sourced from the stagnant, ponded water observed within the canal. | | |

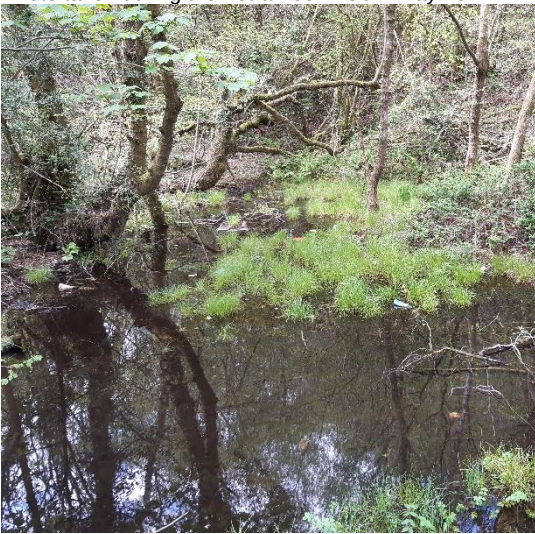
| Map Locality | Description | Photo Plate / Further Comment | Map Extract / Further Photo Plate |
|---|---|---|---|
| 5d | <p>Stagnant, pooled water observed within the south-western corner of the Cyfarthfa pond. This is the area close to where the diverted stream (see Map Locality 1d) which now would have entered the pond. Water levels in the pond likely receive both surface water run-off and spring discharge water from the adjacent tip to the west of the reservoir.</p> <p>There is potential that water is still being sourced by the former diverted channel (although it is understood that this channel has been infilled).</p> <p>No obvious inflow areas could be observed at the time of the Tetra Tech visit in May 2021.</p> | <p>Photo taken during the Tetra Tech visit in May 2021</p> | |

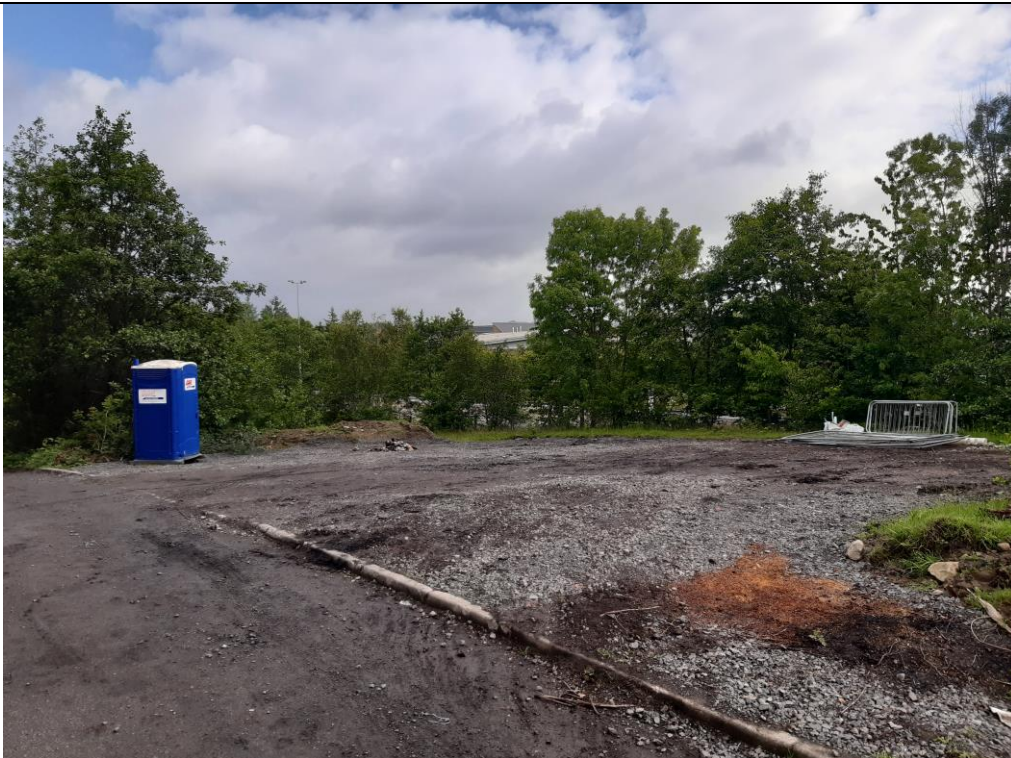
**Photo 1**

**Locality 1** – Gravel lined area, near to the site entrance, which appears to have been used as a temporary storage/ site office location (Photo 1). Portaloo is still located here with a couple of heras fence panels. Evidence of some burning as shown in Photo 2.

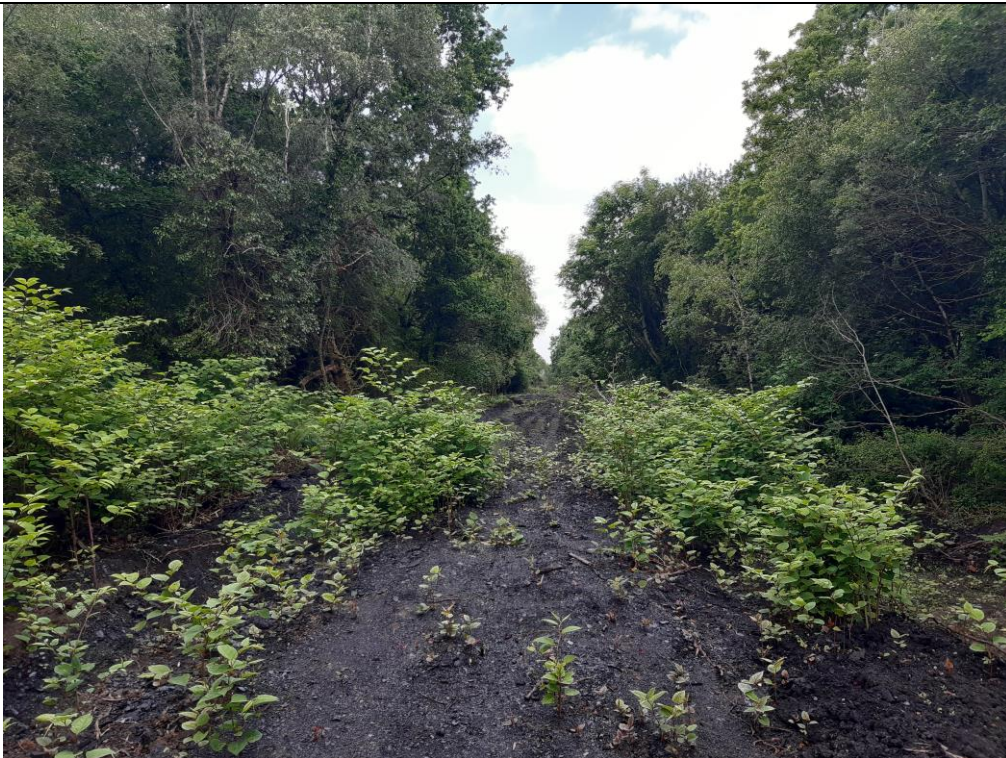
**Photo 3a**

**Locality 3** – The widened track extending from the storage area (Locality 2) meets with a second, newly constructed access track which runs circa 470 metres, in an approximate north to south direction, along the base of the Glyndyrys/ A470 Tip. A drainage/ capture ditch has been constructed along the length of this access track, between the track and the base of the tip. This ditch has likely been constructed capture spring water that emerges at the base of the tip, as well as surface water run-off. The drainage route extends into the stone lined channel at Locality 4 (see below) (Photo 3a). At the junction between the two new tracks, Japanese Knotweed was observed and was found to be growing out through the newly constructed track as shown in Photo 3b.

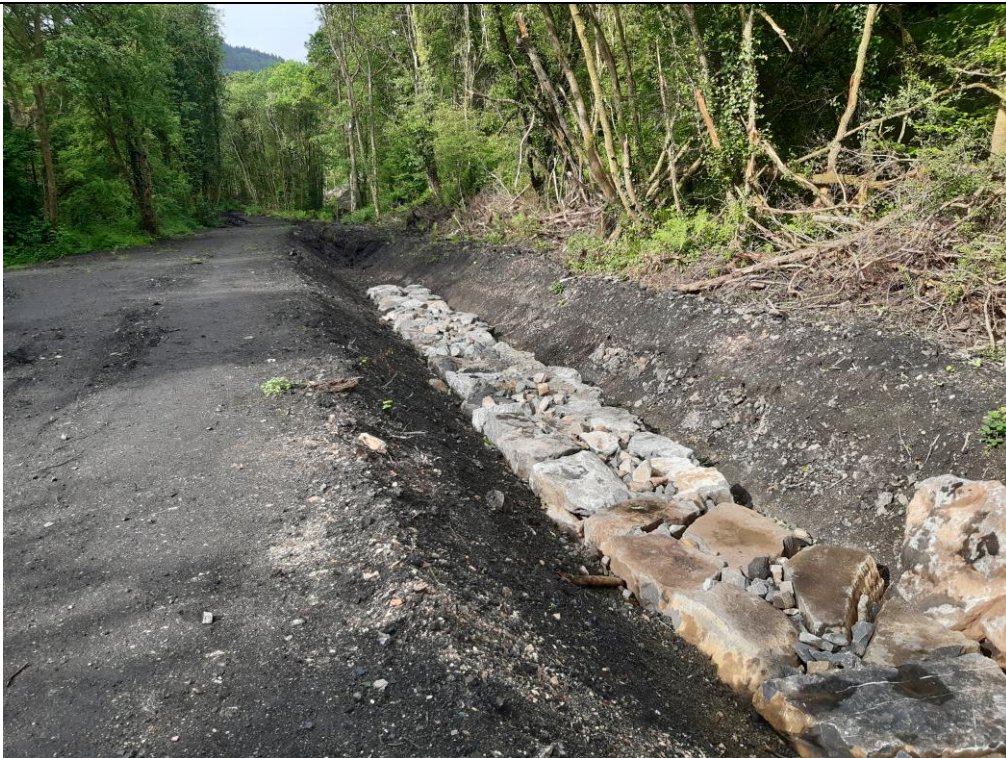
**Photo 4a**

**Locality 4** – A half constructed stone lined drainage channel (Photo 4a) cascades down into the former railway track which trends north to south at 'Cyfartha Junction' (Photos 4b, 5 & 6). All water which is captured/ diverted by the new drainage network discharges to this point. We understand that no further engineering works are planned to be constructed beyond this point and that water discharging from here would flow southwards along the former railway track, connecting to existing streams prior to flowing off site via the culverts beneath the A470. Spring water was still observed to be emerging at this point although there was minimal flow (Photo 7). During previous visits to the site, water emerging from the base of the Glyndyrys Tip to the north of this locality had been observed to flow to this point however, there was no water observed other than the aforementioned spring discharge.

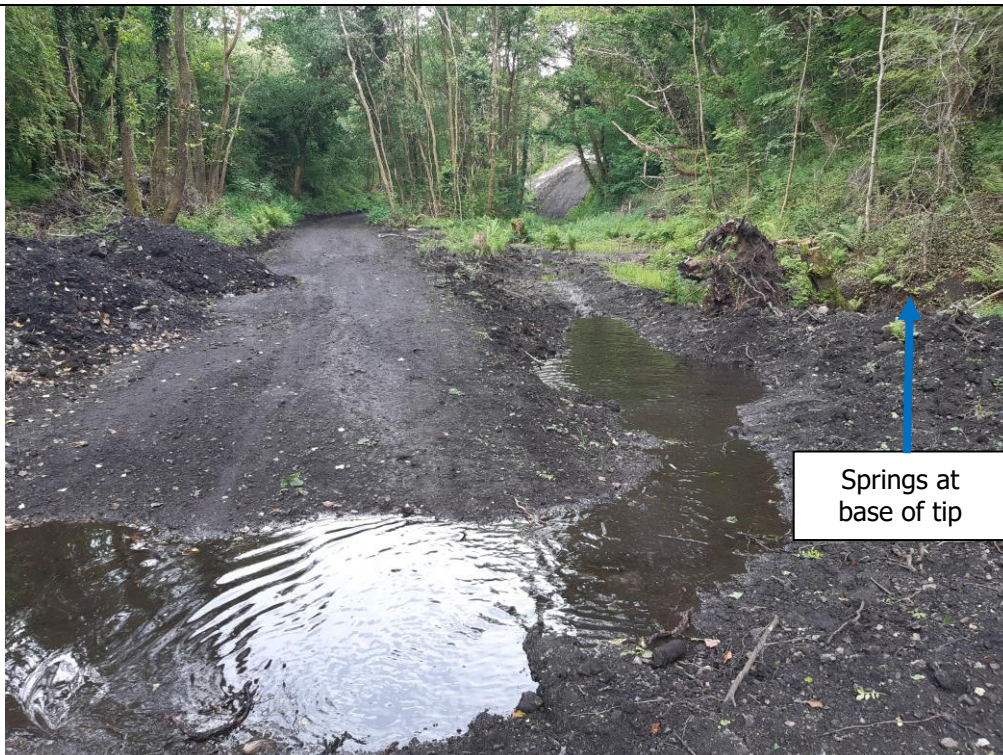
**Photo 8**

**Locality 5** – This is an area where several springs have been observed at the base of the Glyndyrys Tip. Water was observed to be discharging at the base of the tip and pool within the depression area in between the tip base and the former Aberdare to Merthyr railway track/ newly widened track. The water discharging from this area still follows the previous drainage route, which was beneath the railway track (water now flows over the newly constructed/ widened track as shown in Photo 8 & Photo 9) and towards a pond area (Locality 14) to the

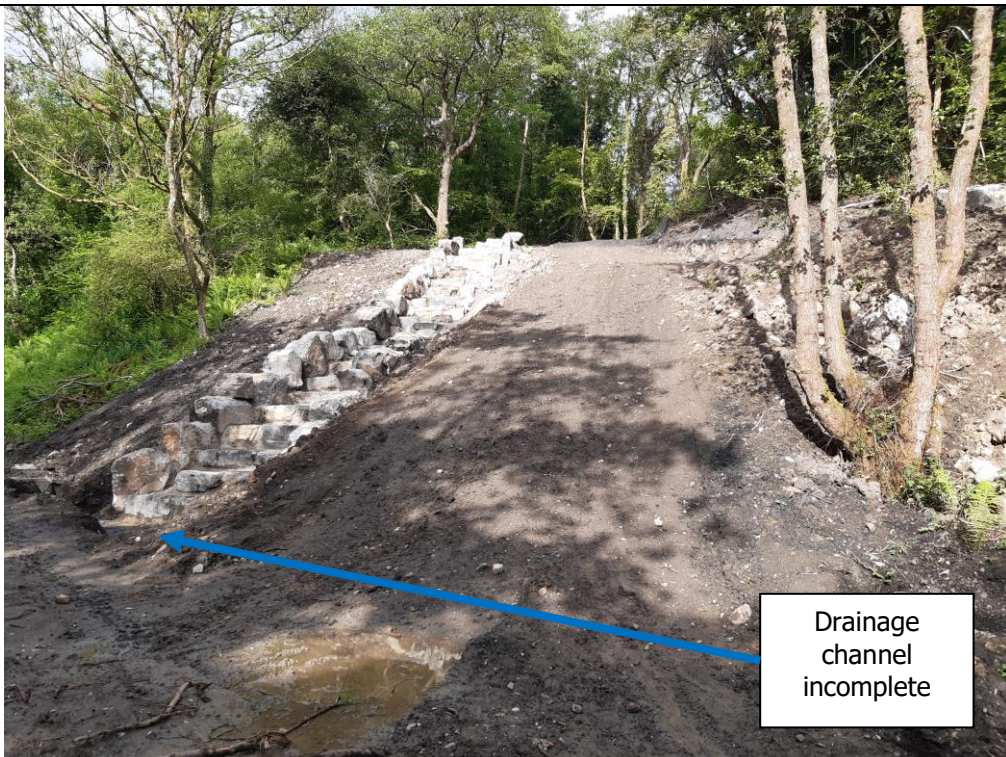
**Photo 10**

**Locality 6** – A large stone lined channel (Photo 10) has been constructed at this locality which cascades down towards the former Aberdare to Merthyr railway line/ widened track. This stone lined channel has not been finished, and the drain at the base of the feature does not connect with the drain observed at Locality 5. As such, it is presumed that during storm/ rainfall events, water will discharge along the newly widened track towards Locality 5 or spill over into the area of depression to the east of this locality. There was no water flowing at the time of the visit. An access track has been constructed alongside the stone lined cascade feature to allow plant to access the top of the slope. Trees and vegetation have been cleared to make a wide track towards the Nant Melin Canaid stream (Locality 13). This locality is the location of a coal seam which had been exposed within the railway embankment, and had eroded overtime from flood waters emerging from Cwm Woods as a result of water spilling out of the 'Hollow' area (depression basin behind the A470/Glyndyrus Tip).

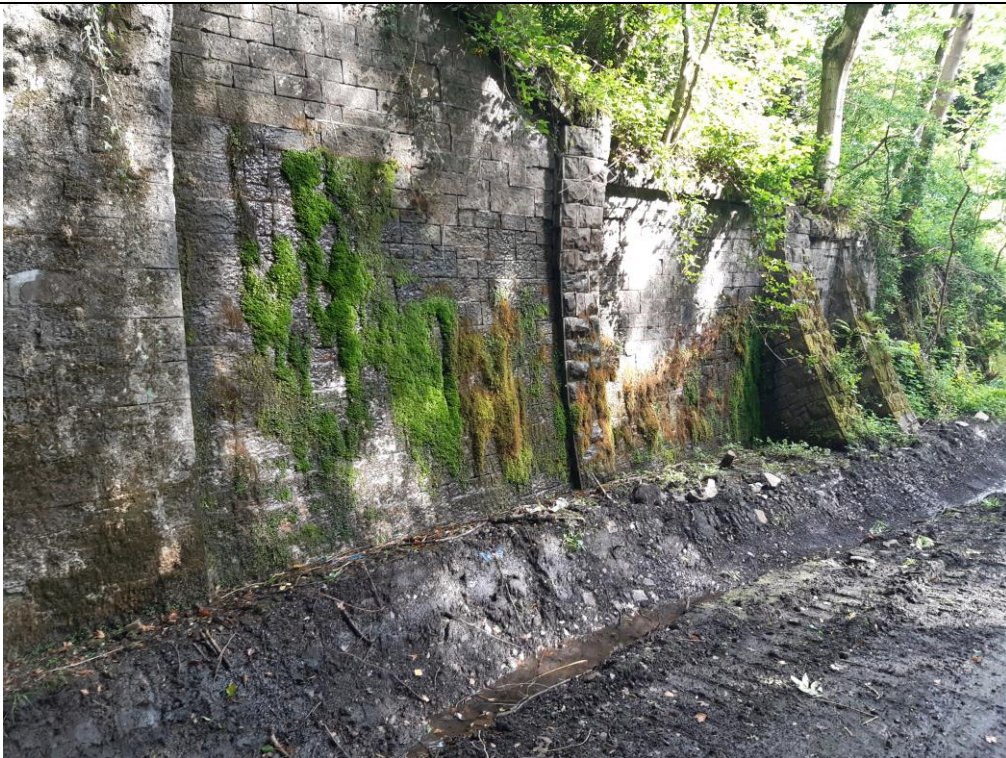
**Photo 11**

**Locality 7** – Groundwater emerging from the masonry wall (Photo 11) on the northern section of the railway bridge wall is collecting within the newly constructed drainage ditch which runs alongside the newly widened track in a north-eastern direction towards Locality 6.

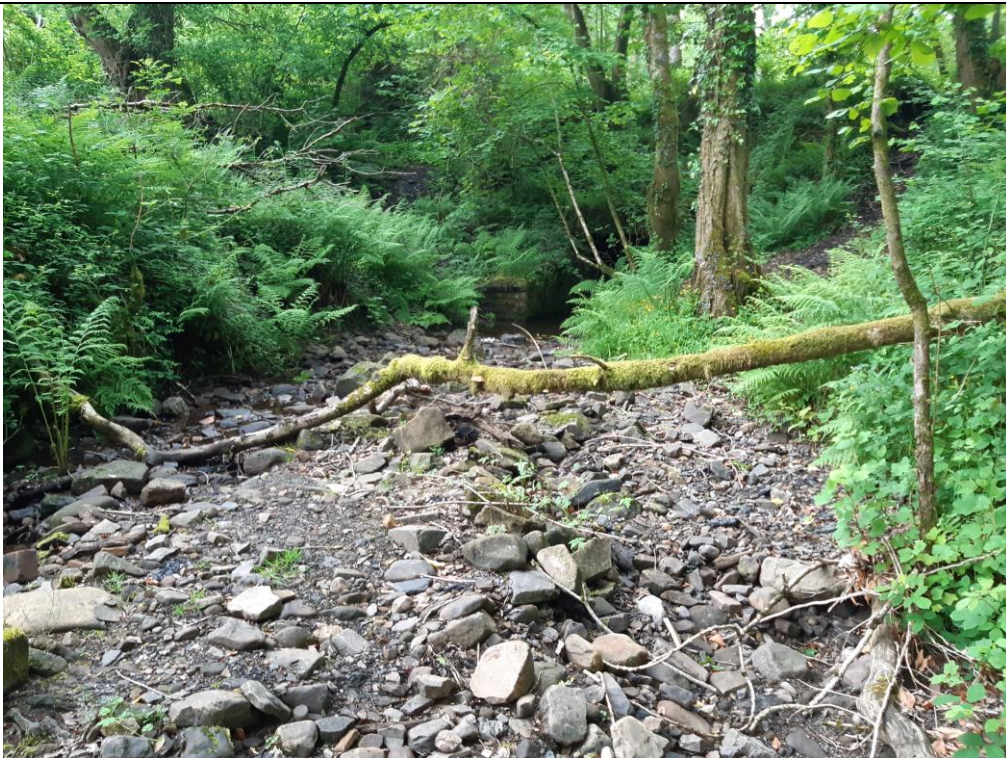
**Photo 12**

**Locality 8** – Within the Nant Canaid Stream, which was dry at time of the visit, save for some standing/ ponded water and small flow of water within the gravel bed of the stream (Photo 12).

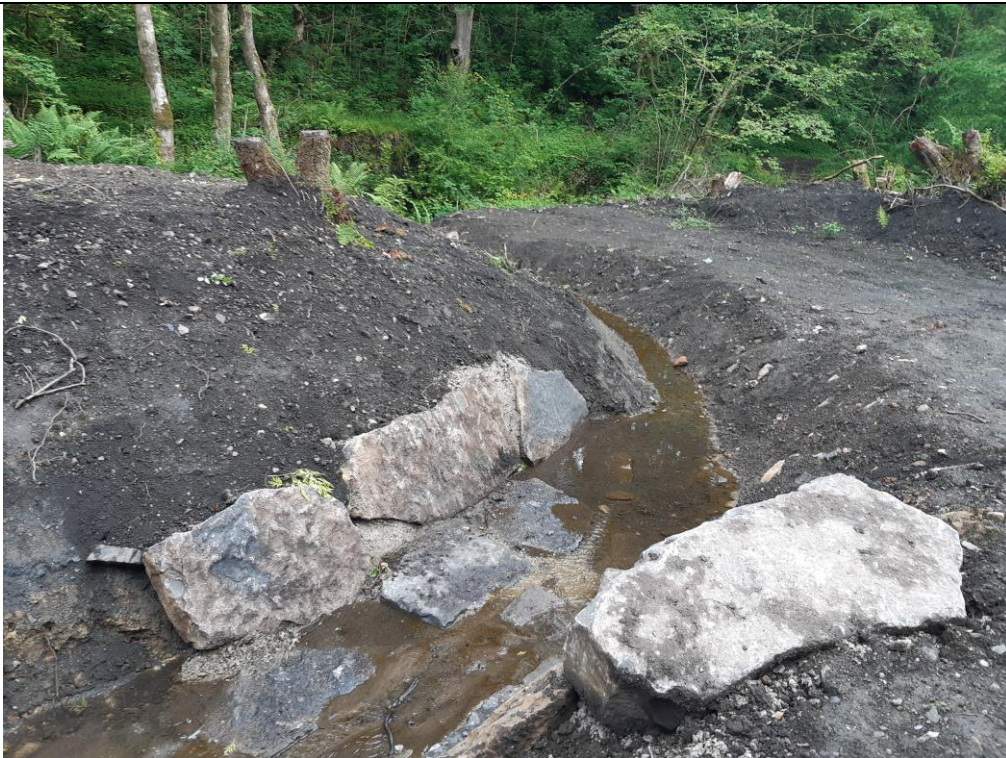
**Photo 13**

**Locality 9** – A small, incised drainage ditch, which extends from near to the former railway tunnel (Locality 11) to this locality, discharges water collected from the tunnel into the Nant Canaid Stream (Photo 13). A culvert has been installed beneath the former railway track/ newly constructed track as shown in Photo 14. Although no water was flowing from the culvert, it has likely been constructed to channel water which flows from the adjacent slopes/ roadway to the south of this locality. The water flowing into the Nant Canaid stream was observed to be laden with silt as shown in Photo 15.
