# Rhydycar West

## Hydrogeology & Hydrology Assessment Desk Top Study

B023905

November, 2022

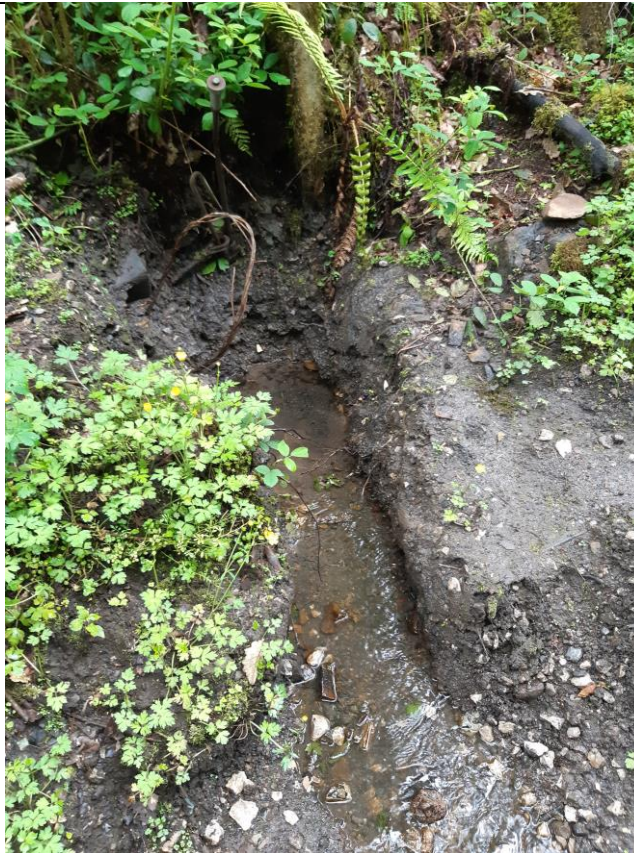
**Photo 16**

**Locality 10** – This locality is viewing a section of pipe (Photo 16) which is broken, with water flowing across the former railway track into the newly constructed drainage ditch which flows towards Locality 9. We understand that a cast iron pipe, which extends from the tunnel (Locality 11), is present within the embankment and discharges into the Nant Canaid at an unknown location.

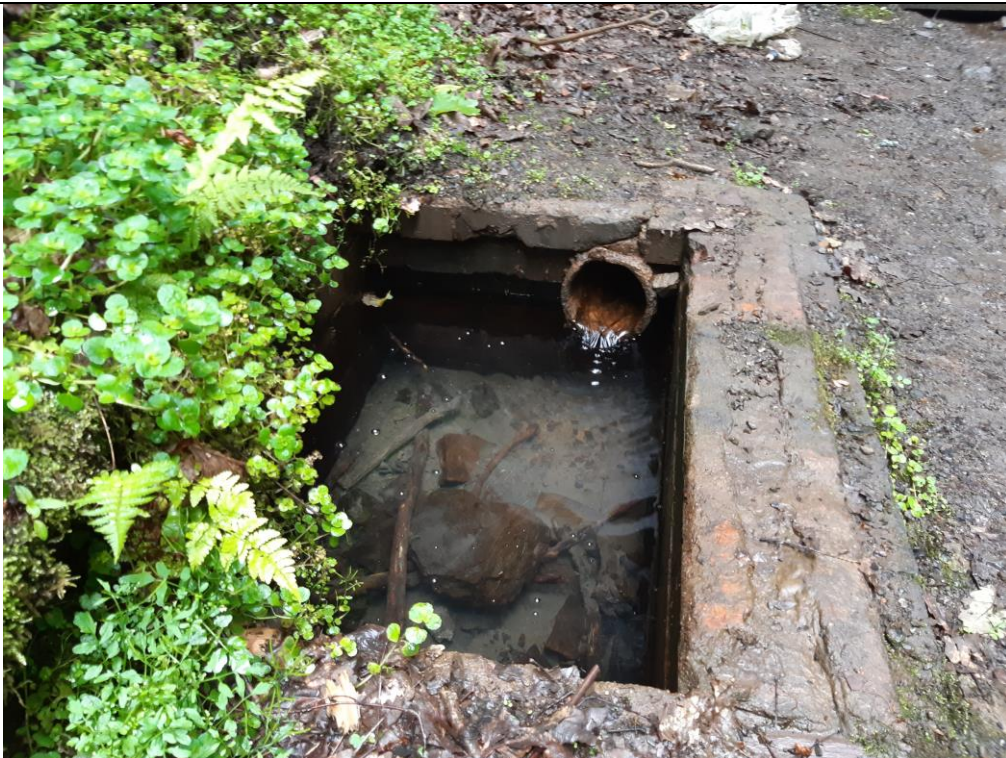
**Photo 17**

**Locality 11** – The manhole lid adjacent to the tunnel entrance has been removed which shows a cast iron pipe entering and leaving the chamber as shown in Photo 17 & 18. The pipe entering the manhole lid extends from the tunnel as shown in Photo 19. The pipes were estimated to be 100mm/150mm in diameter. The pipe entering the manhole is thought to be collecting drainage water collecting in the tunnel. Water was observed to be emerging from beneath the closed tunnel doors and flowing along the track towards the newly constructed ditch at Locality 10.

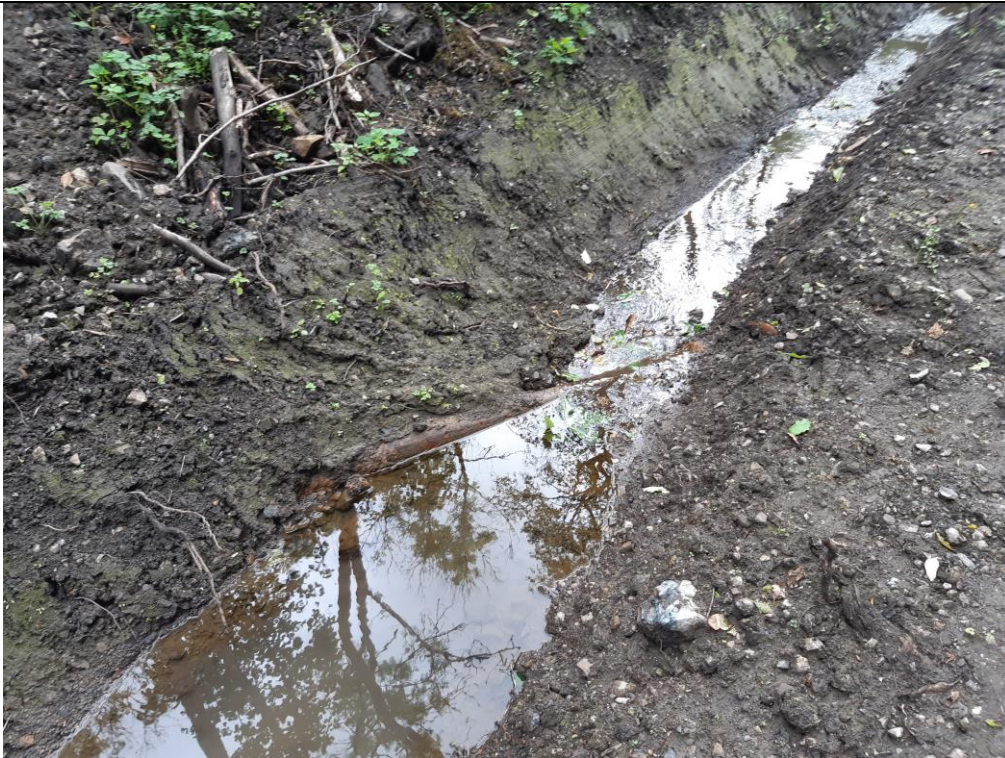
**Photo 20**

**Locality 12** – A second cast iron pipe which was been exposed within the newly constructed drainage ditch at this locality (Photo 20). The purpose or source of this pipe is not understood and could be a drainage pipe draining spoil tips to the west of this location. This pipe has not been observed during previous visits. The pipe is trending approximately south-west to north-west and potentially connects into the cast iron pipe which extends from the tunnel. The discharge point for the pipe is unclear. Photo 21 is looking towards the tunnel and shows the newly constructed drainage ditch with water that is discharging from both the broken cast iron pipe (Locality 10) and the tunnel, flowing within it.

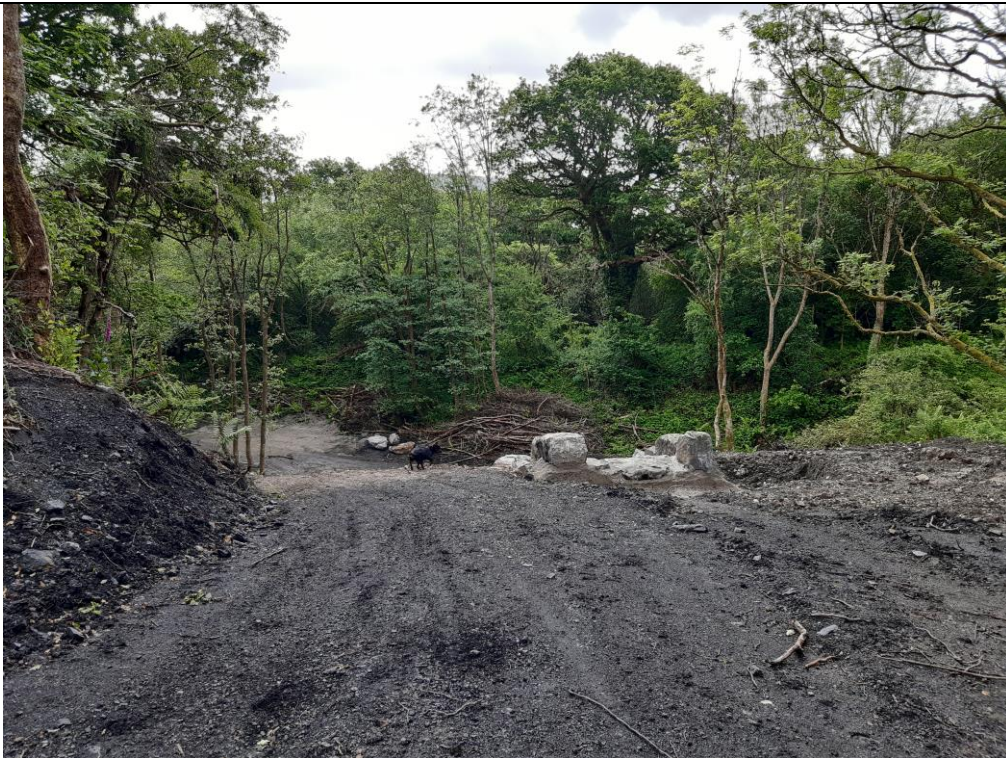
**Photo 22**

**Locality 13** – Photo 22 shows the clearing from this locality towards the stone lined cascade feature which was observed at Locality 6. No drainage works have been completed at this locality although it is considered likely that the Nant Melin Canaid Stream was to be diverted at this point and connected to the stone lined cascade feature at Locality 6; either as an open ditch or via a series of culverts. Sections of 600mm plastic piping were observed to be stockpiled at this locality as shown in Photo 23. The Nant Melin Canaid stream is still flowing as

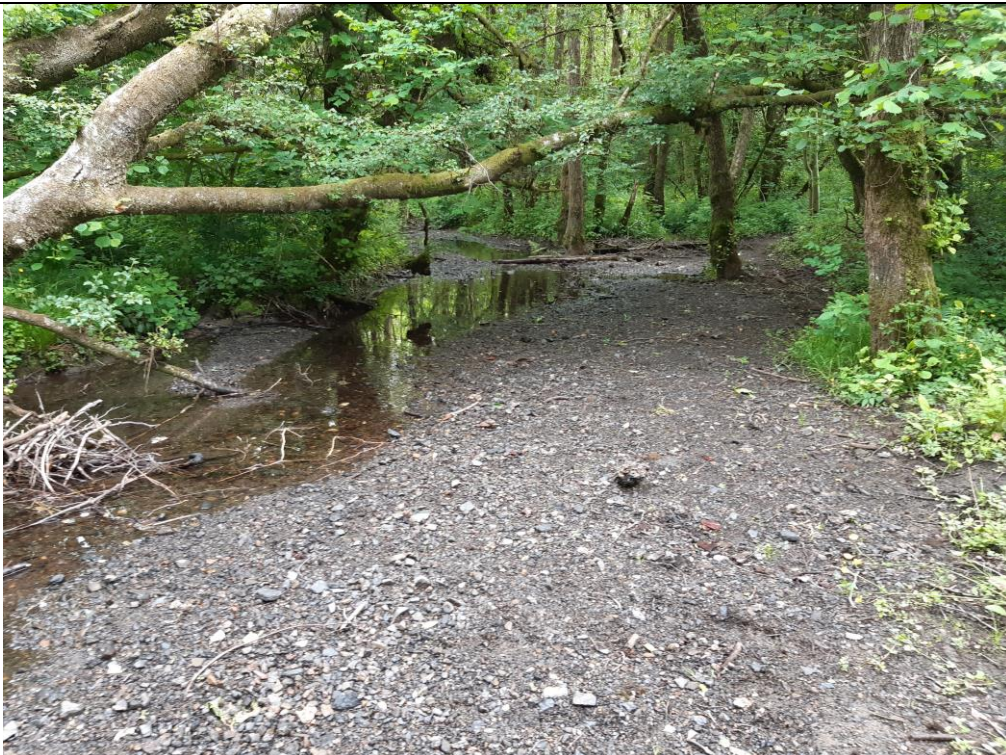
**Photo 24**

shown in Photo 24. Water within the stream continues to flow into the “hollow” (depression behind the A470/ Glyndyrus Tip) which continues to act as a natural soakaway; with water emerging as springs beneath the base of the tip to the east.

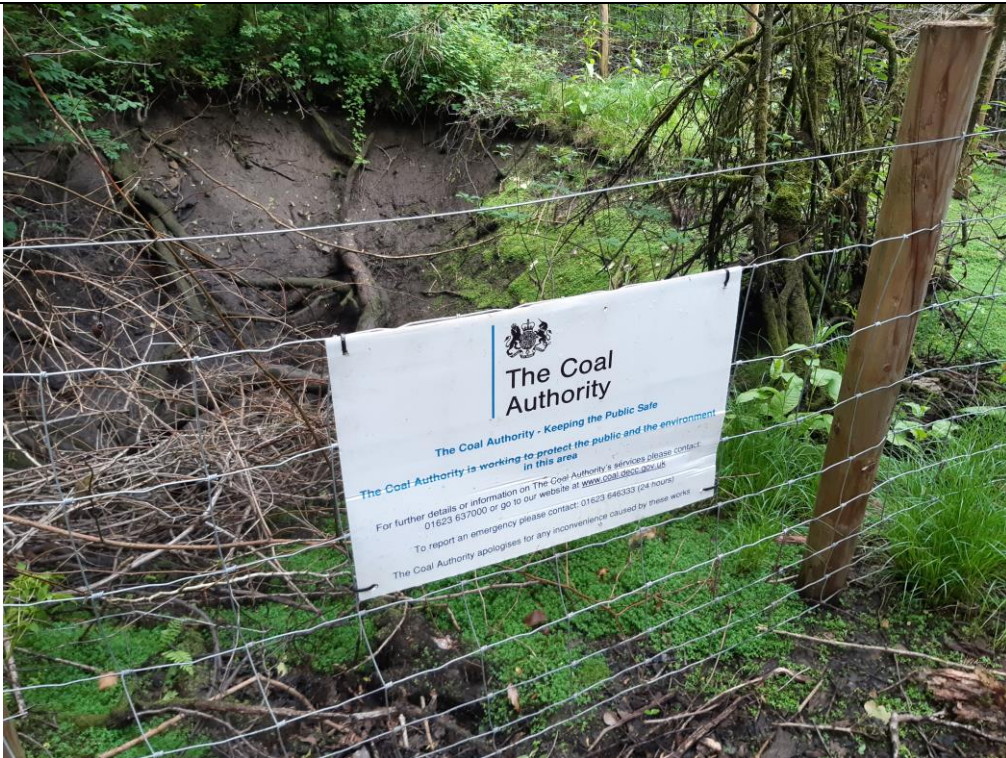
**Photo 25**

**Locality 14** – This is an area of collapse which has been fenced off by the coal authority as shown in Photo 25. Water discharging from the springs at the base of the tip (Locality 5) flows towards a pond feature which eventually over flows into this area of collapse as shown in Photo 26. Anecdotal evidence suggests that there were no licensed mines within this area of the site. It is therefore unclear whether this collapse is the result of natural subsidence, historic drainage feature (i.e., culvert beneath the former railway lines) or a mine feature. Water discharging into this collapsed features is either being lost to below mine workings or is flowing beneath the adjacent railway embankment and re-emerging at the base of the embankment to the east. Tetra Tech has observed this collapsed feature to be full of water during a previous visit, with water then flowing to the south and off-site via culvert beneath the railway track.
