**Infiltration Testing For:**

56 Swansea Road,  
Merthyr Tydfil,  
CF48 1HR

**Prepared for:** Lutra Consultancy

**REF:** 56 Swansea Road #802

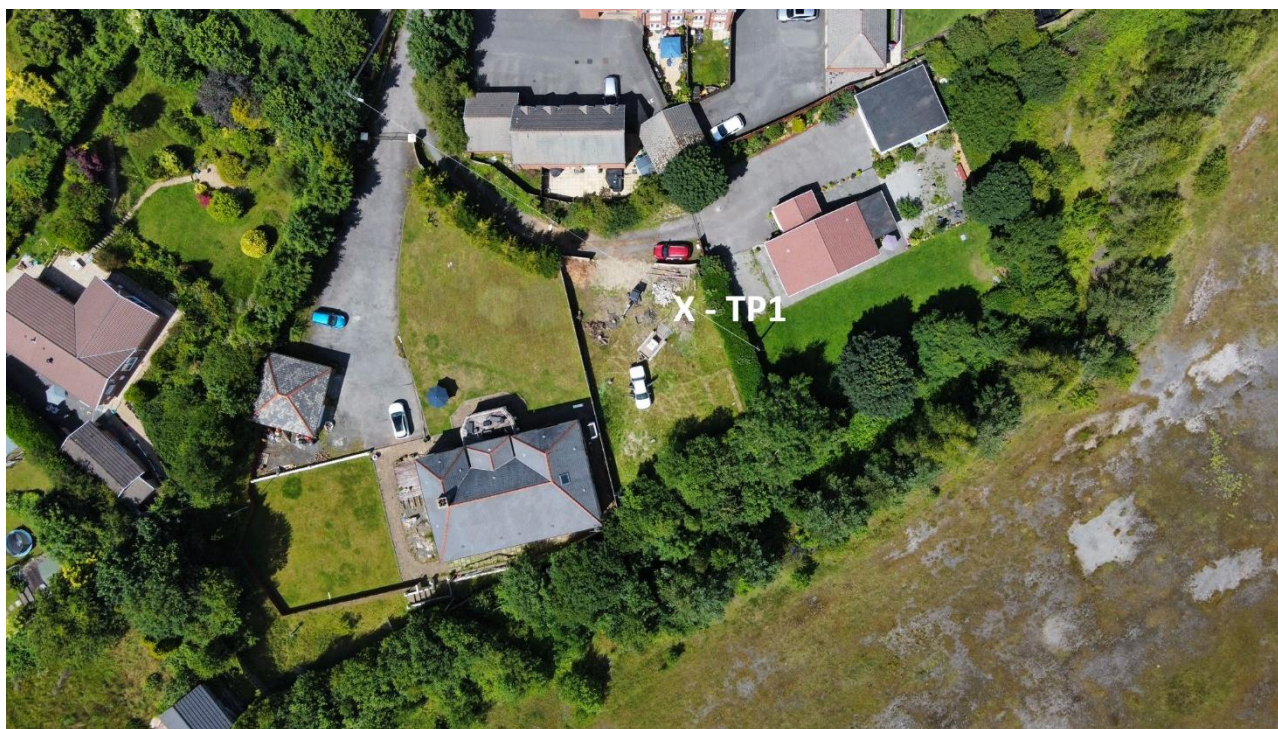
*Figure 1- Test pit location plan*

The following tests were performed to the best of the ability of those involved, subject to site constraints and weather conditions. The test pit was successfully excavated to 1.25m depth in the location on **Appendix A**, with no groundwater encountered on site.

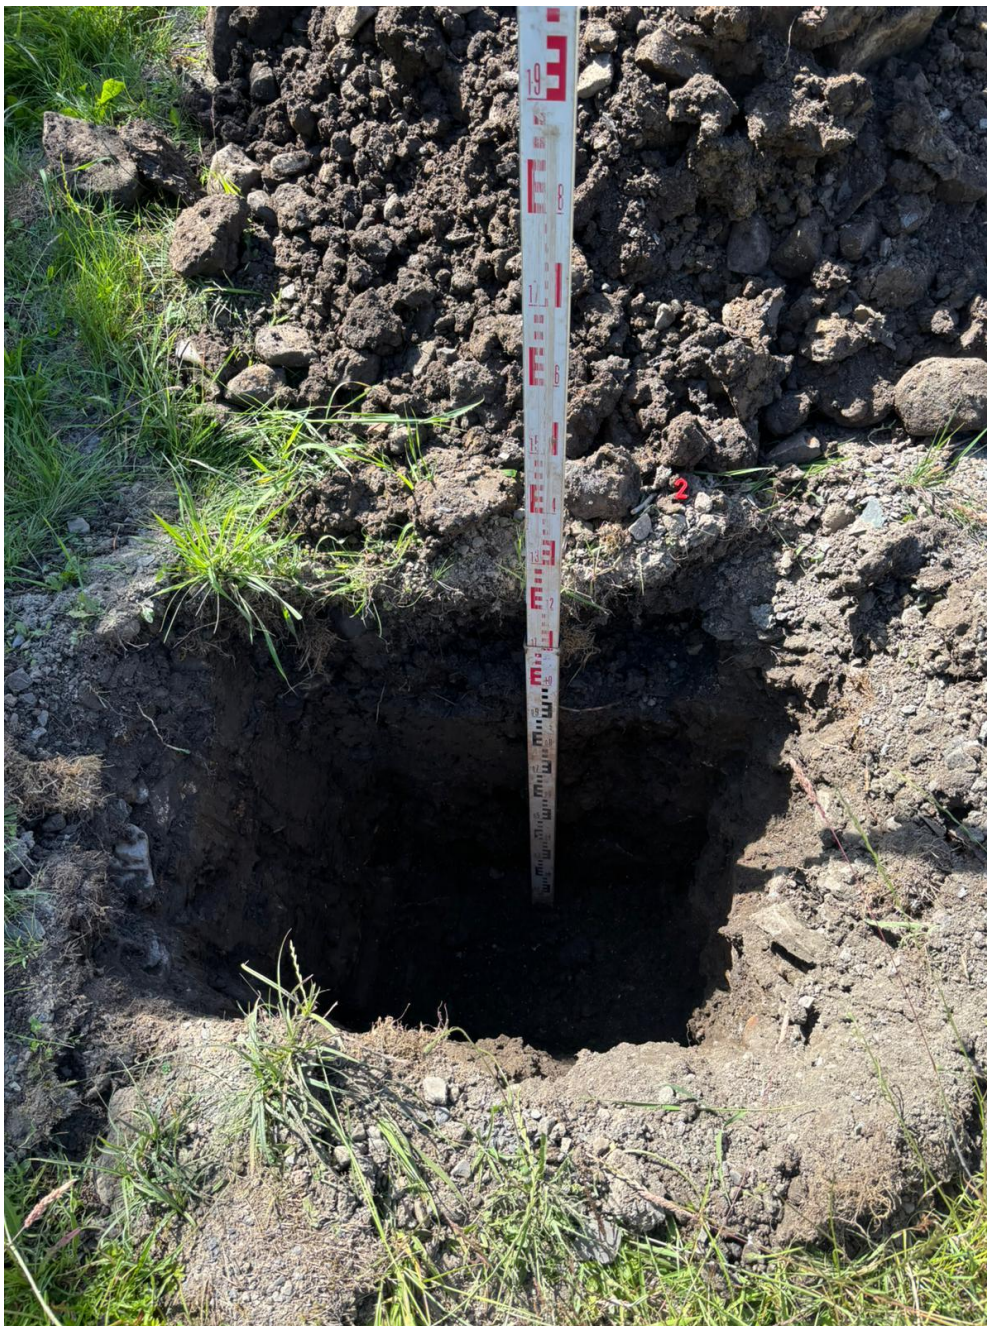
Figure 2 - Test pit 1 during excavation

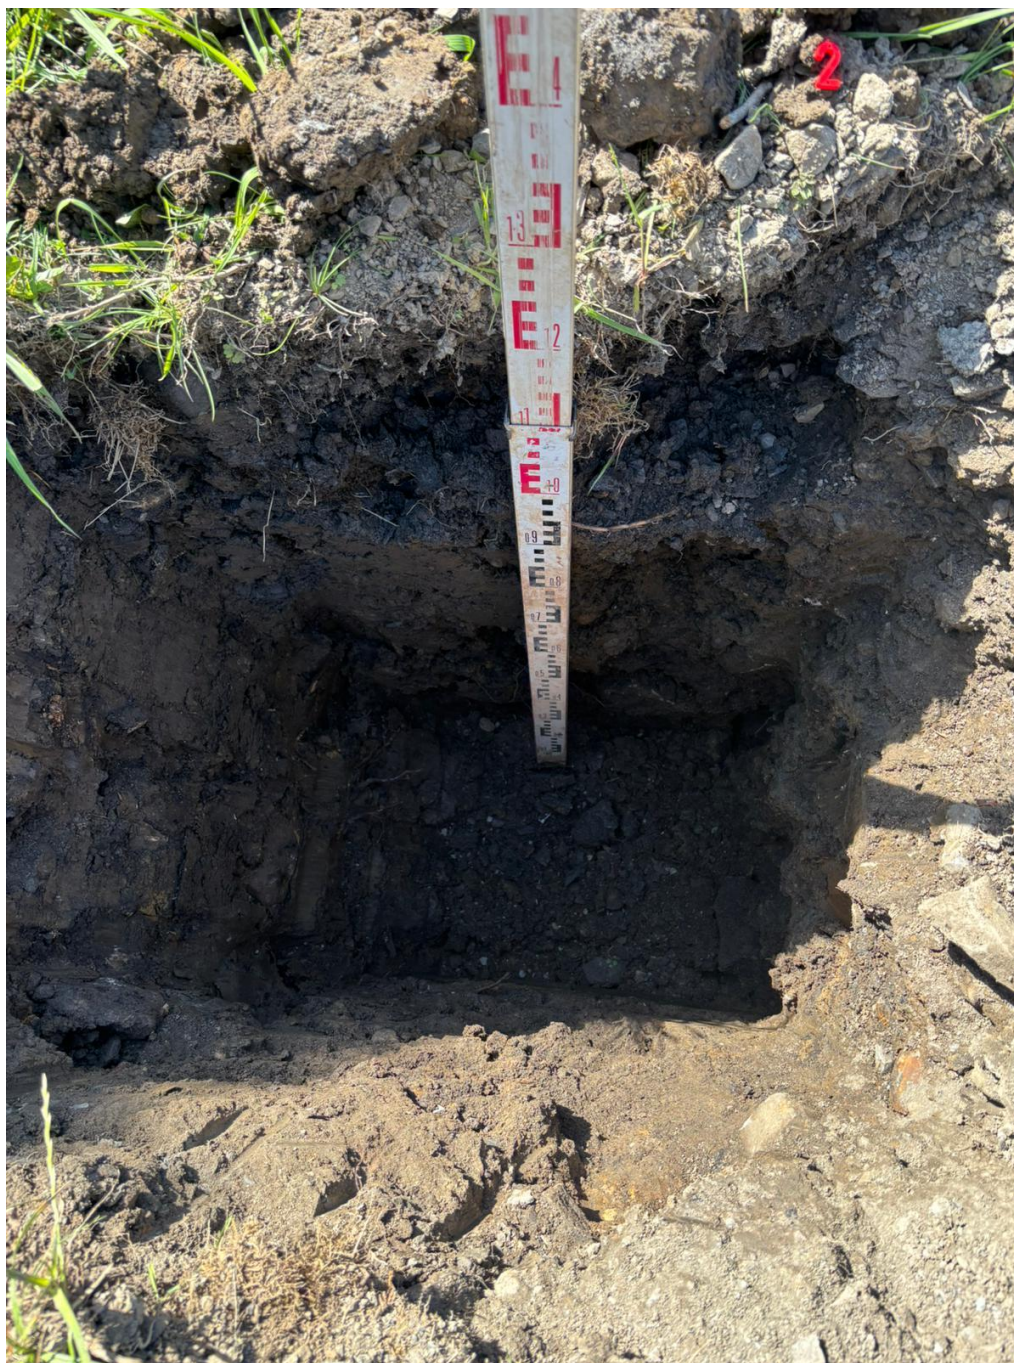
*Figure 3 - Test pit 1 strata*

#### Pit 1

| Topsoil: | 0-0.3m | - Coal spoil/till |
| Superficial soils: | 0.3-1.25m | - Coal spoil/clay |

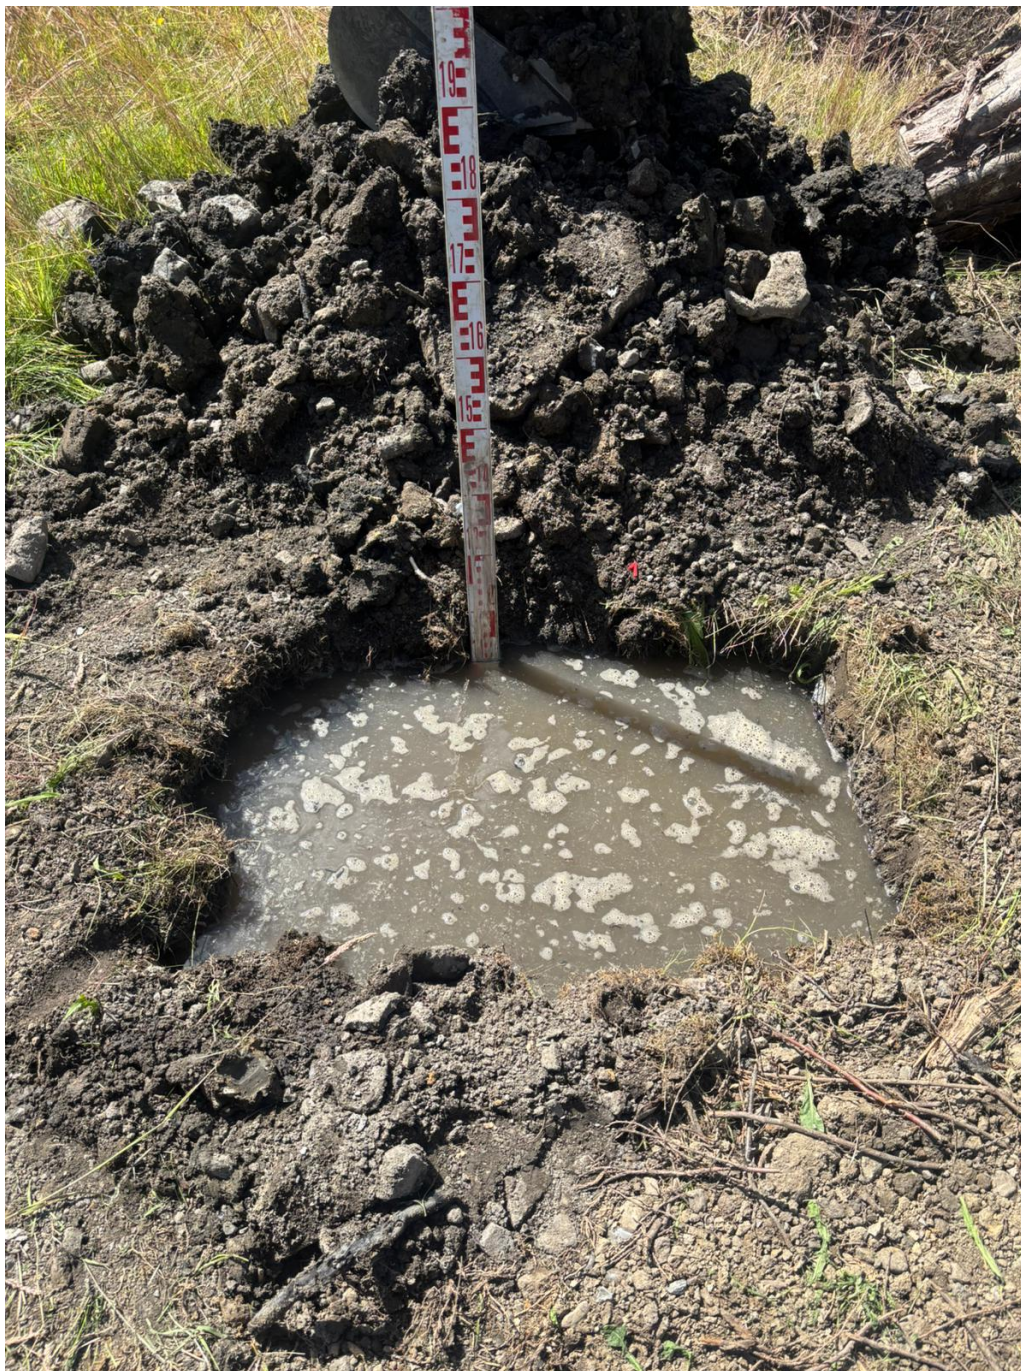
*Figure 4 - Test pit 1 after filling*

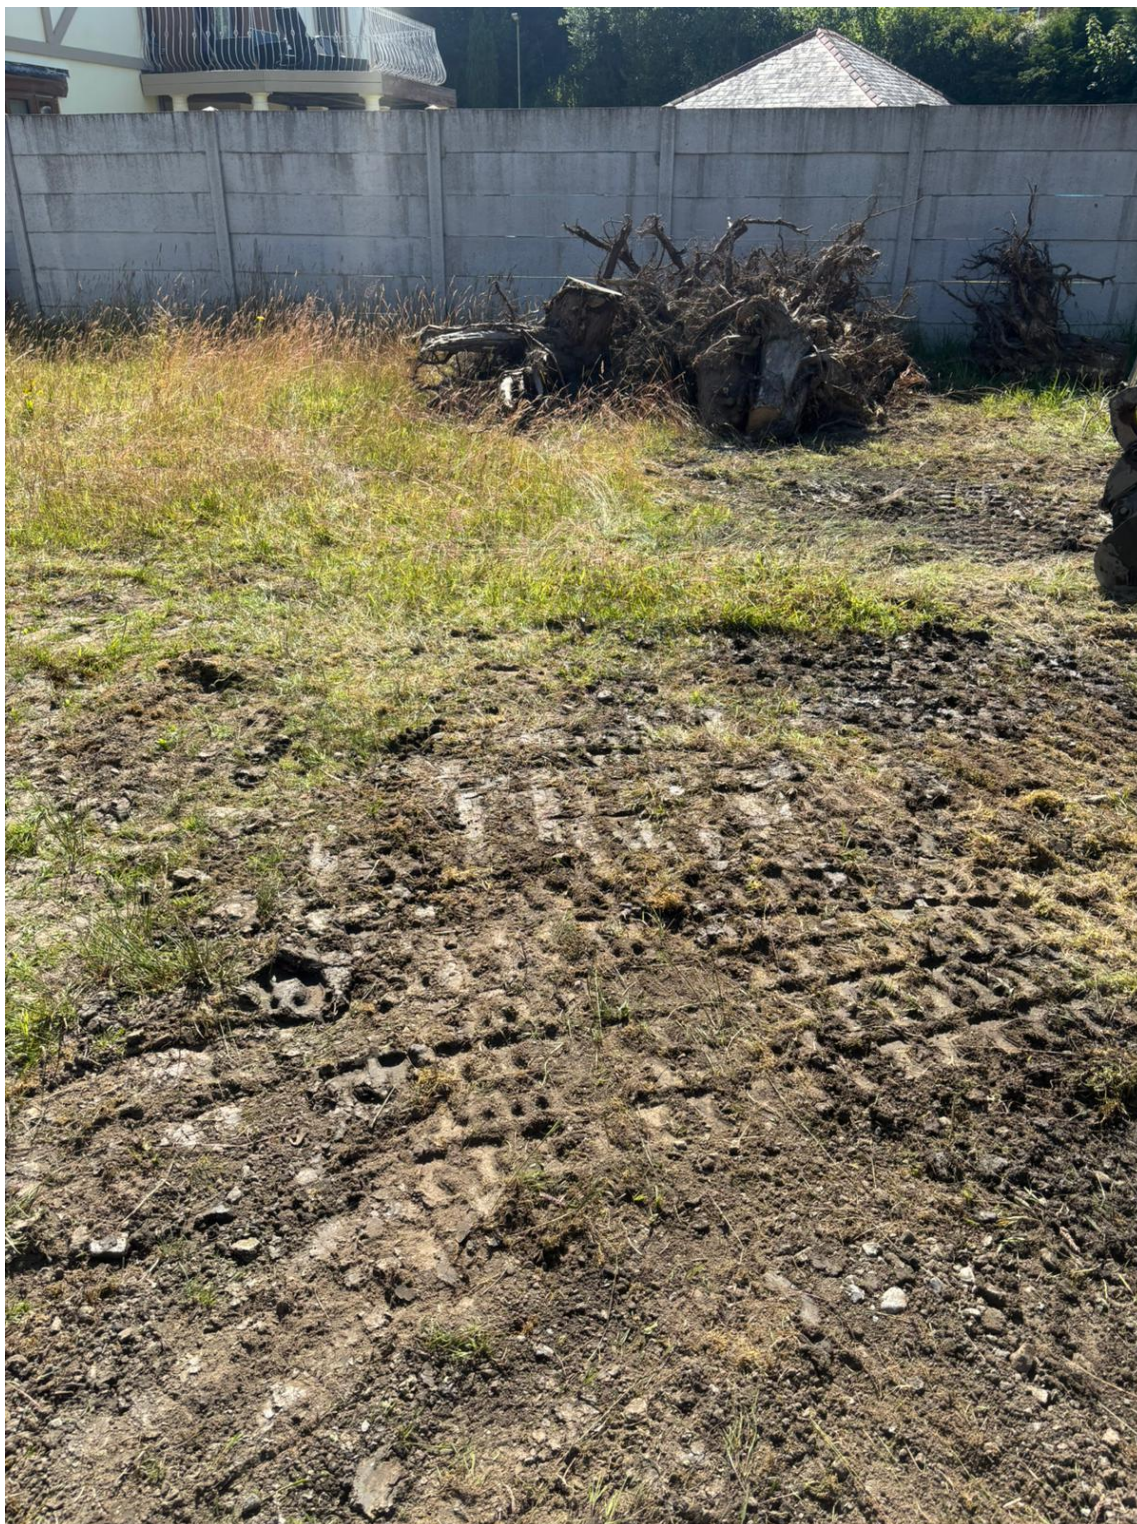
*Figure 5 - Test pit 1 remediation*
