# Ysgol y Graig

## Remediation Validation Report

# Remediation Verification Report

A111030-2

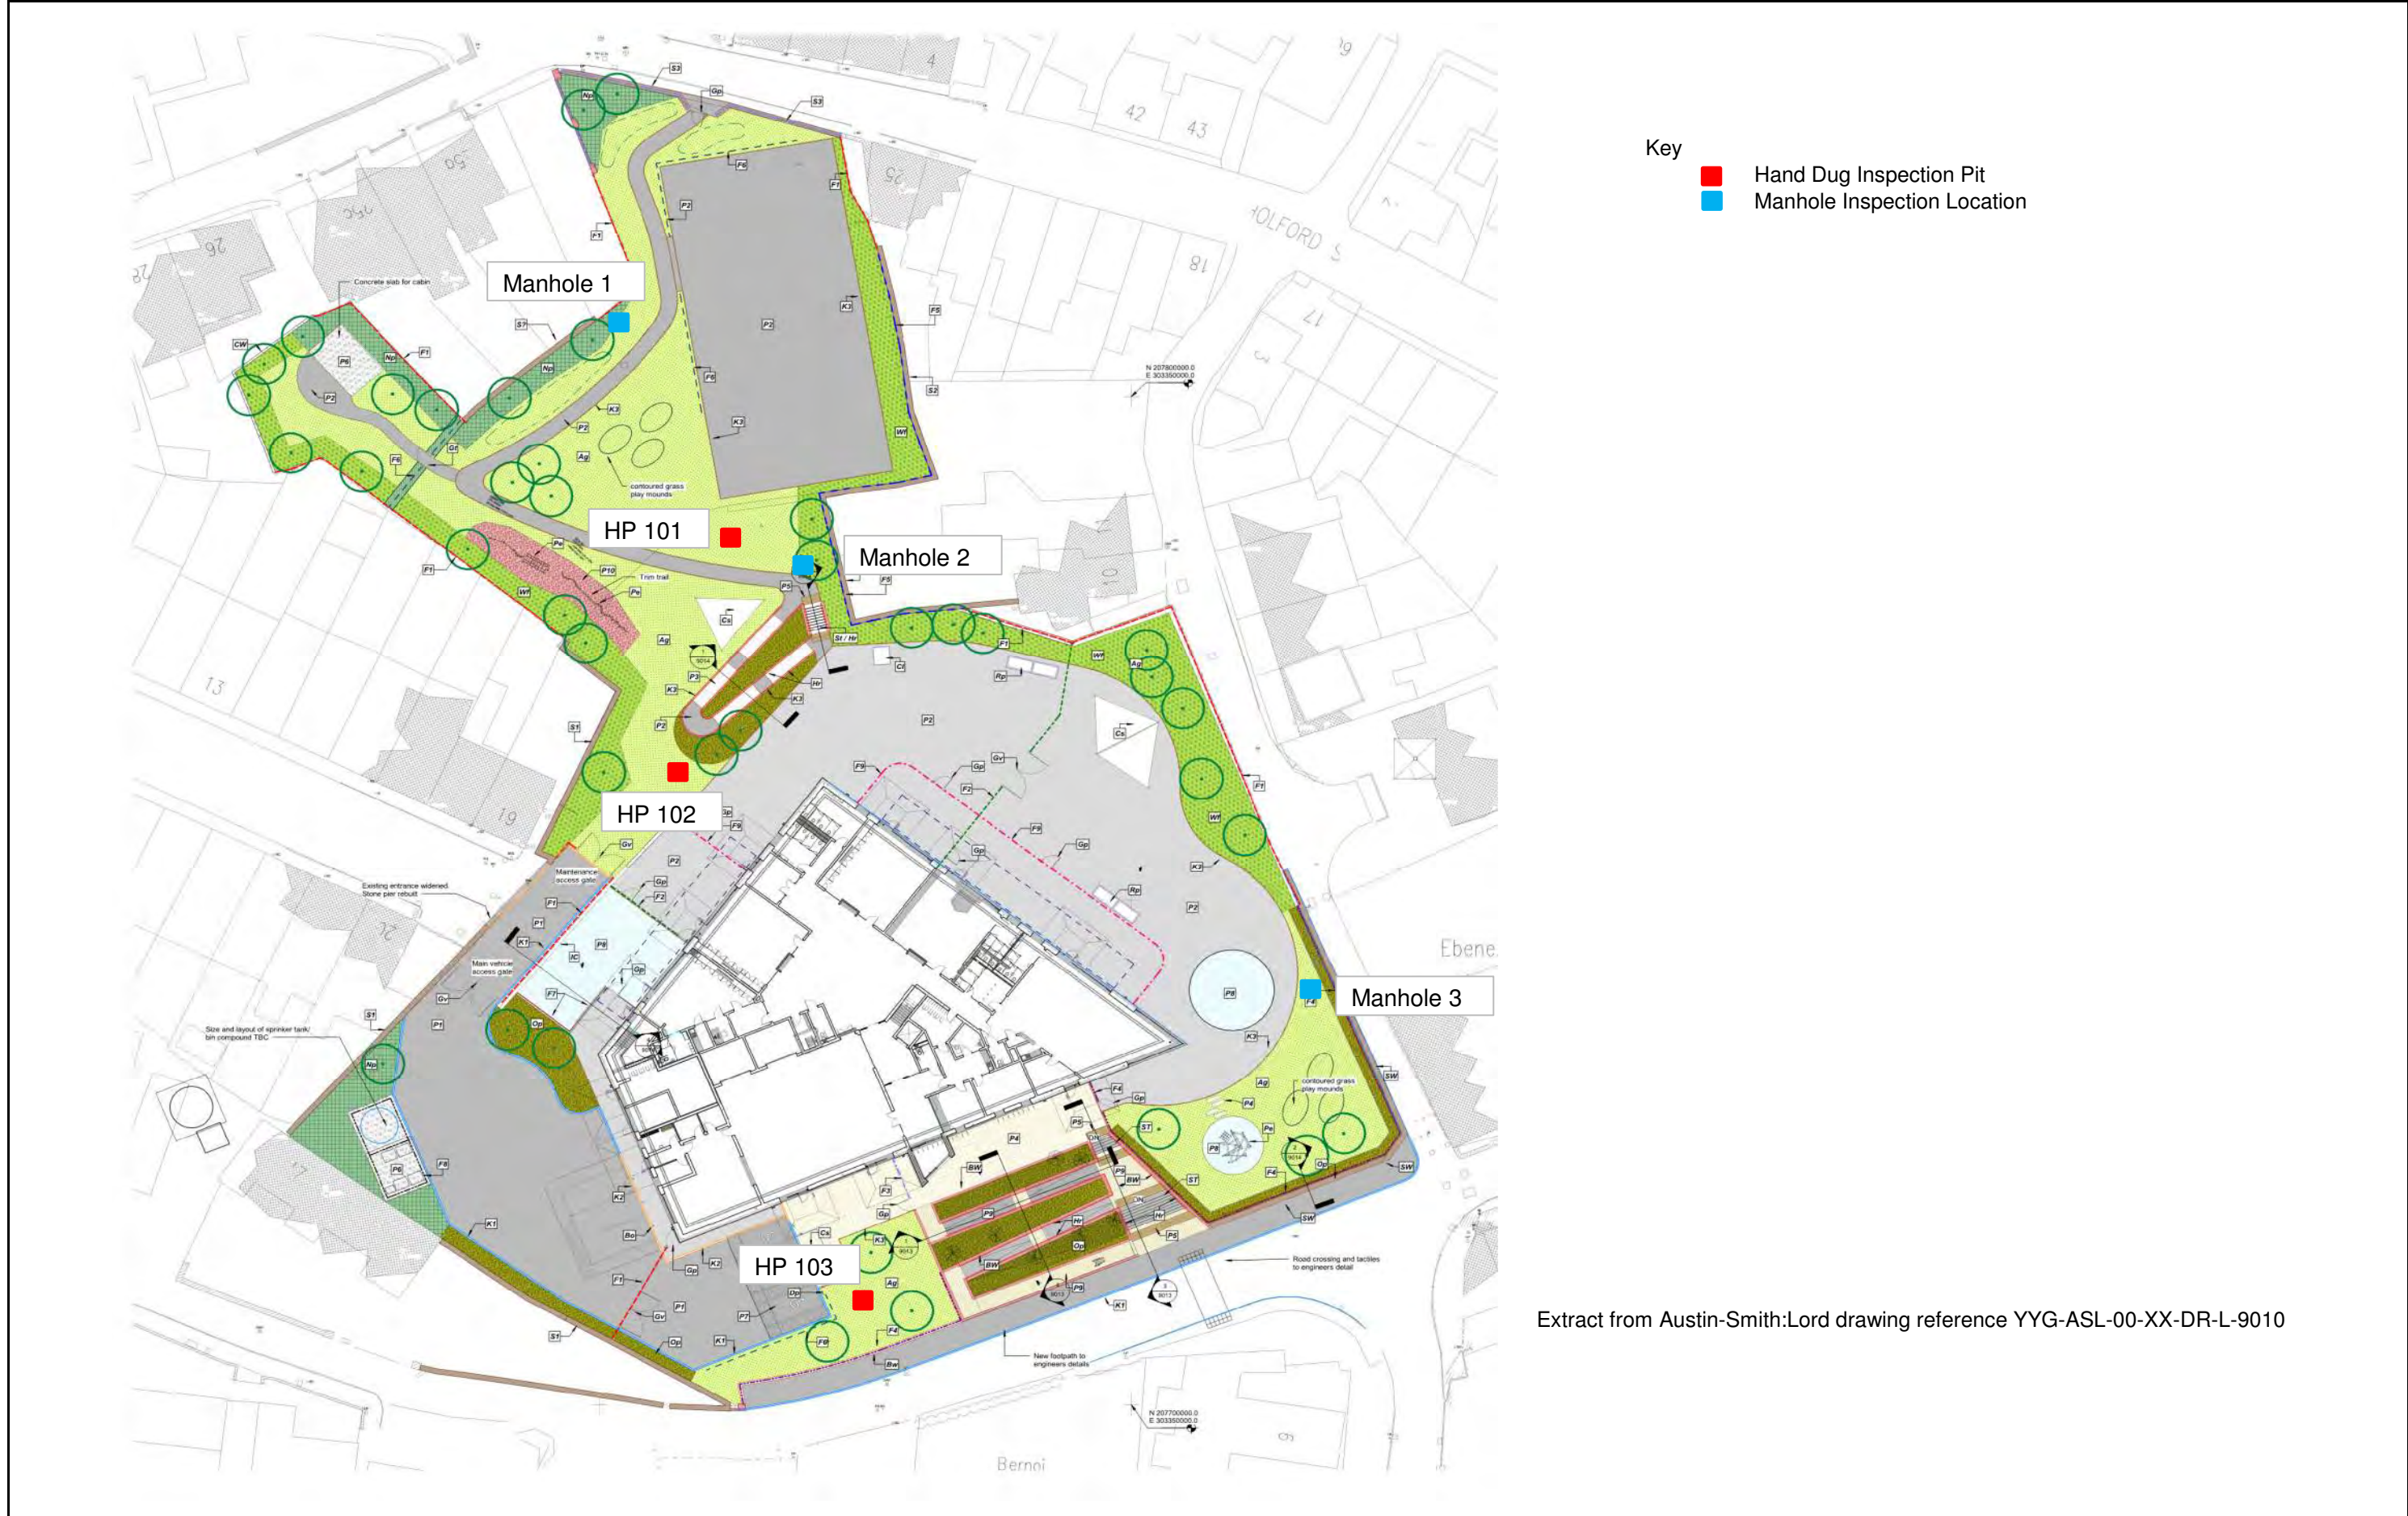
**Figure 2 – Cap Validation Test Locations**

Hand excavated inspection pits were advanced through the capping system to record the thickness of cover system and identify the presence of the visual membrane.

Due to access limitations and planting across the site access to areas of soft landscaping were limited, however inspection pits were advanced to a depth of 600mm in three locations, with the presence of the visual membrane confirmed by a Tetra Tech Engineer overlain by a combination of topsoil and subsoil materials as summarised in the table below.

Additionally, the Tetra Tech Engineer inspected three manhole inspection covers across the site and confirmed the presence of the visual membrane at depths of between 600mm and 700mm bgl.

Figure 2 identifies the location of the inspection pits and manhole covers inspected during the Tetra Tech visit to the site.

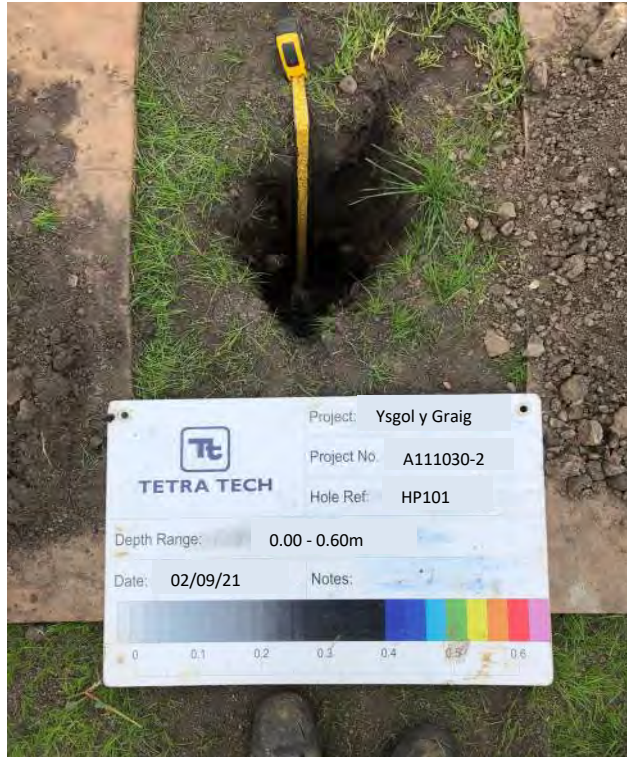
**Plate 1**

| Location | Depth of Strata | | |
|---|---|---|---|
| HP101 | GL - 0.15 | 0.15 – 0.60 | Yes |

HP101 Insepection Pit
