**Bat Survey:** Bontnewydd Hall, Bontnewydd Terrace, Trelewis, CF46 6AF

**Instructed by:** Merthyr Valley Homes

**Reported by:** Ecological Services Ltd  
10 Mount Pleasant, Llanelly Hill, Abergavenny, Monmouthshire, NP7 0NT

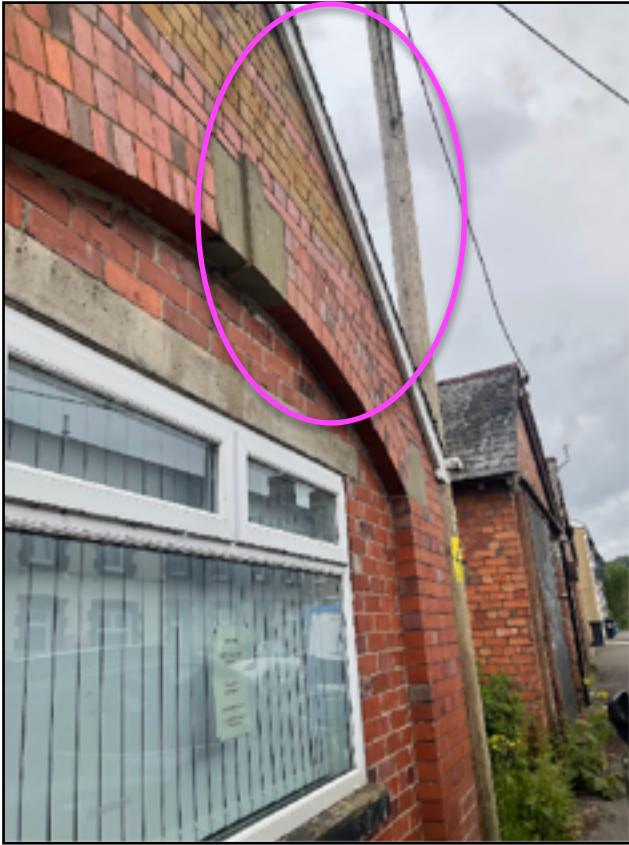
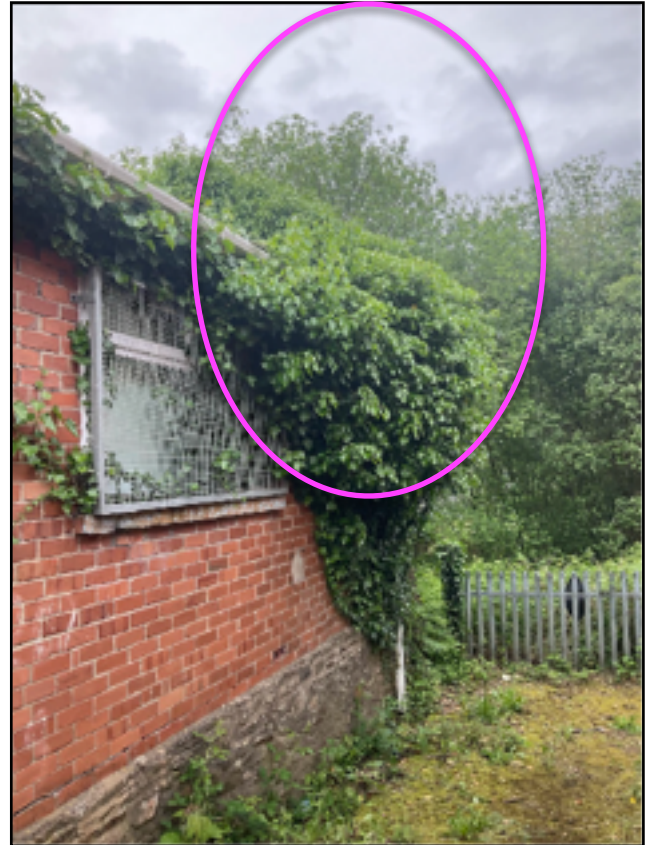
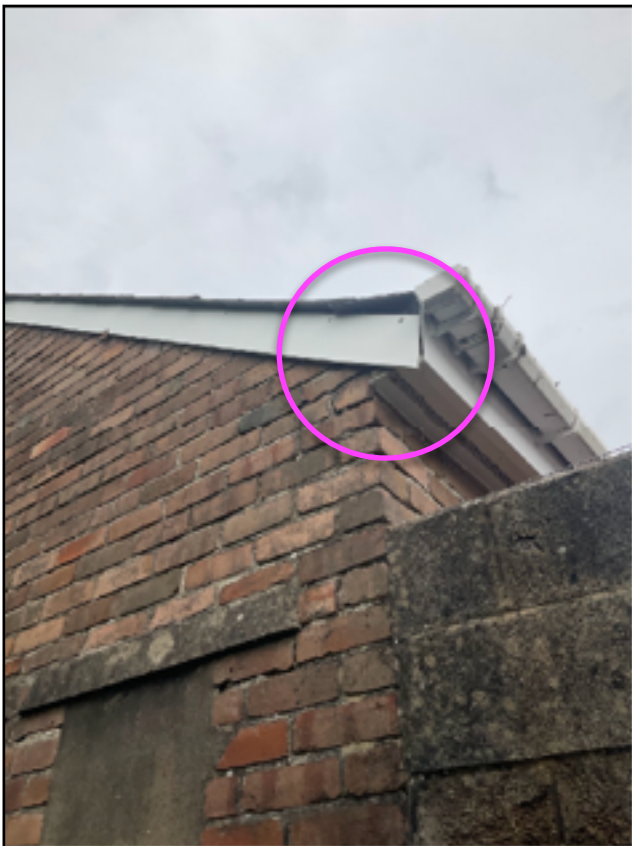
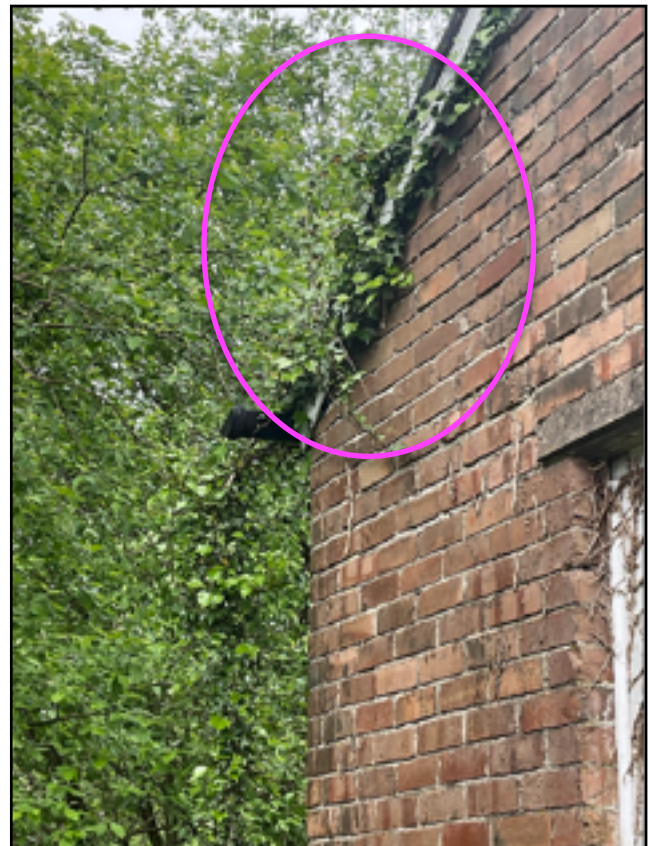
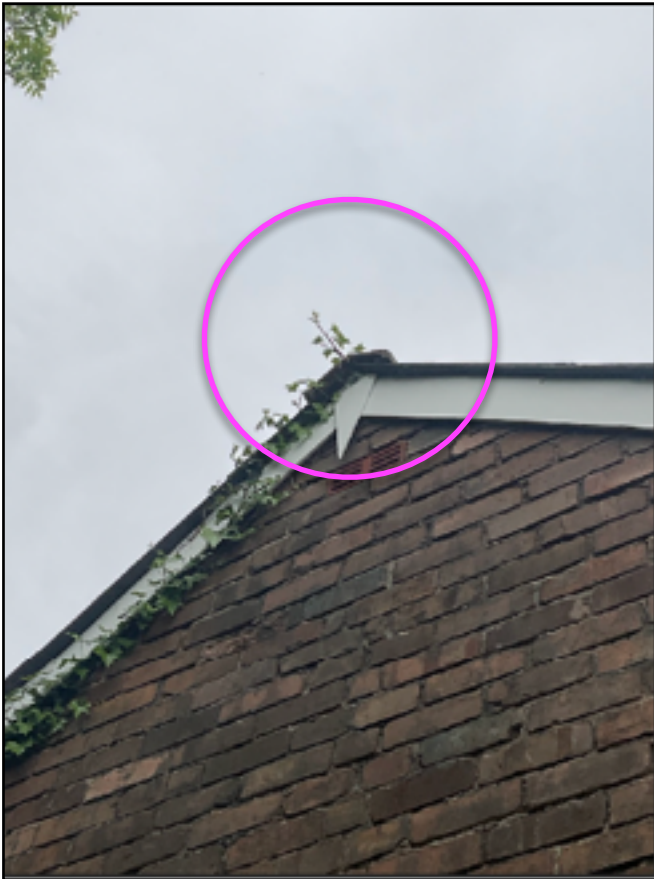
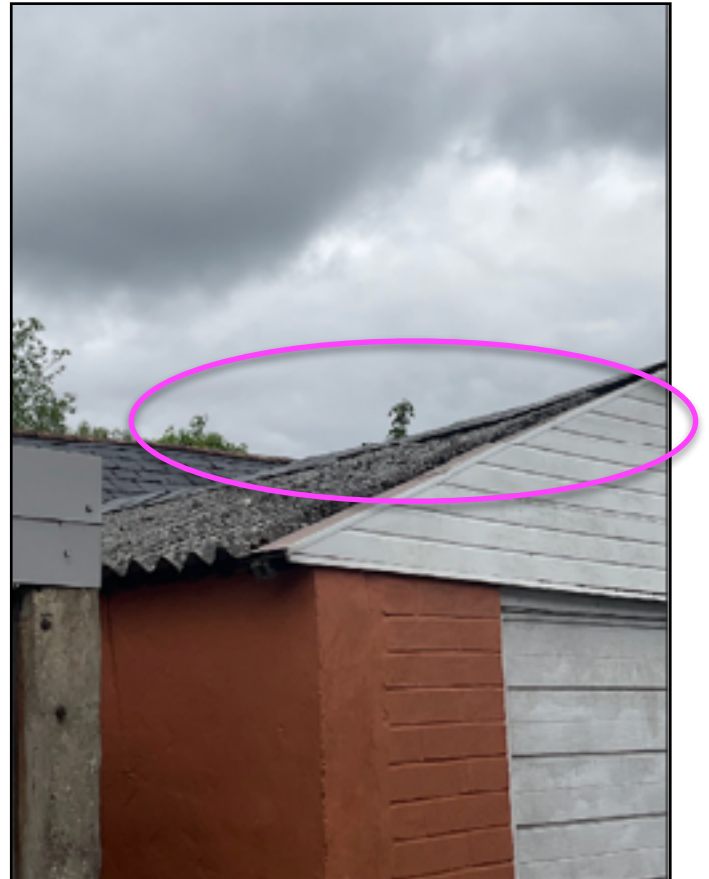
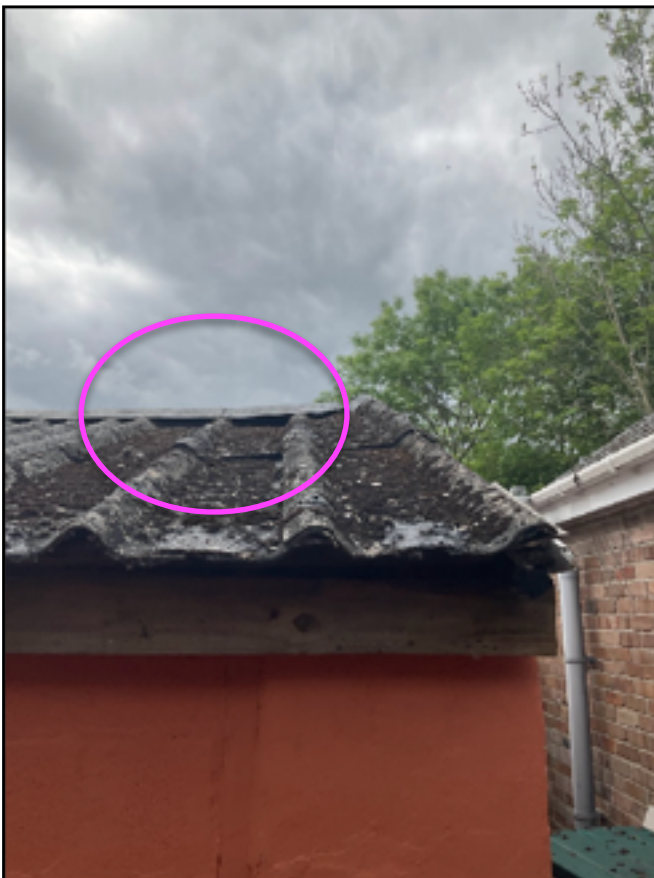
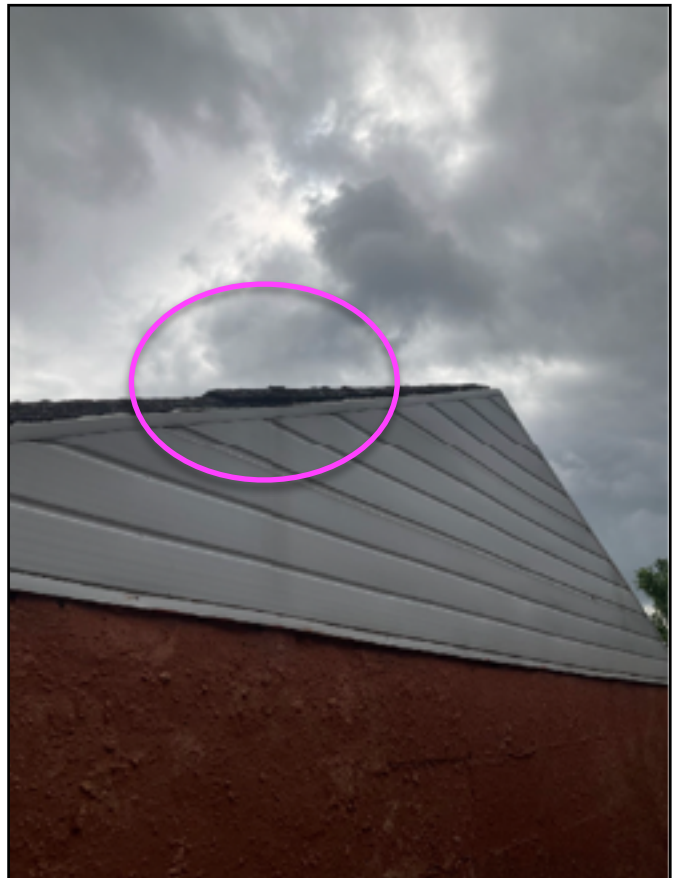
**6.3** Due to the age and condition of the buildings, there were a small number of opportunities present for bats to access and use the buildings and those that were available were deemed as having at least moderate potential for roosting bats. There were apertures between the barge boards and the walls on the gable ends of the hall; apertures between the slates and the barge boards on the southern gable end of the hall; an aperture at the apex on the southern gable end of the hall and a large area of vegetation covering the western elevation of the hall. There were also apertures between the roofing sheets and the ridge line and between the roofing sheets and the fasciae on the garage.

**6.4** No droppings or evidence of bats were discovered on any external features.

**6.6** Examples of apertures allowing access to cavities in the buildings:

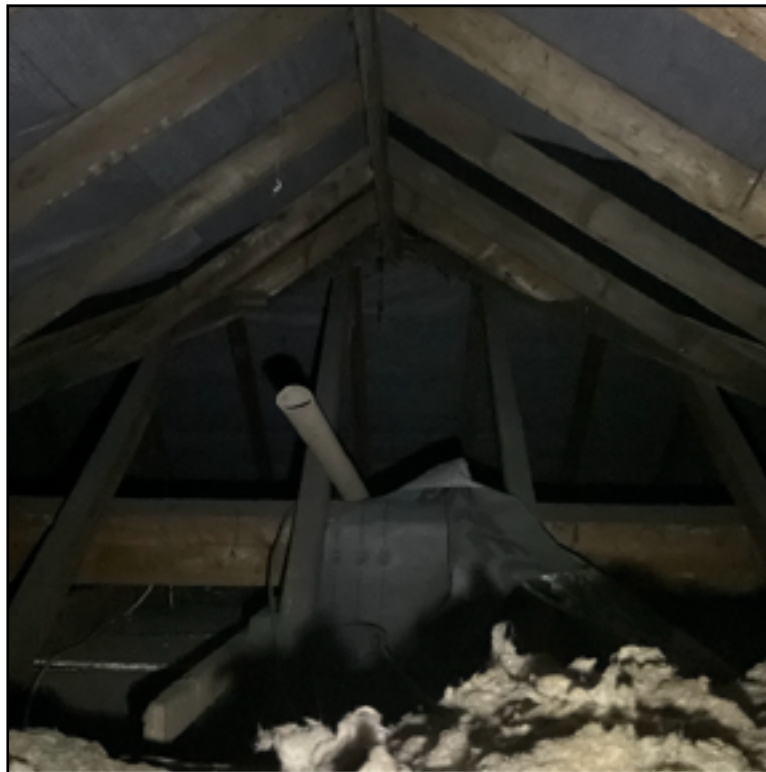
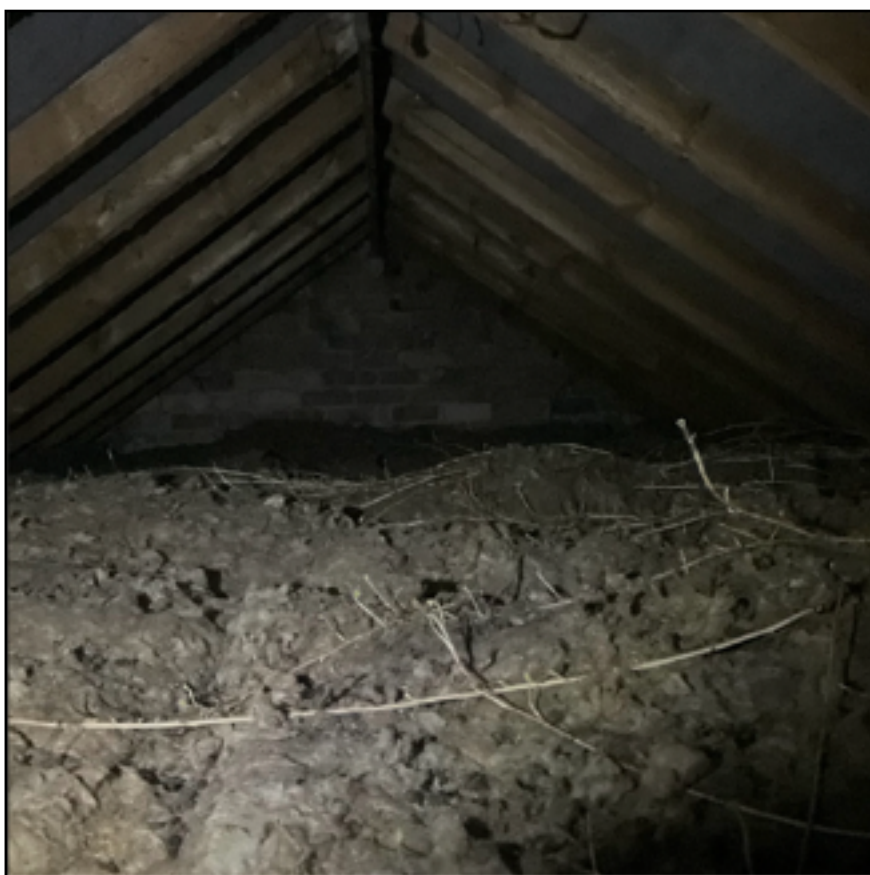
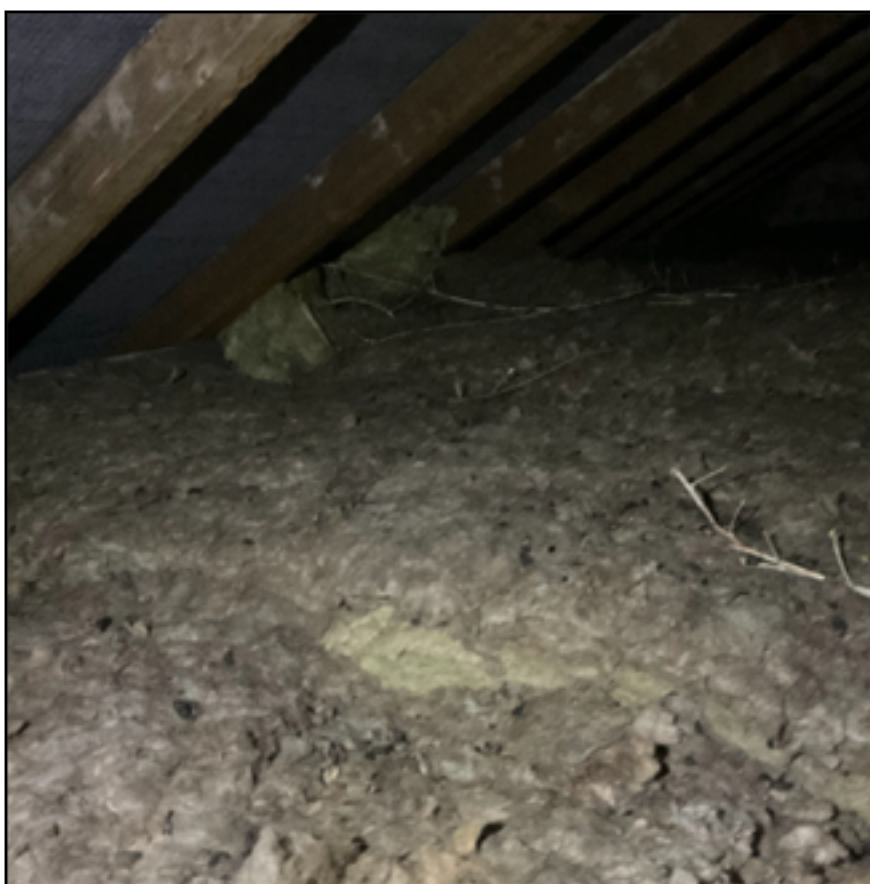
**7.2** There was an attic space within the hall building, however, it was not fully accessible due to the small size of the attic hatch. The attic space was of a trussed design and was lined. There was insulation covering the floor of the space. There were significant areas of light ingress present within the space. There were a number of mouse / rat droppings present, however, no obvious bat droppings were observed. It is noted that the attic space was not fully accessible and there were significant amounts of debris covering the floor.

**7.3 A static bat detector will be deployed in the attic space of the hall during the bat active season and will be left for five consecutive nights. All recorded data will then be downloaded and assessed using Analook software.**

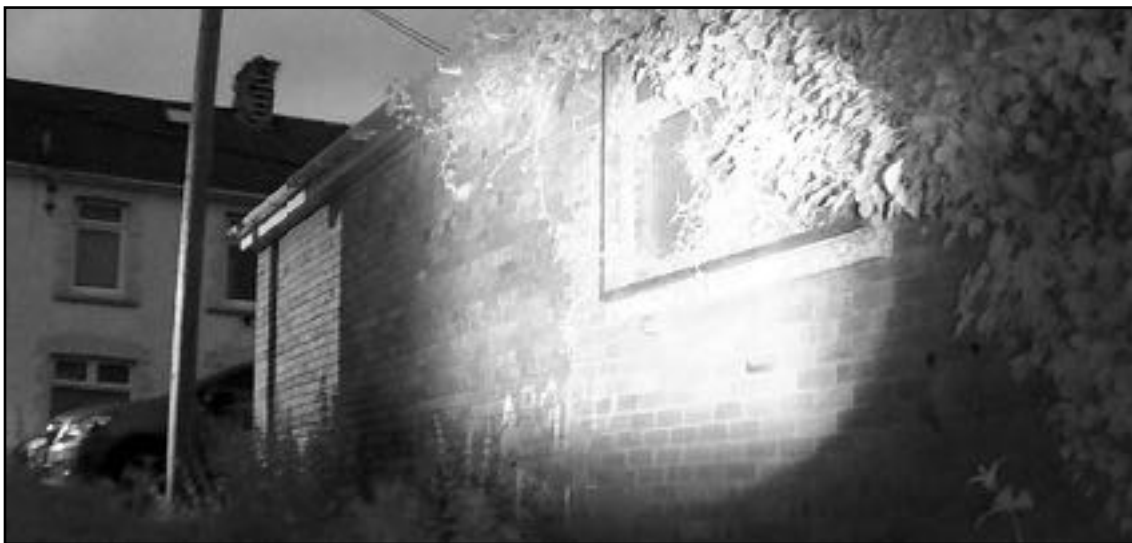
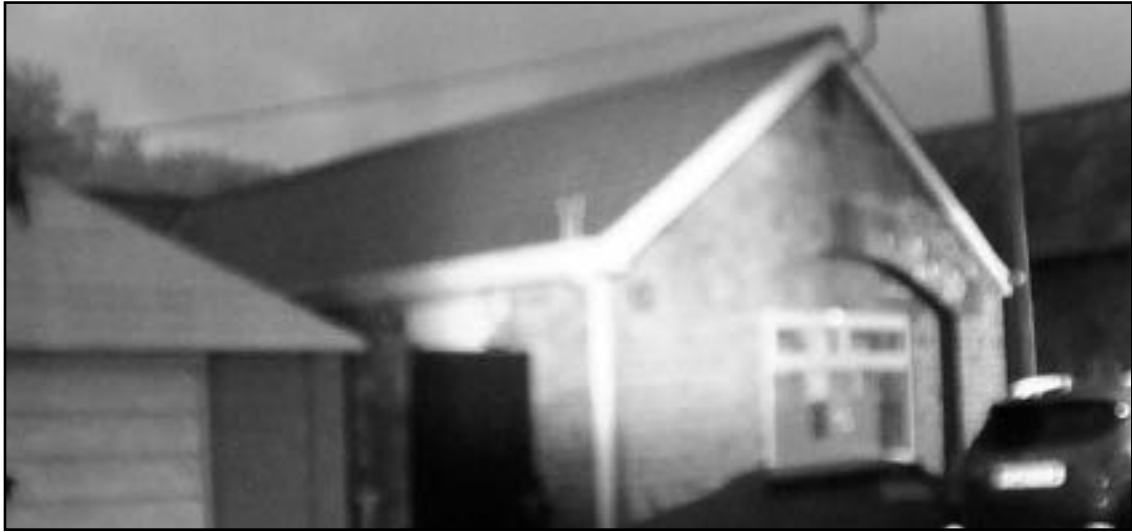
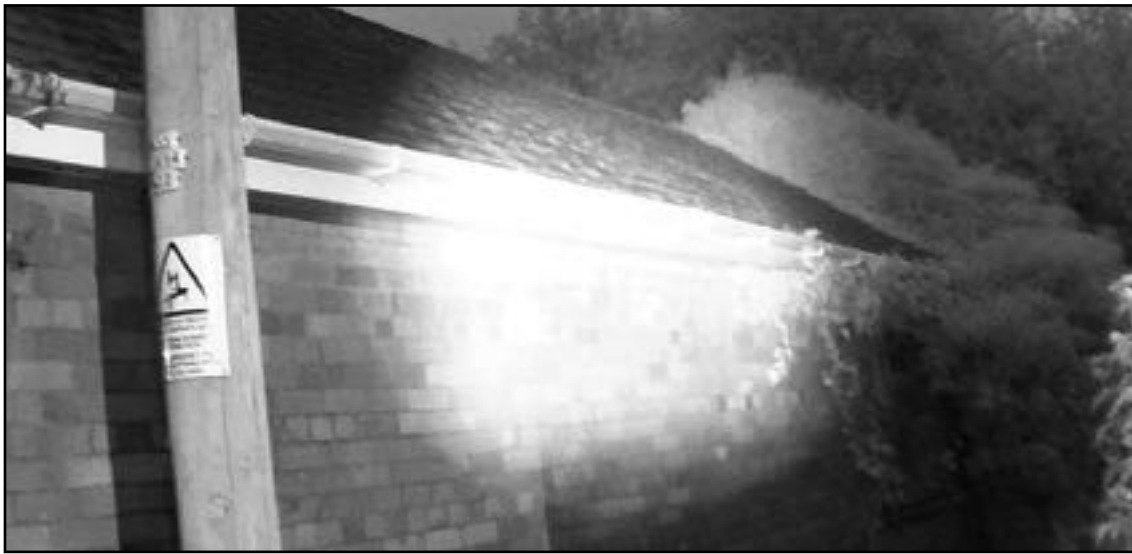
**8.10 Examples of NVA Still Shots:**

**No bats were observed emerging from the buildings.**

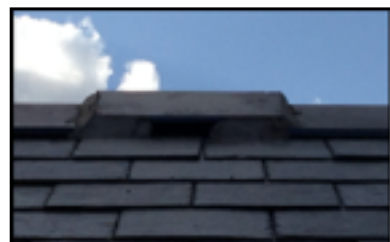
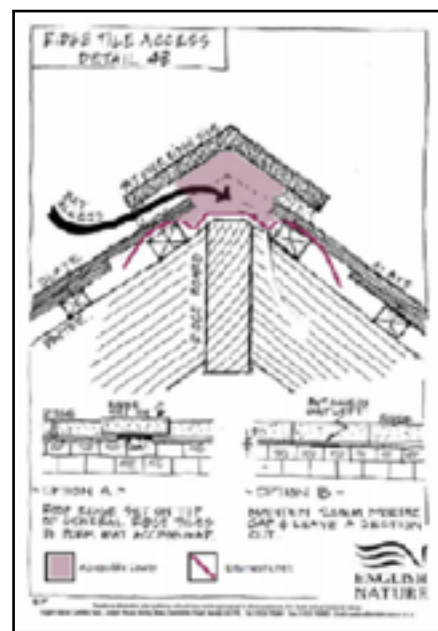
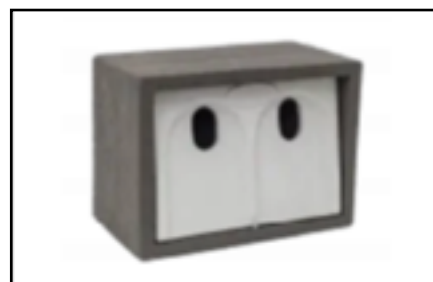
**11.3** The raised ridge tiles will have two access apertures measuring 100mm long by 25mm high; one on the front elevation and one on the rear.

**11.5** Bats will be restricted to the void in the underside of the ridge tile by using a continuous piece of 1F bitumen felt as a base liner. This will be fixed in location over the top rafters as per adjacent image.

**11.6** Breathable membrane is dangerous for bats, therefore it is essential that the detail contained in the adjacent drawing is followed exactly and is to be fitted under direct ecological supervision by a suitably qualified ecologist.

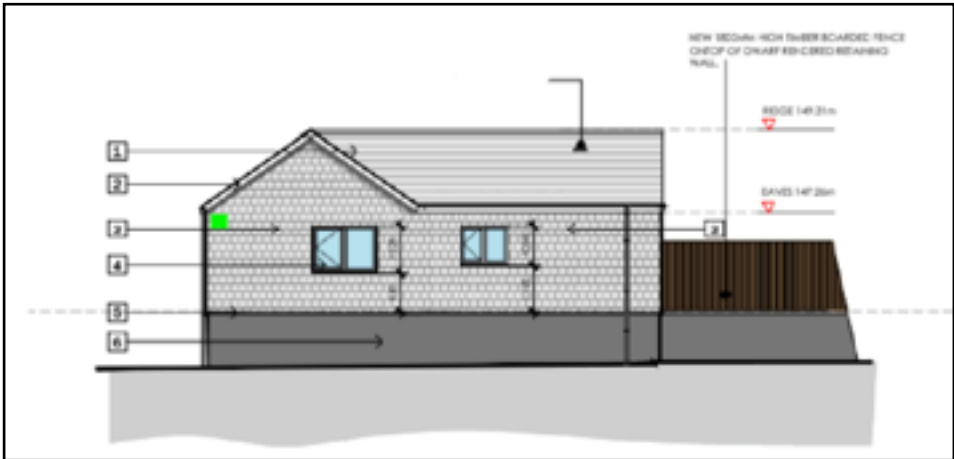
Western Elevation

**11.7** Two Vivara Pro WoodStone House Sparrow Nest Boxes will be built into the block work of the property; one on the northern elevation and one on the western elevation. **These will not be situated on a south facing elevation. Care must be taken not to obstruct the entrance holes.**
