Park View Cottage,  
Merthyr, CF48 4HU  
Grid Ref: SO 06851 02934  
Preliminary Roost Assessment

| DOCUMENT INFORMATION | | | |
|---|---|---|---|
| Title | Park View Cottage – Preliminary Roost Appraisal | | |
| Document Ref | EV002056/PRA | Issue / Revision | 1.0 |

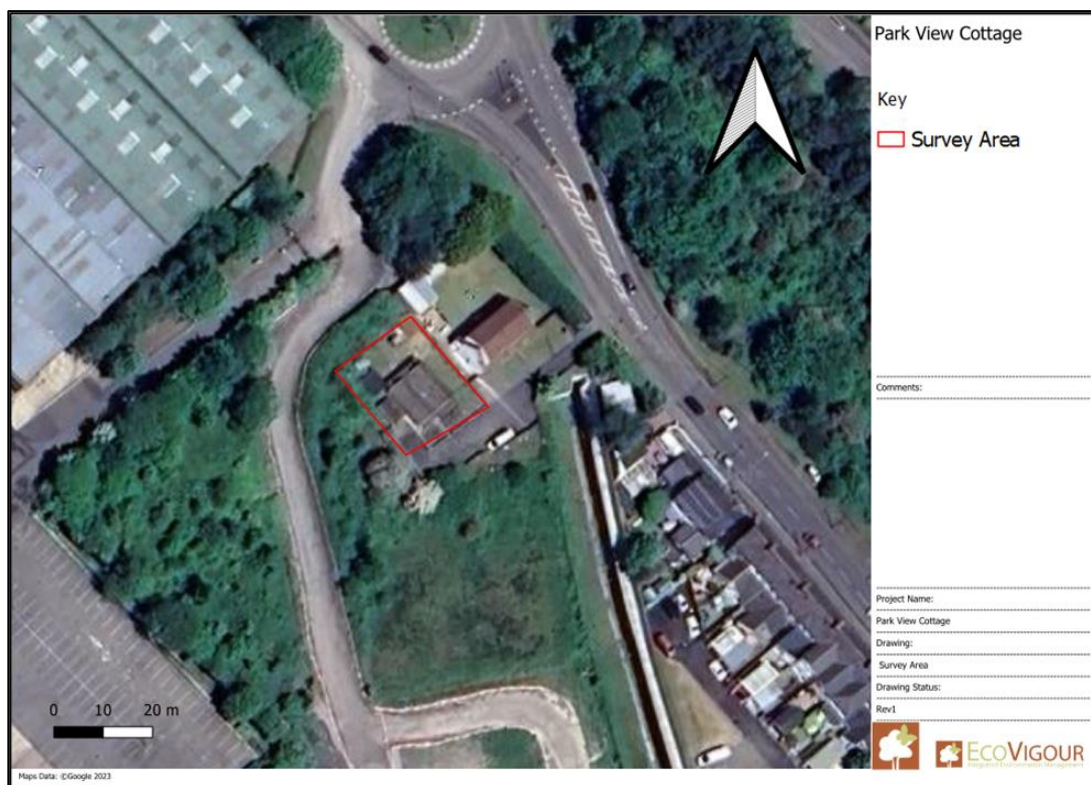
**Figure 1: Survey Area**

2.2.1 The survey area consists of Park View Cottage, Merthyr Road, Troedyrhiw, Merthyr, CF48 4HU. Grid Reference: SO 06851 02934. The survey area was the single-story building, that had its ceilings, and two walls removed prior to the PRA being undertaken. The survey area is outlined below (Figure 1).

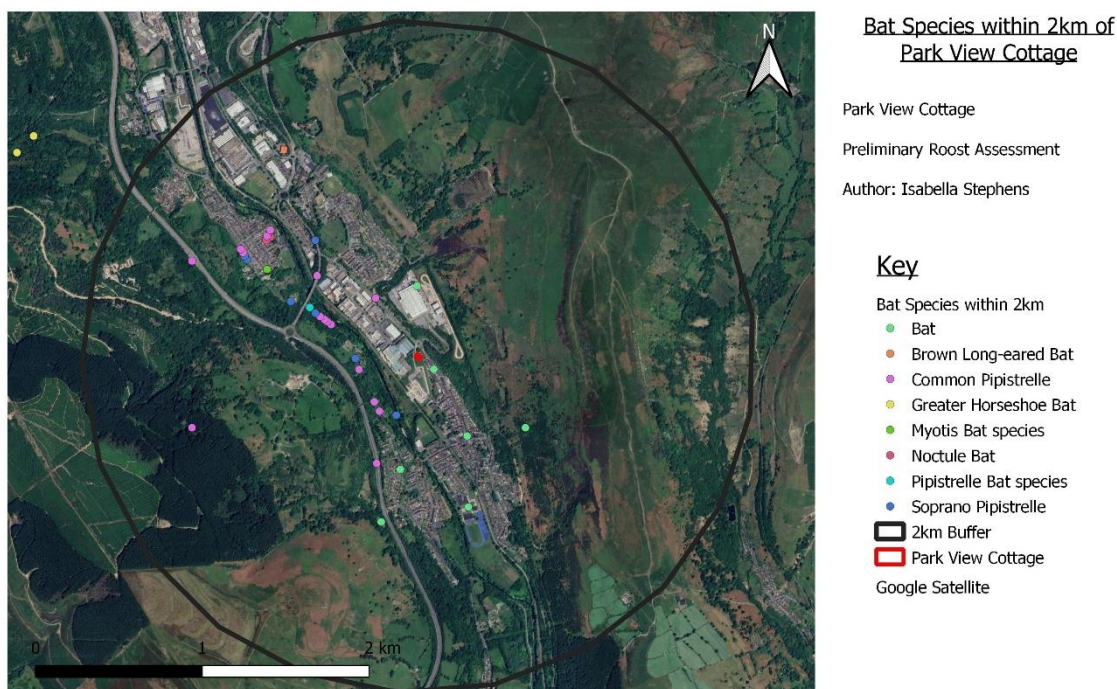
- 4.1.1 52 records were returned within a 2km radius, consisting of 5 confirmed bat species. The closest record to site was an unidentified bat species, recorded 129m from site in 2007. There was also a common pipistrelle (*Pipistrellus pipistrellus*) recorded foraging 360m from site in 2011. The most recent records are recorded in 2018 and consist of two greater horseshoe bats (*Rhinolophus ferrumequinum*), being recorded over 2.6km away in 2018. A lack of records does not represent a lack of species, just what has been recorded. Figure 2 below shows bat records within 2km of site, some records have been recorded using the same grid reference so may only appear as one point on the map.

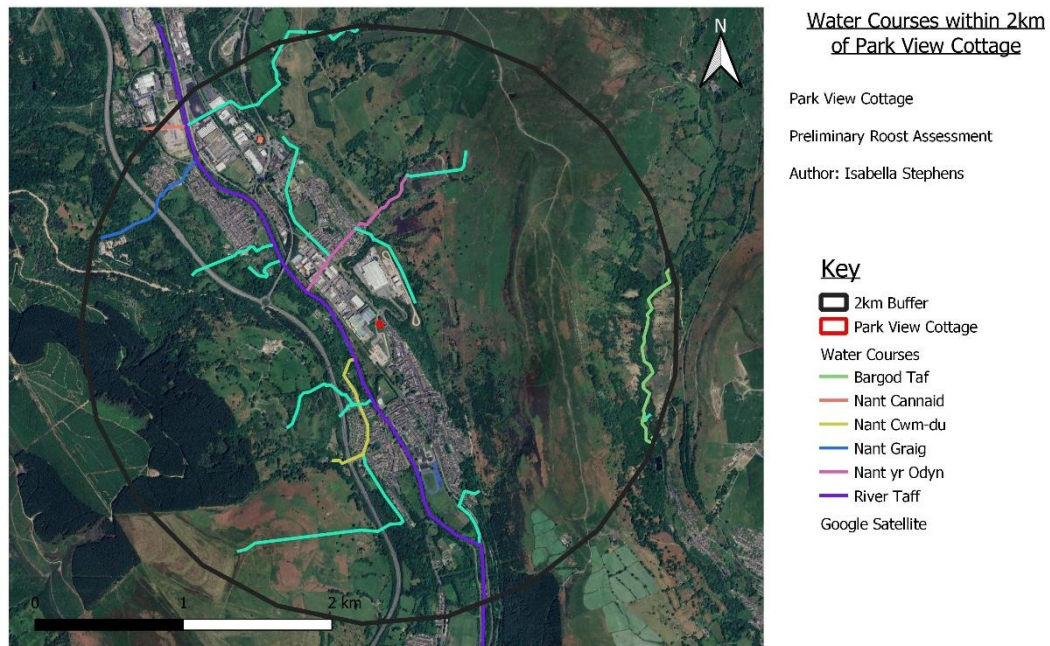
- 4.3.1 There are 6 watercourses within 2km of the site. The closest water course to site is the river Taff, flowing 250m to the south-west of site. Details can be found in figure 4 below.

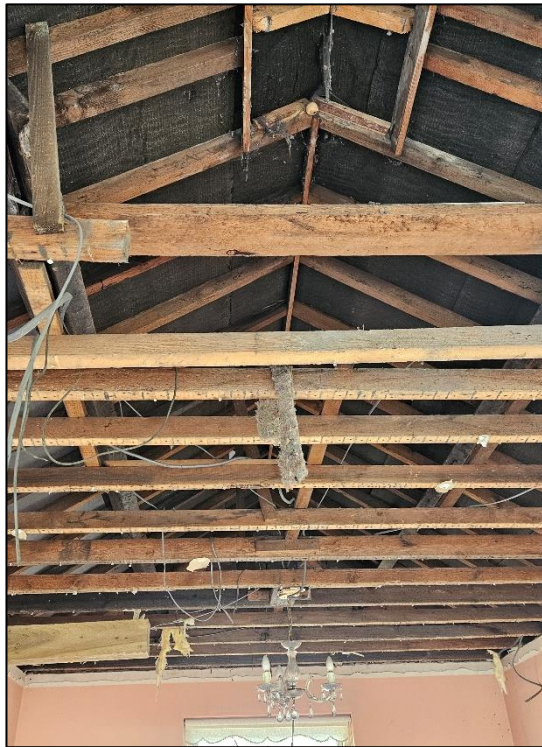
***Plate 1 – The internal ceilings.***

- 4.6.1 Full access around the site was possible as part of this PRA, however the internal ceilings had been removed as well as two external walls therefore there was no loft space to inspect as part of this PRA. The roof and roof tiles on the property were in good condition with no gaps, loose, slipped or raised tiles creating potential roosting features (PRFs). The remaining walls are red brick covered in pebble dash and did not contain any features suitable for PRFs. The plastic soffit and fascia boards were in good condition with no gaps, cracks or crevices identified. Overall the property had limited PRFs identified externally. The works on the building, including the removal of two external walls has opened up the cavity walls and created a potential roosting feature suitable for crevice dwelling species. The cavity walls were inspected during the PRA using an endoscope and high-powered red-light torch by the licensed ecologist. The cavities were filled with thick, undisturbed spiderwebs indicating that nothing had entered or exited these walls prior to the PRA.

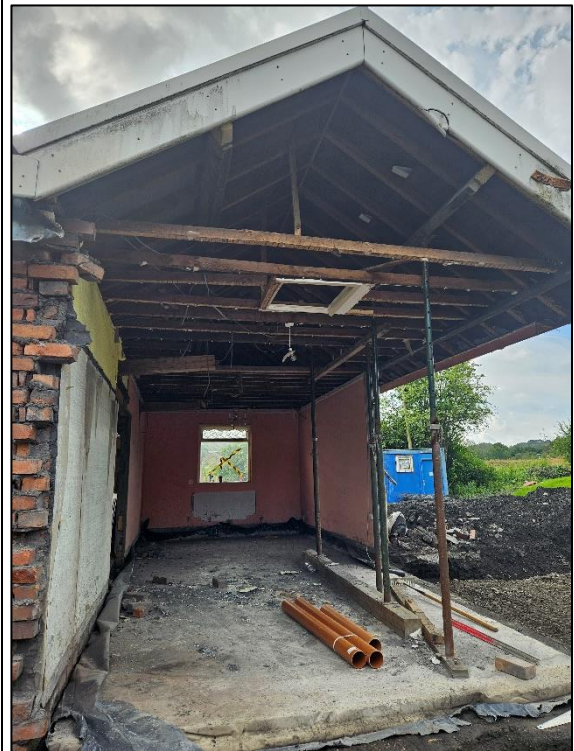
***Plate 2 - The two outer walls being removed.***

- 4.6.2 These cavity walls are open to the elements and are likely disturbed by wind and rain due to the protective outer walls being removed, which does reduce the suitability of any long-term roosting by crevice dwelling bat species. The removal of the walls also leaves the internal aspects, including the wooden foundations of the ceiling exposed creating features that could be used by free hanging bat species; however this is unlikely due to how open to the elements the house is. The beams and internal aspects of the property were all damp, and likely extremely exposed to any bad weather that is likely to occur during the winter months.

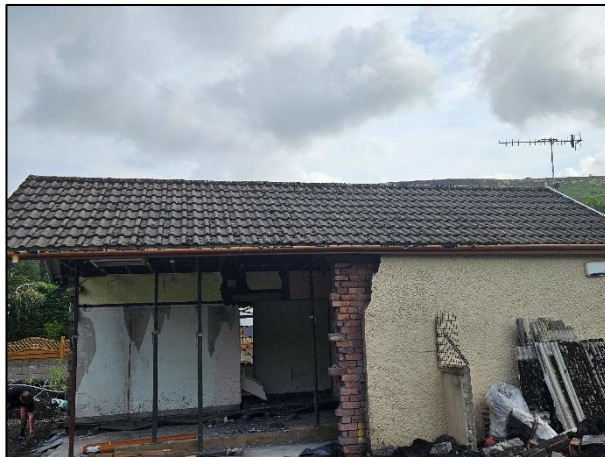
***Plate 3 – The roof tiles in good condition.***

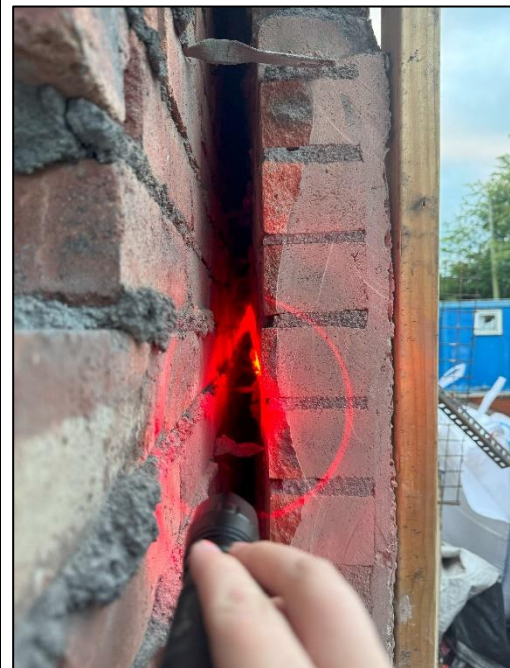
***Plate 4 – The cobwebs within the cavity walls.***

- 5.2.3 The cottage was deemed to be of 'low' potential for roosting bats, this is due to the exposed cavity walls creating a suitable potential roosting feature. The feature was deemed to be of low potential due to the exposure of the cavities to the elements, the disturbance from the construction on site and the fact that the cavities are filled with undisturbed cobwebs indicating no movement internally.

- 5.2.4 It is therefore recommended that one dusk activity survey is undertaken. Due to the fact that the building cannot be left open all winter and the construction site is currently a health and safety risk it was decided that the activity surveys should be undertaken outside of the optimal season (May – August). Surveys can be undertaken during September, providing weather conditions are within the recommended range, as well as the fact that the features identified are unlikely to support a maternity roost which would not be able to be surveyed for at this time of year. This recommendation is based on information within the Bat Surveys for Professional Ecologists: Good Practice Guidelines (Collins, 2023). If bats are found emerging during the survey or no bats are recorded at all due to the sub-optimal time of year / weather conditions, then further surveys will need to be undertaken on the property between May-August 2025.

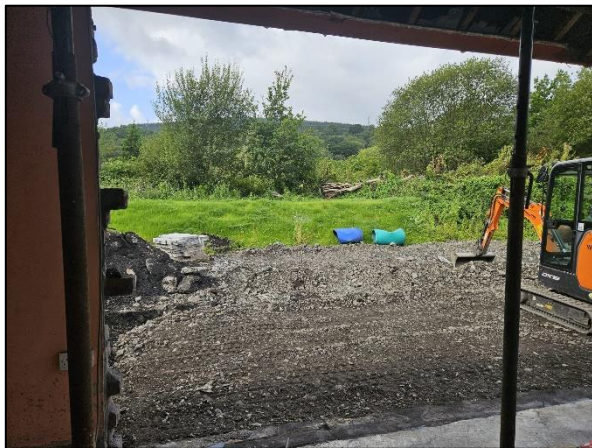
**Plate 5 – The works occurring on site.**

- 4.6.3 The site is currently subject to sound, light and vibration disturbance caused by some minor works on site as well as the disturbance caused by the active site compound to the south of site that is largely illuminated by flood lights at night. The site sits within a busy urban residential area. The site has linear features provided by treelines and hedgerows within the wider area however within the property footprint itself there is no vegetation. The linear features created by the treelines and the river Taff itself provide suitable commuting habitat for bat species, as well as the surrounding agricultural fields and woodland within the wider habitat creating suitable foraging habitat.

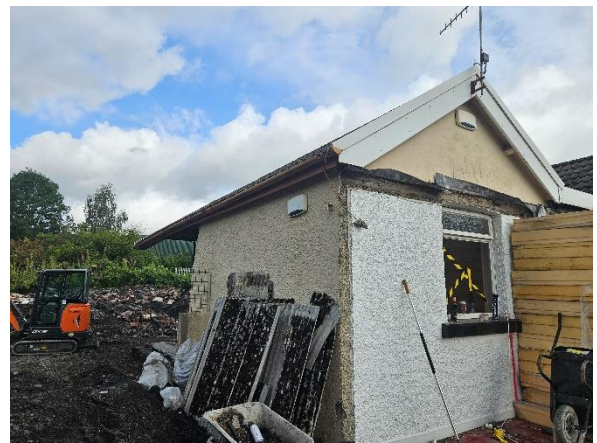
**Plate 6 – The plastic soffit and fascia boards.**

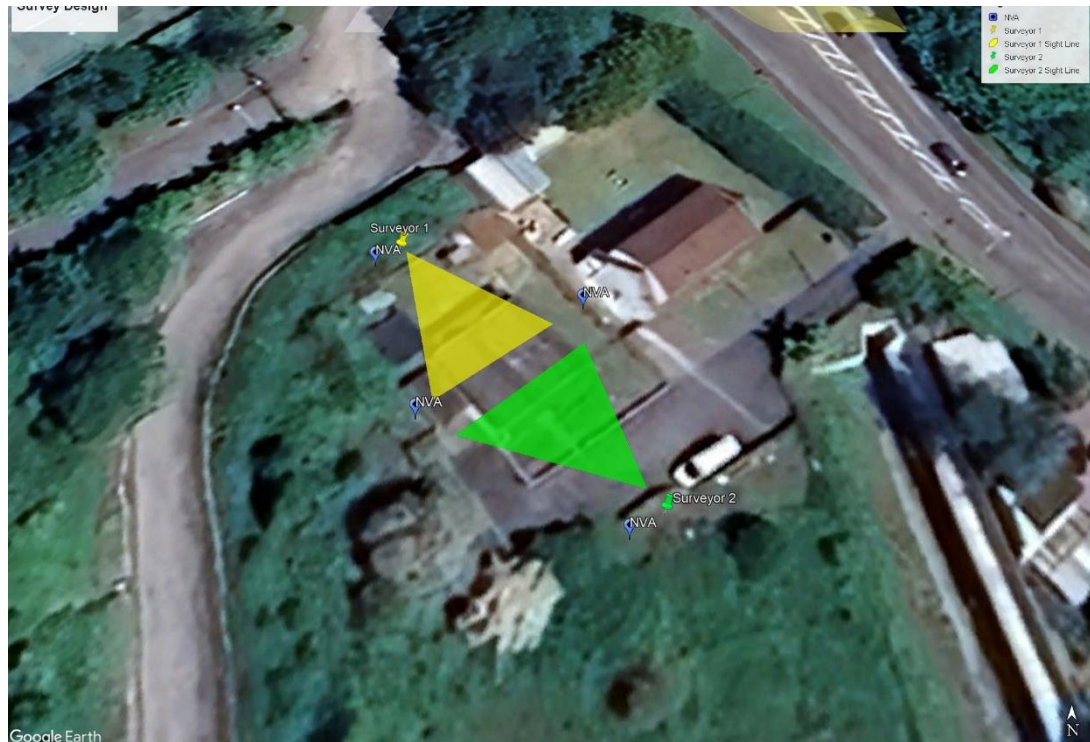
- 5.2.5 The surveys will be undertaken utilising two surveyors to maintain line of site onto both the cavity walls and suitable NVA (night vision aids). The night vision aids used will be a combination of Night Fox Vulpes night vision cameras, Canon XA11-60 IR cameras and Pixfra ARC thermal camera. Each surveyor will be equipped with a bat detector (Echometer touch 2 or a bat logger M2). The surveys will commence at 15 minutes before sunset and proceed up to 2 hours after sunset. Figure 5 below shows the survey design.

**Figure 4 - Bat Survey Design**
