**Bat Survey:** Pen-Y-Dre Comprehensive School, Gurnos Estate, Merthyr Tydfil, CF47 9BY

**Instructed by:** Morgan Sindall Ltd.

**Reported by:** Ecological Services Ltd  
10 Mount Pleasant, Llanelly Hill, Abergavenny, Monmouthshire, NP7 0NT

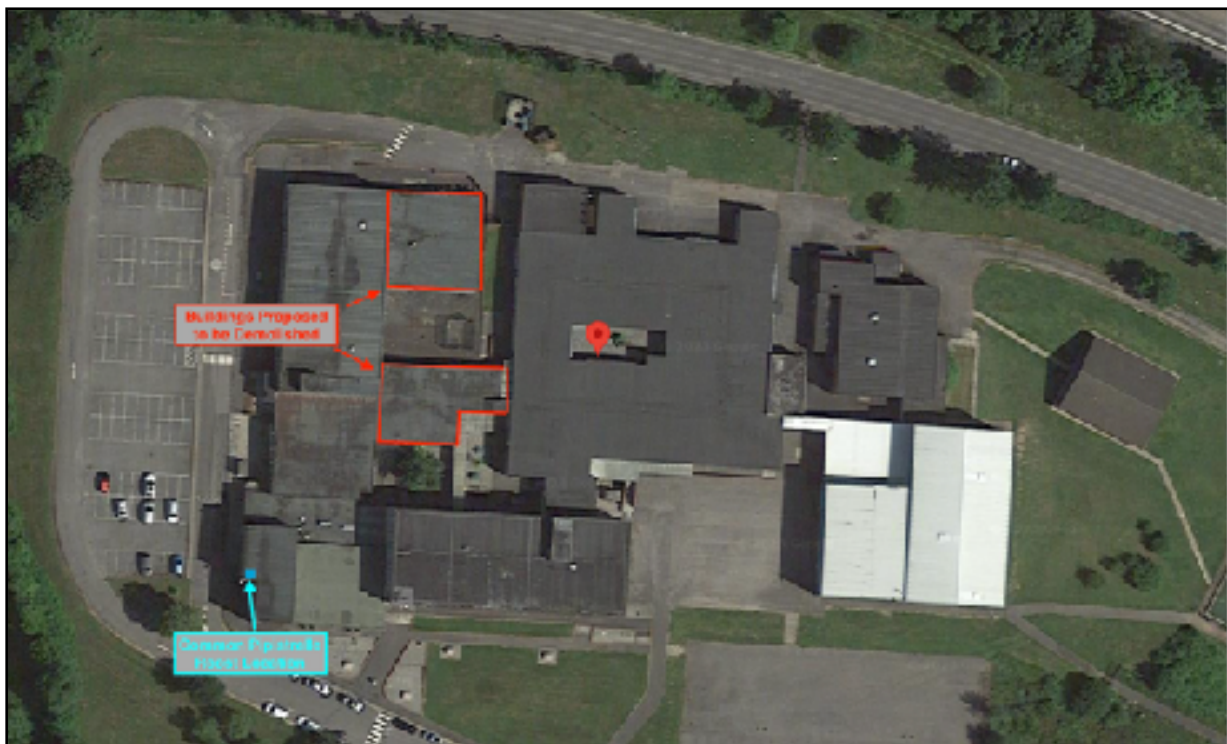
**1.2** As of September 2023, it is proposed to demolish two sections of the school building. **There will be no destruction of the 2022 identified bat roost location. Given the proximity of the proposed demolition works away from the confirmed bat roost locations it is considered unlikely that disturbance of the roost location will be experienced.**

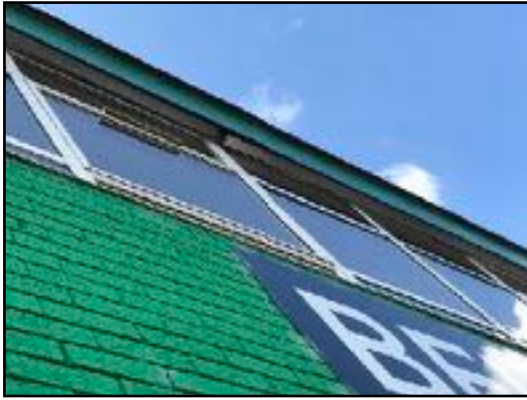
**Dislodged fascia board on the west elevation of the main school building.**

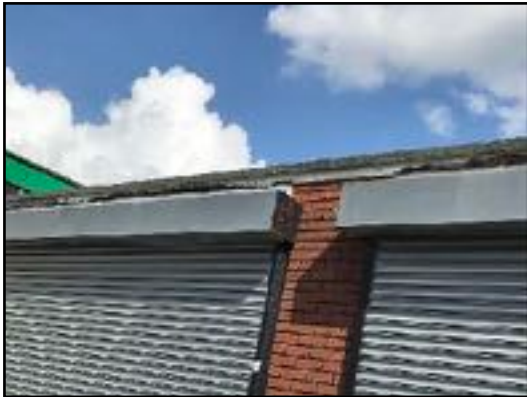
**Warped barge boards above the roller doors on the main school building.**

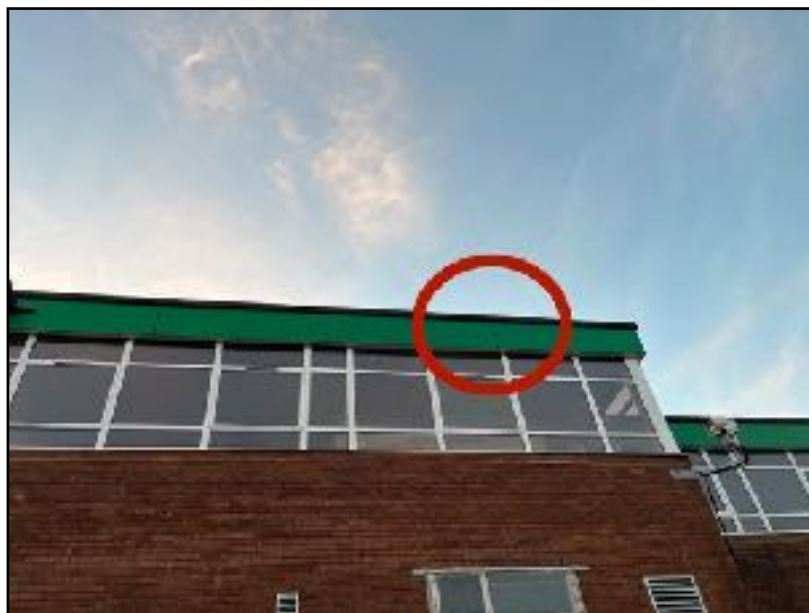
**2 Common Pipistrelles (*Pipistrellus pipistrellus*) were observed returning to an aperture underneath the cladding on a western area of the main school building.**

**9.10 The main school building is now a confirmed bat roost. No work that could affect the bat roost is permitted by law, without the permission from Natural Resources Wales, including any works to the roof. Direct illumination of the building is also not permitted, as this could constitute disturbance. (Please see Section 5 of this report for further information).**

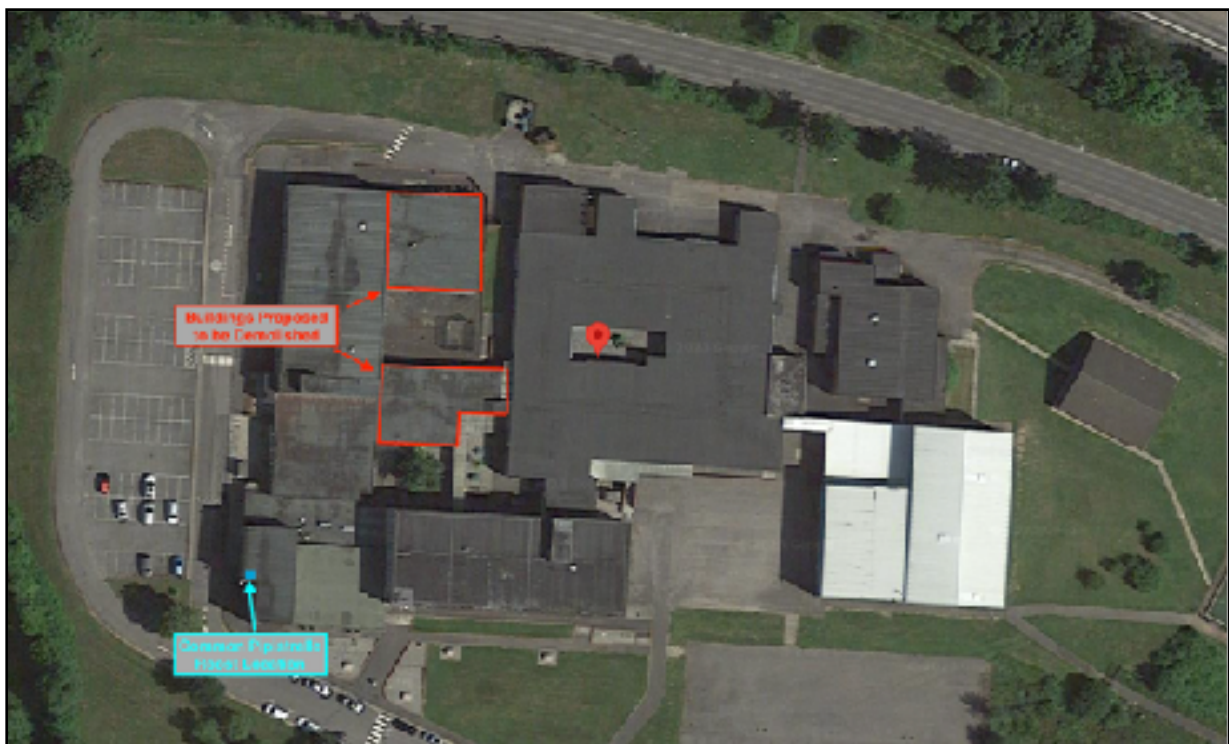
**9.17** As of September 2023, it is proposed to demolish two sections of the school building. There will be no destruction of the 2022 identified bat roost location. Given the proximity of the proposed demolition works away from the confirmed bat roost locations it is considered unlikely that disturbance of the roost location will be experienced.

**9.18** A method statement and direct ecological supervision of the two sections proposed to be demolished will be required to ensure that no protected species are impacted upon by the demolition works.
