# Cefn Fforest Farm Treharris

## Bat Activity Survey Report

June 2026 | Issue 1VA

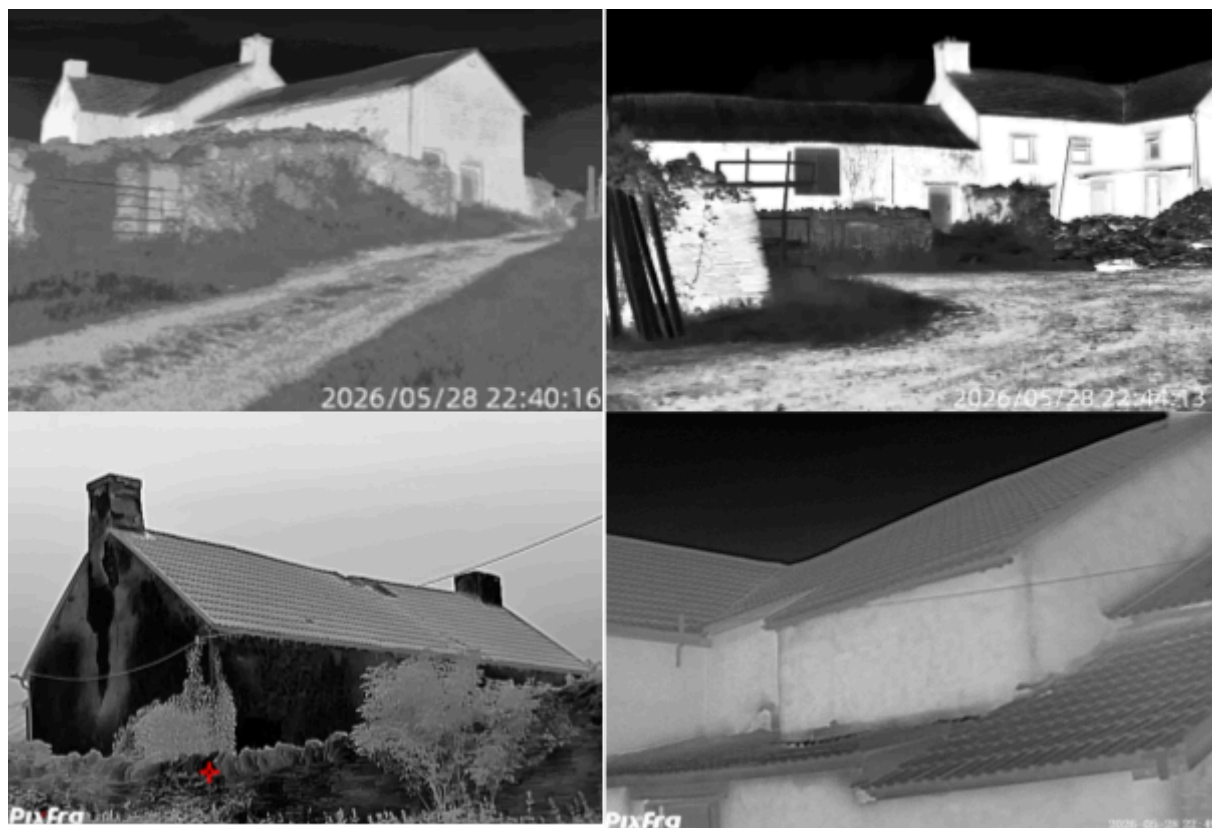
Bat activity on this date was little and intermittent.

The first bat heard was a common pipistrelle at 23 minutes post sunrise. The bat was seen flying high from east to west above the property. A small number of passes by common pipistrelle and soprano pipistrelle were recorded foraging and commuting in the vicinity of the buildings. No bats were observed emerging from, or interacting with, either building.

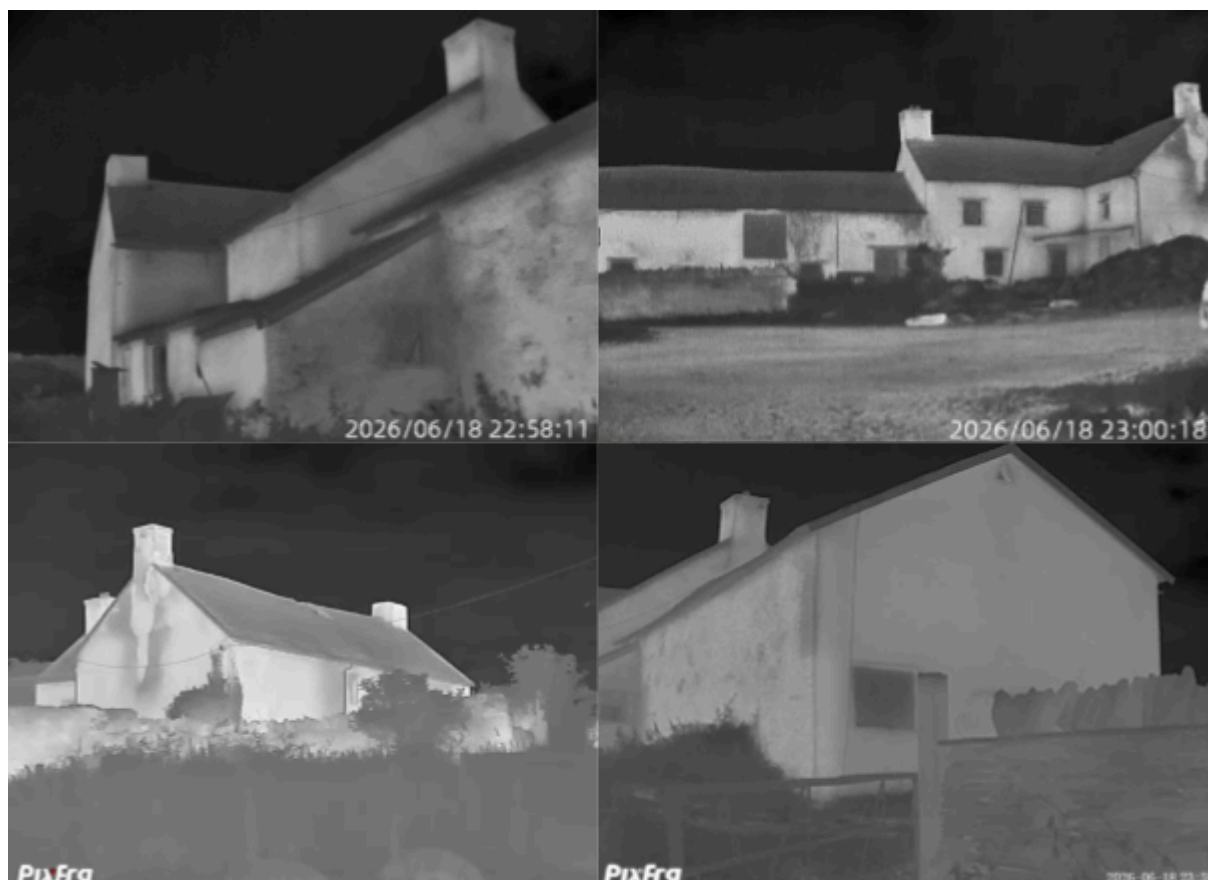
Bat activity was markedly higher than on the first survey. Approximately six bats (common and soprano pipistrelles) were recorded foraging around the buildings and grounds throughout the survey.

Species recorded included common pipistrelle, soprano pipistrelle, noctule and *Myotis* sp., foraging and commuting across the site.

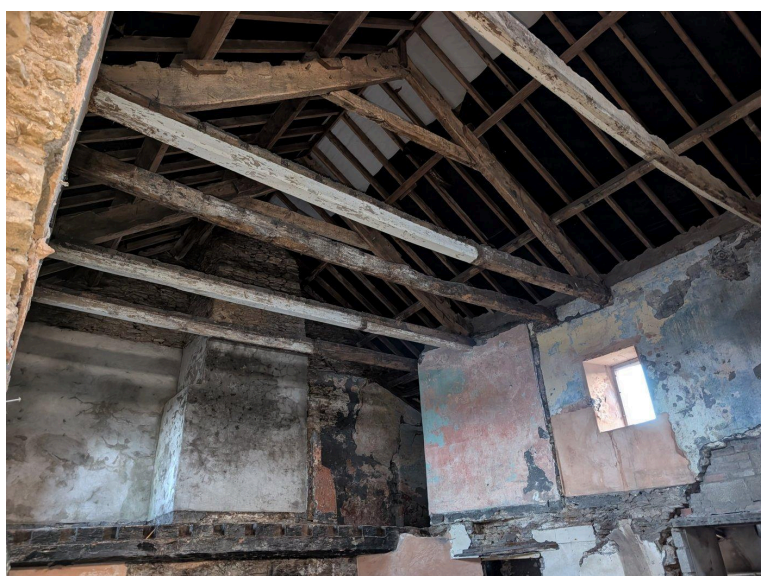
*Plate 2 - Farmhouse roof structure viewed from below, showing exposed pitched roof timbers and rafters over degraded plaster and bare stone walls, with a small square window opening to the gable.*

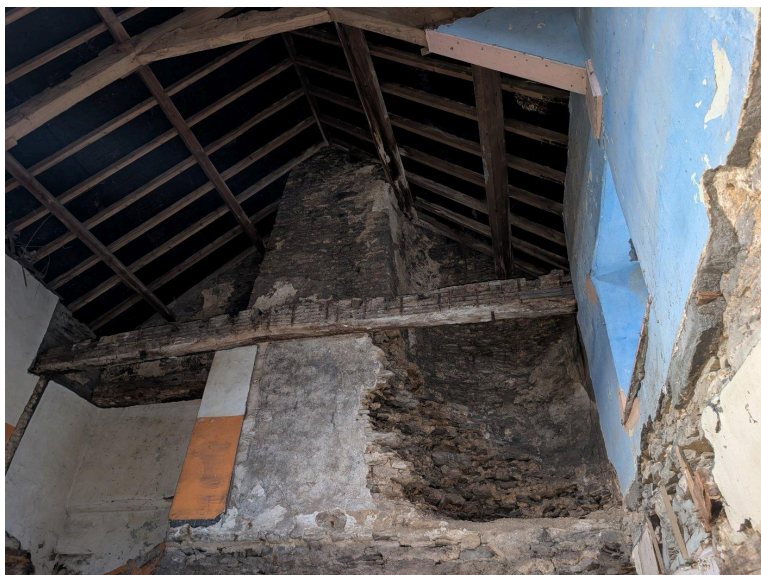
*Plate 3 - Internal corner showing exposed roof timbers meeting a stone chimney breast,*

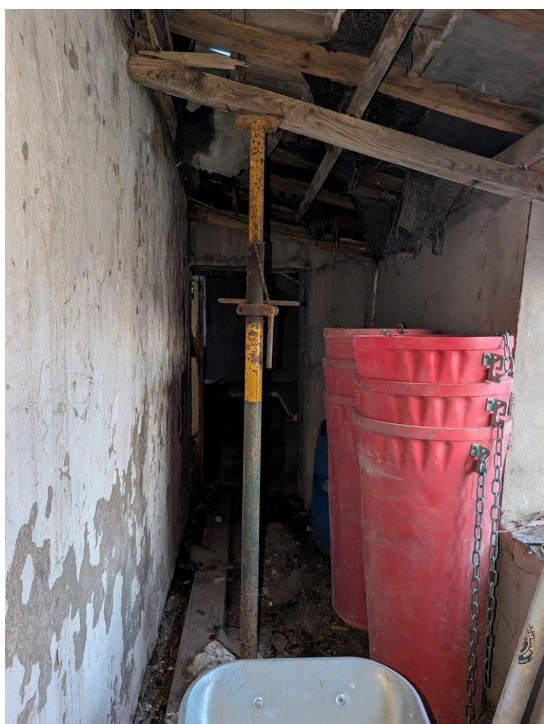
Beneath the suspended floor of the barn is a ground-level area used for storage. This area was accessed and inspected; it was found to contain stored materials and items, with degraded plastered and bare stone walls and exposed ceiling timbers above. No bats or evidence of bats was found within this area.

*Plate 4 - Derelict internal area with peeling plastered walls, exposed ceiling timbers, an acrow prop and stored materials*

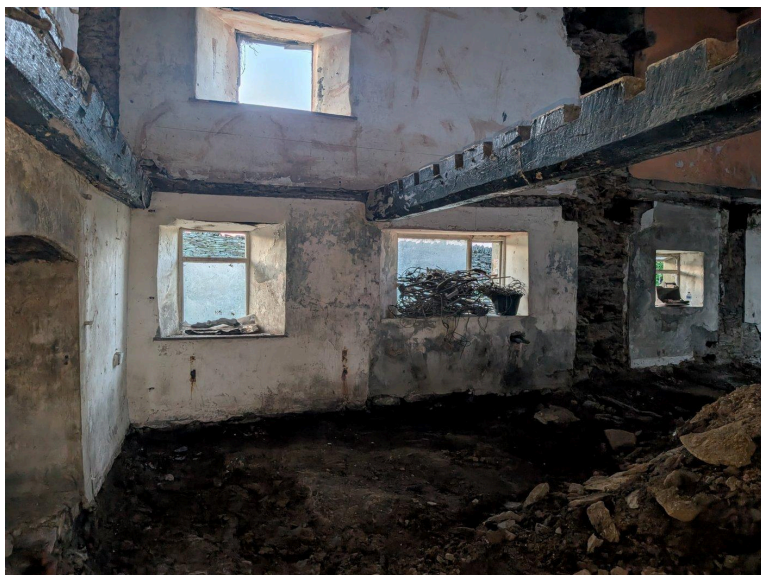
*Plate 5 - Guttered ground-floor room showing multiple small window openings, exposed bressummer/ceiling beams and a bare earth and rubble floor.*

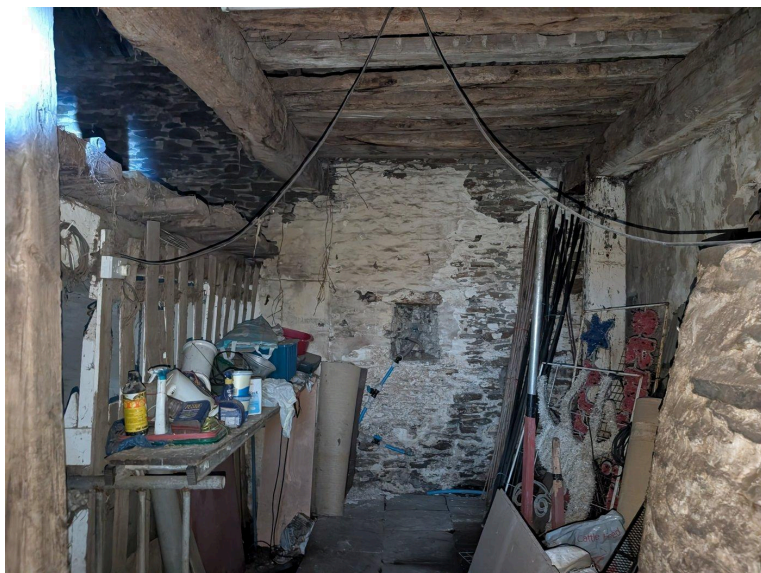
*Plate 6 - Internal storage room with degraded plaster over stone walls, exposed ceiling beams, stored tools and materials and a blocked former opening.*

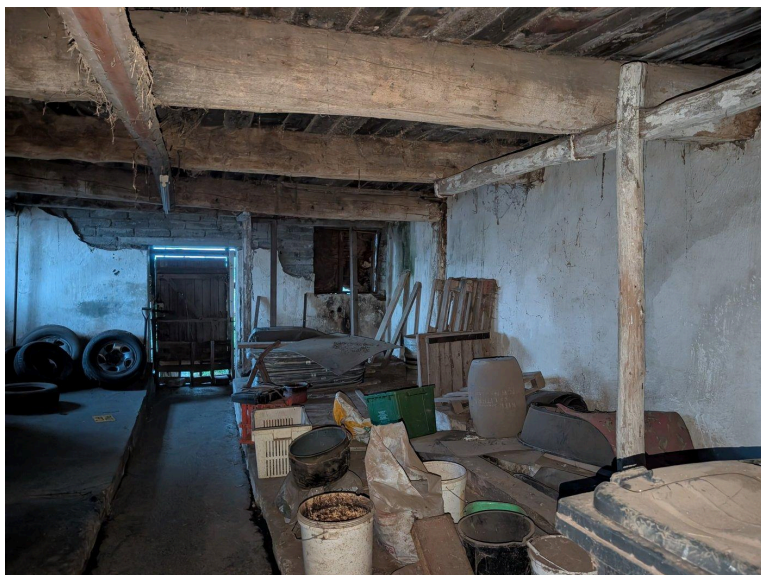
Within the barn, a suspended timber floor is retained, above which an open void was accessed and inspected. The void and its exposed roof timbers were searched for live bats and field signs; none were found.

*Plate 7 - Barn interior used for storage beneath exposed ceiling beams and timber roof structure, with an open doorway and stored materials*

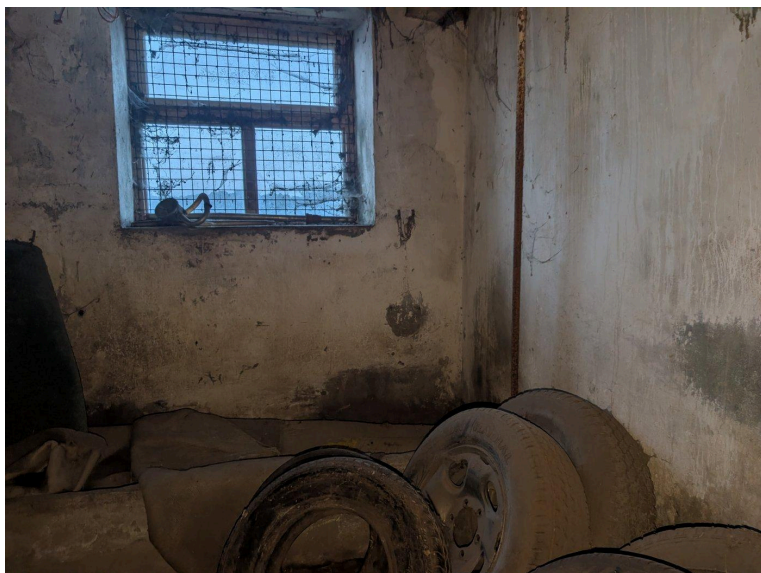
*Plate 8 - Barn/store corner showing a mesh-covered window*

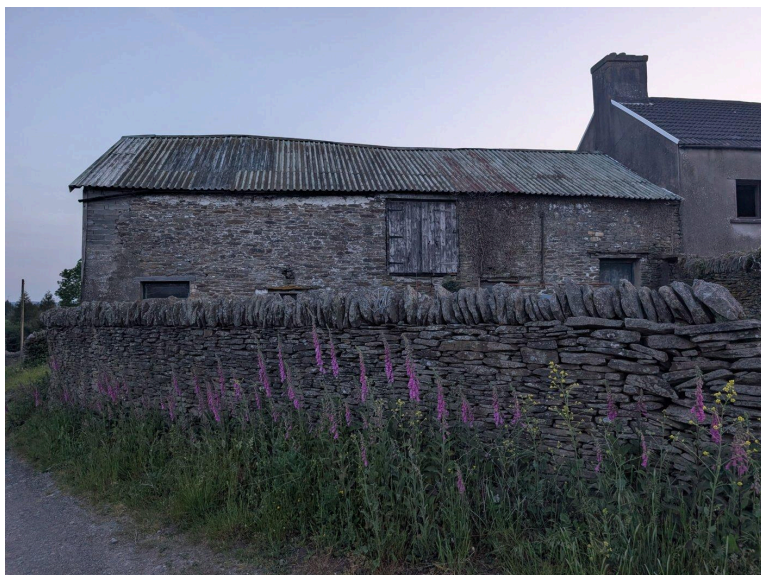
- Gaps beneath and between the corrugated roof sheets of the barn
- Missing and slipped roof coverings to the farmhouse, with open gaps at the ridge and along the slopes
- Open joints and gaps within the stonework and around window and door openings
- Gaps around exposed and weathered timbers at eaves and verges

*Plate 9 - External elevation of the stone-built barn with corrugated metal roof and boarded loft opening*

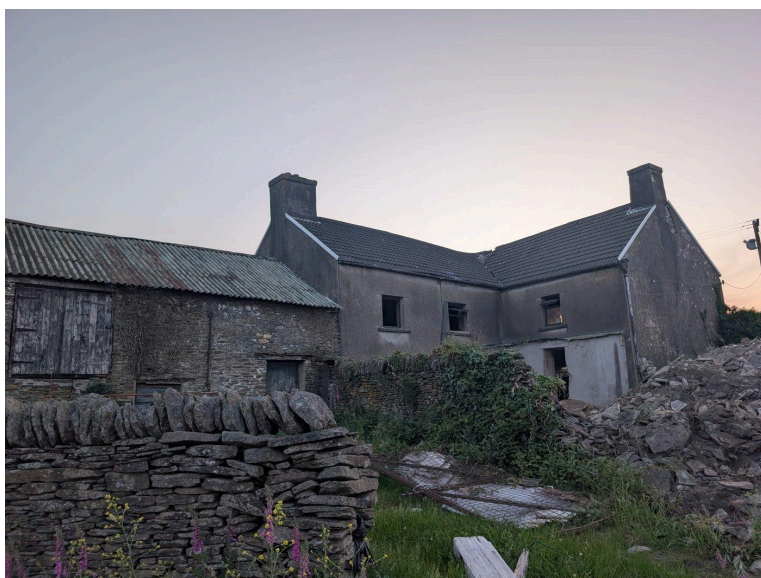
*Plate 10 - Site context: the farmhouse and attached barn range viewed from the rear, showing tiled and corrugated roofs, chimney stack.*
