**Smart Electrical Systems,  
3-4 Phoenix Industrial Estate  
Goat Mill Road,  
Dowlais,  
Merthyr Tydfil**

**Preliminary Roost Assessment**

**September 2025 (V2)**

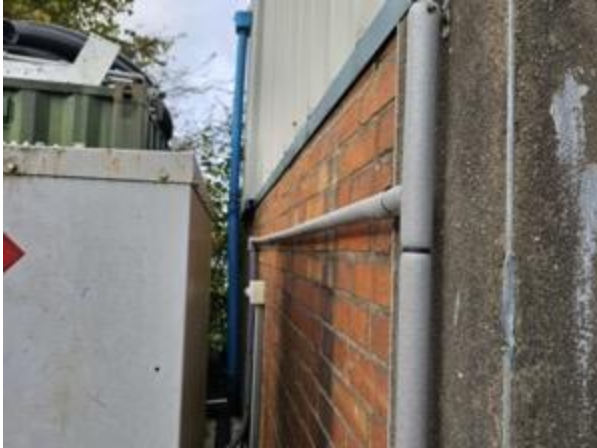
Photo 3: External Wall at the Southern Elevation

| External Walls | The external walls are constructed of brick and mortar and corrugated metal. The brick is in good condition with no gaps and the corrugated metal sheeting is well aligned and in good condition (Photo 3). |

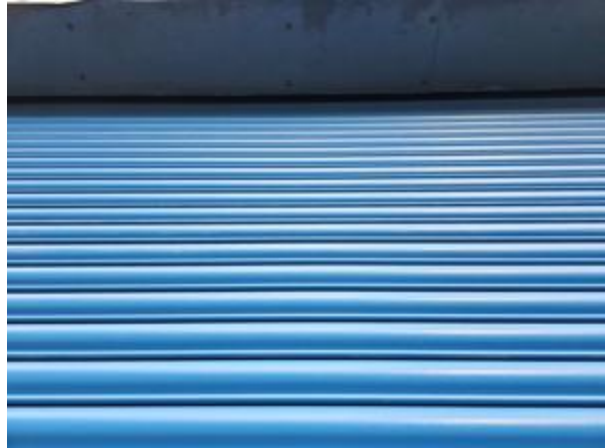
Photo 4: Shutter Door at the Southern Elevation

| Doors | The shutter door to the building is found on the southern front and is constructed of metal. The shutter door is in good condition with no gaps around it (Photo 4). |

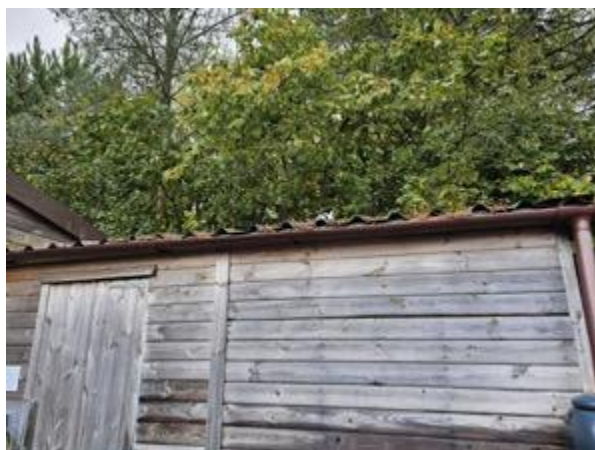
Photo 9: Roof at the North-Western Elevation

| External Walls | The walls are constructed of timber boards which are in good condition (Photo 9). |

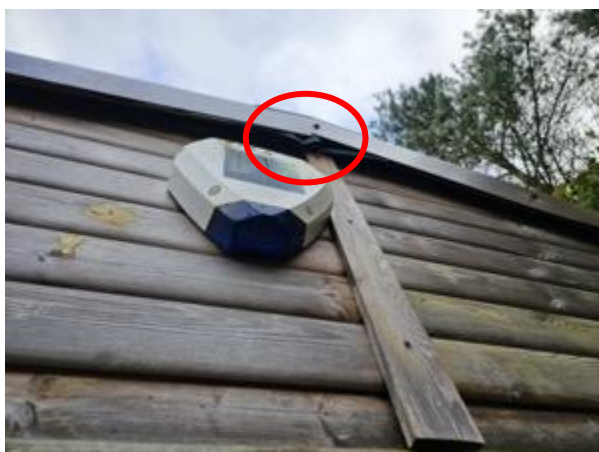
Photo 10: Gap Underneath the Metal Trim at the Apex (Circled)

The shed has one potential roost feature which is found above the door at the apex of the gable end on the northern elevation (Photo 10).

Any removal work will be undertaken using hand tools, (i.e. picks, crowbars, slate rippers, bow saws etc.). These features will be carefully removed by hand and contractors will check for the possible presence of bats on the undersides of these features before they are lifted off, prior to discarding or storing them. During the soft strip process, any cracks or crevices that have the potential to be used by bats will be inspected by a licensed bat worker using a high-powered torch to ensure they are not in use. Cavities will be carefully prised open using a crowbar.

The removal of such features will be observed and supervised at close quarters by a licensed bat handler from an appropriate viewing position to be provided by the demolition contractor (e.g. scaffolding or lifting platform).

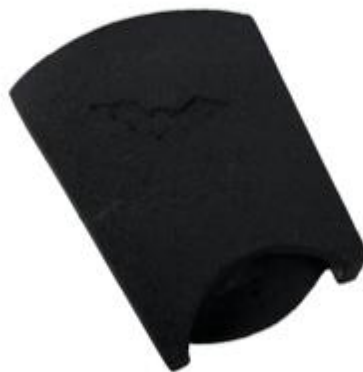
This bat box is made entirely from WoodStone, a robust material comprising concrete and wood fibres. This means that the box has excellent insulating properties maintaining a more consistent temperature throughout the year and provides excellent protection from predators. The Beaumaris box has a single narrow entrance, making it suitable for crevice roosting bats such as the common pipistrelle, soprano pipistrelle, Nathusius' pipistrelle, Brandt's bat and whiskered bat. The box's interior has a rough surface for bats to cling to and the front of the box features a subtle but attractive imprint of a bat in flight.

Suitable for attaching to external walls and should be sited as high up on the façade as possible, at a height of at least 3m from the ground. Avoid siting under artificial lights. Bats prefer to change roosts to benefit from varying ambient temperatures, so bat boxes should ideally be clustered in small groups.

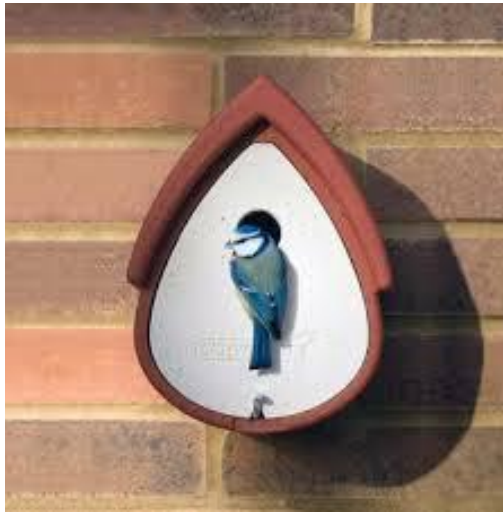
### Schwegler Bird Home

This nest box is for installation on external walls of buildings (including sheds and garages) and is suitable for a range of bird species. With a 32mm hole it allows entry to species such as coal tit, blue tit, great tit, redstart, nuthatch, house sparrow, tree sparrow and other species.

The recommended height is between 1.5m and 5m above ground with a south-east to south-west orientation.

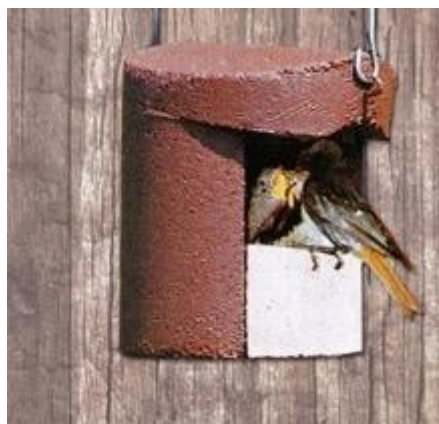
### Schwegler Bird Home

This nest box should always be installed on the external walls of houses, barns, garden sheds etc. It is designed to be hung so that the entrance is to one side (90° angle to wall).

These should never be hung on trees or bushes as this could allow small predators to access the interior and predate nesting birds.
