**RWE Renewables Ltd**

# **Pen March Wind Farm: Peat Slide Risk Assessment**

Technical Appendix 6.1

2760801-P6.1 (00)

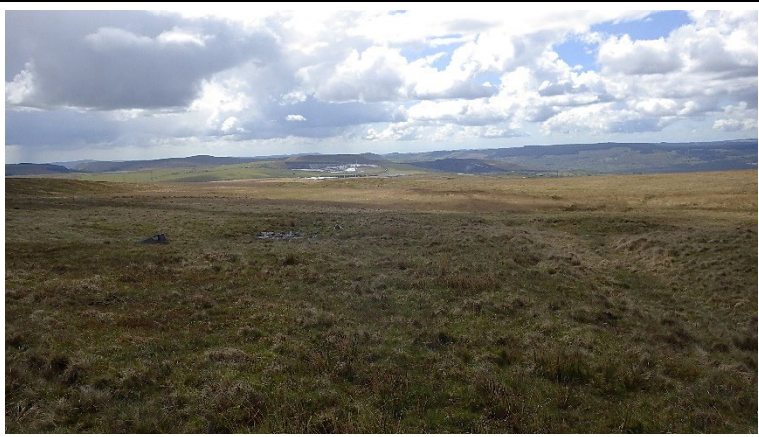
| | <p><b>(A) View of western part of site, NGR SO 0791 1103</b></p> <p>View looking S from track to Turbine 1. View shows a typical area of the site with close-cropped turf in the foreground and more boggy ground with extensive rushes further down the slope. The foreground area is mainly without peat. Peat depths in the boggy area are up to 1.5 m but are mainly &lt;0.5m.</p> |

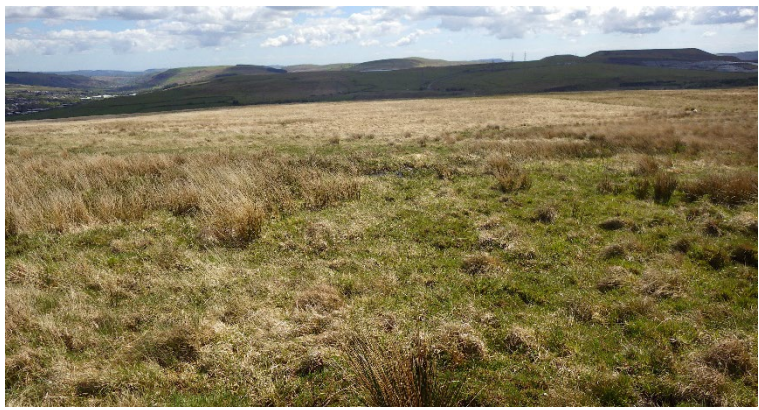
| | <p><b>(B) View of central part of site, NGR SO 0863 1010</b></p> <p>View looking SE across the central site area near Turbine 6. View shows typical section of the slope with short grass turf, rough grass tussocks and rushes. Peat in this area is variable. Most of the grass turf has peat &lt;0.5 m but some rushy areas include peat up to 0.8 m deep.</p> |

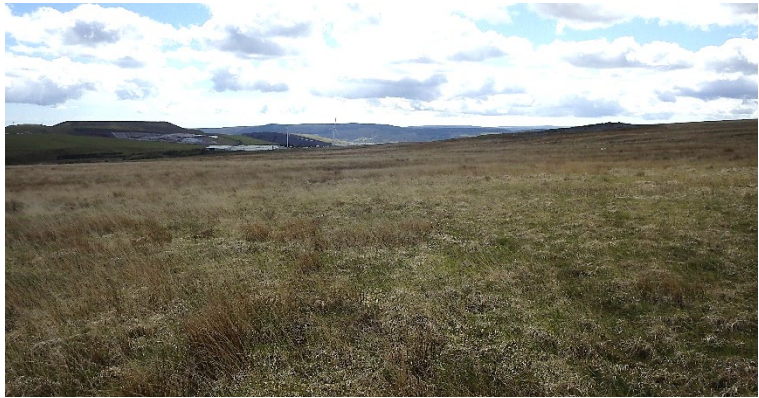
| | <p><b>(C) View of central part of site, NGR SO 0863 1010</b></p> <p>View looking SW across the central site area near Turbine 6. View shows typical section of the slope with short grass turf, rough grass tussocks and rushes. Rock outcrop is visible on the skyline to the right. Peat in this area is variable, ranging from 0 to &gt;1.0 m in boggy areas.</p> |

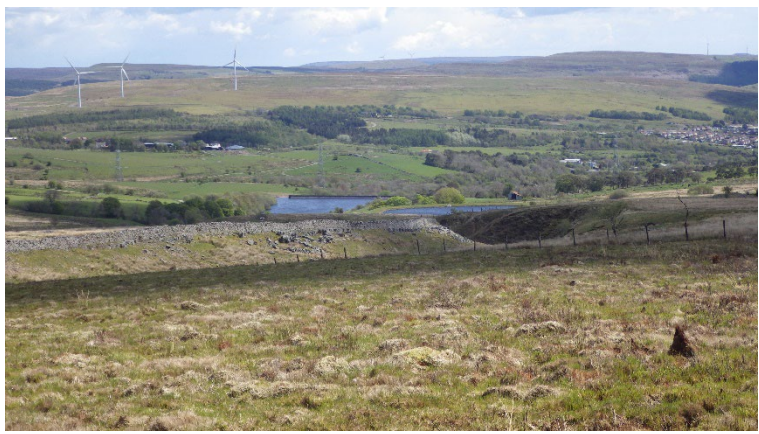
| | <p><b>(D) View of eastern part of site, NGR SO 0884 1133</b></p> <p>View looking SE from the narrow site section. View shows an area of mown and burned rush pasture in the foreground, with the Nant Pitwellt valley and the two reservoirs behind. Limited peat depth records are available for this section as a high-pressure gas pipeline passes through this area.</p> |

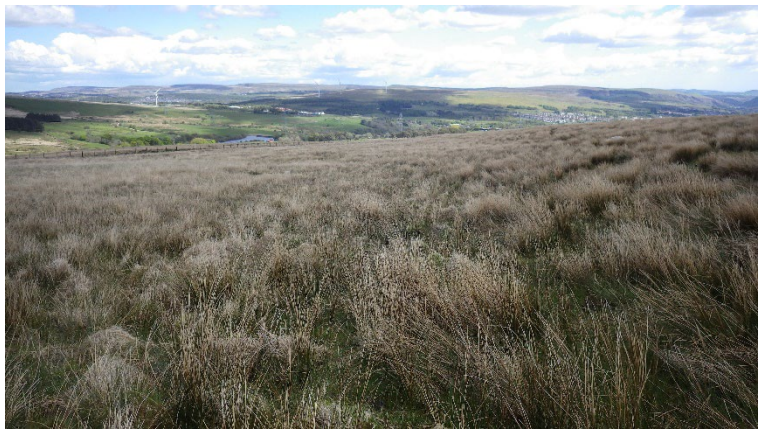
| | <p><b>(E) View of eastern part of site, NGR SO 0905 1056</b></p> <p>View looking SE from near Turbine 4. View shows an area of rush pasture; this is extensive in this part of the site. The ground is wet in places but flow channels are poorly defined. Peat depths in this area are variable, ranging from 0.2 to 1.0 m.</p> |

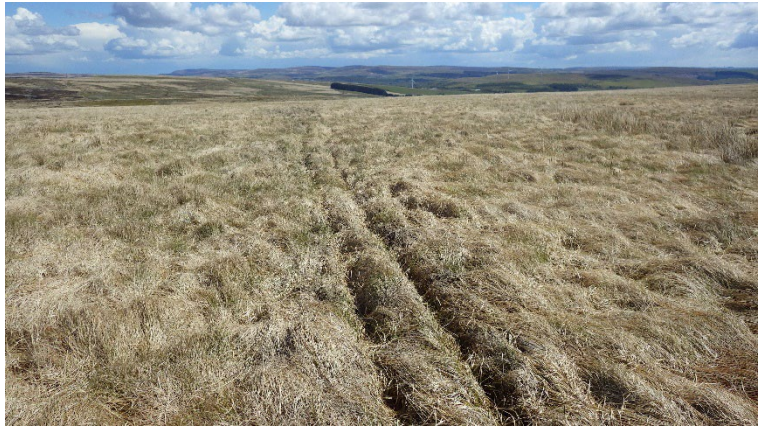
| | <p><b>(F) View of northern part of site, NGR SO 0832 1116</b></p> <p>View looking SE from the northern site boundary. View shows an area of extensive Molinia grassland with rushes, characteristic of this part of the site. Much of this area is boggy. Peat depths in this area range from 0.4 to 1.0 m. Deeper peat is likely to be present in areas north of the boundary.</p> |

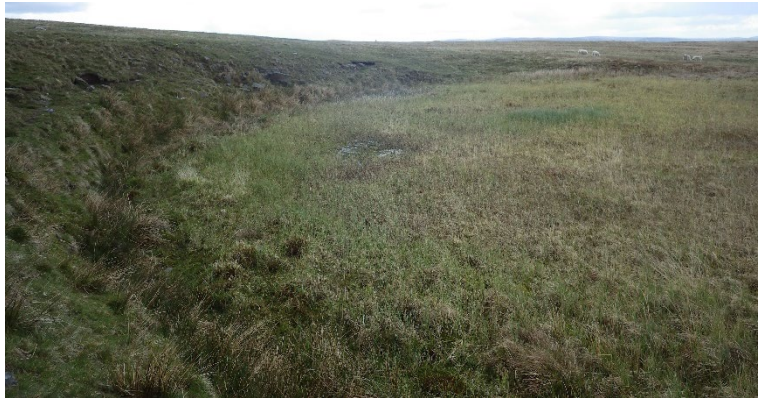
| | <p><b>(G) View of Pwll Mere, NGR SO 0803 1103</b></p> <p>View looking E from track to Turbine 1. View shows the northern margin of Pwll Mere, clearly showing the bog vegetation within the mere. No open water is visible. Peat depths were not measured here as the mere surface is unstable. Nearby soil profiles indicate soil depths &lt;0.2 m.</p> |

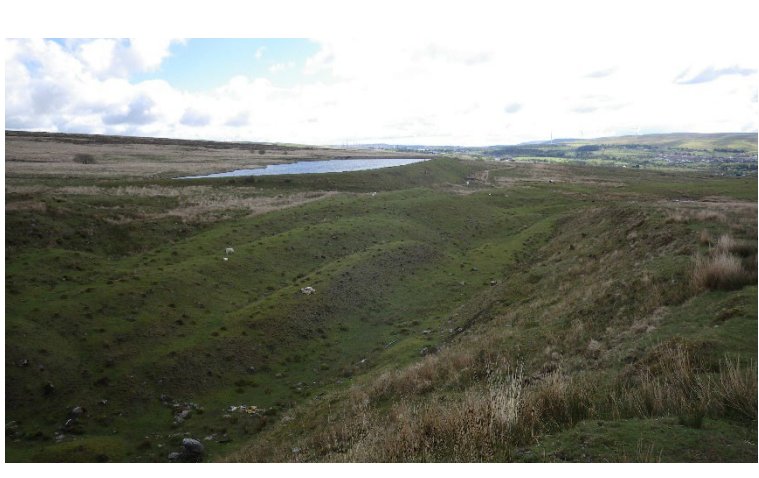
| | <p><b>(H) View of south-western part of site, NGR SO 0828 0908</b></p> <p>View looking E across former quarry to Jepson's Pond. View includes the lower part of the access and construction compound, in the distance behind Jepson's Pond. Most of this area is without peat, although the boggy ground N of Jepson's Pond has some peat. The foreground is made ground from former quarry spoil.</p> |

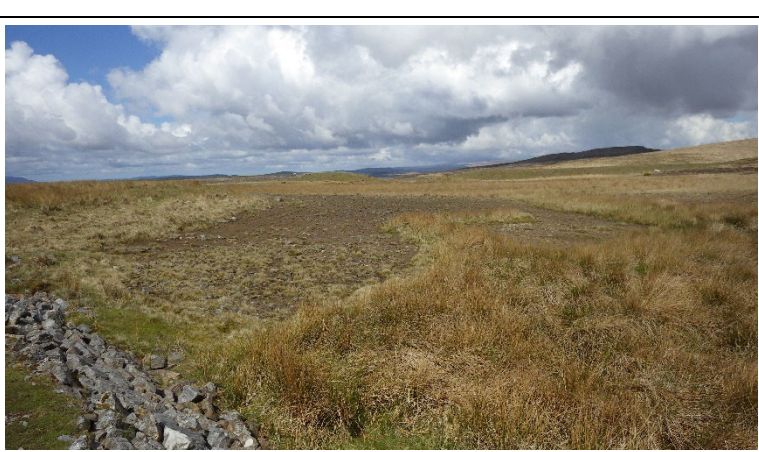
| | <p><b>(I) View of Pitwellt Pond, NGR SO 0800 0981</b></p> <p>View looking E across Pitwellt Pond near the substation. View shows Pitwellt Pond with no standing water and extensive vegetation within the former flooded area. This area is largely without peat. Soils here are all very thin, &lt;0.2 m.</p> |

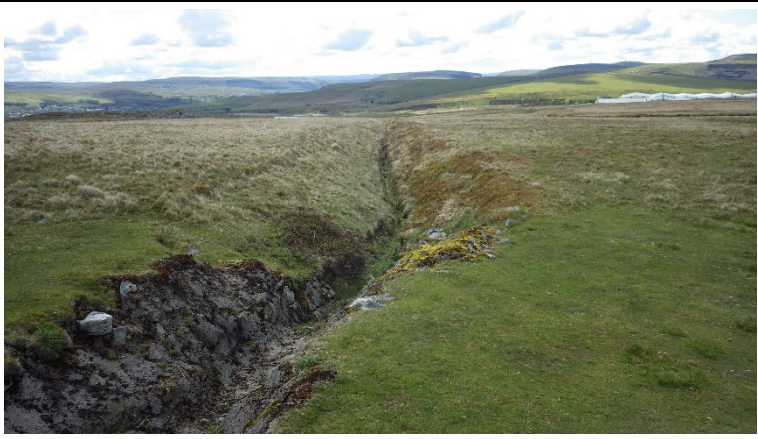
| | <p><b>(J) View of artificial watercourse channel, NGR SO 0791 0968</b></p> <p>View looking SW across the southern site area. View shows a former outflow channel from Pitwellt Pond, cut into bedrock. Channel was dry during the survey with no signs of recent flow. This area is largely without peat.</p> |

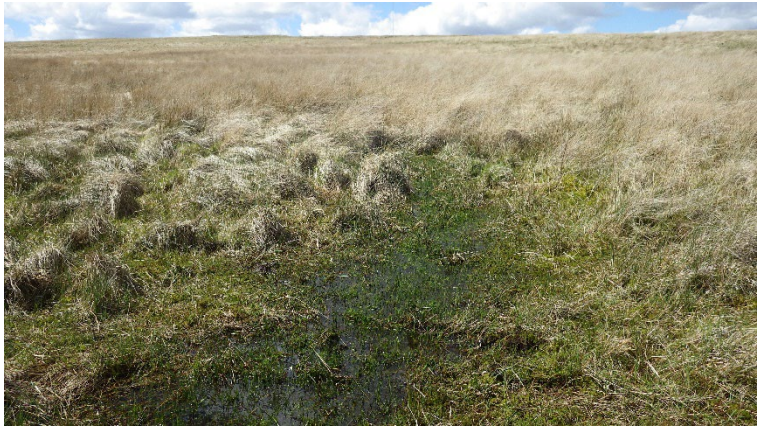
| | <p><b>(K) View of a natural flush, NGR SO 0940 0981</b></p> <p>View looking NW across the south-eastern site area. Flushes of this type are relatively common, collecting water from boggy ground upslope. Further downslope a more defined watercourse becomes visible. Peat in this area varies between 0.4 and 0.8 m in depth.</p> |

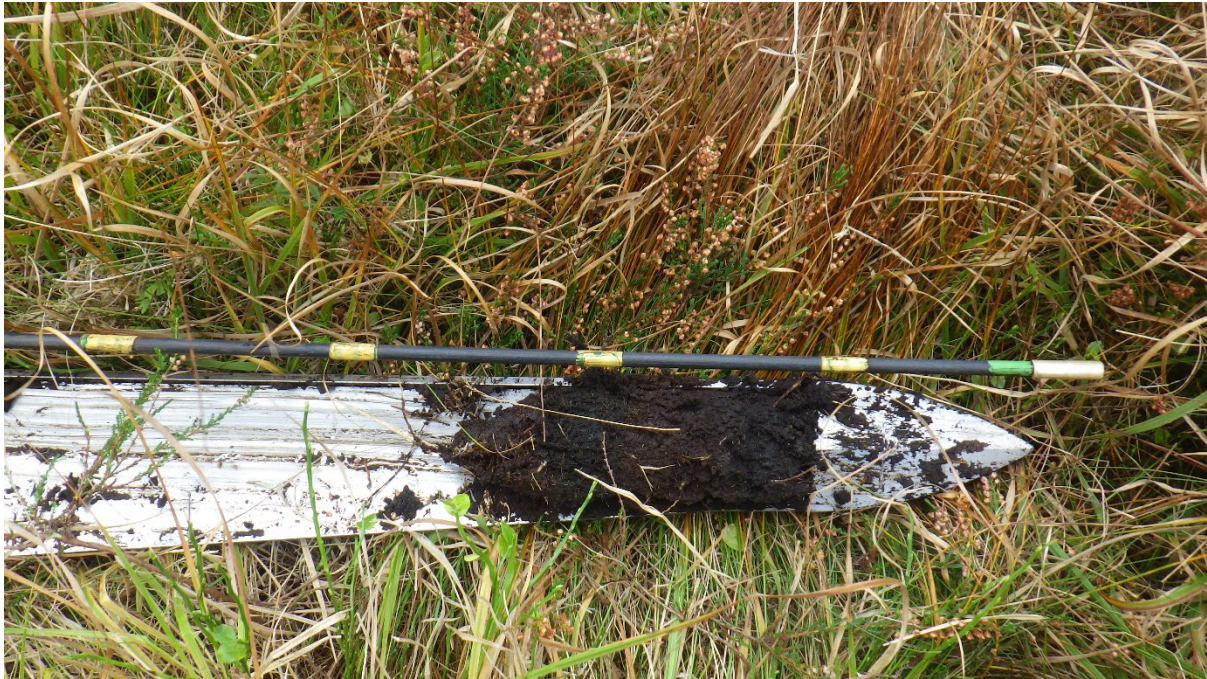
| Location: C01a | Depth: 0.00 – 0.30 m bgl | Date: 12/10/2021 |

| Notes: Thin peaty soil, dark brown and slightly fibrous with frequent roots | | |

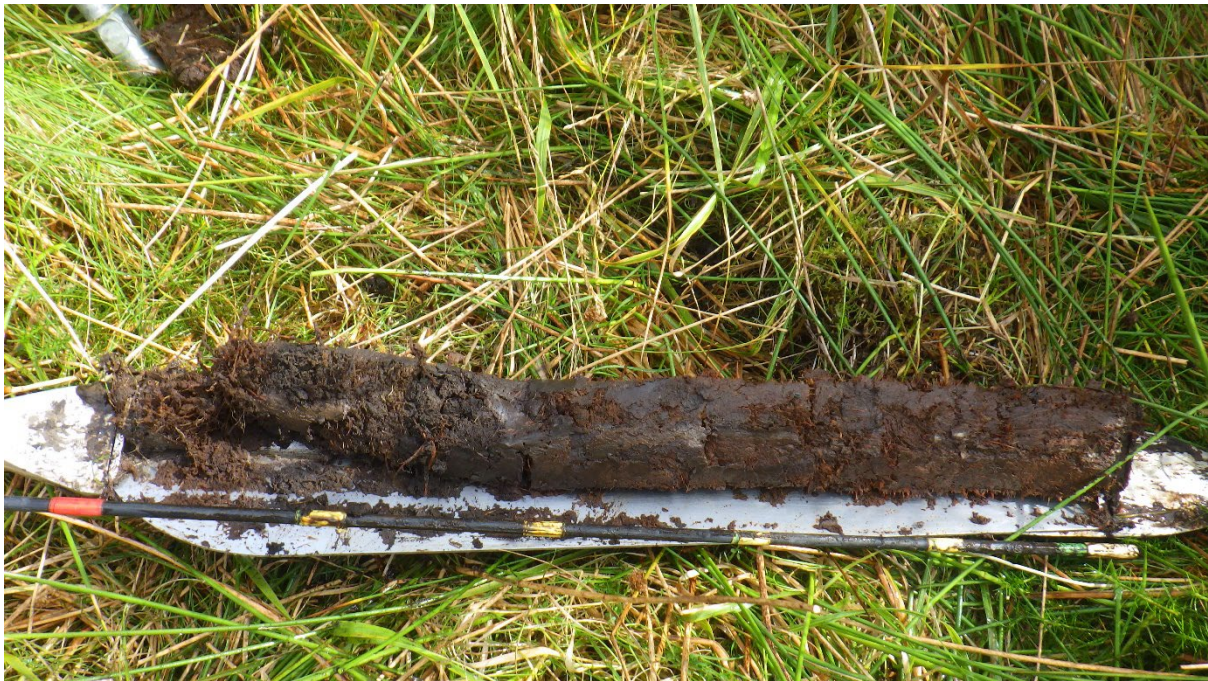
| Location: C01b | Depth: 0.20 – 0.70 m bgl | Date: 12/10/2021 |

| Notes: Light brown peat, moist & very fibrous with substantial identifiable plant material | | |

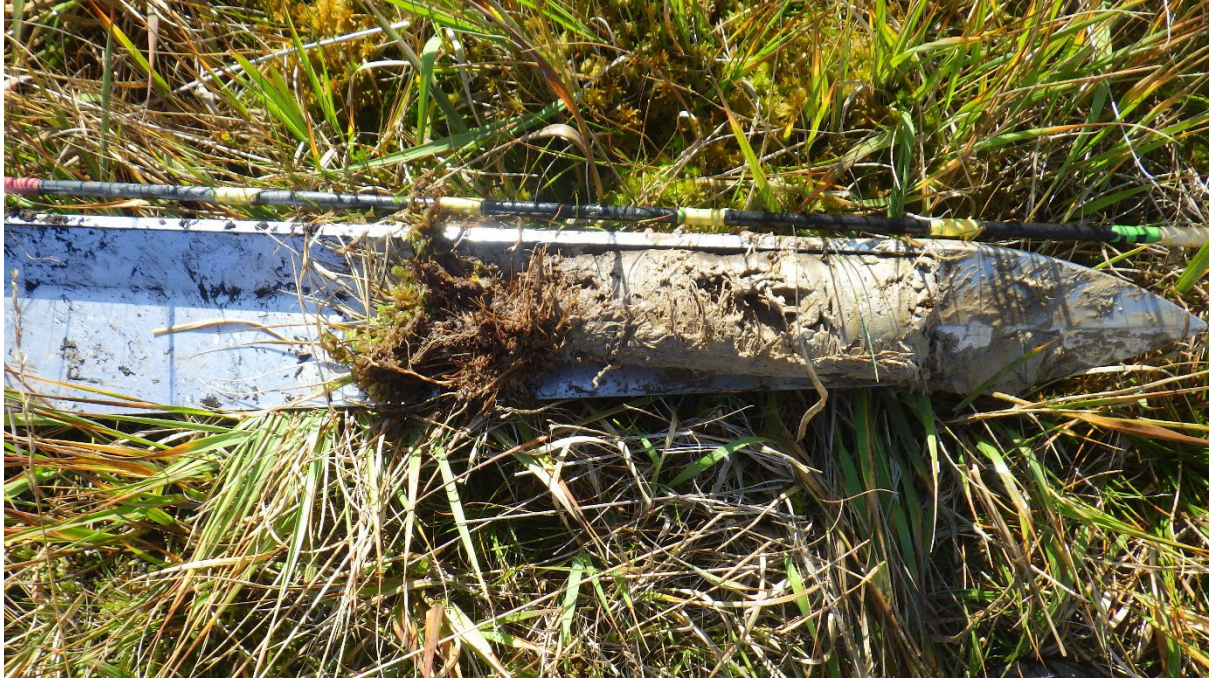
| Location: C02a | Depth: 0.00 – 0.30 m bgl | Date: 12/10/2021 |

| Notes: No peat. Soil characterised by grey and orange silty clay with frequent roots. | | |

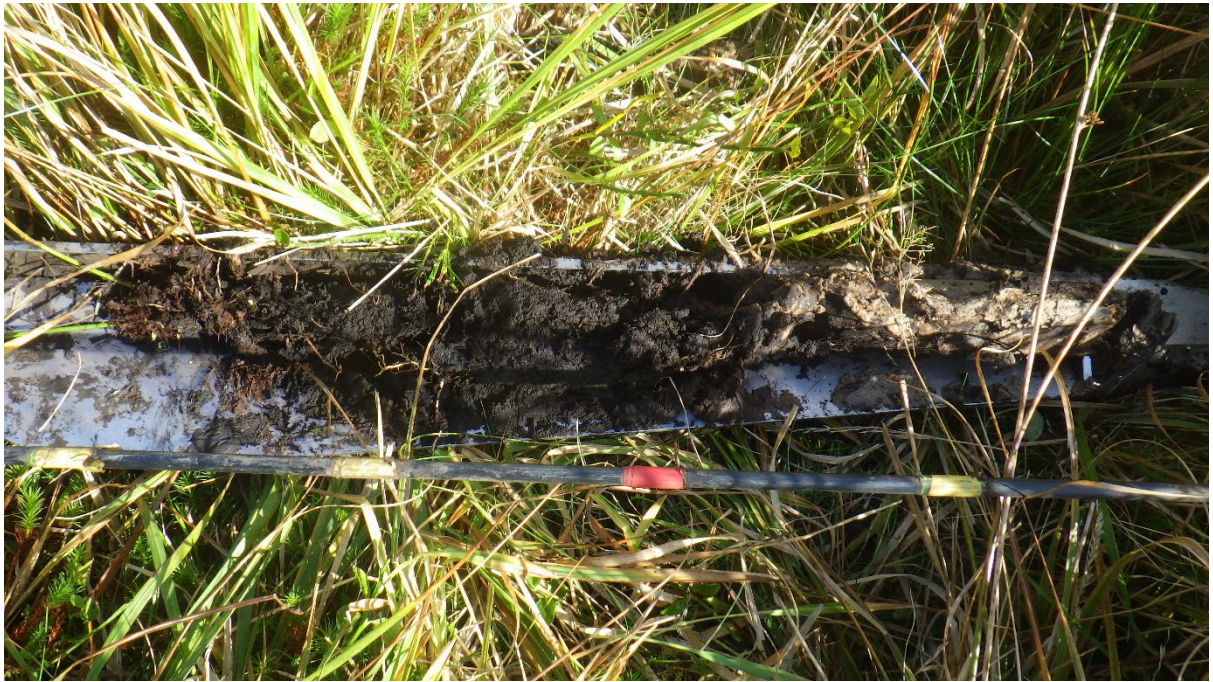
| Location: C02b | Depth: 0.25 – 0.60 m bgl | Date: 12/10/2021 |

| Notes: Relatively dry peat with occasional roots. Replaced by firm light grey and orange silty clay at base. | | |

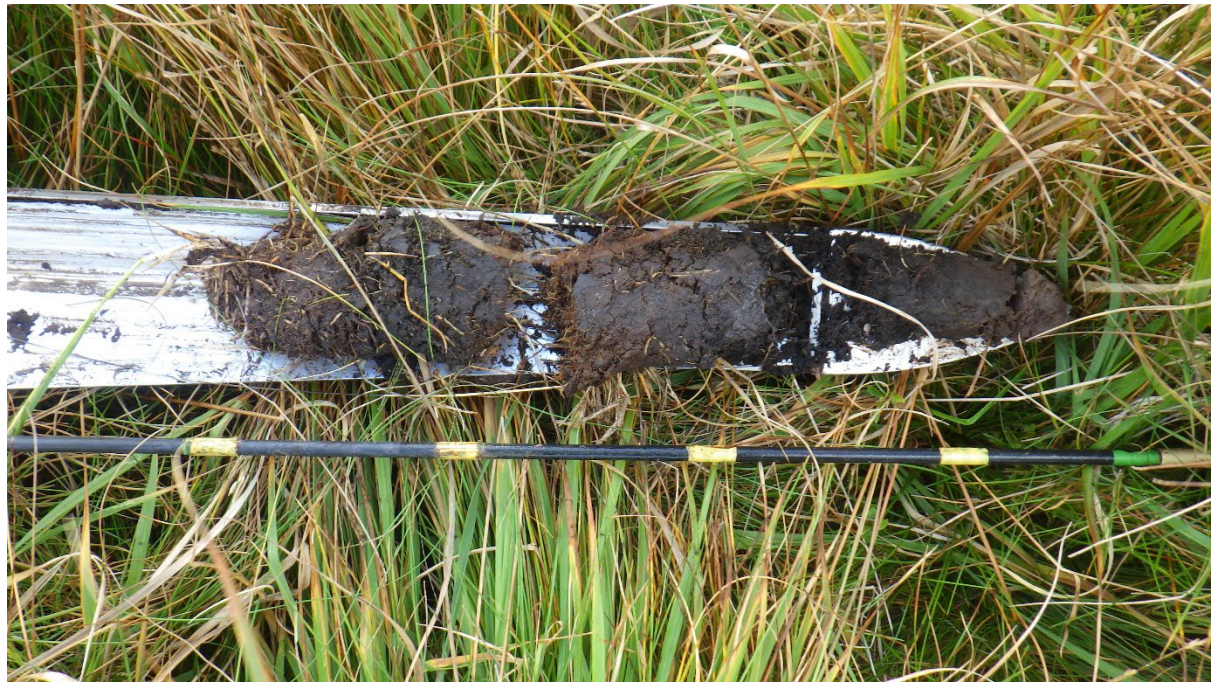
| Location: C03a | Depth: 0.00 – 0.20 m bgl | Date: 12/10/2021 |

Notes: Dark brown peaty soil, very fibrous and rooty. Transition to clay at base, dark grey and silty

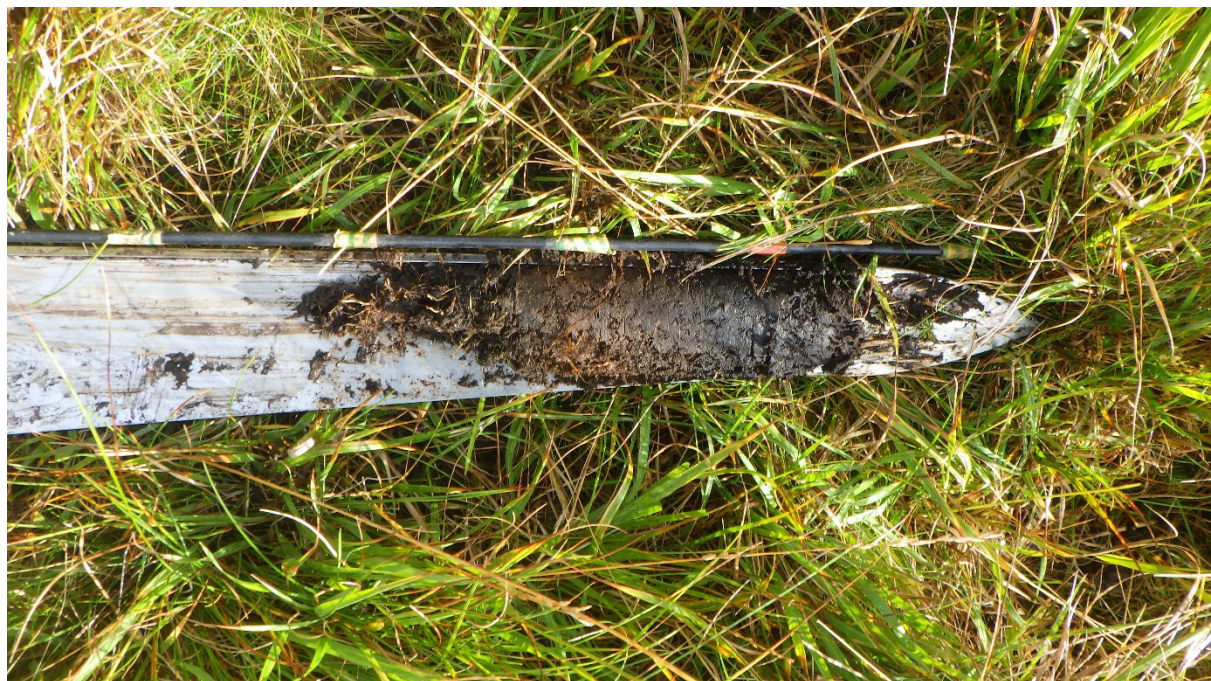
| Location: C03b | Depth: 0.15 – 0.30 m bgl | Date: 12/10/2021 |

Notes: Brown fibrous peaty soil with frequent roots.

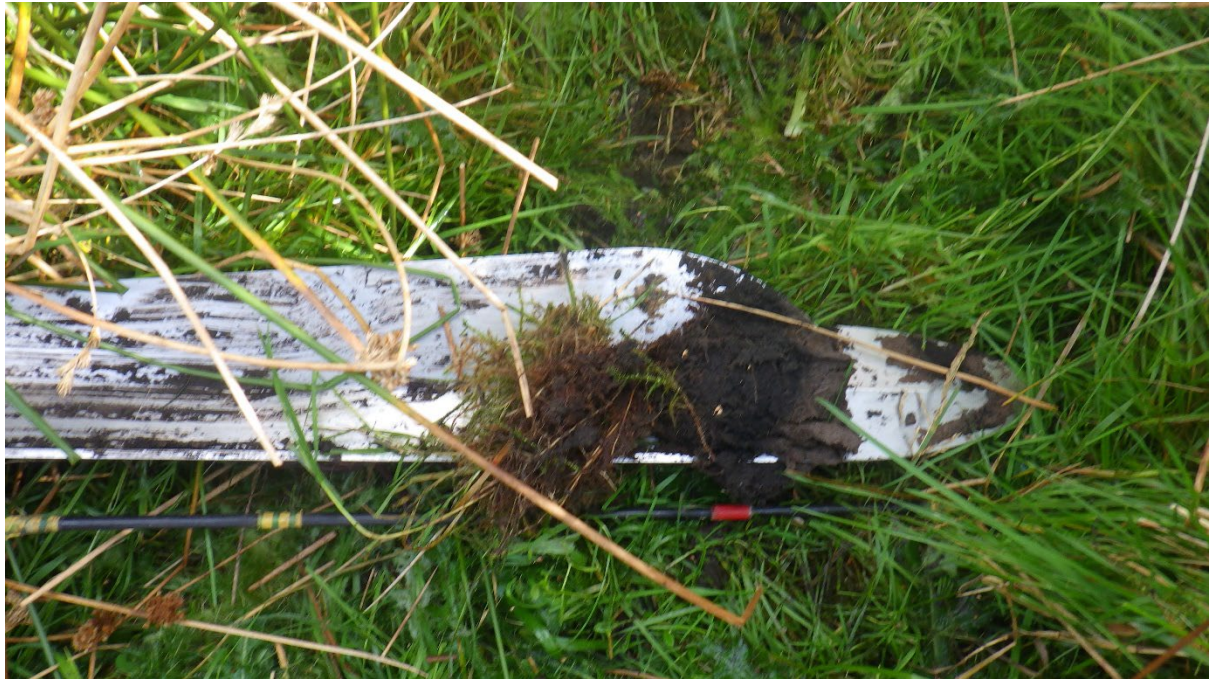
Location: C04a

Notes: Very shallow dark brown rooty soil with transition to clay occurring over c. 5 cm.

| ID | Label | X | Y | Probe Depth (m bgl) | Layer | Top Depth (m bgl) | Bottom Depth (m bgl) | Von Post | Moisture | Notes |
|---|---|---|---|---|---|---|---|---|---|---|
| 156520 | C04a | 309110 | 210560 | 0.35 | 1 | 0.0 | 0.15 | H3 | B2 | View E. Base rocky. Peat loose, dark brown and rooty. Clay light grey and silty. Transition from peat to clay gradual over approx. 5cm. |

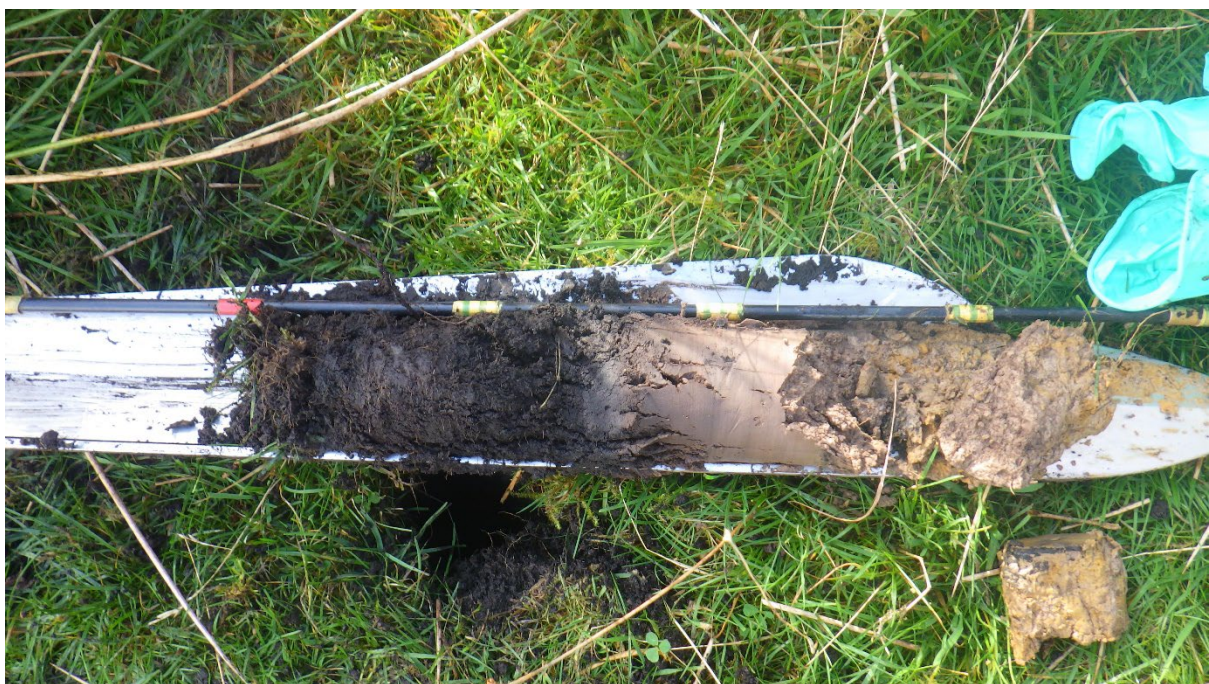
Location: C04b

Notes: Dark brown fibrous peaty soil overlying grey and orange silty clay.

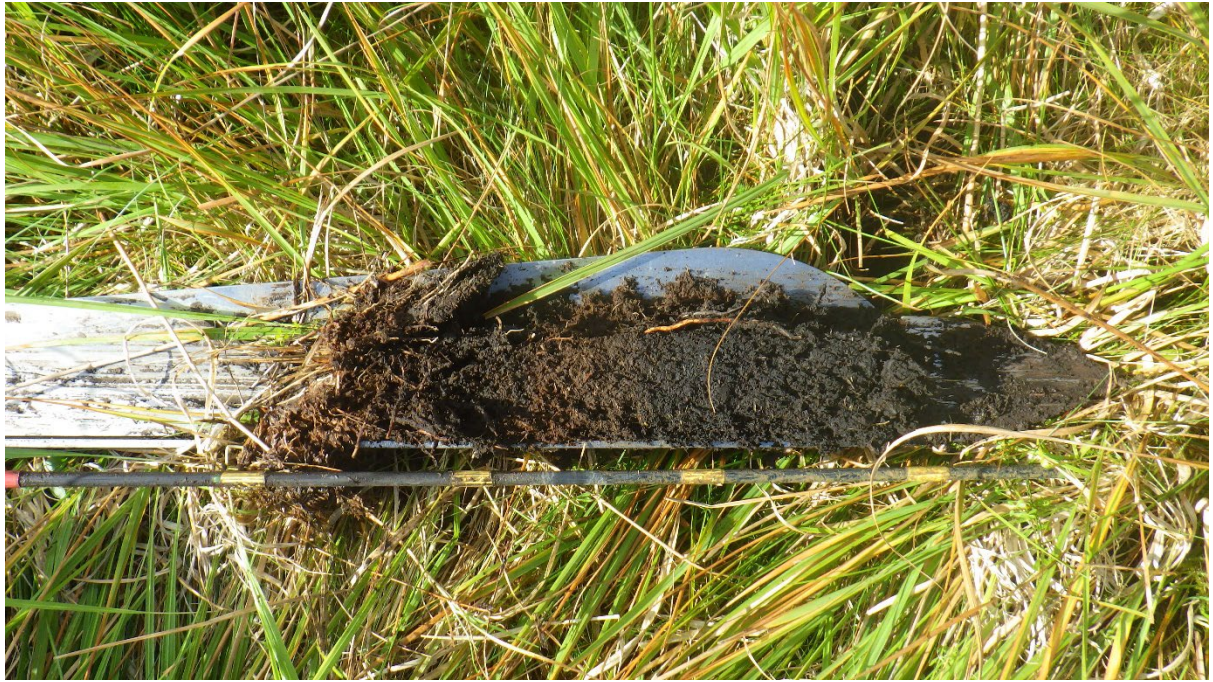
| <b>Location: C05a</b> | <b>Depth: 0.00 – 0.20 m bgl</b> | <b>Date: 12/10/2021</b> |

| <p>Notes: Upper section of core showing largely undecomposed plant fibres in upper section, very dry, becoming more decomposed at depth</p> | | |

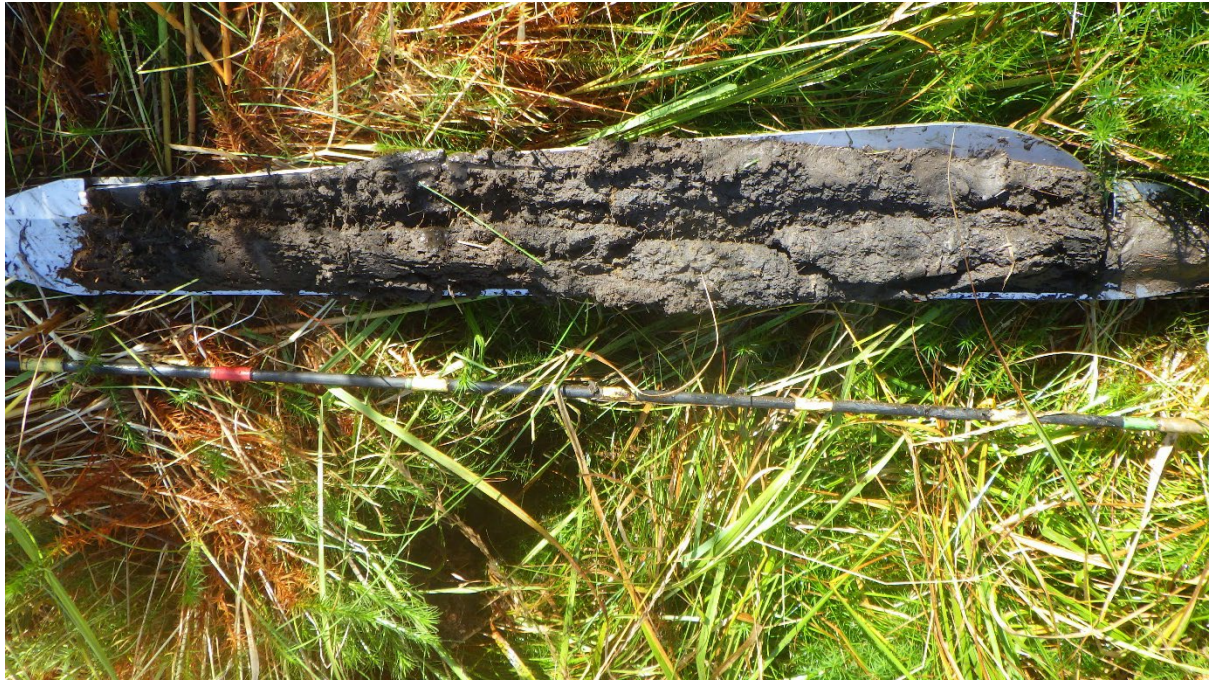
| <b>Location: C05b</b> | <b>Depth: 0.10 – 0.55 m bgl</b> | <b>Date: 12/10/2021</b> |

| <p>Notes: Upper section of core showing fibrous peaty upper section (0.1-0.2 m) with thick soft clay below</p> | | |

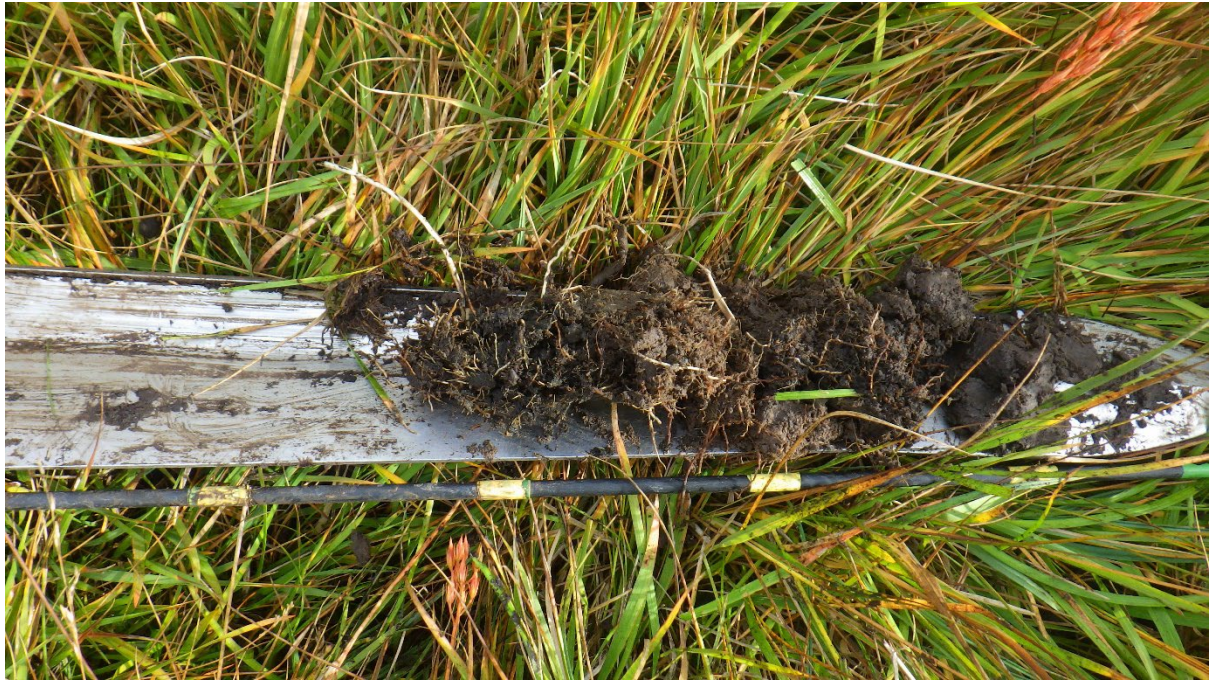
| Location: C06a | Depth: 0.00 – 0.15 m bgl | Date: 12/10/2021 |

| Notes: Largely undecomposed rooty soil overlying dark grey silty clay | | |

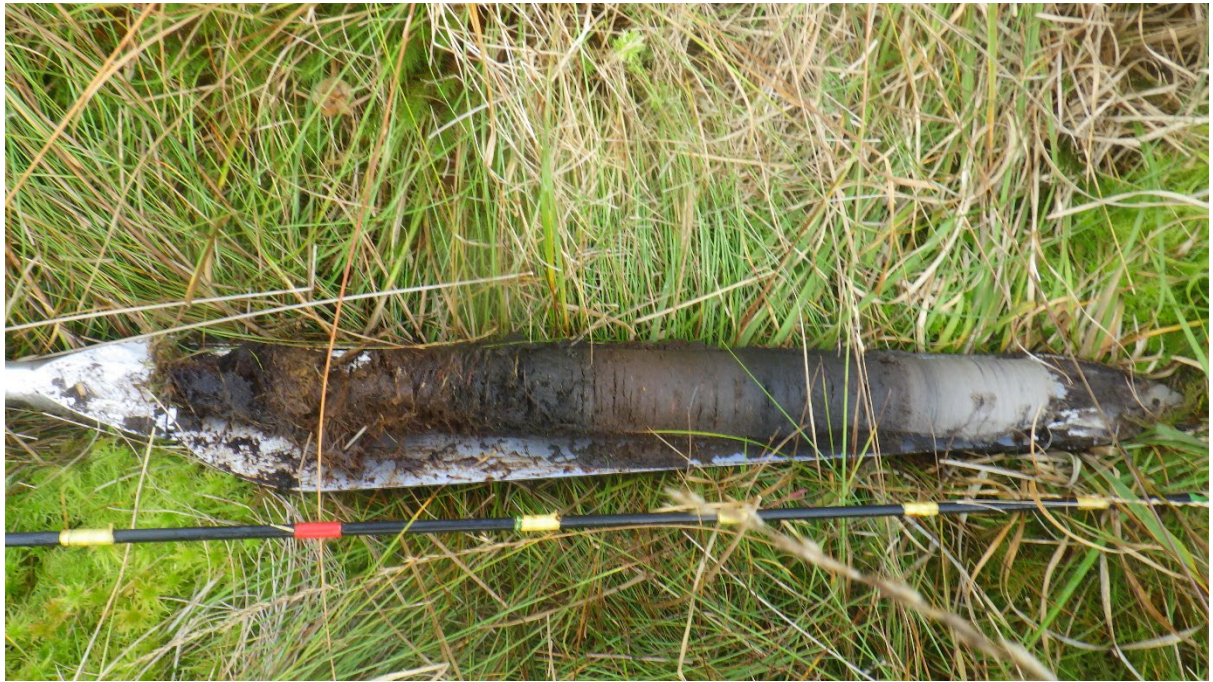
| Location: C6b | Depth: 0.00 – 0.40 m bgl | Date: 12/10/2021 |

| Notes: Thin moist peat, fibrous with frequent roots, becoming more decomposed at depth. Transition to very soft light grey clay from about 0.3 m | | |

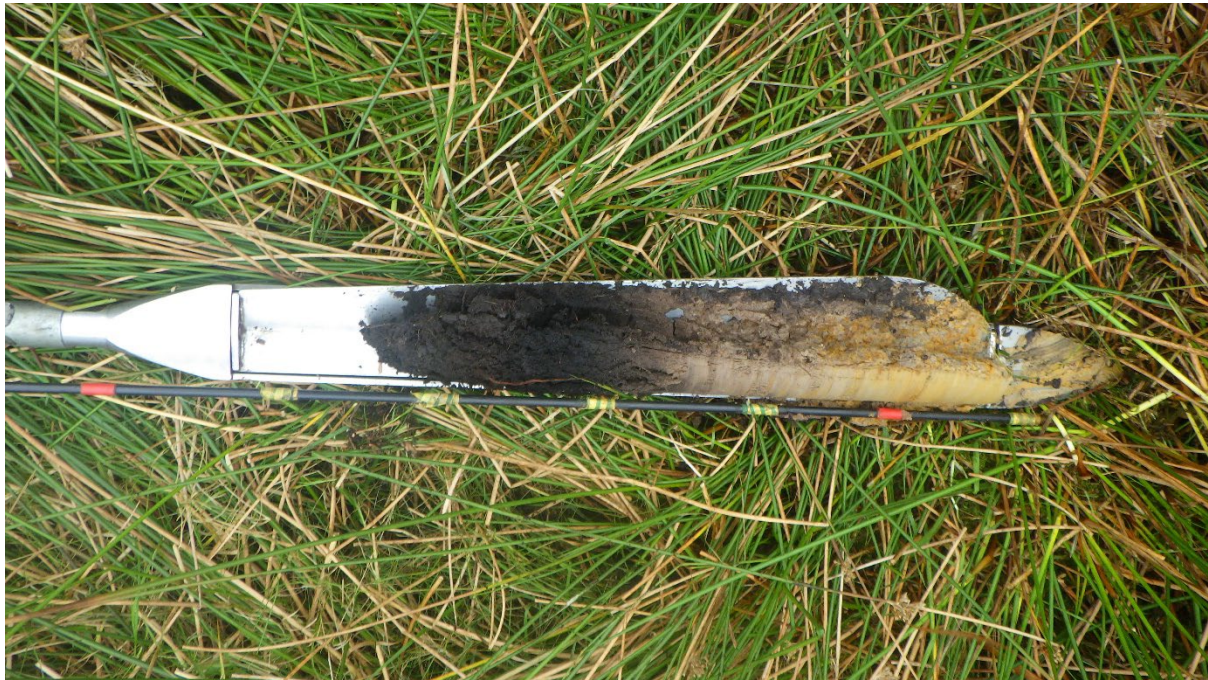
| Location: C07 | Depth: 0.00– 0.20 m bgl | Date: 12/10/2021 |

| Notes: Shallow slightly rooty peaty soil, moist/damp, overlying grey and orange silty clay | | |

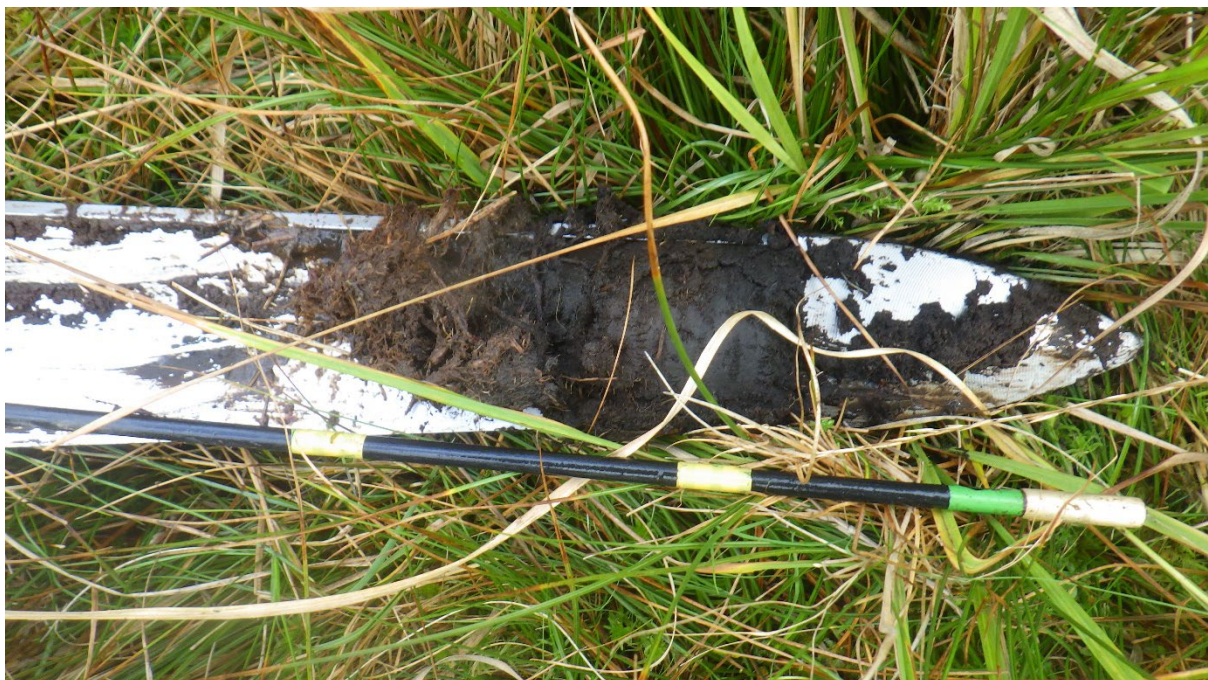
| Location: C08 | Depth: 0.00– 0.25 m bgl | Date: 12/10/2021 |

| Notes: Dark brown fibrous peaty soil, fairly dry | | |

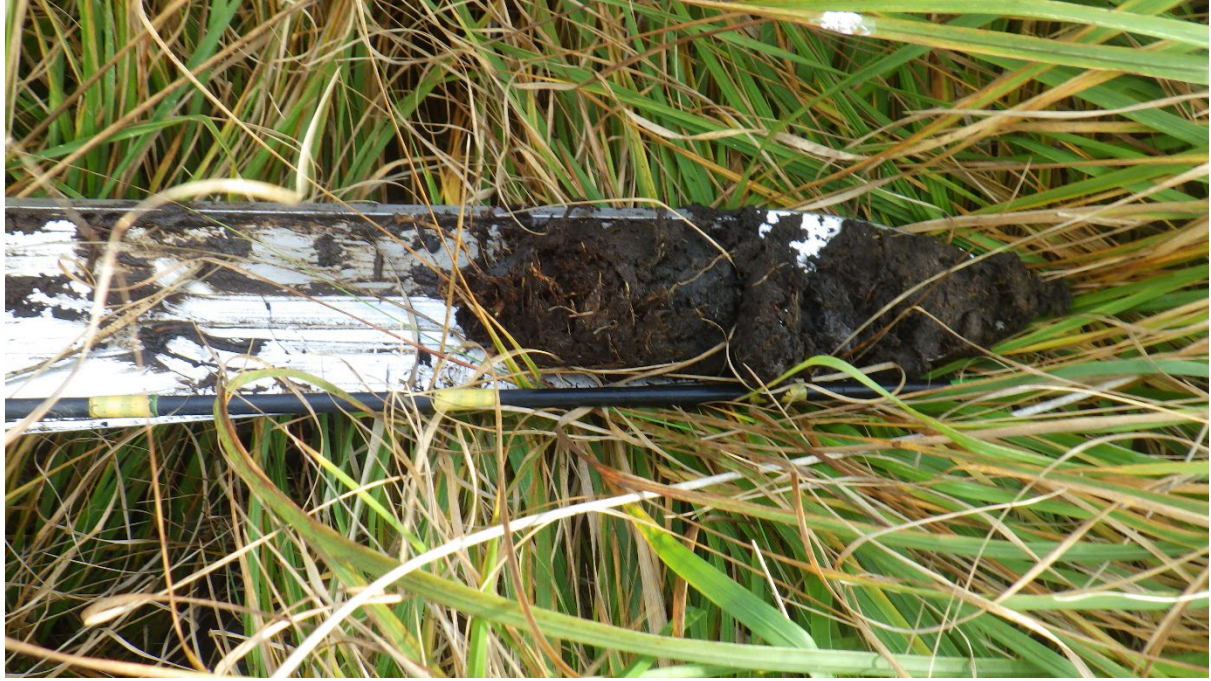
| Location: C09 | Depth: 0.00– 0.15 m bgl | Date: 12/10/2021 |

| <p>Notes: Dark brown fibrous peaty soil, overlying dark grey and brown very silty clay, occasional roots throughout</p> | | |

| ID | Label | X | Y | Probe Depth (m bgl) | Layer | Top Depth (m bgl) | Bottom Depth (m bgl) | Von Post | Moisture | Notes |
|---|---|---|---|---|---|---|---|---|---|---|
| 156533 | C09 | 309208 | 209331 | 0.35 | 1 | 0.0 | 0.15 | H4 | B3 | View S. Peat very dark brown, fibrous. Overlying dark grey and brown, very silty clay with occasional roots |
