**120-121 HIGH STREET, MERTHYR TYDFIL**

**BAT SURVEY**

**Bat Survey Report**

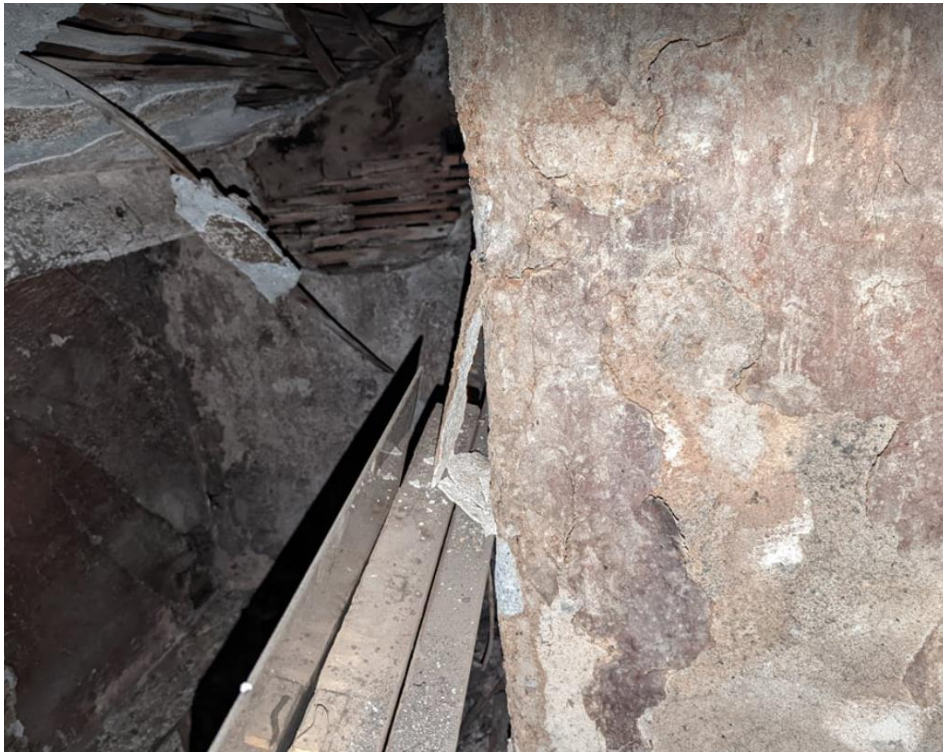
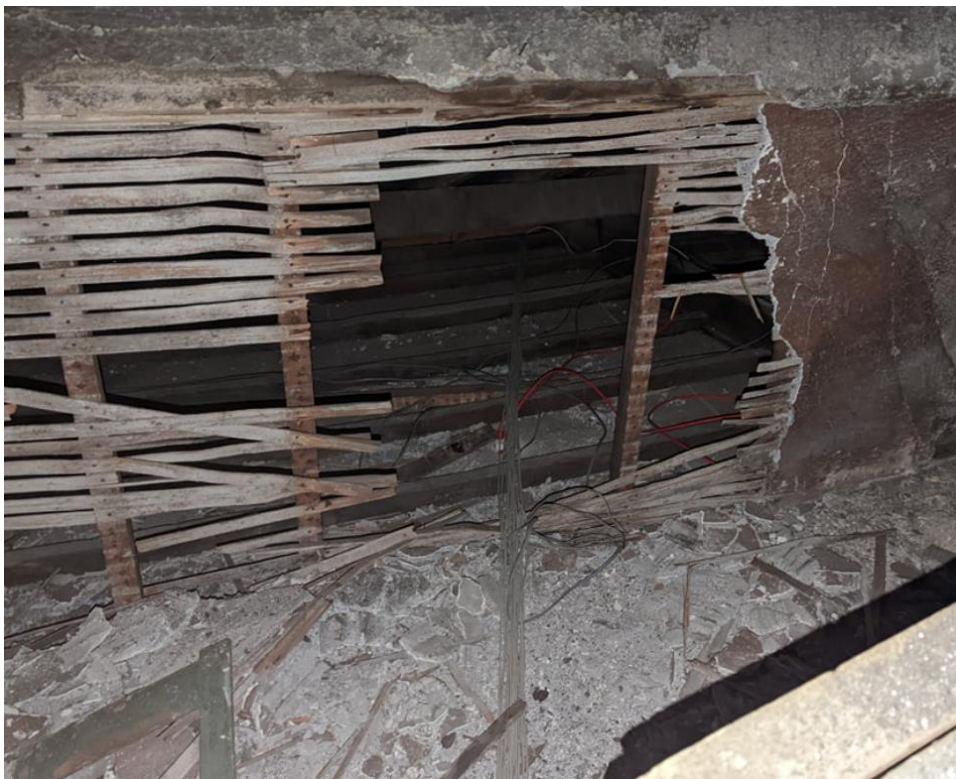
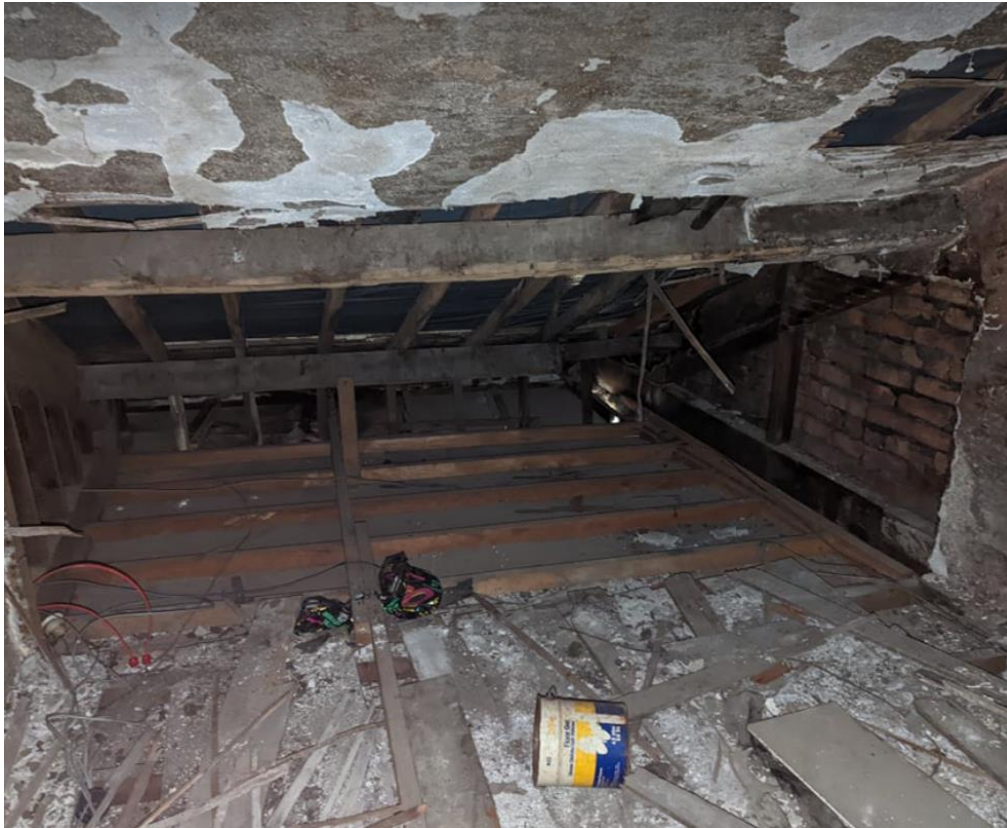
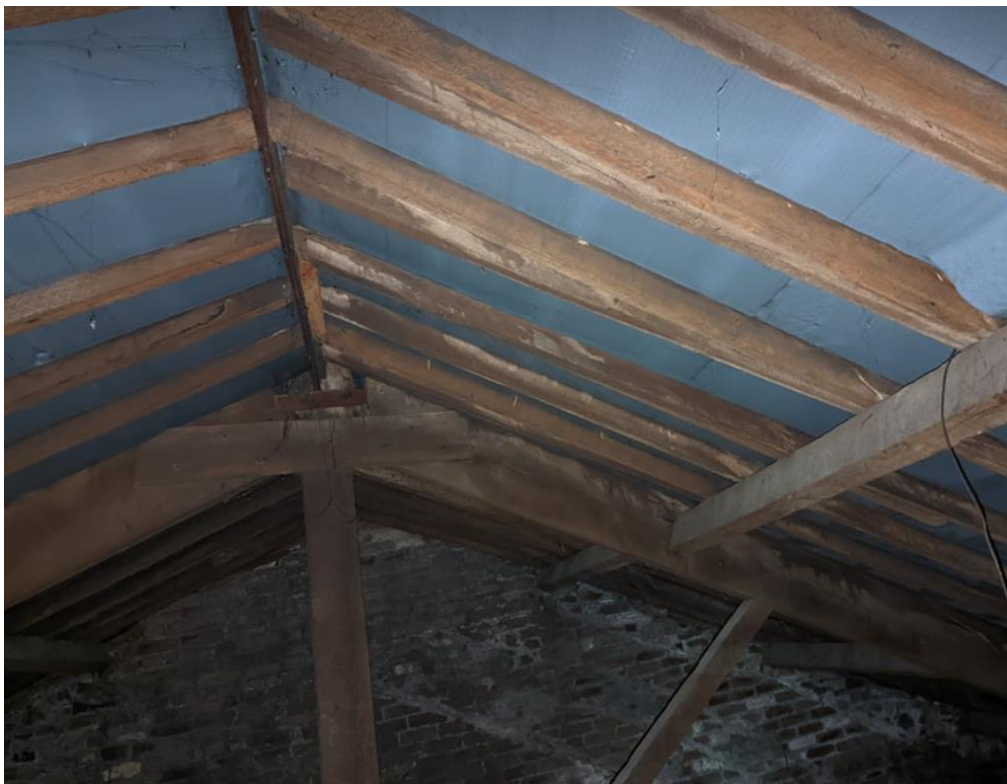
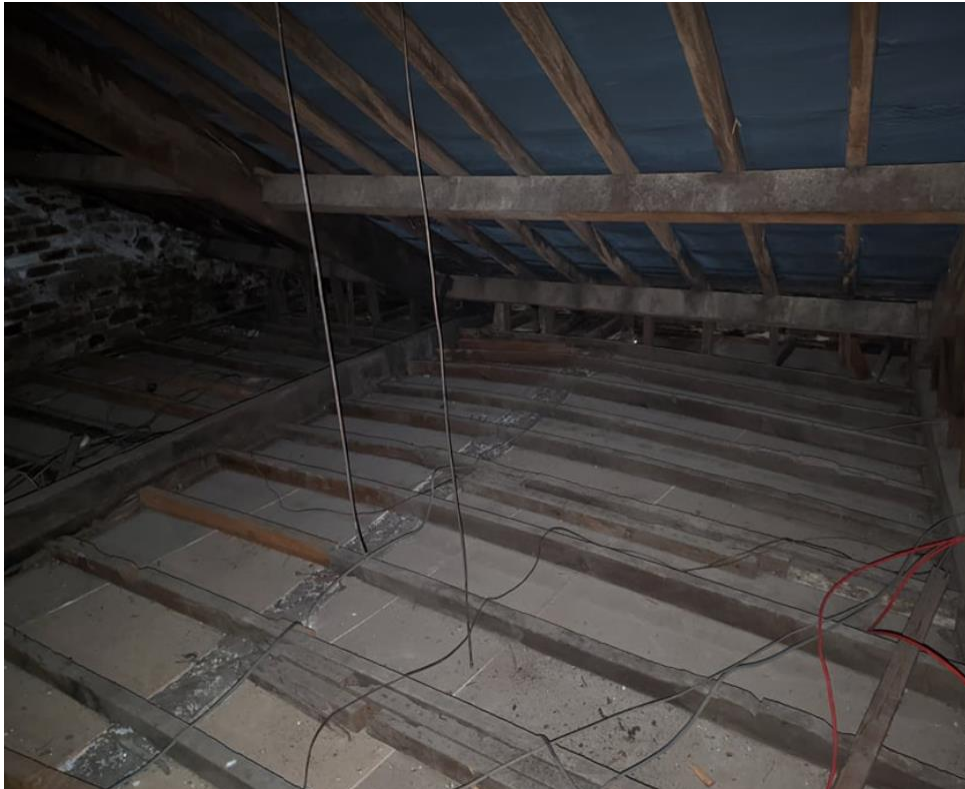
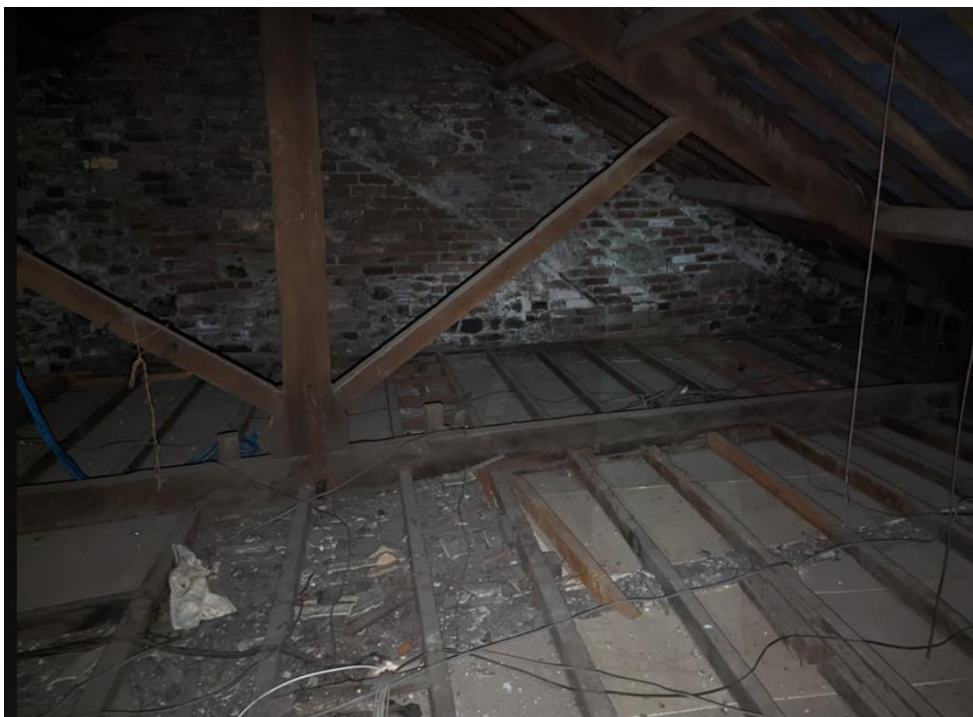
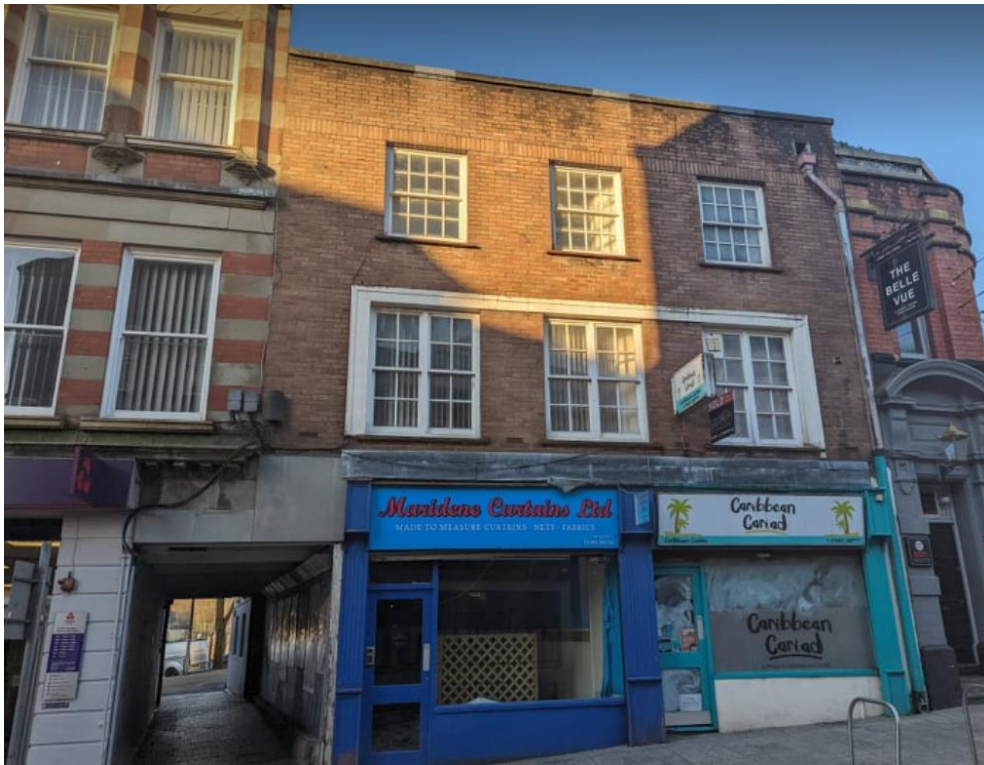
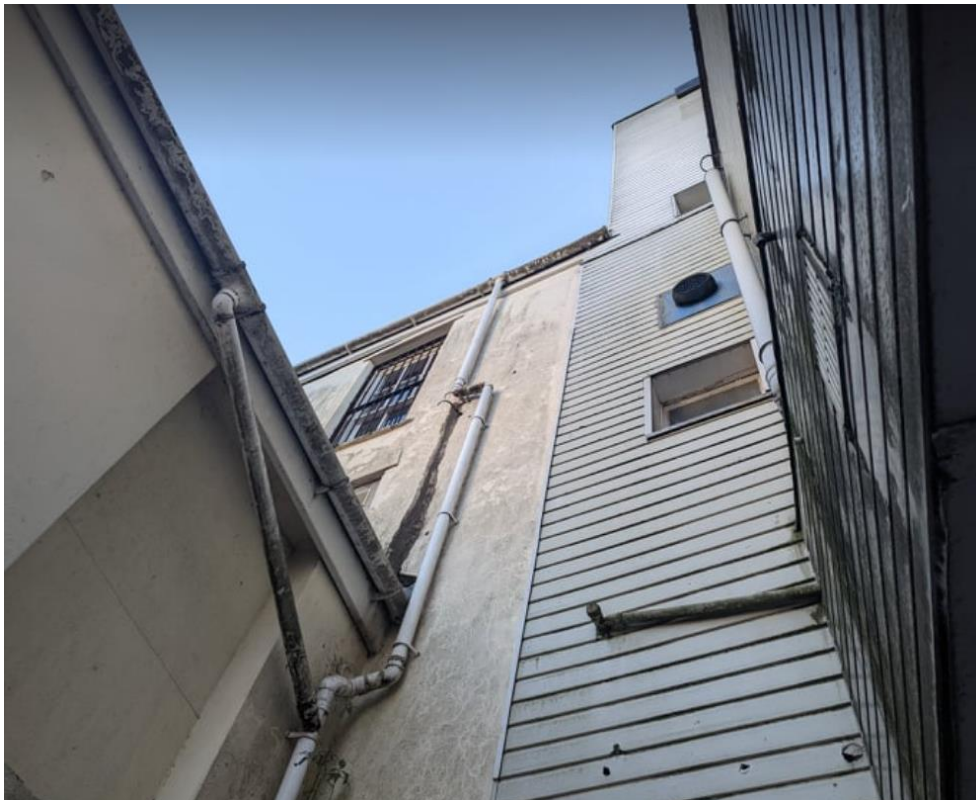
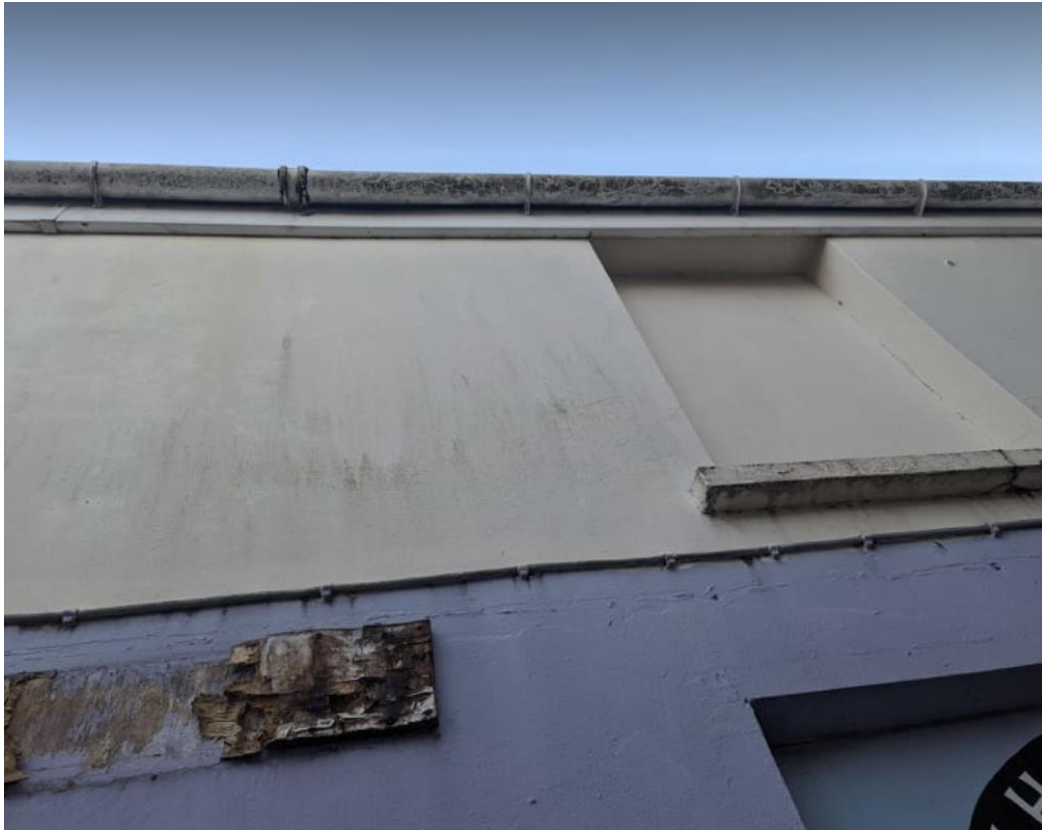
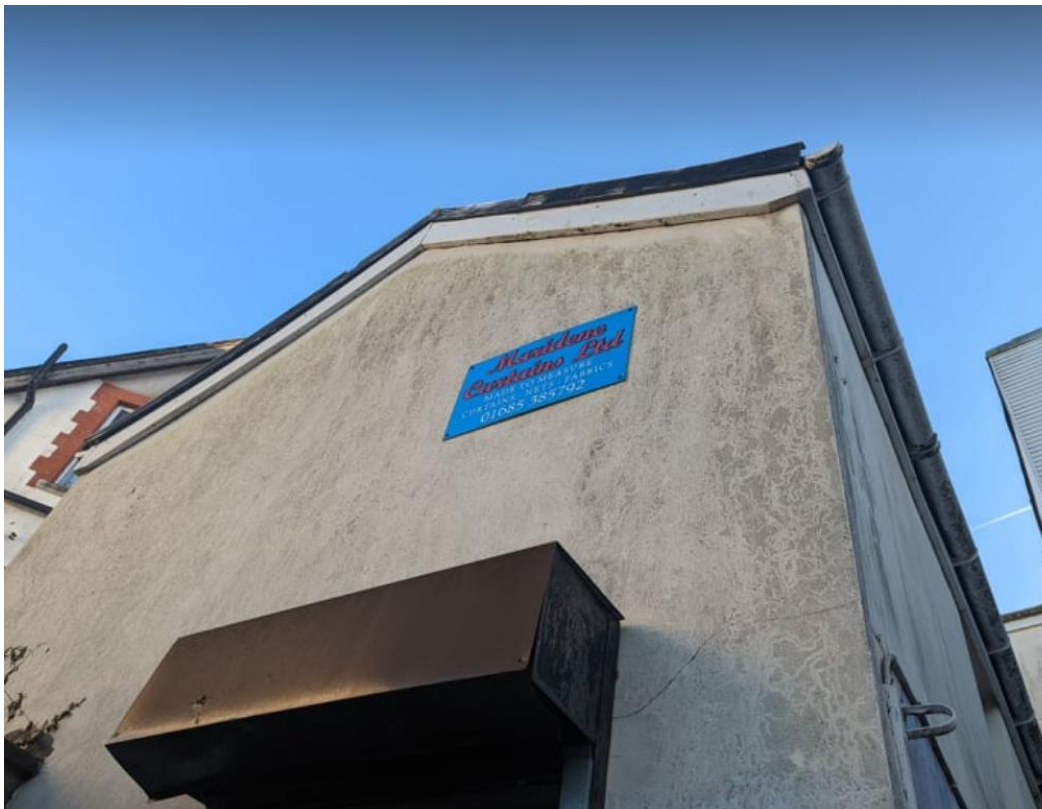
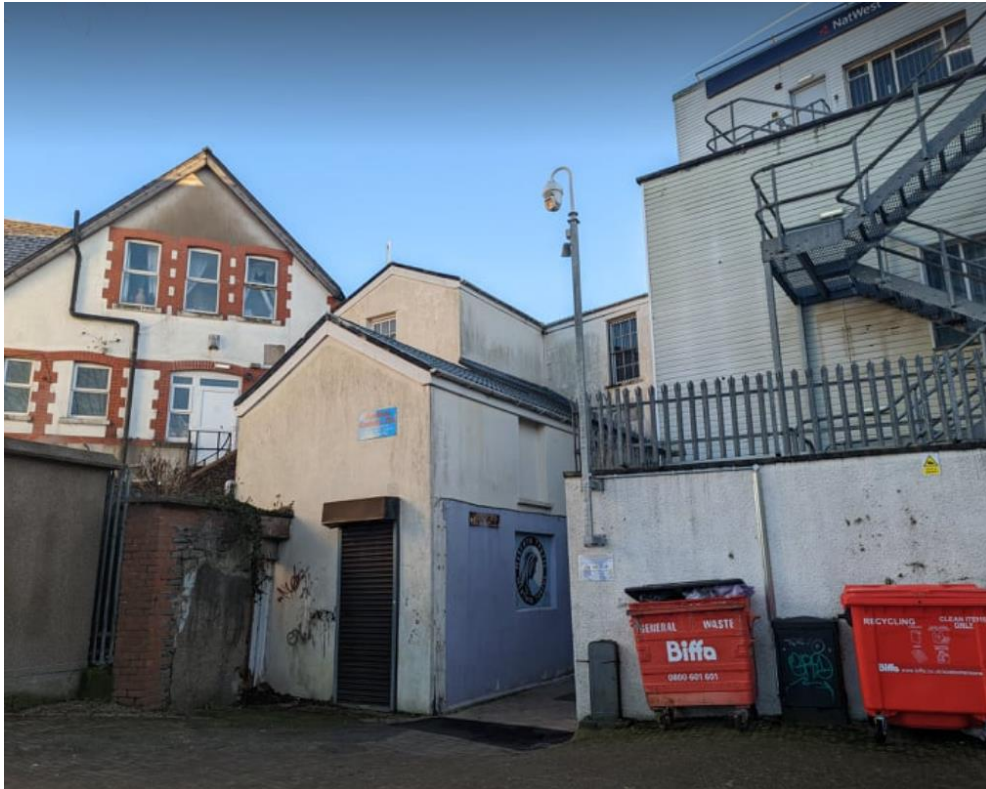
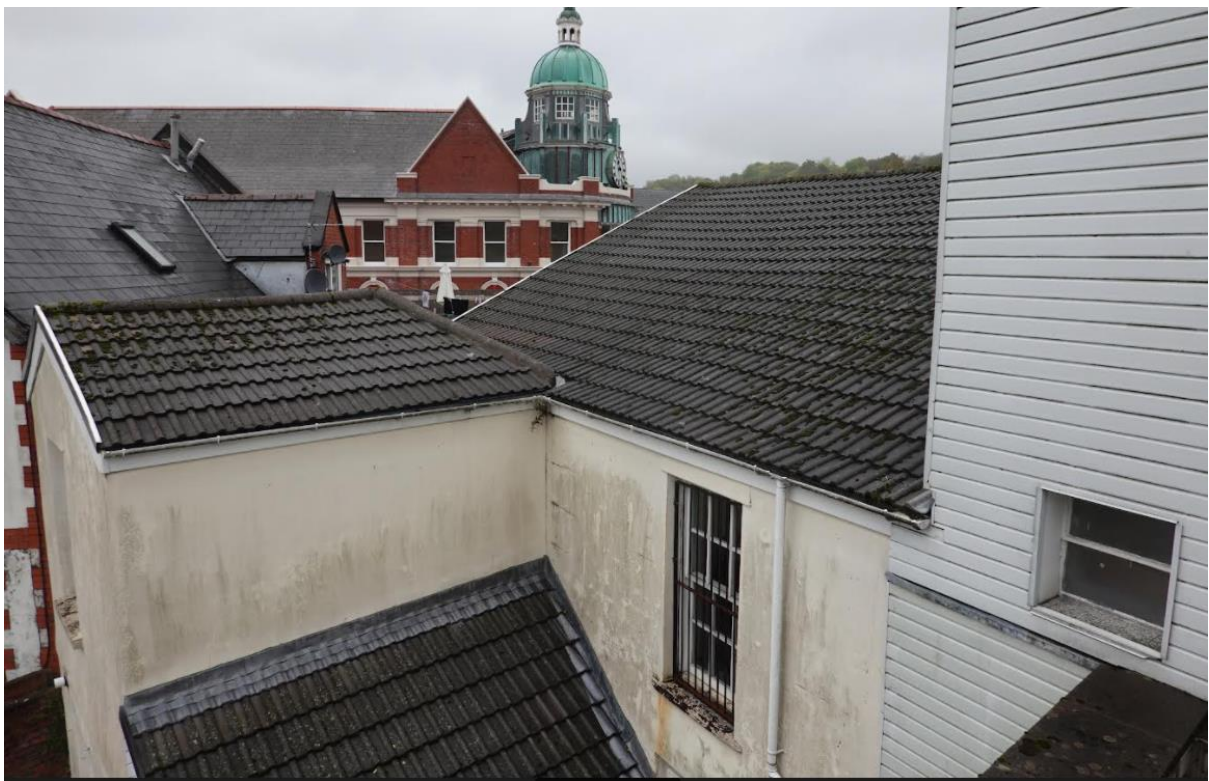
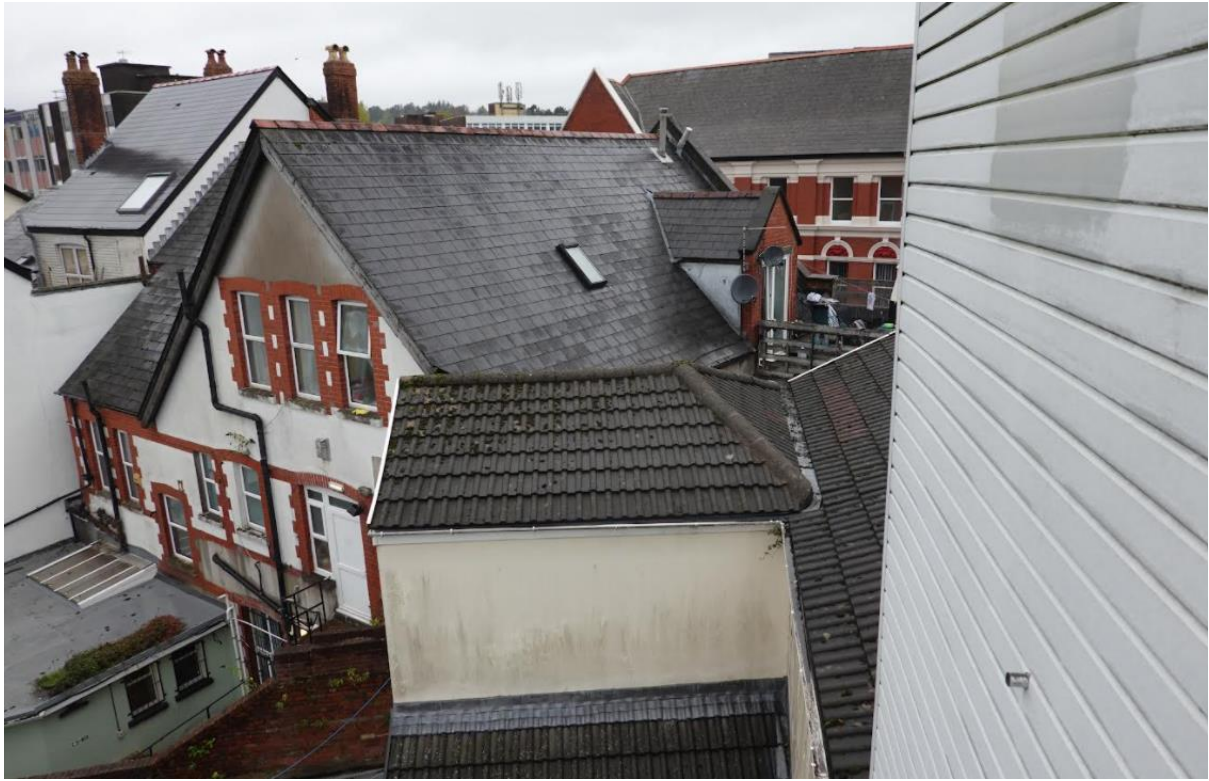
## APPENDIX A- PHOTOGRAPHS

The survey carried out by BE Ecological Ltd revealed no droppings or evidence of bats on the exterior of the buildings and failed to find any suitable, obvious access points for roosting bats.

Some of the roof is difficult to view from the ground due to obstruction. There are small gaps beneath fascias and barge boards.

Please see appended plates for photographs of the building exterior.

Internally the building is extremely damp, the ceilings are unsafe and in desperate need of repair. The roof is a king post design with an approximate height of 3m from joist to ridge. The roof is lined. There is old plaster board present that is currently crumbling due to the state of the building. The roof space is musty and dirty.

No bats or evidence of bats were found in this location. There are no obvious light ingress' into the roof void.
