**Ty Brynseion, Dowlais, Merthyr Tydfil**  
**Preliminary Roost Assessment**

**November 2024**

| Ty Brynseion, Dowlais, Merthyr Tydfil<br>Preliminary Bat Roost and Nesting Bird Assessment | | | | |

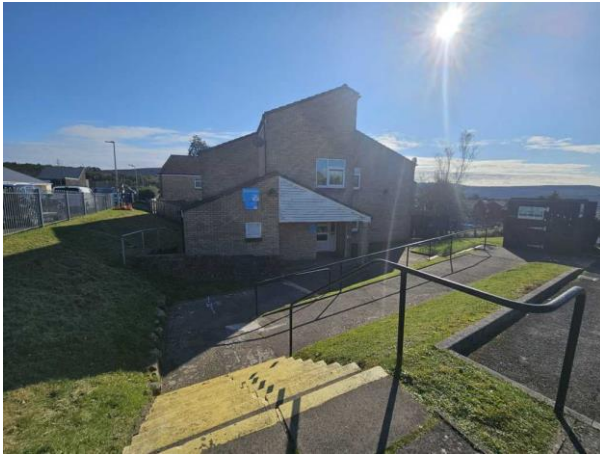
Photo 3: Northern elevation

| Windows and doors | The windows and doors have uPVC frames. All windows and doors appear well sealed with no visible gaps (Photos 3 and 10). |

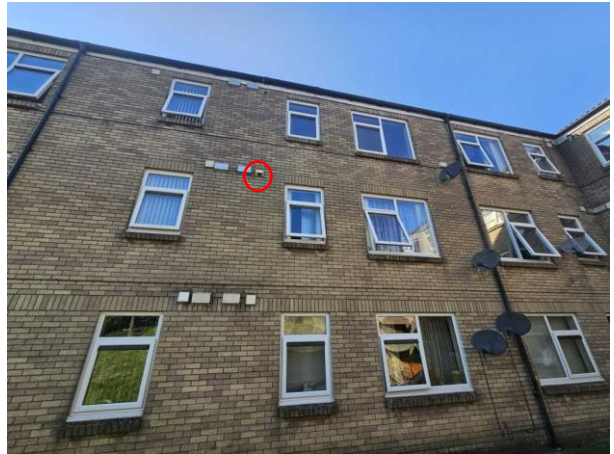
| Vents | There are multiple vents across all floors on the southern and eastern elevations. Vent stacks are also present on all roof sections. Many vents are damaged or missing (Photos 4 and 10). |

Photo 4: South-east elevation, example of broken vent and well-sealed windows

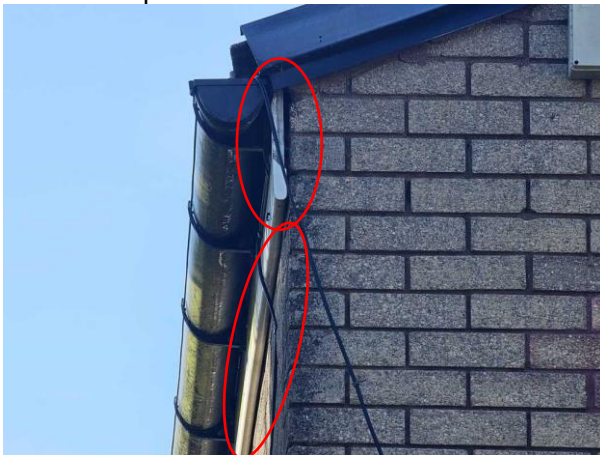
| Soffits, Fascias and Bargeboards | The barge boards and fascias across all elevations have visible gaps beneath or are missing entirely (Photo 5). |

Photo 5: Gaps behind fascia boards

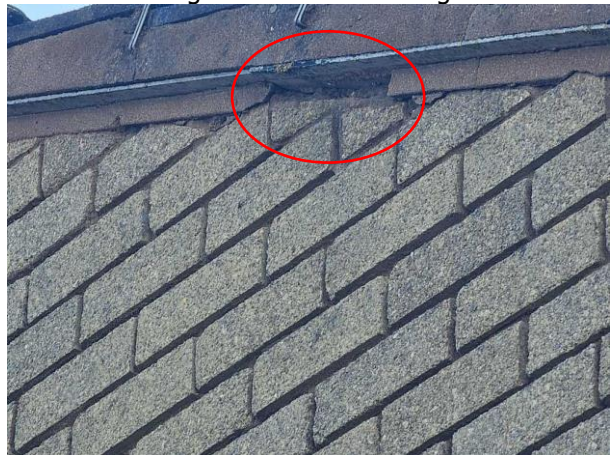
| Roof | The roof is multi-pitched, with interlocking curved tiles in good condition and few visible gaps overall. Plastic anti-wildlife spikes are installed along the edge of each tile run; however, some are bent or missing, creating gaps that may allow access between the roofing felt and tiles, potentially leading into the roof void (Photos 7 and 9). Notably, there are additional gaps at the apex on the southern elevation pitch, and a large section of missing mortar along the edge of the western elevation, compromising the tile seal in that area (Photos 6 and 8). |

Photo 6: Missing mortar on western gable

- **PRF 1:** Gaps created by missing mortar along the edge of the roof tiles and at the roof apexes, which may provide access beneath the tiles (Photos 6 and 8).
- **PRF 2:** Bent or missing anti-wildlife spikes along the roof tile runs, potentially allowing entry to the space between tiles and the 1F bitumen roof lining (Photo 7).
- **PRF 3:** Gaps beneath bargeboards and fascias, which could lead into crevice spaces suitable for bat roosting (Photo 5).
- **PRF 4:** Missing or damaged vents on the southern and eastern elevations, which may provide entry into the wall cavities or other enclosed spaces (Photo 10).
- **PRF 5:** Lifted lead flashing around the vent stacks and at the north-east elevation joint, creating small gaps (Photo 9).

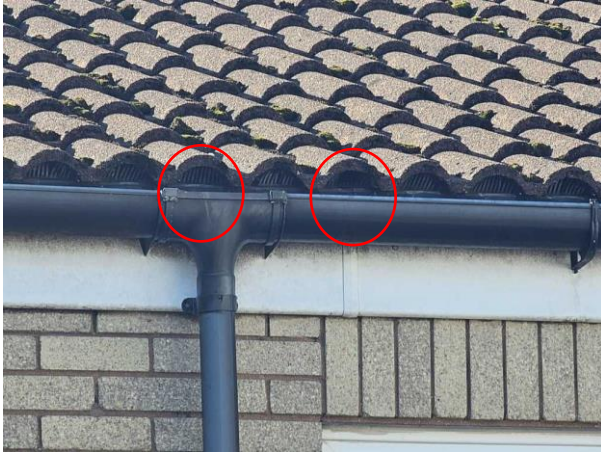
Photo 7: Interlocking tiles with missing wildlife spikes

- Gaps created by bent or missing plastic anti-wildlife spikes along the roof tile runs (Photos 7 and 9);
- Missing mortar along the edge of the western elevation roof tiles (Photo 6);
- Gaps beneath or around bargeboards and fascias on all elevations (Photo 5);
- Lifted lead flashing at the joint of the single-storey extension on the north-east elevation and around vent stacks (Photo 9);
- Damaged or missing vents across the southern and eastern elevations (Photos 4 and 10); and
- Gaps within the brickwork due to missing mortar on all elevations (Photos 6, 8 and 11).

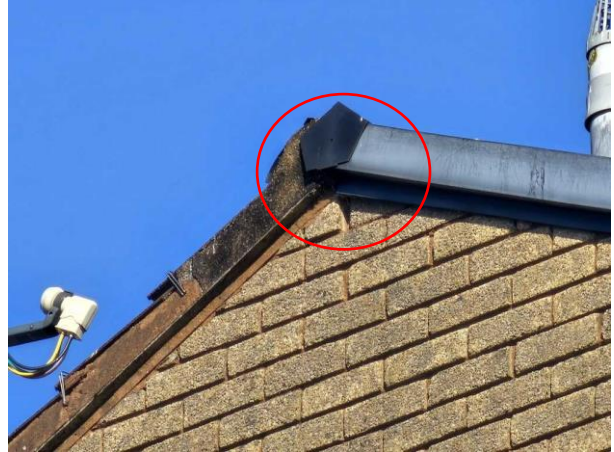
| External Walls | External walls are constructed of brick and mortar across all elevations, gaps due to missing mortar are present within the brickwork on all elevations (Photos 8 and 11). |

Photo 8: Gap at apex on southern elevation and missing mortar between bricks

- **PRF 6:** Gaps in masonry caused by missing mortar in the brickwork, along all elevations (Photos 8 and 11).

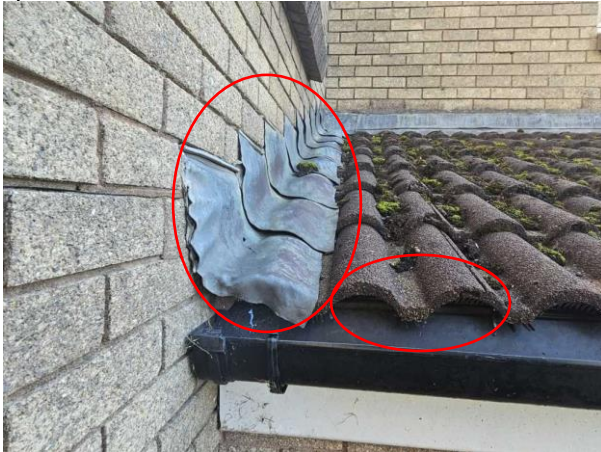
Photo 9: Lifted led flashing and missing wildlife spikes

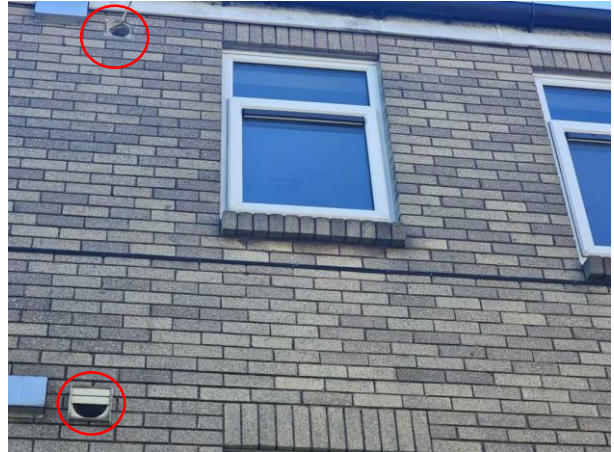
Photo 10: Broken and missing vents

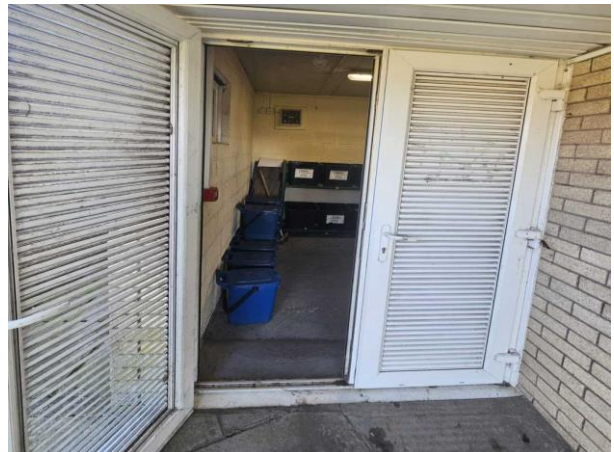
Photo 12: Well-lit plant room on northern elevation

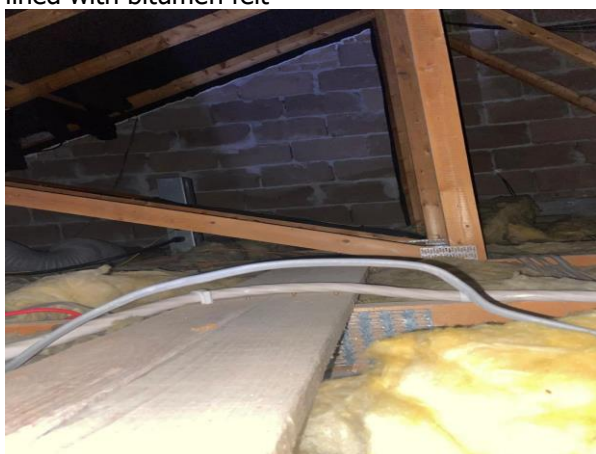
Photo 13: Internal loft space on eastern elevation, lined with bitumen felt

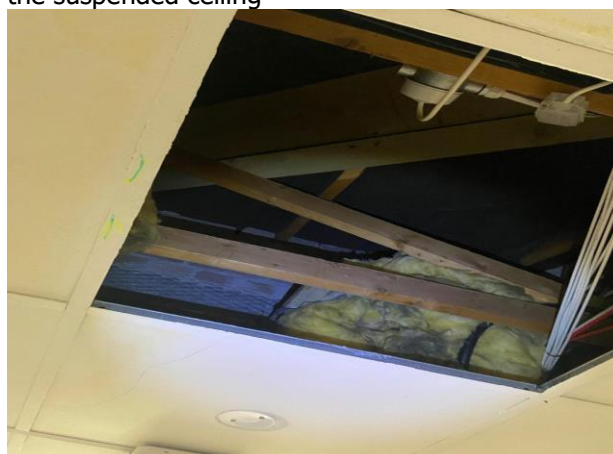
Photo 14: View into a section of the loft void above the suspended ceiling
