Japanese Knotweed  
Survey and Remediation  
Report

The Grawen Takeaway  
19 Brecon Road  
Merthyr Tydfil  
CF47 8NR

GWP Property Services  
07737 172483

Date: 20/09/2024

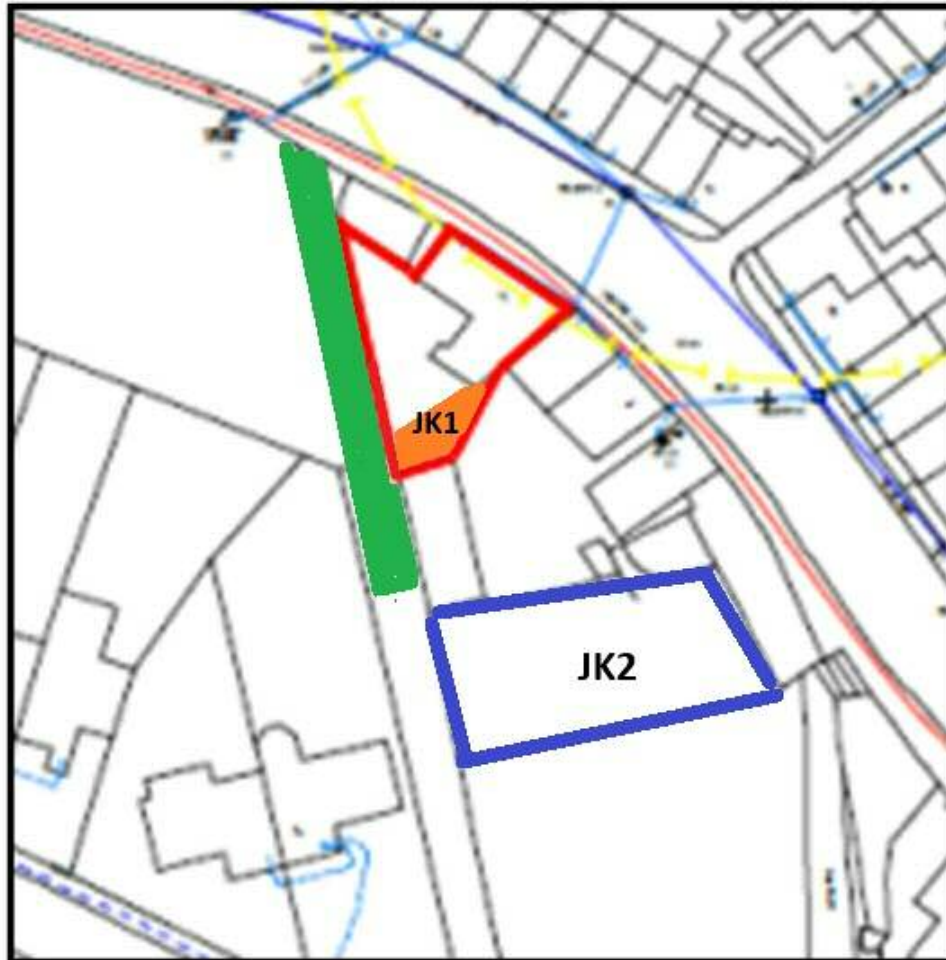
### Japanese Knotweed Location Plan

The affected area is identified as JK1 on the attached plan.

Dangerous and unstable spoil/rubble mound.
-

JK1 Area of garden affected by Japanese Knotweed
-

JK2 Japanese Knotweed on land within the vicinity of The Grawen takeaway
-

The area to be treated is identified as JK1 on the attached plan.

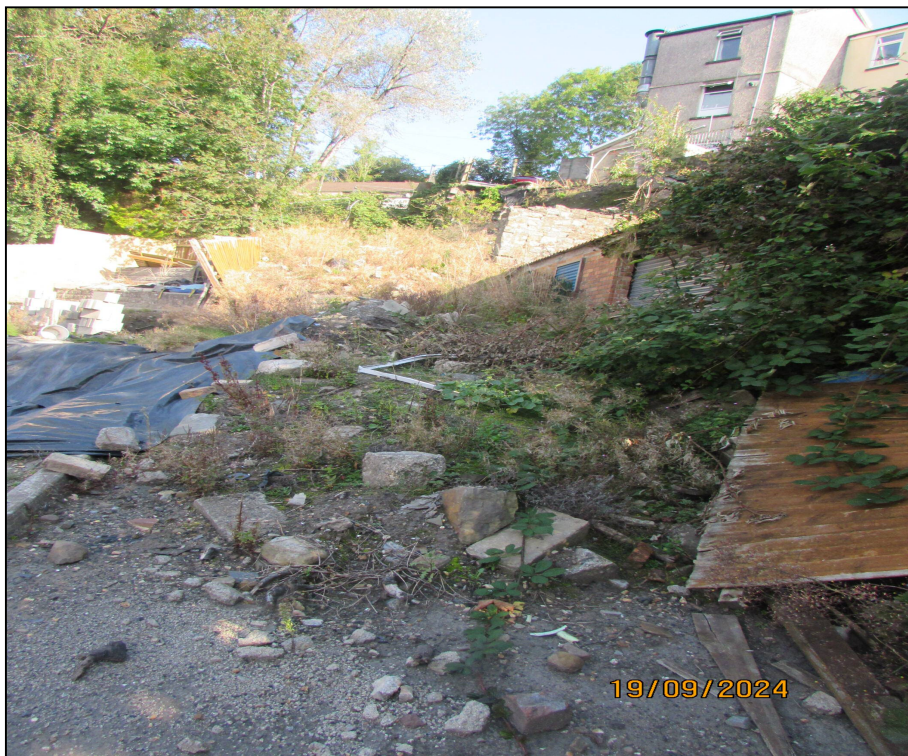
Access to the rear of the property was severely restricted by the dangerous and unstable spoil/rubble mound in the rear lane.

**Rubble/Spoil on main Access Route**

All material contained within the spoil/rubble mound at the rear of The Grawen Takeaway should be removed to a waste disposal facility licenced to receive Japanese Knotweed waste.

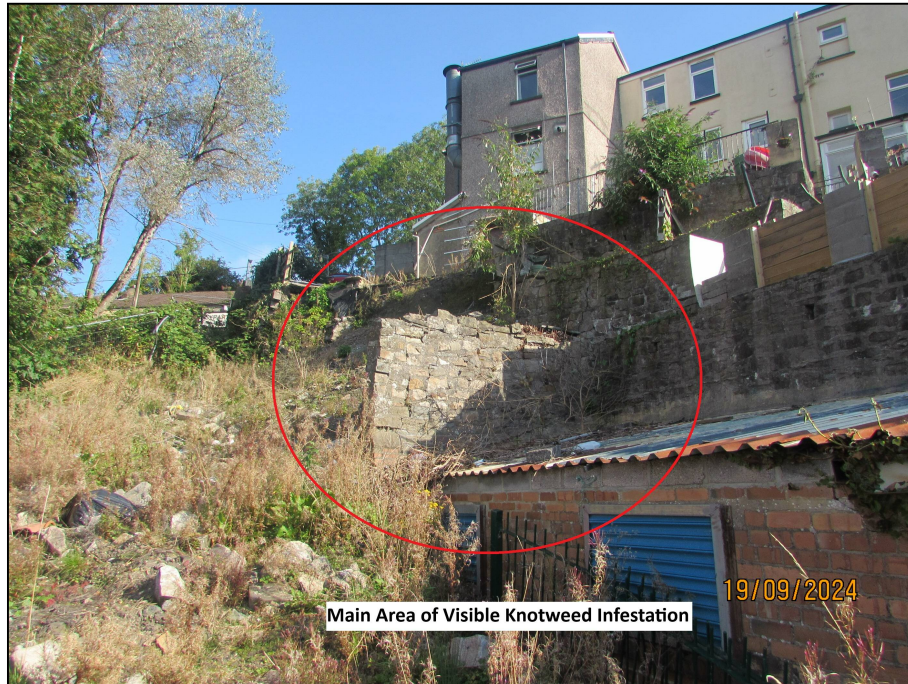
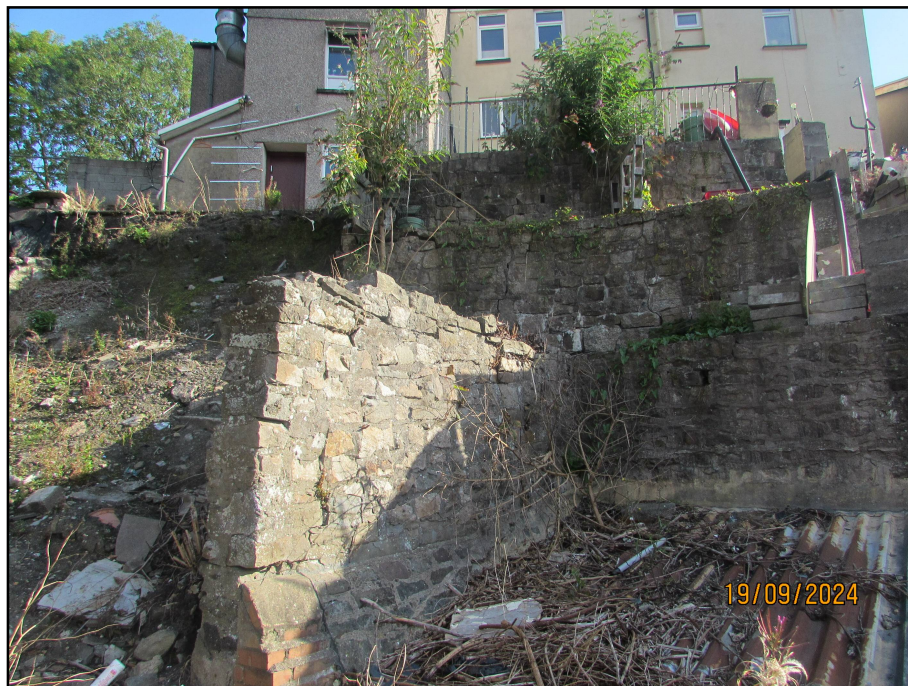
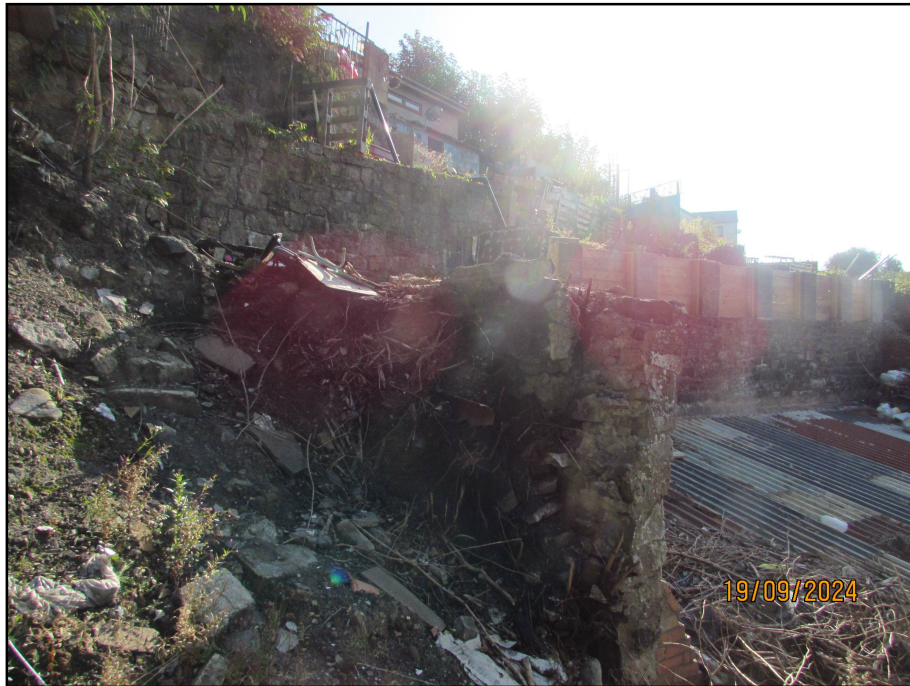
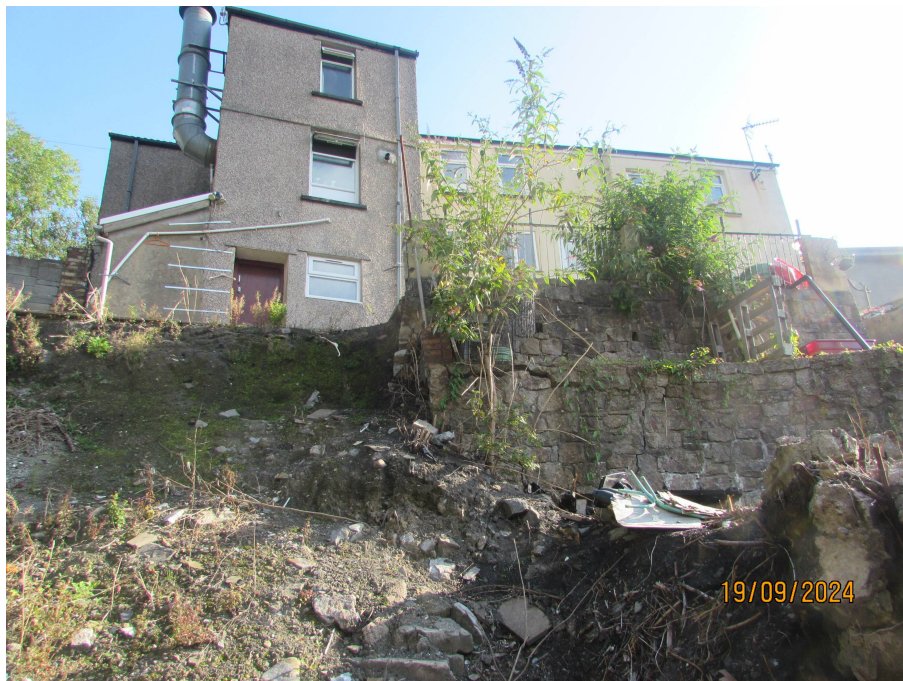
The Japanese Knotweed is located on an area of collapsed retaining wall at the North East side of the site.

The area affected is between 2.5m and 3m above rear lane level and some 5m from any habitable space

**Japanese Knotweed Location**

Prior to commencement of works on site an approved herbicide treatment shall be applied to all areas affected by Japanese Knotweed.
