*Report No. BC/MB/08.19.04.*

# **Geo-Environmental Report: Land at Colliers Row, Brondeg, Merthyr Tydfil.**

**Maxiom Developments Ltd.**

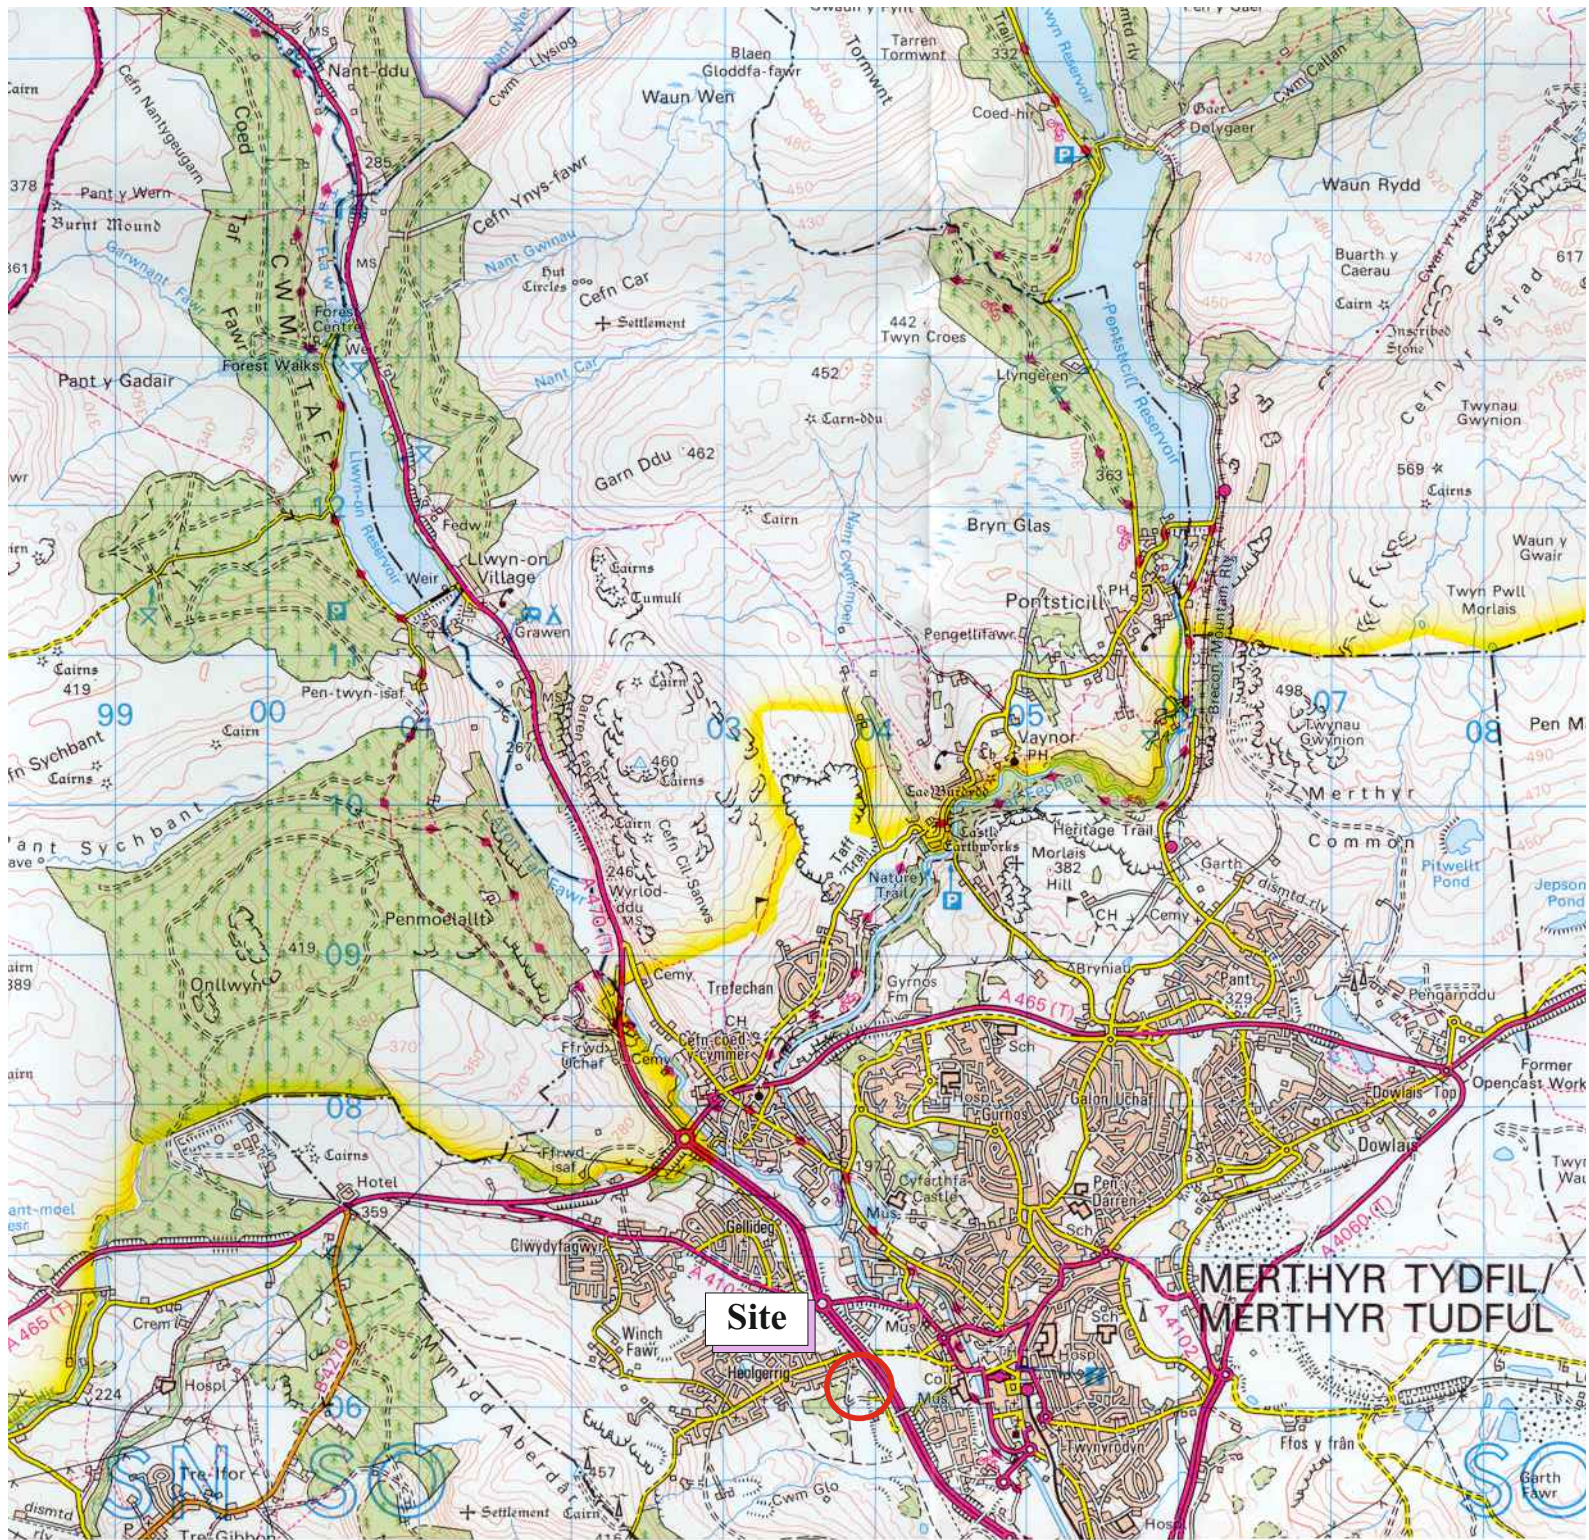
Geology Plan.

The coal measures of the South Wales Coalfield have been affected by large faults. In the Brondeg area these large faults have a slightly sinuous trace at the surface and an average trend towards the north-west. The published geological sheet indicates that the Site is not affected by large scale faulting.

The published geological sheet indicates that locally the coal measures are overlain with deposits of glacial till, Boulder Clay; we have no detailed information regarding the thickness and engineering properties of the Boulder Clay in the vicinity of the Site. Published geological records indicate that the Site is not affected by landslip.

There are no features associated with the solid geology of the Site that would require any particular measures to be included in the design and construction of the foundations for the proposed development. It is recommended that no further action is required in this respect.

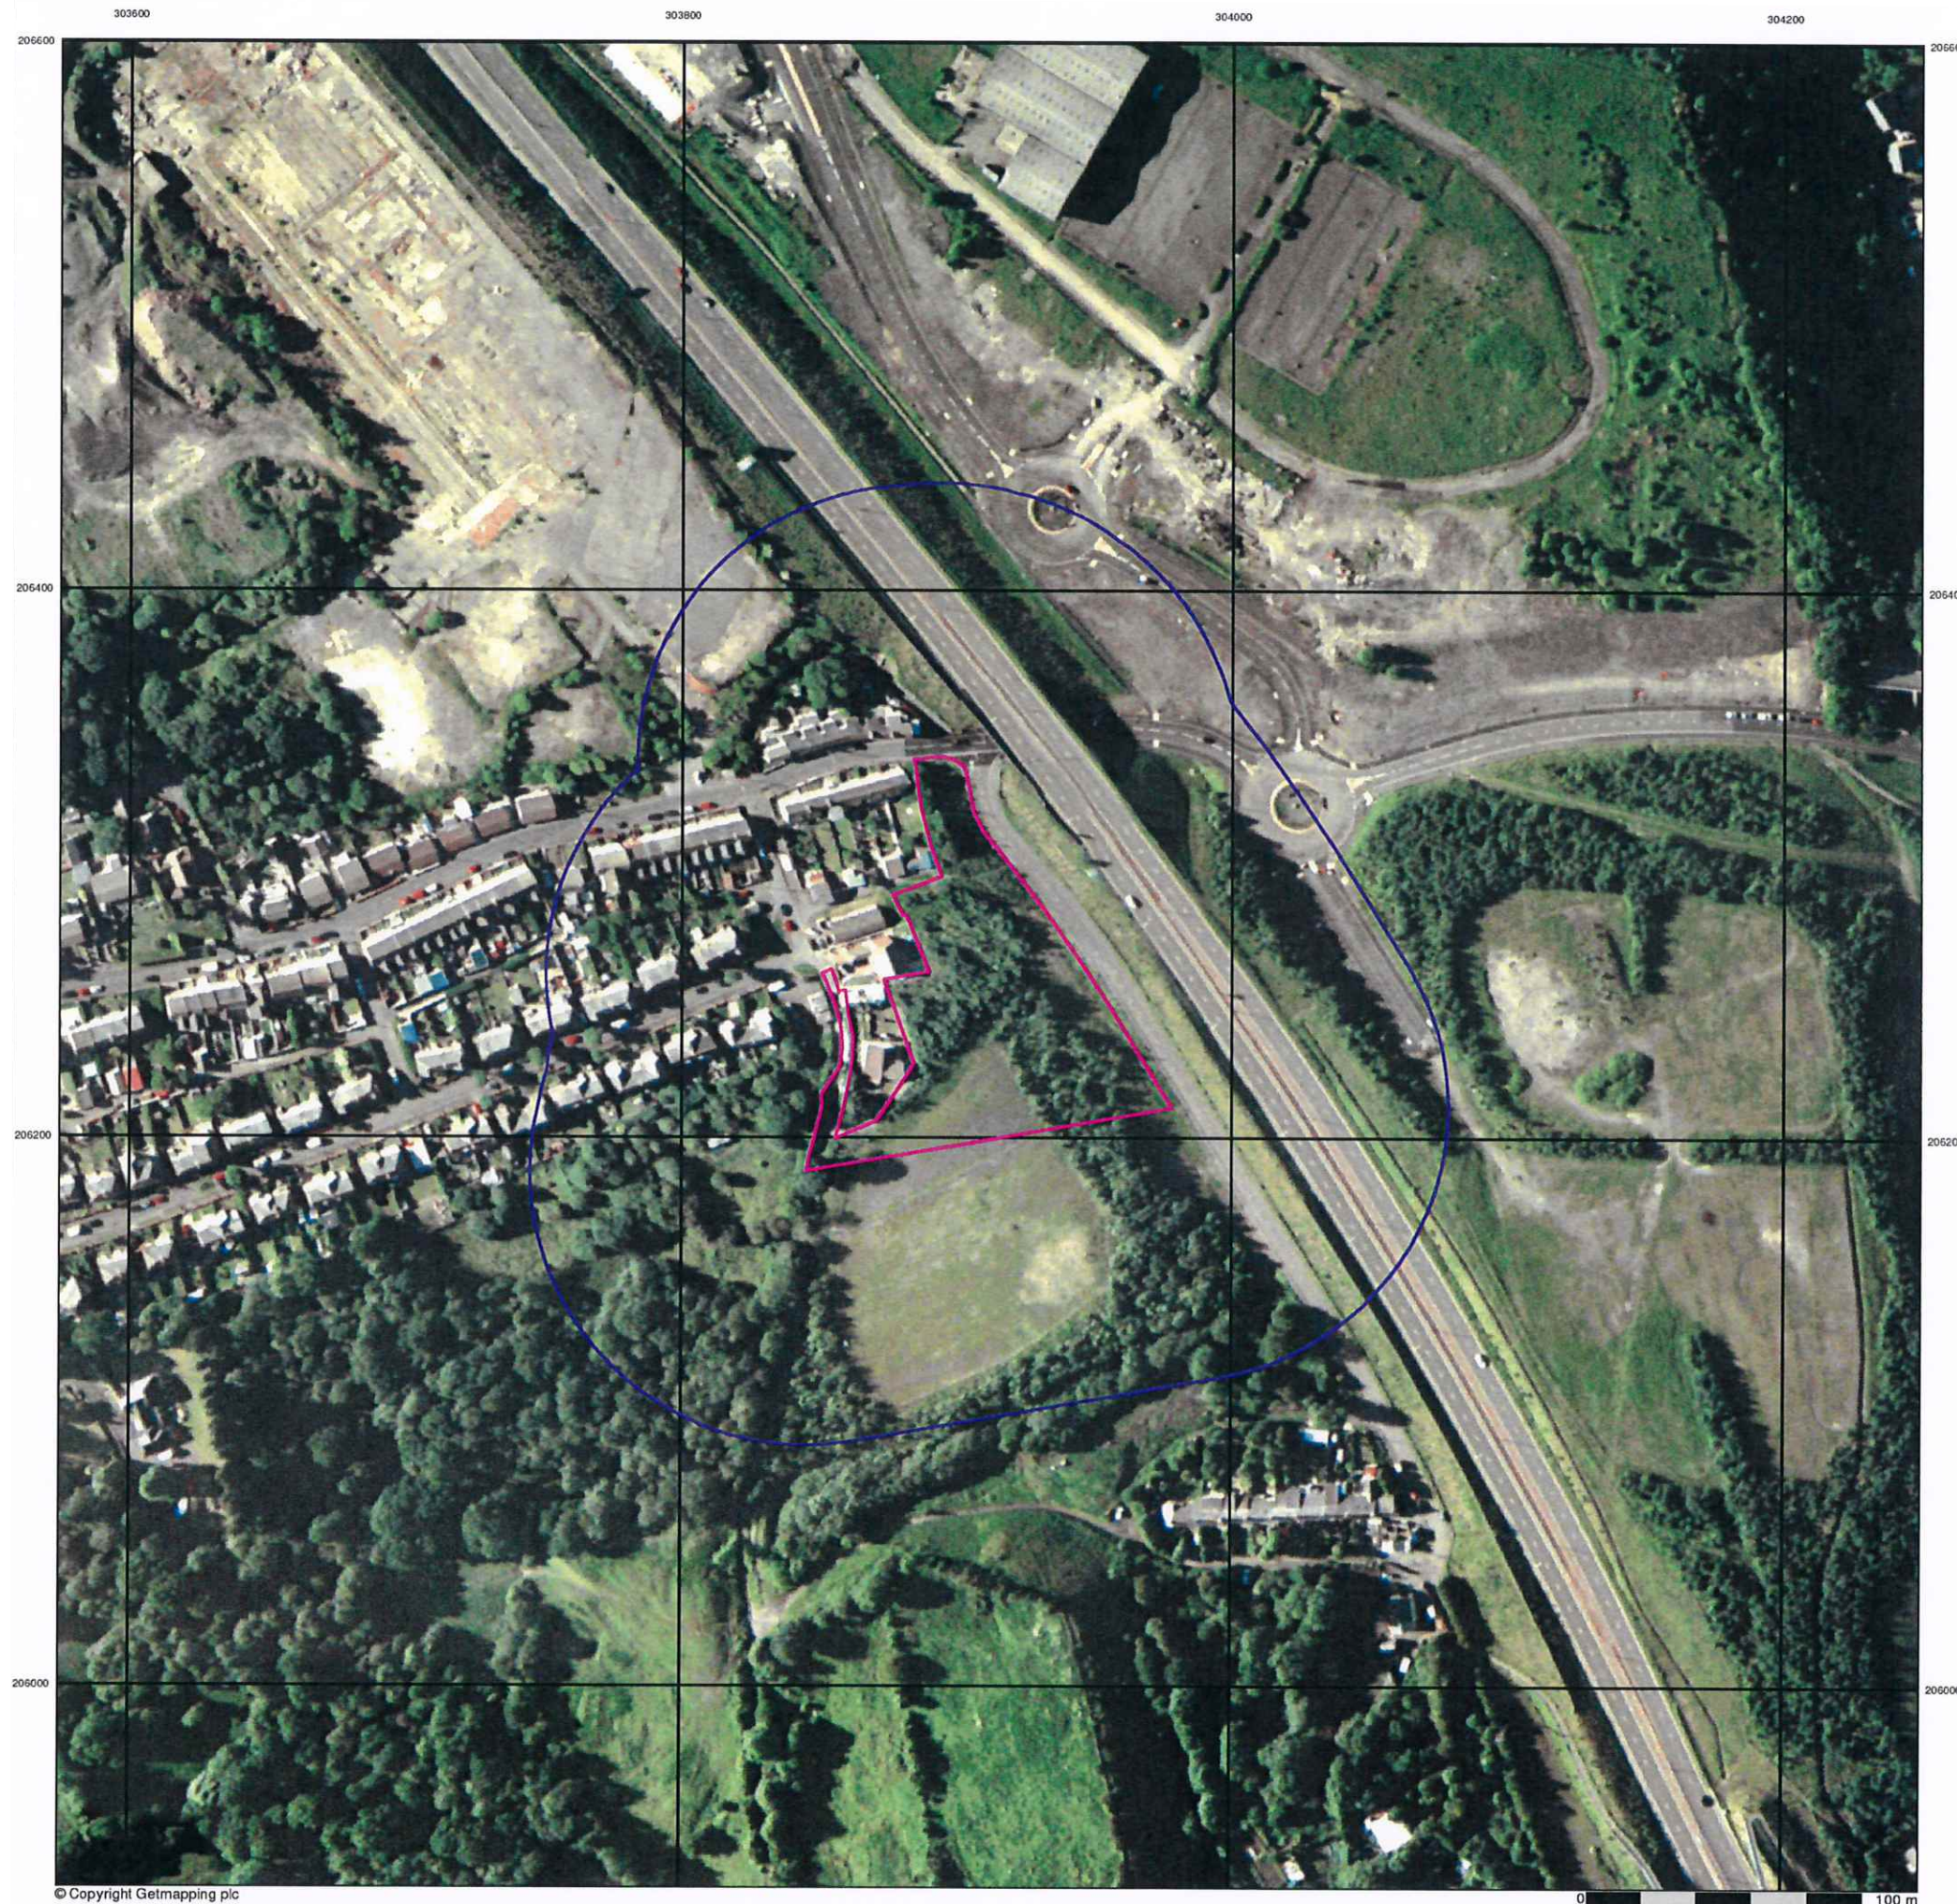
**Drawing No: BC/MB/08.19.04.15.**

The Site and the immediately surrounding area were largely unchanged from what was evident on the previous edition (see *Extract from Ordnance Survey Sheet 1994-1995, drawing no. BC/MB/08.19.04.14*). The brickworks had closed.
