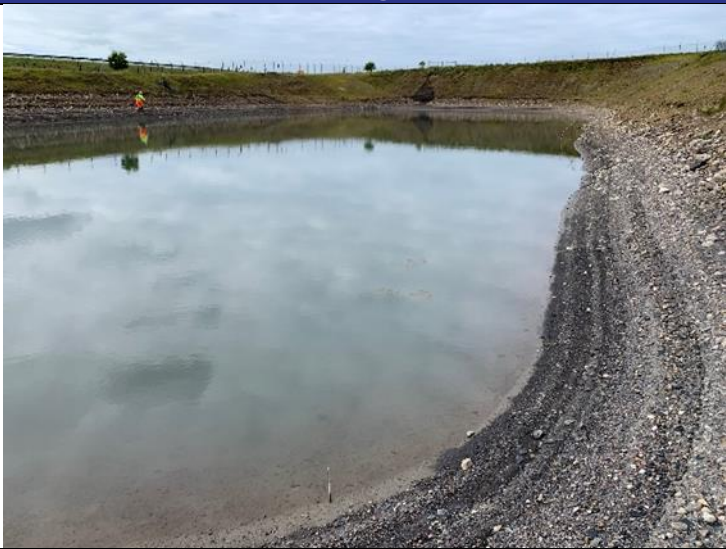
| Ref | Description | Image |
|---|---|---|
| P01 | <p>Settlement lagoon with riparian zone consisting of a combination of colliery silt and small pebbles, almost devoid of vegetation with the exception of three saplings of <i>Salix</i> spp. growing on extruding silt deposits. Patches of <i>Potamogeton</i> spp. are present in the centre and toward the margins, covering approximately 10% of surface area.</p> <p>eDNA result: Negative<br/> HSI Score: 0.58 (below average)<br/> Lined (y/n): No</p> | |

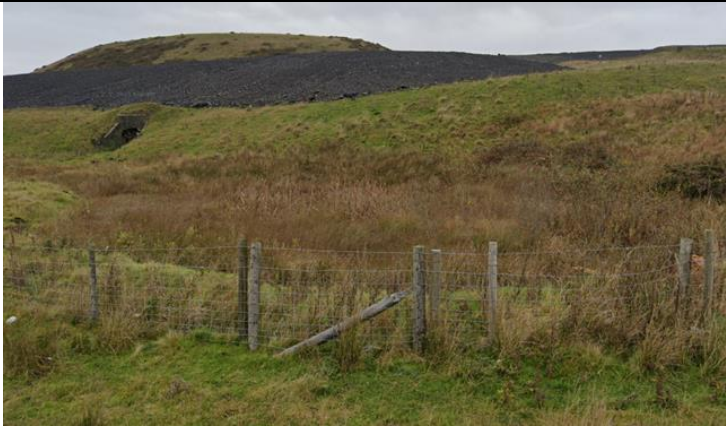
| Ref | Description | Image |
|---|---|---|
| P02 | <p>At the time of surveying (June) this pond was almost entirely vegetated, with minimal open water and had taken on the characteristics of marshy grassland. The dominant plants were rushes such as <i>Juncus effusus</i> and <i>Typha</i> spp. During the winter months it is likely that the water level increases, forming a more typical pond.</p> <p>eDNA result: Negative<br/> HSI Score: 0.50 (Poor)<br/> Lined (y/n): No</p> | |

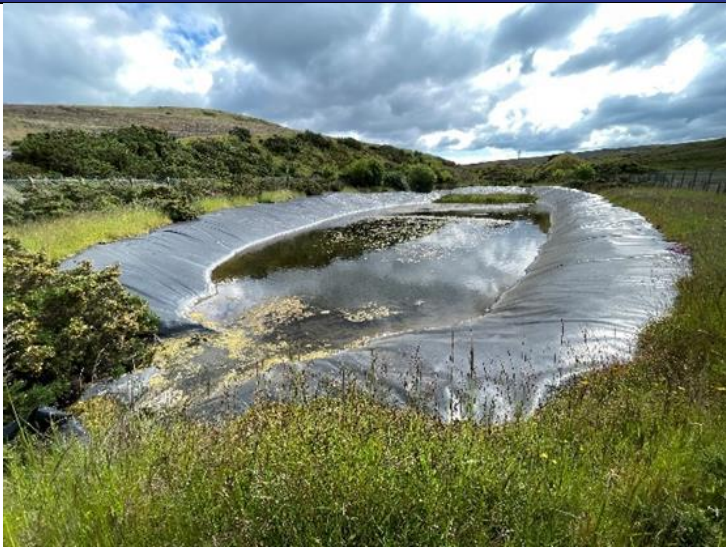
| Ref | Description | Image |
|---|---|---|
| P03 | <p>The riparian zone/banks were entirely of exposed pond liner with no vegetation. Approximately 20% of the eastern end of the pond area was composed of a solidly vegetated mat. This mat consisted of a diverse range of grasses (such as common Bent, <i>Agrostis capillaris</i>; crested dog's-tail, <i>Cynosurus cristatus</i> and Sweet Vernal-grass, <i>Anthoxanthum odoratu</i>), sedges (primarily <i>Carex</i> spp.), numerous saplings of eared willow (<i>Salix aurita</i>) and some small gorse. Submerged vegetation was dominated by <i>Elodea</i> spp. Which covered almost the entire bottom of the pond. Approximately 40-50% of the surface area was comprised of <i>Potamogeton</i> spp.</p> <p>eDNA result: Positive<br/> HSI Score: 0.75 (Good)<br/> Lined (y/n): Yes</p> | |

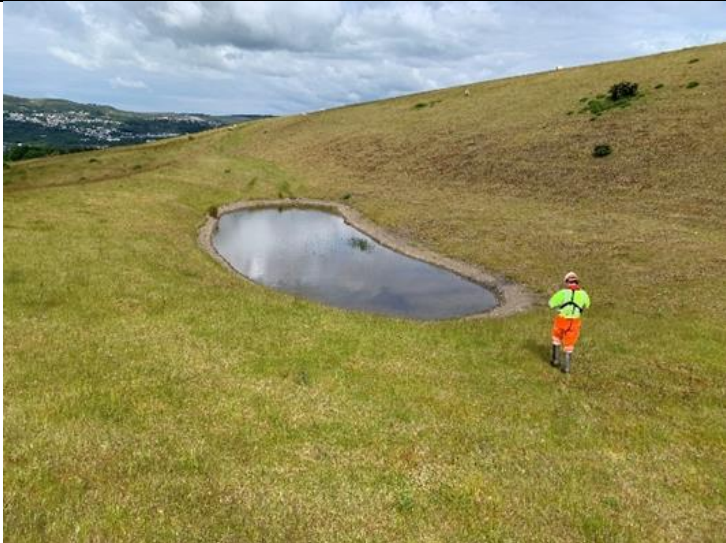
| Ref | Description | Image |
|---|---|---|
| P04 | <p>Set within a previously restored area of grazed grassland, the majority of the riparian zone was free of vegetation, consisting of bare stoney ground, with the exception of a single stand of <i>Juncus</i> spp. This species also comprised the only vegetation within the pond itself, in the form of an emergent stand of less than 5% of the area</p> <p>eDNA result: Positive<br/> HSI Score: 0.51 (Below average)<br/> Lined (y/n): No</p> | |

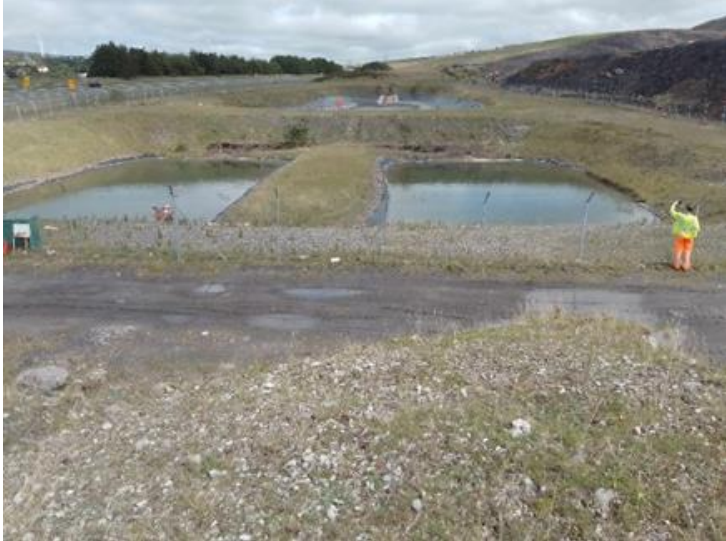
| Ref | Description | Image |
|---|---|---|
| P06 | <p>The banks of the largest of the three sub-divisions was formed of exposed liner and free of vegetation. At the northeastern end was a small strip of densely matted vegetation (primarily <i>Juncus</i> spp.) which formed approximately 5% of the pond area. Minimal aquatic vegetation was observed. The banks of the two adjacent smaller sub-divisions also consisted of exposed liner, though the degree of exposure was significantly less than the larger pond. Marginal vegetation in both these ponds was comprised of <i>Typha</i> spp. (less than 10% of the total area) and floating vegetation in the form of <i>Potamogeton</i> spp. covered approx. 20-30% of the surface of each.</p> <p>eDNA result: Negative<br/> HSI Score: 0.47 (Poor)<br/> Lined (y/n): Yes</p> | |

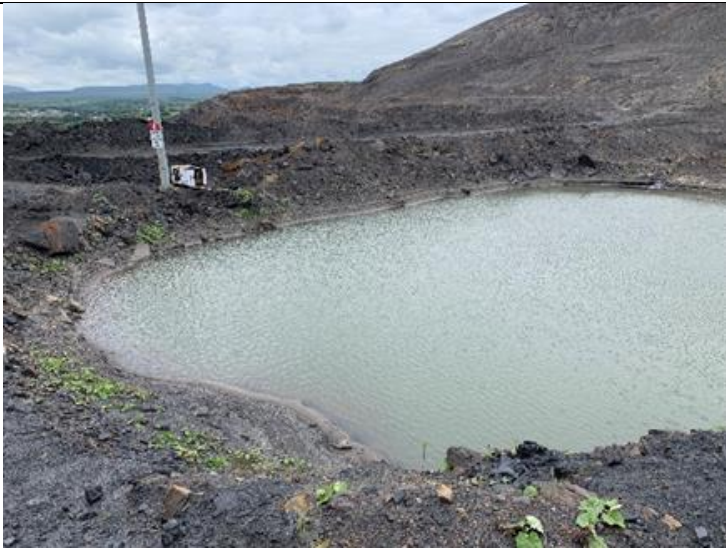
| Ref | Description | Image |
|---|---|---|
| | <p>This pond contained minimal vegetation with the exception of coltsfoot (<i>Tussilago farfara</i>) growing within the colliery spoil which forms the banks and surrounding area. No aquatic vegetation was observed.</p> <p>eDNA result: Negative<br/> HSI Score: 0.30 (Poor)<br/> Lined (y/n): No</p> | |

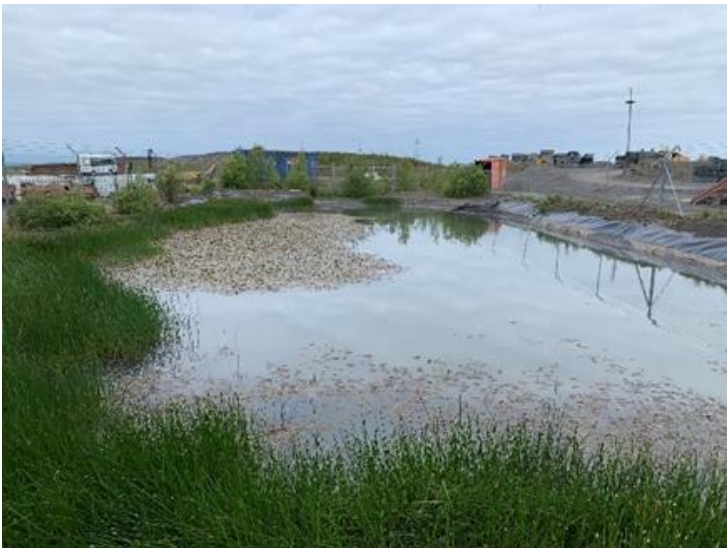
| Ref | Description | Image |
|---|---|---|
| P09 | <p>This pond was comprised of two adjacent sub-divisions. Both were surrounded by a short strip of exposed liner which transitioned into an area of silt deposit before the waters edge. Of the easterly of the two were several small overhanging bushes (<i>Salix</i> spp.) forming approximately 40% of the margin. The surface of this pond was largely covered by <i>Potamogeton</i> spp. interspersed with emergent <i>Juncus</i> spp. Leaves and a stand of <i>Typha</i> spp. The more westerly pond was largely of the same composition but contained significantly more <i>Juncus</i>, which formed a dense strip around approximately 40% of the margin.</p> <p>eDNA result: Positive<br/> HSI Score: 0.45 (Poor)<br/> Lined (y/n): Yes</p> | |

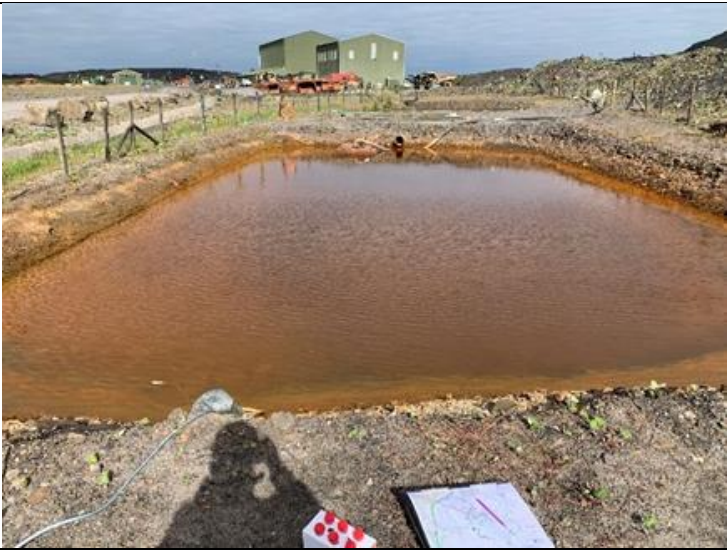
| Ref | Description | Image |
|---|---|---|
| P9a | <p>This washout lagoon was heavily coloured by ochre and contained no submerged or floating vegetation. There were small patches of <i>Juncus</i> and <i>Tussilago farfara</i> around the margins, making up less than 5%.</p> <p>eDNA result: Inconclusive*<br/> HSI Score: 0.43 (Poor)<br/> Lined (y/n): No</p> <p>*Due to suspended sediment levels.</p> | |

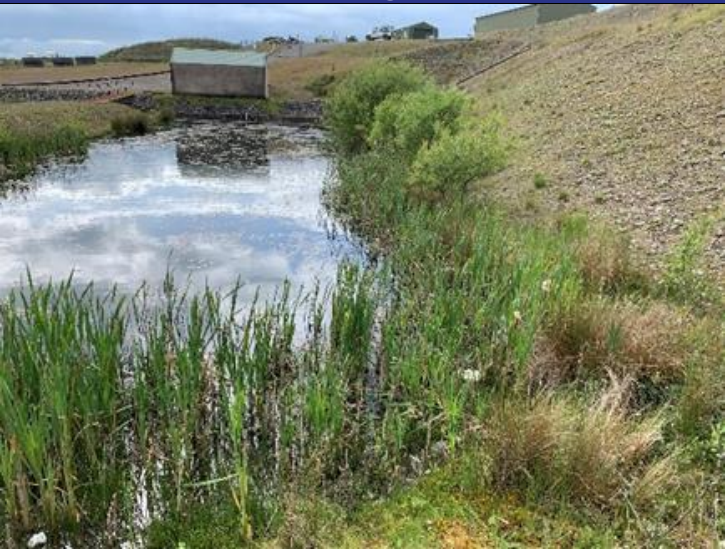
| Ref | Description | Image |
|---|---|---|
| P10 | <p>The margins of both sub-divisions were well vegetated with a composition of sedges (primarily <i>Carex</i> spp.), rushes (<i>Juncus</i> spp.), reedmace (<i>Typha</i> spp.), <i>Salix</i> saplings and <i>Elodea</i> spp. The surface was covered by <i>Potamogeton</i> spp.</p> <p>eDNA result: Positive<br/> HSI Score: 0.64 (Average)<br/> Lined (y/n): No</p> | |

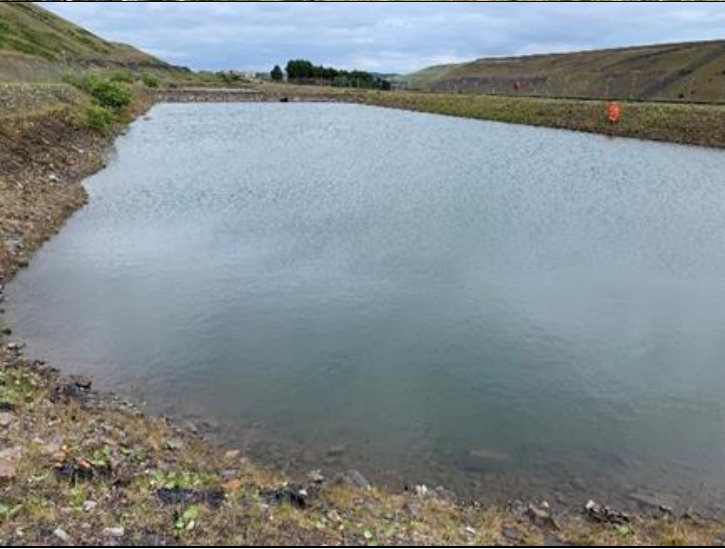
| Ref | Description | Image |
|---|---|---|
| P11 | <p>Banks were dominated by short, patchy graminoids and forbs. These included various grasses, rushes, sedges, horsetail (<i>Equisetum</i>), coltsfoot, thistles, red sorrel (<i>Rumex acetosella</i>). Vegetation was most dense where silt had accumulated at the outflow. Here there were taller stands of <i>Typha</i>, <i>Equisetum</i>, <i>Juncus</i> and <i>Salix</i> saplings.</p> <p>eDNA result: Negative<br/> HSI Score: 0.43 (Poor)<br/> Lined (y/n): No</p> | |

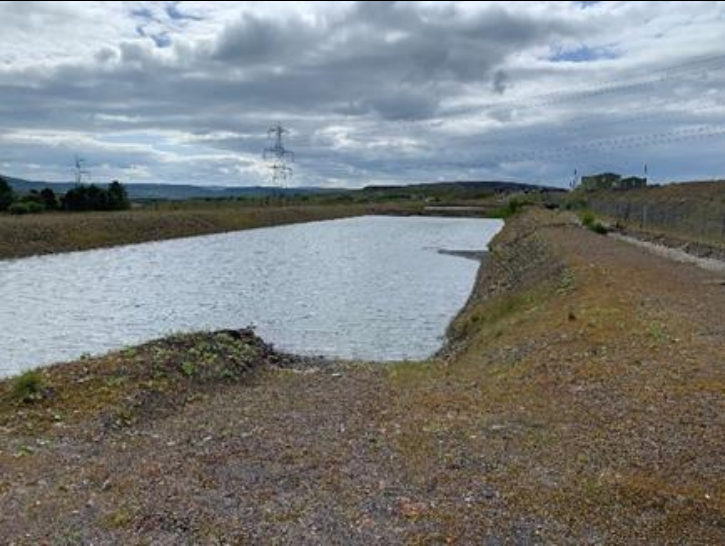
| Ref | Description | Image |
|---|---|---|
| P12 | <p>Largely similar to the adjacent pond 11, with the exception of dense marginal patches of <i>Equisetum</i> in the corners.</p> <p>eDNA result: Negative</p> <p>HSI Score: 0.44 (Poor)</p> <p>Lined (y/n): No</p> | |

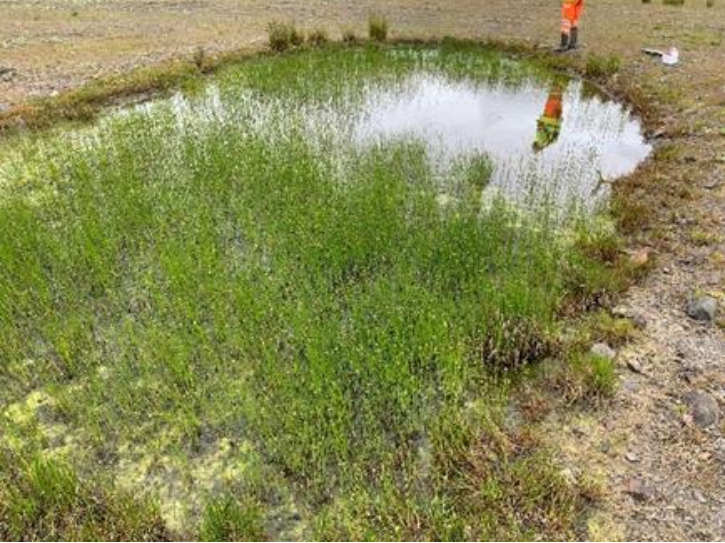
| Ref | Description | Image |
|---|---|---|
| P13 | <p>A shallow pond with minimally discernible banks on the top of OB2, much of the margin and surface was dominated by emergent <i>Juncus</i> interspersed with patches of algae.</p> <p>eDNA result: Negative</p> <p>HSI Score: 0.45 (Poor)</p> <p>Lined (y/n): No</p> | |

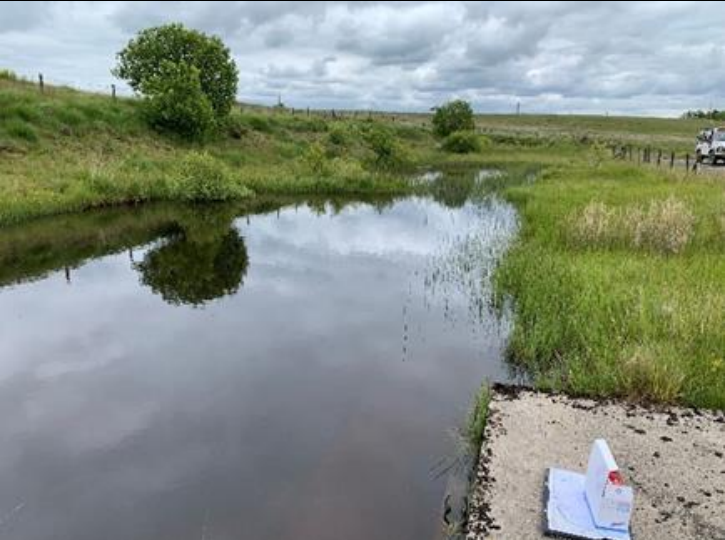
| Ref | Description | Image |
|---|---|---|
| P15 | <p>The margins of this pond were very well vegetated, primarily by <i>Equisetum</i> interspersed with <i>Juncus</i> and <i>Carex</i> as well as a few small <i>Salix</i> saplings. Submerged vegetation was limited but there were areas of <i>Elodea</i> spp. and some floating <i>Potamogeton</i> patches.</p> <p>eDNA result: Positive</p> <p>HSI Score: 0.74 (Good)</p> <p>Lined (y/n): No</p> | <p>The photograph shows a calm pond with a grassy bank on the left. A single tree stands on the bank, its reflection clearly visible in the still water. The sky is overcast with grey clouds. In the foreground, on the right, there is a concrete curb and some discarded white paper or trash.</p> |

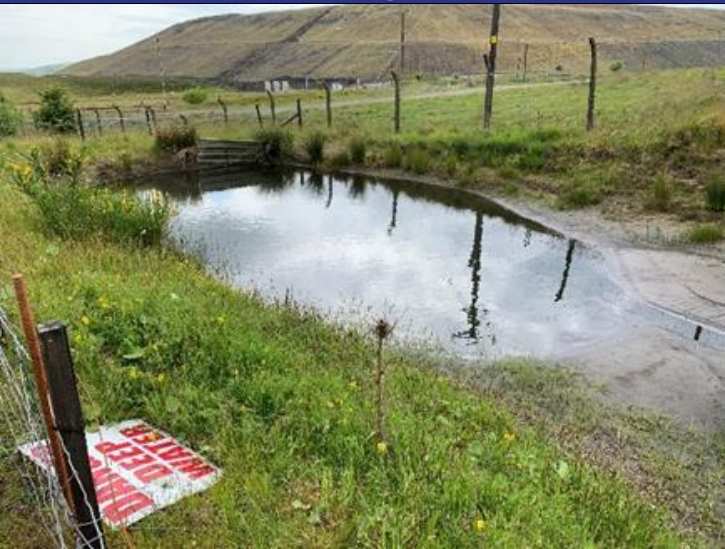
| Ref | Description | Image |
|---|---|---|
| P16 | <p>Approximately 50% of the area was predominantly exposed silt with a narrow channel of shallow water draining into a deeper section at the other end. The margins were well vegetated, primarily by grasses, a single gorse bush and patches of <i>Juncus</i>, with <i>Equisetum</i> occasionally protruding through the exposed silt deposits.</p> <p>eDNA result: Positive<br/> HSI Score: 0.43 (Poor)<br/> Lined (y/n): No</p> | |

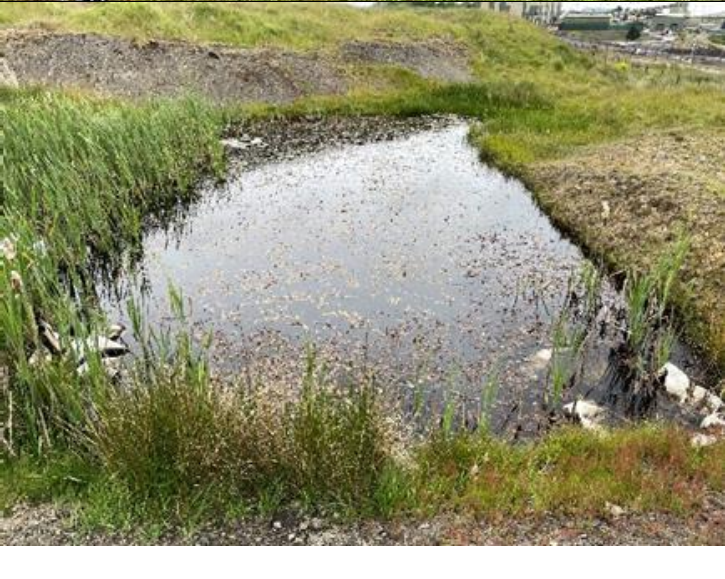
| Ref | Description | Image |
|---|---|---|
| P16a | <p>Well vegetated with 50% of the margin consisting of a dense <i>Typha</i> stand with the remaining area comprised primarily of short grasses and small patches of <i>Juncus</i>. The majority of surface area consisted of a dense mat of <i>Potamogeton</i>.</p> <p>eDNA result: Positive<br/> HSI Score: 0.64 (Average)<br/> Lined (y/n): No</p> | |

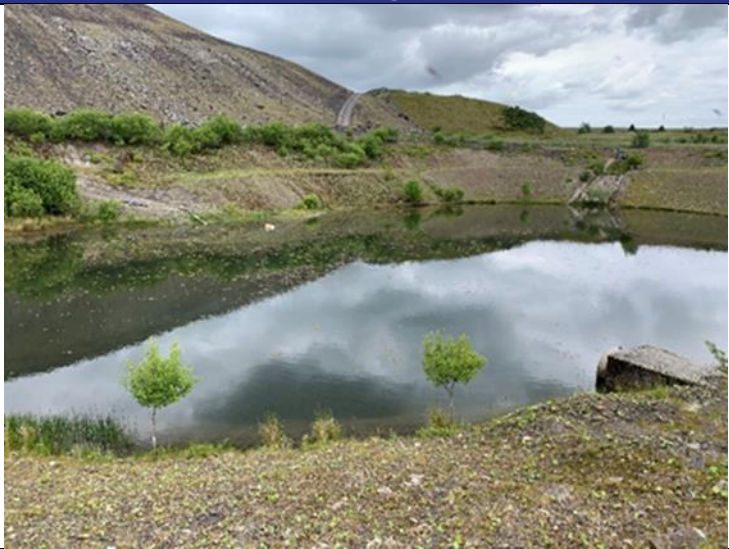
| Ref | Description | Image | |
|---|---|---|---|
| P17 | <p>Wide banks covered with short and patchy grasses and mosses interspersed with coltsfoot. The margin was largely dominated by a thin strip of <i>Juncus</i> with occasional overhanging <i>Salix</i> bushes. Much of the surface area was covered by a thin mat of <i>Potamogeton</i>.</p> <p>eDNA result: Positive<br/> HSI Score: 0.68 (Average)<br/> Lined (y/n): No</p> | | |

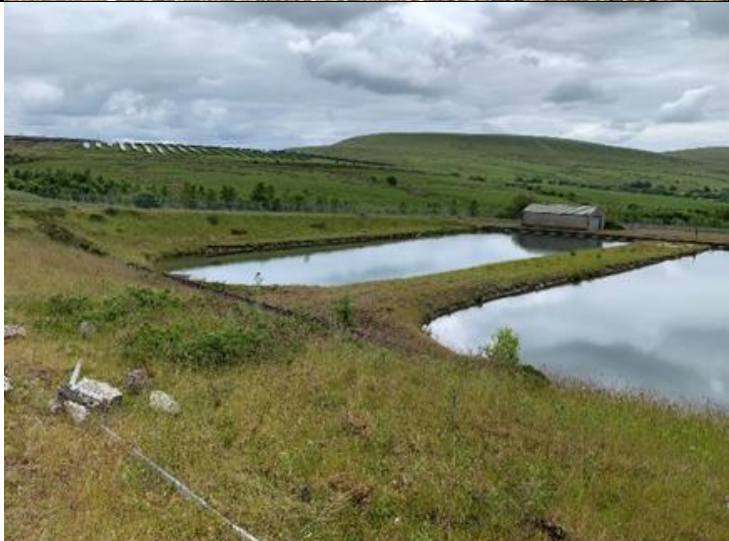
| Ref | Description | Image | |
|---|---|---|---|
| P18 | <p>The banks of both sub-divisions were well vegetated, consisting mostly of very short grasses and forbs. Marginal vegetation was minimal with the occasional small stand of <i>Juncus</i> and <i>Typha</i>. Floating vegetation was also relatively minimal, with some small areas of <i>Potamogeton</i> toward the margins where the water was shallower.</p> <p>eDNA result: Positive<br/> HSI Score: 0.65 (Average)<br/> Lined (y/n): No</p> | | |

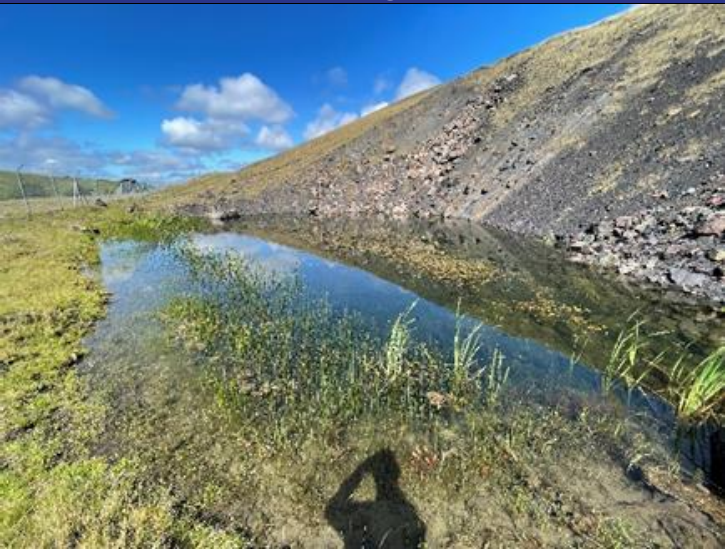
| Ref | Description | Image |
|---|---|---|
| P19 | <p>50% of the margin comprised a sheer wall where material has slipped from the adjacent OB3. The accessible margin showed no discernible bank, transitioning from grassland directly to shallow water, followed by a steep drop off into deep, clear water. Around the shallow marginal strip was submerged grass with emergent <i>Juncus</i> and the occasional <i>Typha</i>. Over the deepest section a mat of <i>Potamogeton</i> was evident.</p> <p>eDNA result: Negative<br/> HSI Score: 0.58 (Below average)<br/> Lined (y/n): No</p> | |

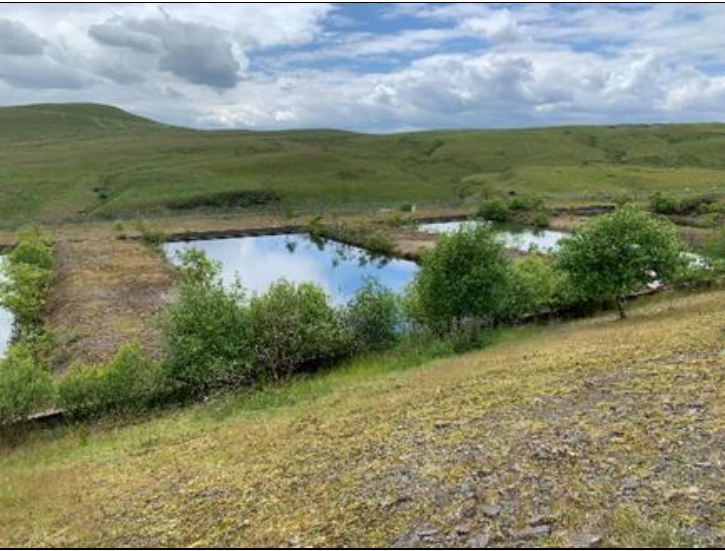
| Ref | Description | Image |
|---|---|---|
| P20 | <p>The banks of both sub-divisions were sparsely vegetated by short, dry and patchy grasses and mosses interspersed with lichen. Marginal vegetation was limited to small patches of <i>Juncus</i>. The dominant feature was the presence of large over-hanging bushes around much of water's edge, predominantly <i>Salix</i> and <i>Betula</i> with the occasional <i>Buddleja</i>.</p> <p>eDNA result: Positive<br/> HSI Score: 0.68 (Poor)<br/> Lined (y/n): No</p> | |

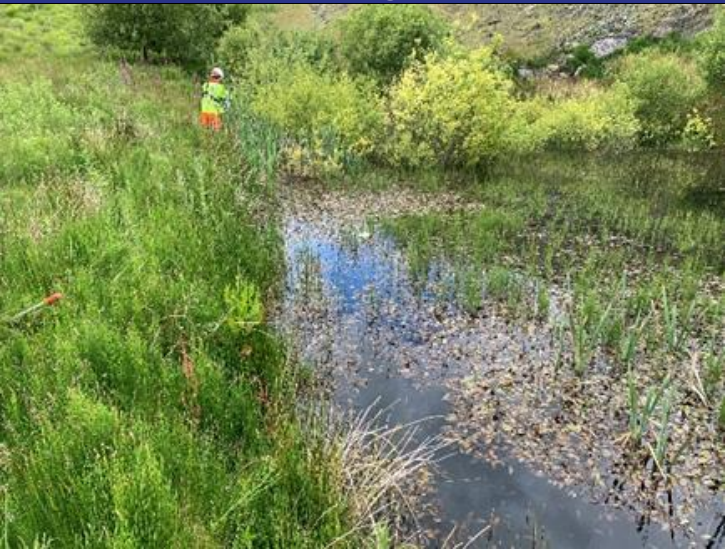
| Ref | Description | Image |
|---|---|---|
| P21 | <p>Fed by Bargod taf stream and formed in a depression at the foot of OB3. A high-quality and heavily vegetated pond with clear water. Much of the riparian zone is dominated by large <i>Salix</i> bushes surrounded by <i>Juncus</i> and tall ruderals such as rosebay willowherb (<i>Chamaenerion angustifolium</i>) and foxglove (<i>Digitalis purpurea</i>). The margins are dominated by a dense mat of <i>Equisetum</i> interspersed with <i>Juncus</i>, <i>Carex</i> and grasses (mainly <i>Cynosurus cristatus</i> and <i>Anthoxanthum odoratu</i>). The surface of the pond is largely covered by <i>Potamogeton</i> with emergent <i>Typha</i> and <i>Equisetum</i> scattered throughout.</p> <p>eDNA result: Negative<br/> HSI Score: 0.75 (Good)<br/> Lined (y/n): No</p> | |

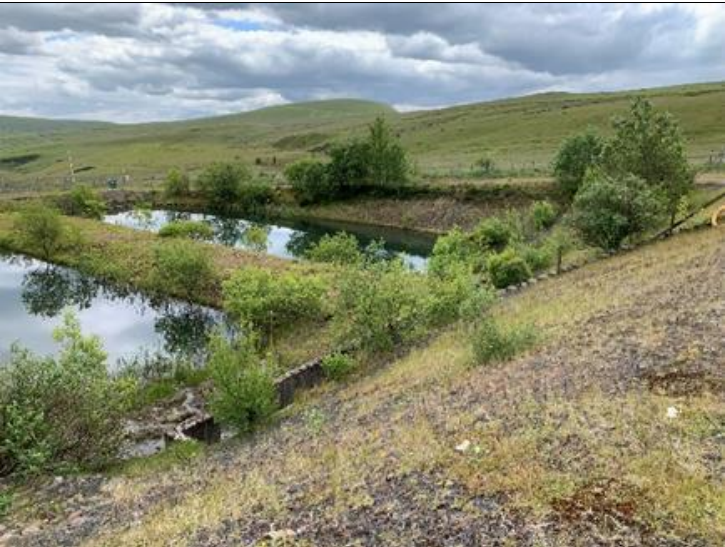
| Ref | Description | Image |
|---|---|---|
| P22 | <p>Both sub-divisions have similar characteristics, with banks dominated by <i>Salix</i> bushes and occasional <i>Buddleja</i>. The majority of the margins consist of a thin covering of <i>Typha</i>. Submerged and floating vegetation were not observed.</p> <p>eDNA result: Positive<br/> HSI Score: 0.70 (Good)<br/> Lined (y/n): No</p> | |

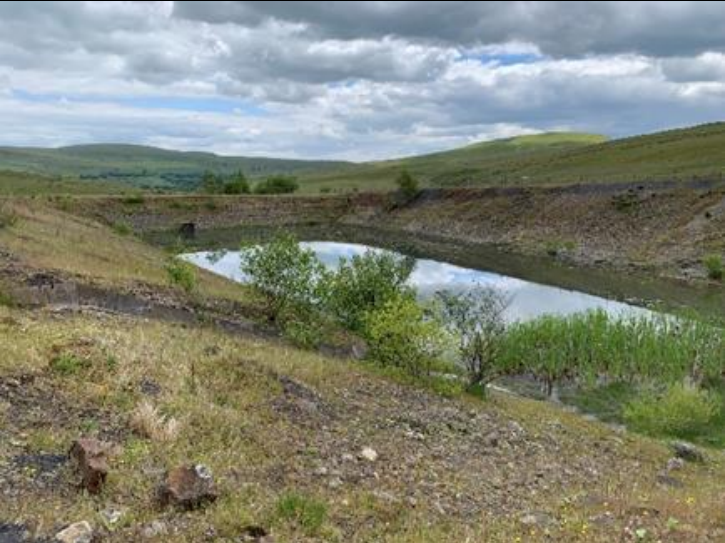
| Ref | Description | Image | |
|---|---|---|---|
| P23 | <p>The banks were dominated by mosses and short grasses interspersed with <i>Tussilago farfara</i>, hawksbit (<i>Leontodon</i> spp.), thistles (<i>Cirsium</i> spp.) and <i>Equisetum</i>. Numerous self-set <i>Salix</i> and <i>Buddleja</i> bushes were also present along the banks. Marginal vegetation was generally minimal, with the exception of dense <i>Typha</i> stands growing on a silt deposit at the western end. Sparse mats of <i>Potamogeton</i> were present on the surface over much of the area.</p> <p>eDNA result: Negative<br/> HSI Score: 0.60 (Average)<br/> Lined (y/n): No</p> | | |

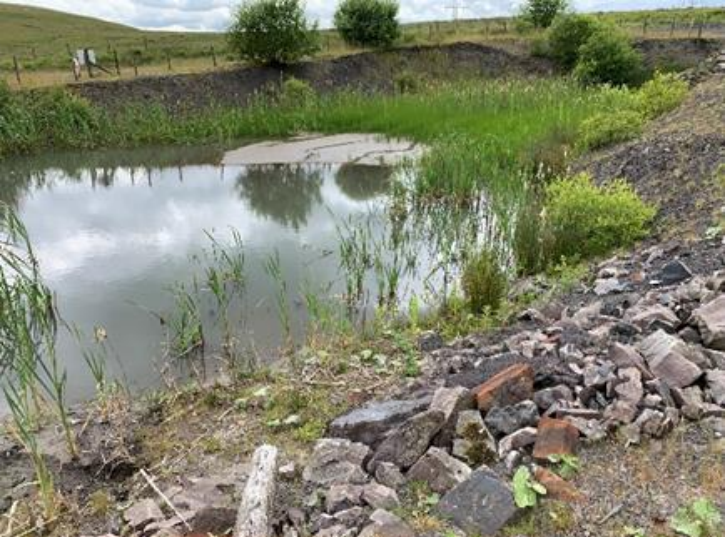
| Ref | Description | Image | |
|---|---|---|---|
| P24 | <p>Banks consist mainly of coal spoil and fine gravel, with some areas of larger rubble deposits, thinly covered by short grasses and <i>Tussilago</i>, with self-set <i>Salix</i> saplings dotted throughout. <i>Typha</i> covers nearly the entire margin, with some small patches of <i>Juncus</i> growing on transitional silt deposits. The eastern half of the pond is largely un-vegetated open water, with the northern half divided equally between exposed silt followed by dense <i>Typha</i>.</p> <p>eDNA result: Negative<br/> HSI Score: 0.66 (Average)<br/> Lined (y/n): No</p> | | |

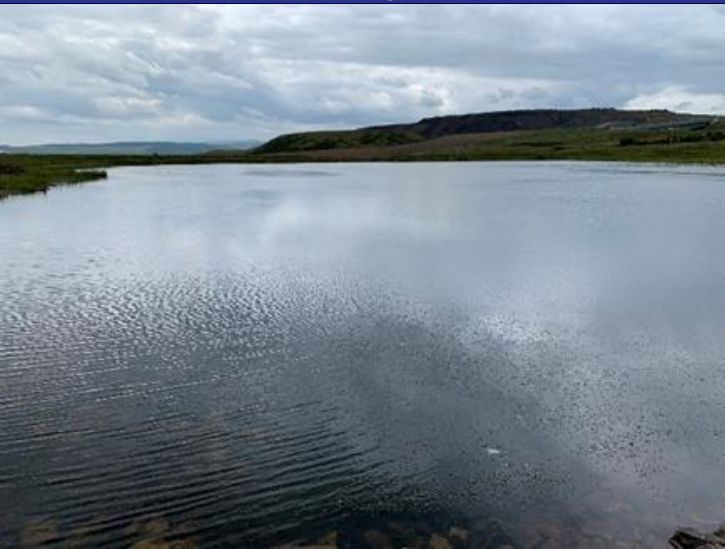
| Ref | Description | Image |
|---|---|---|
| P25 | <p>A large pond with characteristics of a small lake, set within a moorland habitat of grasses (Yorkshire fog, <i>Halcus lanatus</i>; Purple moor-grass, <i>Molinia caerulea</i>; Cotton grass, <i>Eriophorum angustifolium</i>), rushes (mainly <i>Juncus effusus</i>) and sedges (mainly yellow sedge, <i>Carex demissa</i>). Banks were shallow and poorly defined, dominated by <i>Juncus</i> transitioning into a rocky bed. Submerged vegetation was primarily of <i>Elodia</i> spp. and floating vegetation was absent.</p> <p>eDNA result: Negative<br/> HSI Score: 0.47 (Poor)<br/> Lined (y/n): No</p> | |

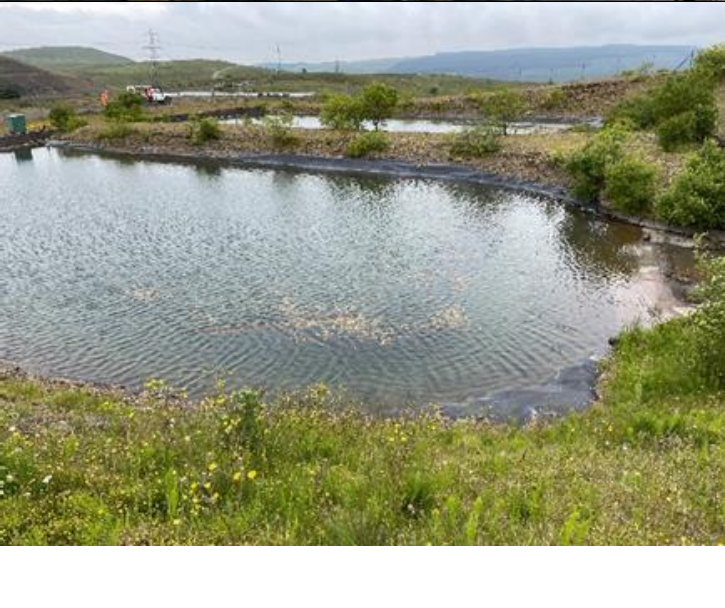
| Ref | Description | Image |
|---|---|---|
| P27 | <p>The banks were dominated by a sparse mixture of <i>Equisetum</i>, <i>Juncus</i>, Hawkbit (<i>Leontodon</i>), Bird's-foot trefoil (<i>Lotus corniculatus</i>) and white clover (<i>Trifolium repens</i>), interspersed with spear-thistle (<i>Cirsium vulgare</i>) and self-set <i>Salix</i> of varying sizes. A small strip of pond liner was exposed adjacent to the water's edge and marginal vegetation was largely absent. The more southerly of the two sub-divisions contained a thin mat of <i>Potamogeton</i> over approximately 20% of the area, whereas aquatic vegetation was absent from the more northerly sub-division.</p> <p>eDNA result: Positive<br/> HSI Score: 0.61 (Average)<br/> Lined (y/n): Yes</p> | |

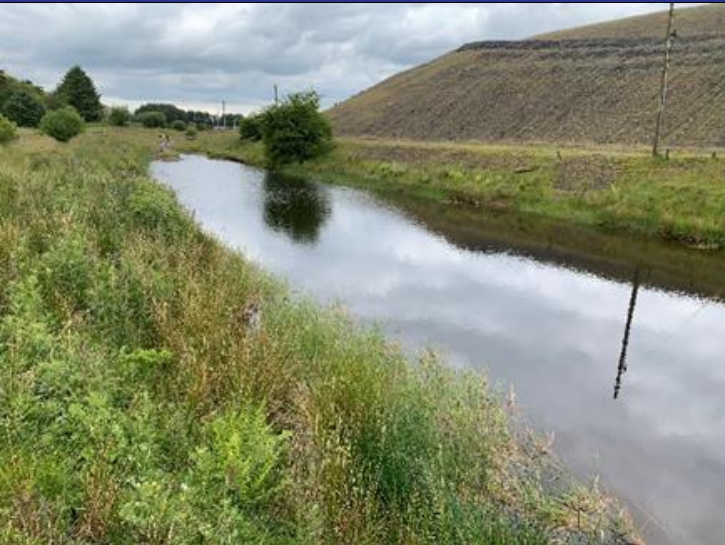
| Ref | Description | Image | |
|---|---|---|---|
| P28 | <p>The pond is formed in a narrow depression along the route of the old railway track. The western edge is largely un-vegetated and of bare ground and small pebbles. The northern, eastern and southern banks are covered mainly by <i>Juncus</i>, with bracken (<i>Pteridium</i>) and spear-thistle (<i>Cirsium vulgare</i>). The pond itself was free of aquatic vegetation. In addition to the pond, a narrow drainage channel, with some open water, dominated by <i>Typha</i>, <i>Juncus</i> and <i>Eriophorum</i> runs adjacent to the northern edge.</p> <p>eDNA result: Positive<br/> HSI Score: 0.68 (Average)<br/> Lined (y/n): Unknown</p> | | |

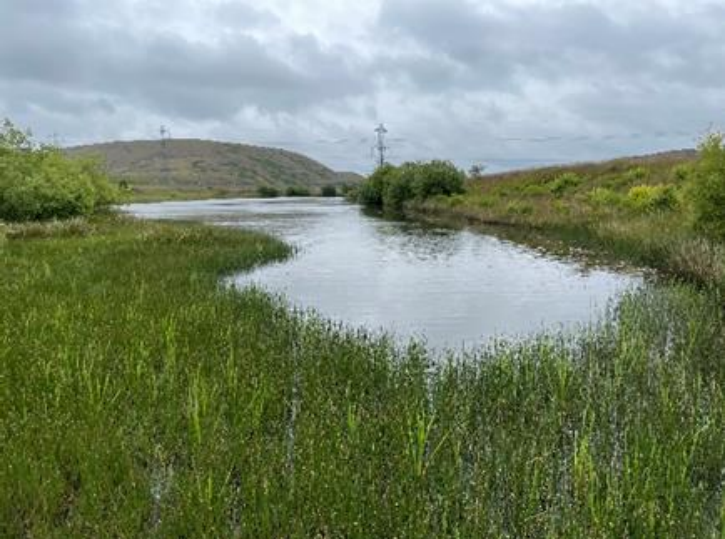
| Ref | Description | Image | |
|---|---|---|---|
| P29 | <p>Within the central ecological zone, the northern and western edges of this large pond show no discernible bank, with dense <i>Juncus</i> transitioning into open water. This area is also interspersed with <i>Carex</i>, <i>Typha</i>, <i>Eriophorum</i> and large <i>Salix</i> bushes. The southern and eastern edges are defined by a grassy bank with <i>Pteridium</i>. Aquatic vegetation was limited to sparse areas of <i>Elodea</i> around the margins.</p> <p>eDNA result: Positive<br/> HSI Score: 0.77 (Good)<br/> Lined (y/n): No</p> | | |

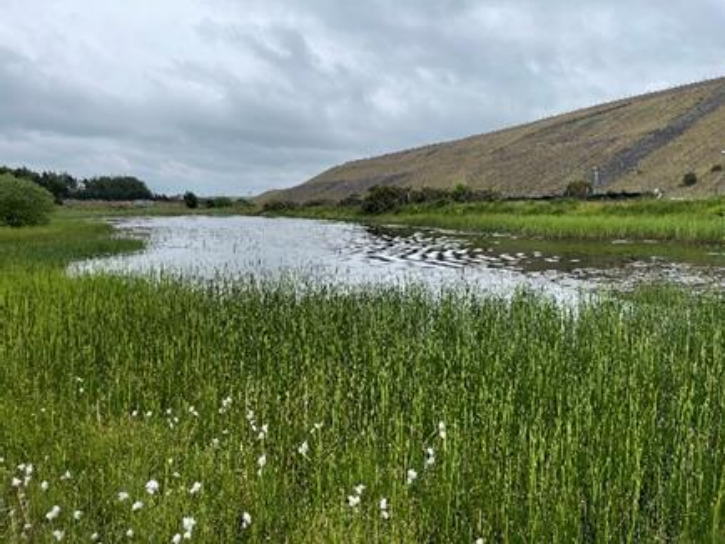
| Ref | Description | Image |
|---|---|---|
| P30 | <p>A large pond within the central ecological zone, very similar in composition to Pond 29, with the exception of a significant amount of <i>Equisetum</i> interspersed with <i>Juncus</i> and ground flora of <i>Sphagnum</i>. The bank along the eastern and southern edges contains some bushes of gorse (<i>Ulex</i>) and hawthorn (<i>Crataegus monogyna</i>) in addition to the <i>Salix</i>. The eastern and western margins are dominated by dense stands of <i>Typha</i>.</p> <p>eDNA result: Positive<br/> HSI Score: 0.77 (Poor)<br/> Lined (y/n): No</p> | |

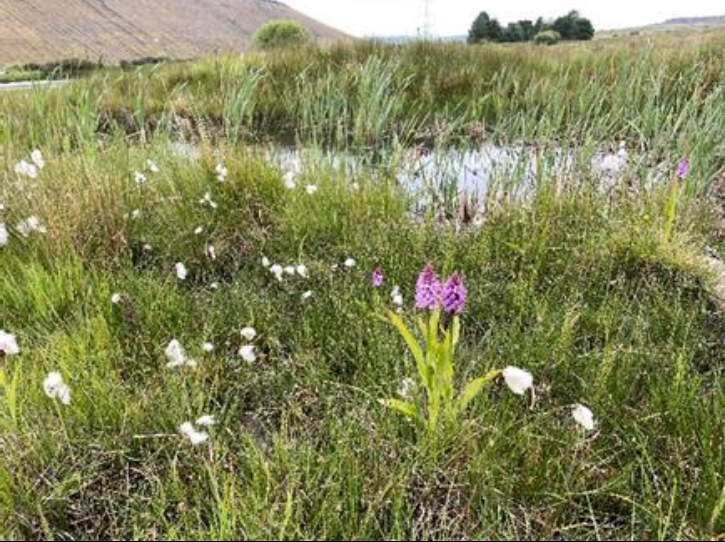
| Ref | Description | Image |
|---|---|---|
| P30a | <p>A smaller pond within the central ecological zone with poorly defined banks covered by <i>Carex</i>, <i>Juncus</i>, <i>Eriophorum</i> and <i>Equisetum</i>. <i>Typha</i> grows around the margins and is sparsely emergent throughout the rest of the surface area.</p> <p>eDNA result: Positive<br/> HSI Score: 0.62 (Average)<br/> Lined (y/n): No</p> | |
