**2, SOMERSET LANE, CEFN-COED-Y-CYMMER, MERTHYR  
TYDFIL**

**ECOLOGICAL APPRAISAL**

**DECEMBER 2020**

Proposed Development: Demolition of 2 Somerset Lane

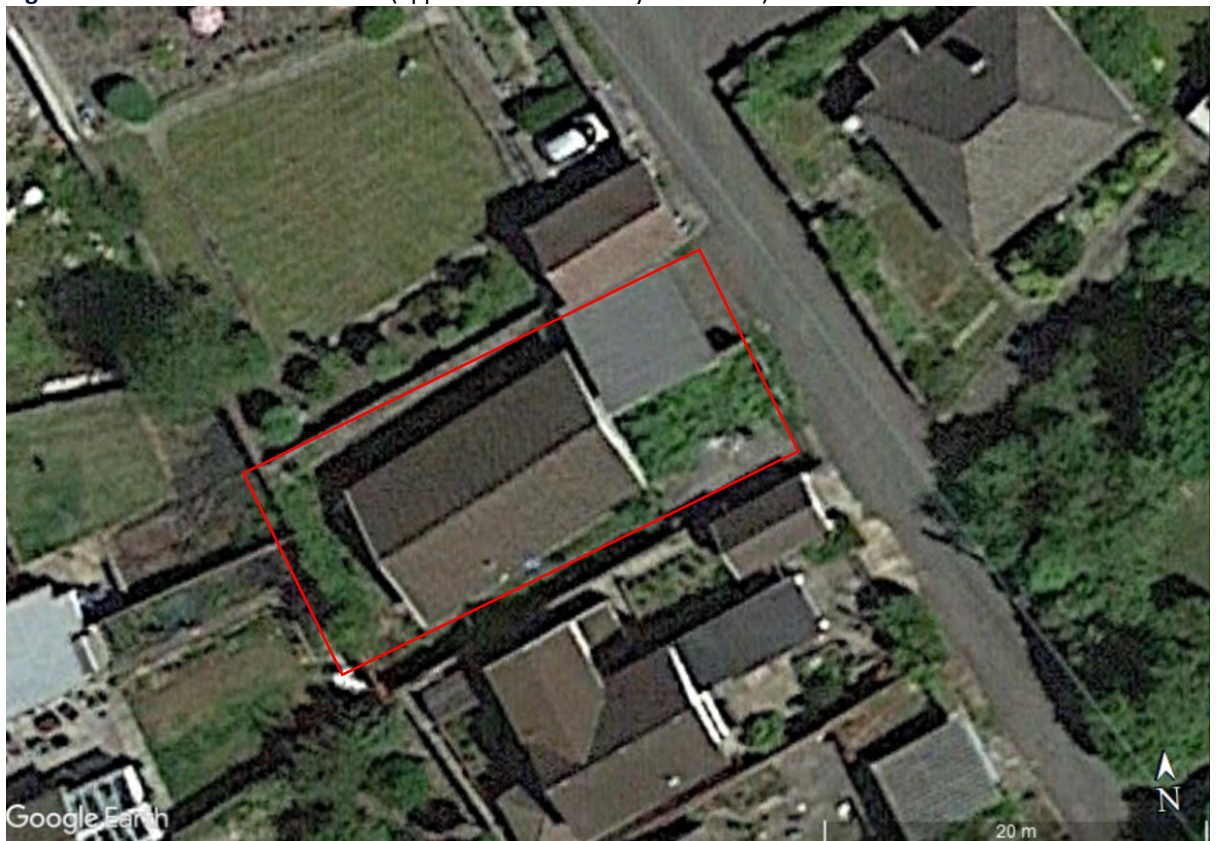
**Figure 1** – Detailed view of the site (approximate boundary boxed red)

The site is located on the western edge of 2 Somerset Lane, Cefn-Coed-Y-Cymmer, Merthyr Tydfil. The site comprises of a bungalow, a single storey garage, a drive, hard standing and a small patch of bramble scrub.

The bungalow is a single-storey structure that is rectangular in shape and has a ridge that generally runs from west to east. There is a single-storey garage to the east that fronts Somerset Lane.

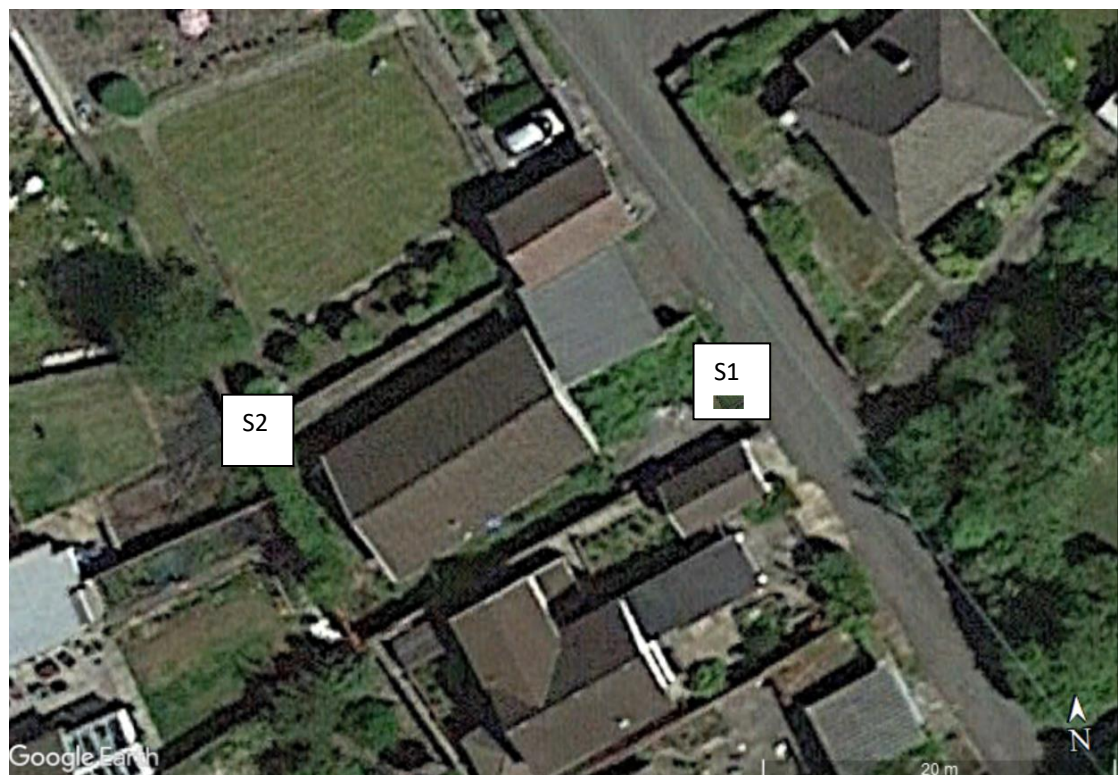
Figure 3: Approximate surveyor locations

A survey was carried out on 10<sup>th</sup> August using two surveyors ,positioned in such a way that as much of the building was visible to surveyors as possible. Surveyors were equipped with Batlogger M detectors (figure 3).
