## **3 PANDY COTTAGES, TRELEWIS, MERTHYR TYDFIL**

### **POTENTIAL ROOST ASSESSMENT AND BAT PRESENCE ABSENCE SURVEY 2023 AND ENHANCEMENTS**

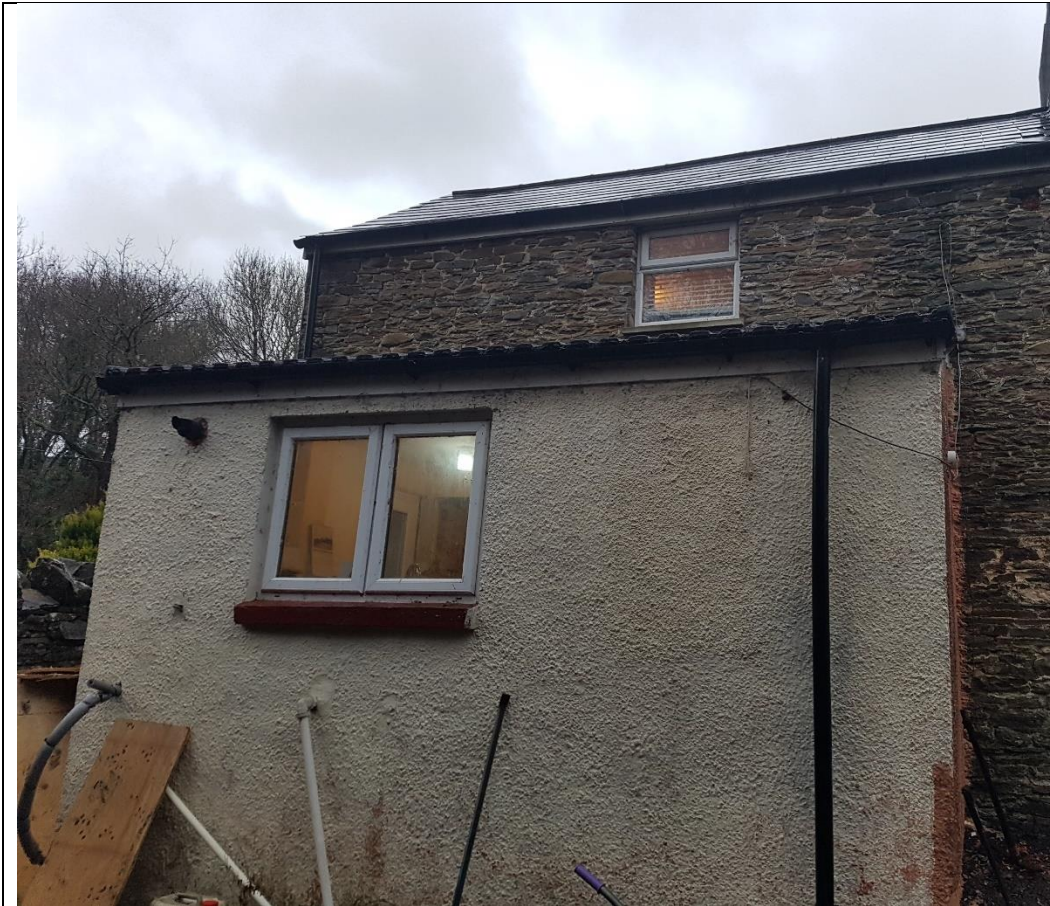
Photo 2.  
Rear  
(west)  
with  
lean -to  
for  
demoliti  
on

The most notable gaps affected by the proposed demolition and construction were noted at the edges of the join of the extension to the rear wall of the house. A gap was noted on both sides of the extension. There was small gap along beneath the barge boards on the north and south sides.

- Part of the removal of the existing extension must be done by hand using a soft strip method. The flashings, tiles fascia and barge boards must be removed using this method under the supervision of an ecologist, following a toolbox talk (Ec & Con).
