**Bat Survey:** Tregenna Hotel, Park Terrace, Merthyr Tydfil, CF47 8RF

**Instructed by:** Merthyr Valley Homes

**Reported by:** Ecological Services Ltd  
10 Mount Pleasant, Llanelly Hill, Abergavenny, Monmouthshire, NP7 0NT

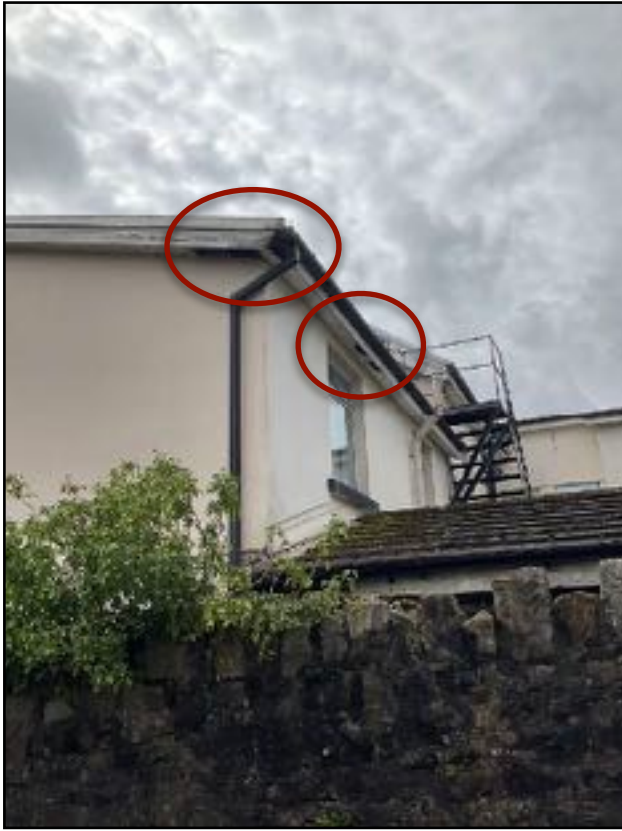
Potential Access Point

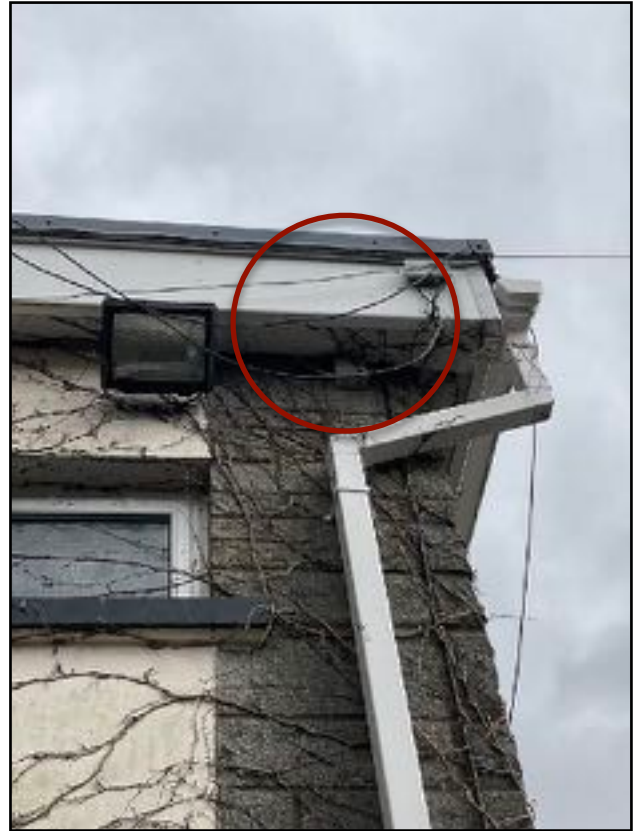
**6.5** Evidence of nesting bird use of the south western elevation of the main hotel building was observed during the scoping survey. The species of bird was not confirmed but back and forth behaviour was observed from the soffit in this area by a small bird.

Evidence of Nesting Bird Use

**10.4 Evidence of nesting bird use of the south western elevation of the main hotel building was observed during the surveys. Any building works must if possible be completed outside of the bird nesting season of March to August inclusive. If works are to proceed in the nesting bird season then a suitably qualified ecologist must first inspect the building for active birds nests. No works can commence until any active birds nests become vacant.**

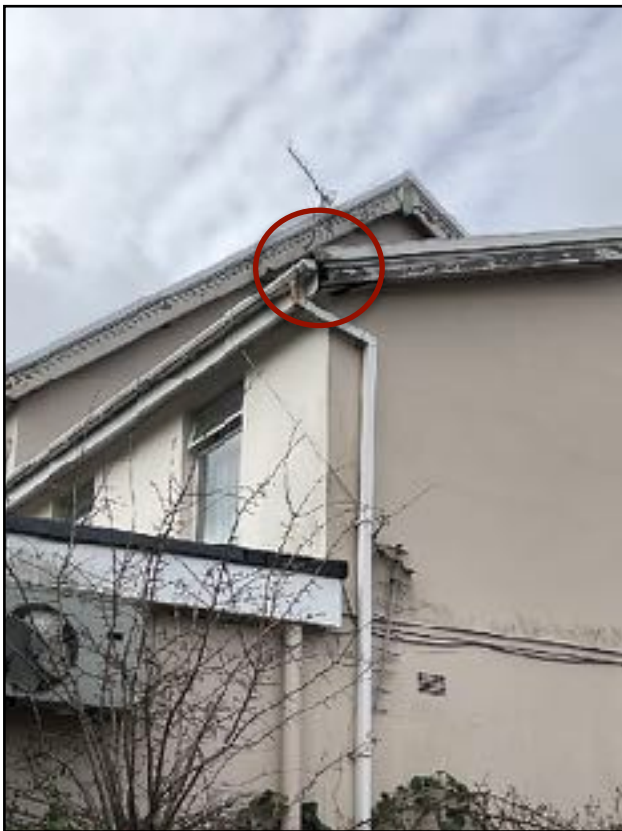
Potential Access Point

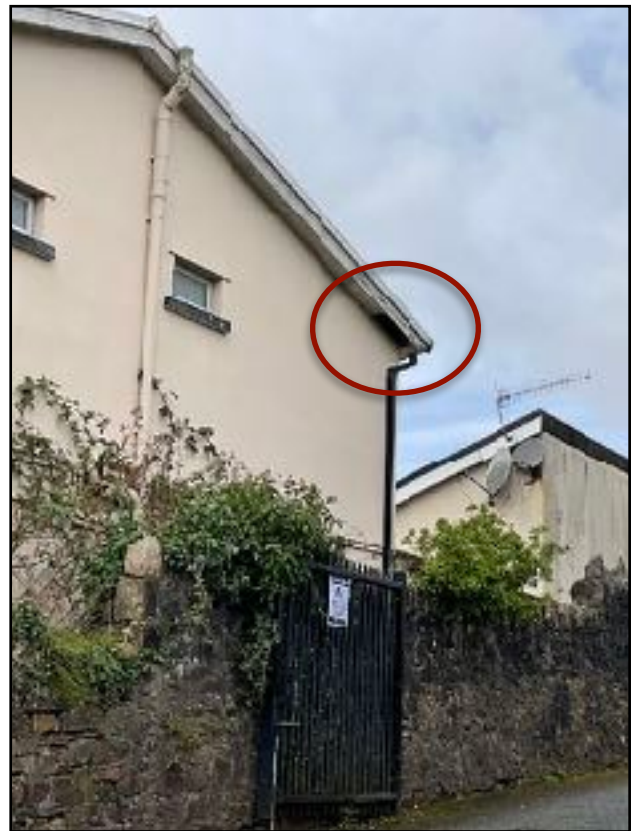
Potential Access Point

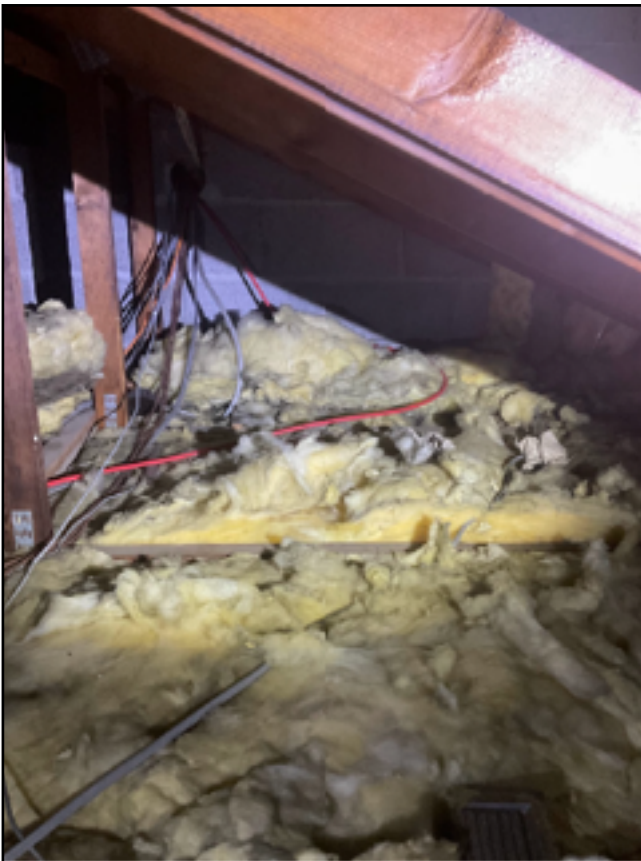
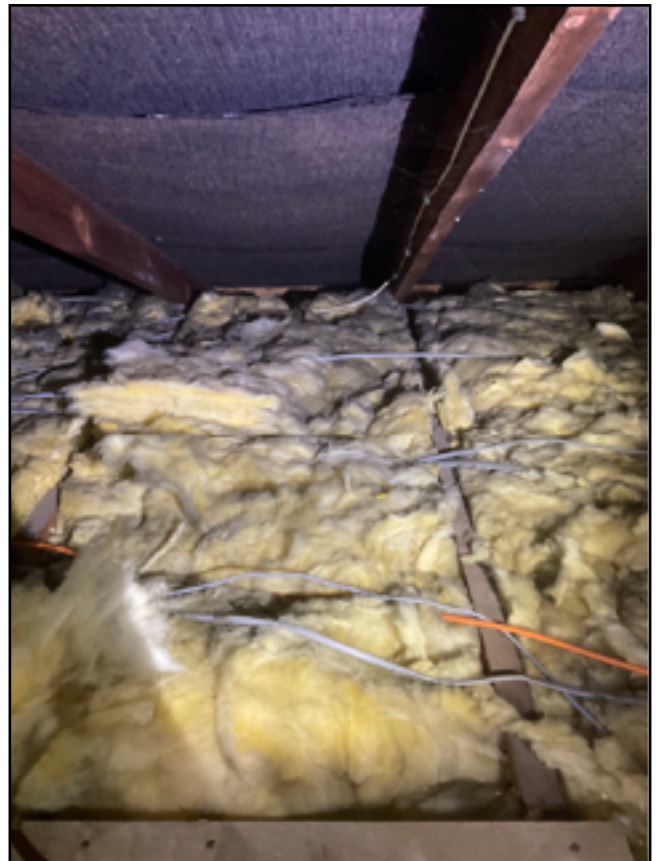
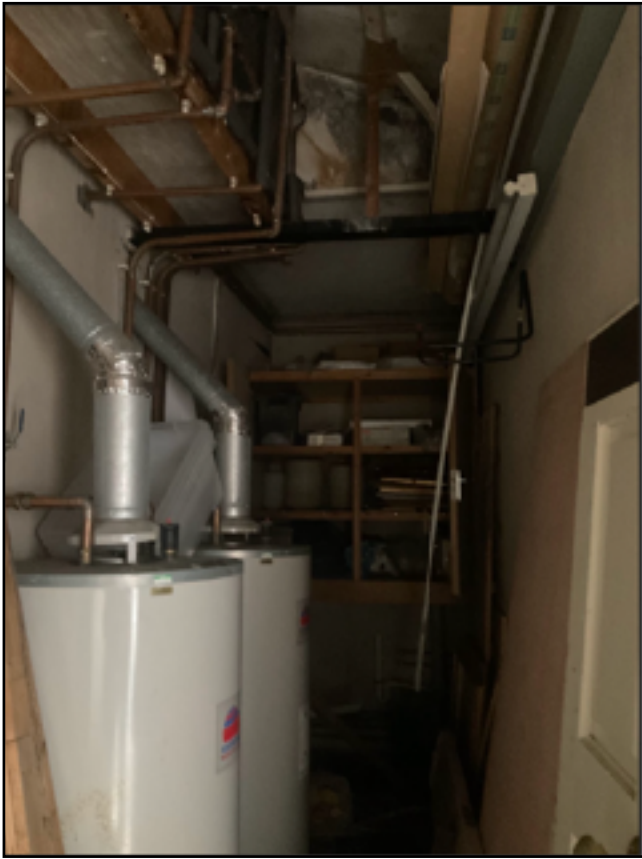
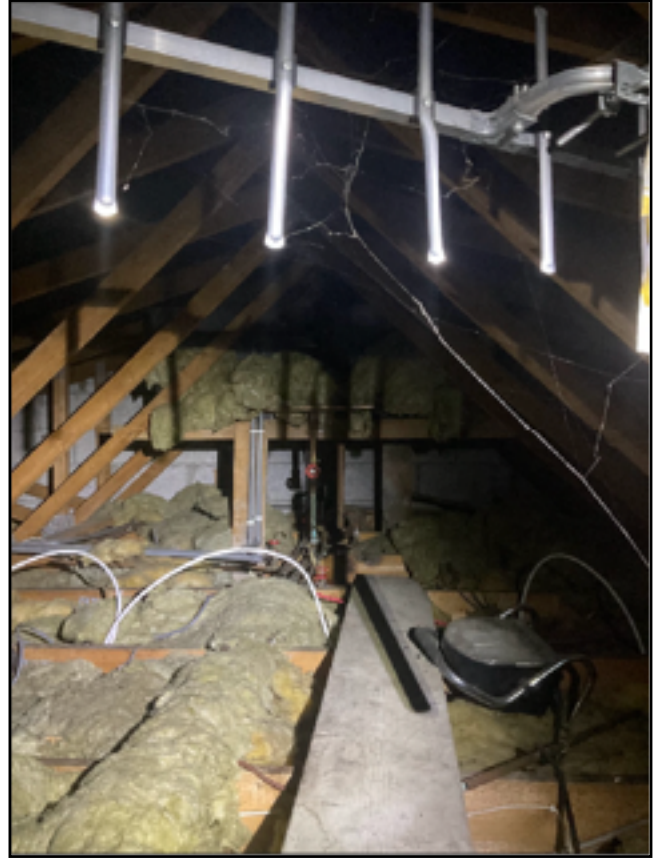
7.2 There were individual attic spaces within each of the 'chalet' rooms. These attic spaces were all of the same construction and consisted of a trussed design with insulation covering the floor. All of the attic spaces were lined and were not boarded out. There were small areas of visible light within each of the attic spaces along the south eastern elevation of the roofline. **There were a number of mouse droppings present within the attic spaces, however, no bat droppings were observed.**

7.3 There were two accessible attic spaces within the main building. These attic spaces were of the same construction as the 'chalet' attic spaces. **There were a number of mouse droppings present within the attic spaces, however, no bat droppings were observed.**

7.4 There was a boiler room present within the 'chalet' block which did not have an accessible attic space. **The odd singular bat dropping was observed on the tops of the water heaters.** The droppings were indicative of a crevice dwelling species of bat and are likely to be exploratory in nature.

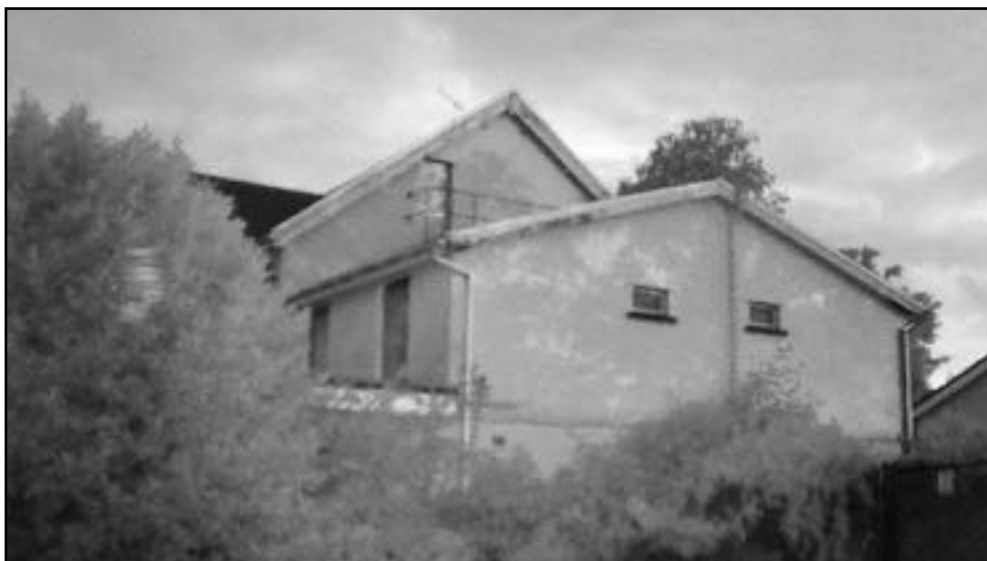
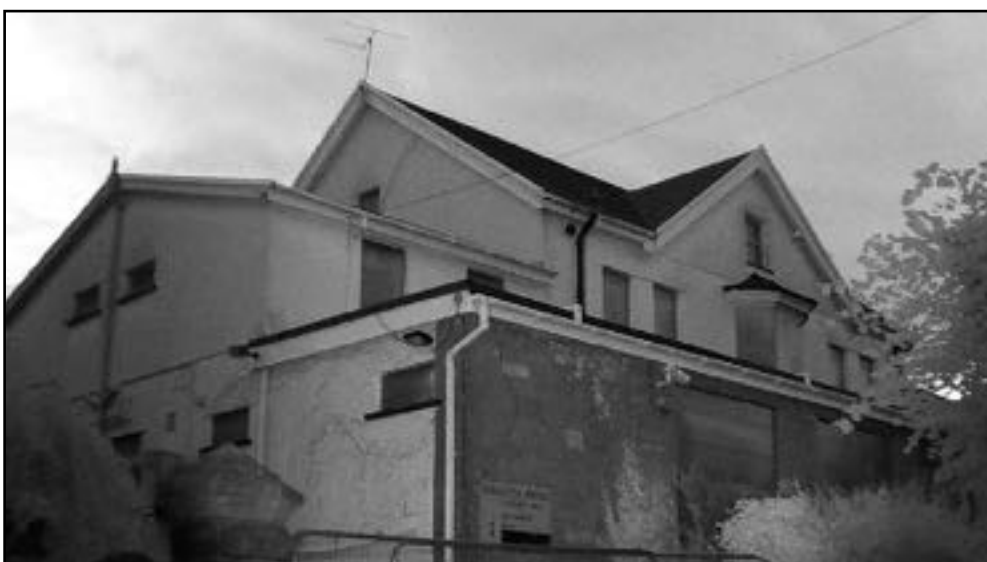
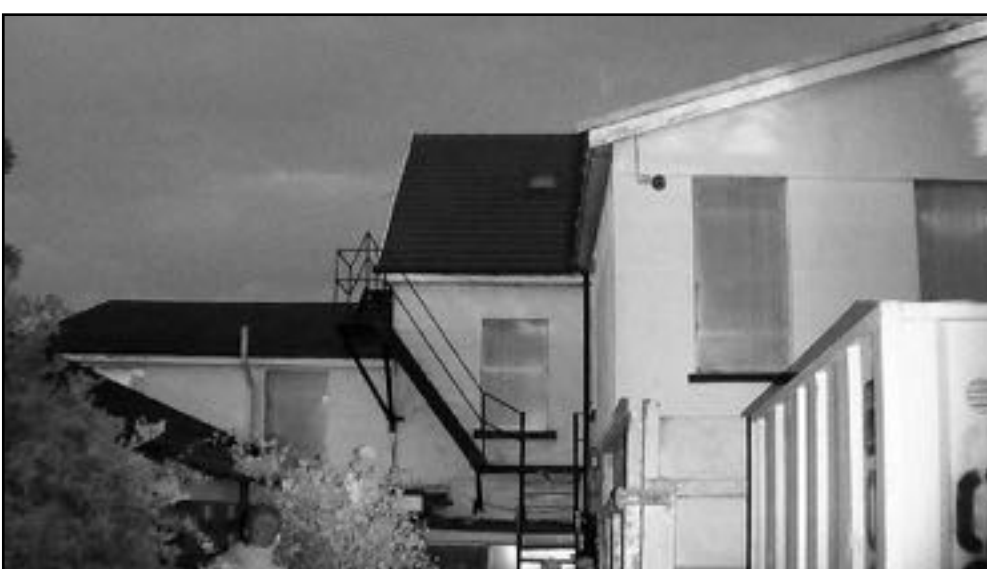
### 8.11 Examples of NVA Still Shots:

**8.10** During the second emergence survey, no bats were detected or observed.

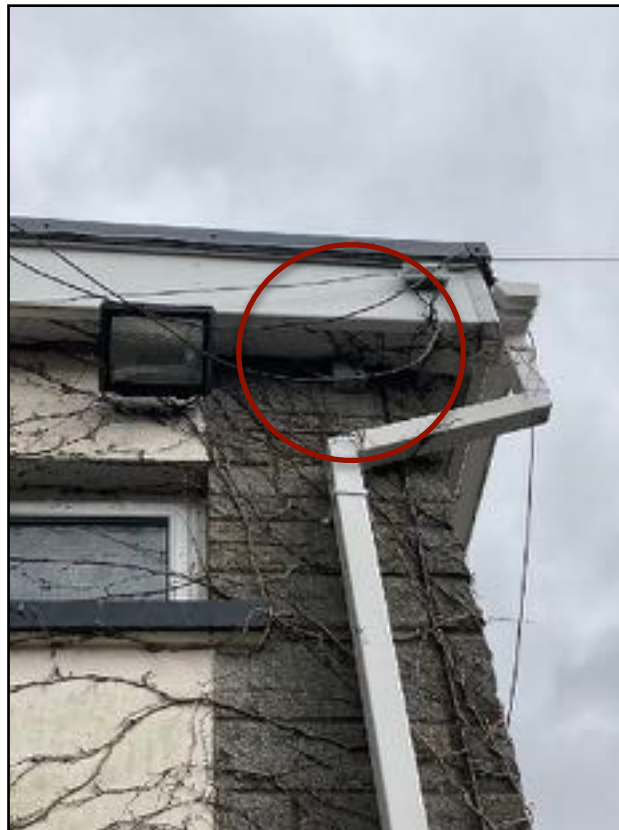
Evidence of Nesting Bird Use

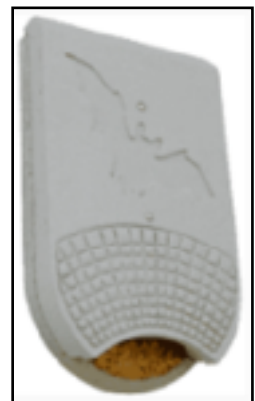
11.7 It is proposed that further new roosting for bats be created by fitting one Schwegler 1FQ surface mounted bat box on the south western elevation of the main hotel building.

11.8 Bat enhancements will benefit from the southern elevation or an elevation where there is direct access to sunlight as the bats can tolerate and prefer high levels of temperature in their roost.

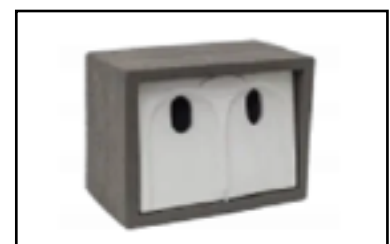
11.9 Two Vivara Pro WoodStone House Sparrow Nest Boxes will be surface mounted on the north eastern elevation of the main hotel building. **These will not be situated on a south facing elevation.**

11.10 Any nesting bird enhancements will not be suited on the south elevation as this may experience excess heat from the sun.
