## EAST BOUNDARY WALL & ASSOCIATED LANDSCAPING

### THE YMCA BUILDING, MERTHYR TYDFIL

October 2022

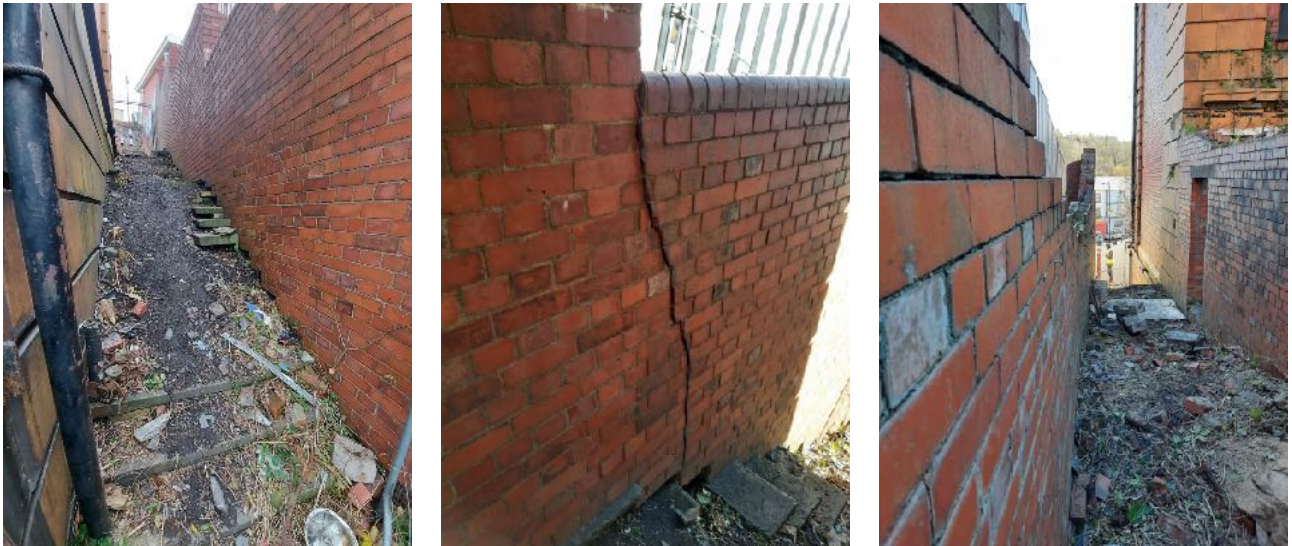
*Above: The gap between the YMCA and the east retaining wall, following removal of the rubbish that covered it. This removal confirmed:*

- *An earlier path, including stairs with large stone nosings/goings (partially visible in the above).*
- *The retaining wall had simply been built immediately on top of this earlier landscaping, with no foundation.*

*Due to the pressure imposed by the retained soil and its inadequate construction, this wall was leaning towards the YMCA and with a prominent crack within it.*

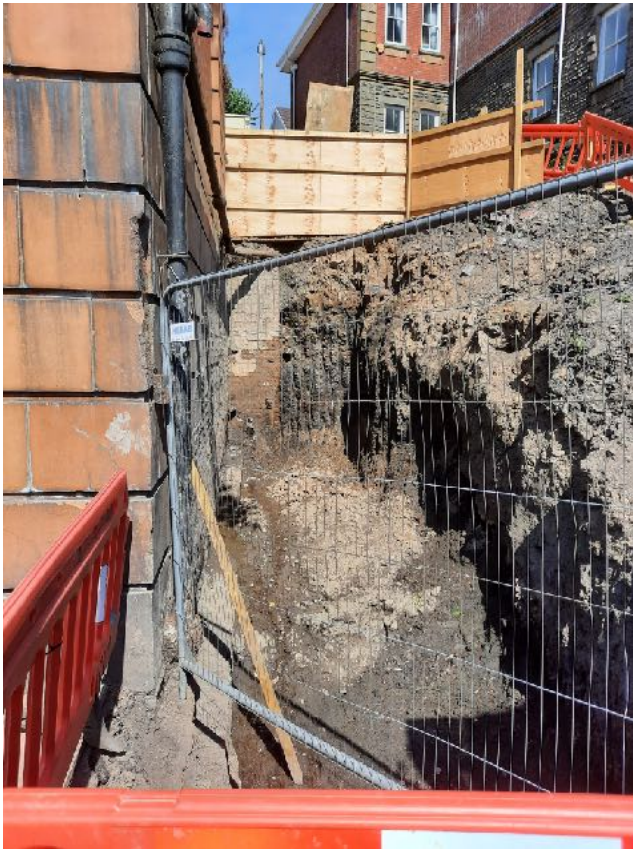
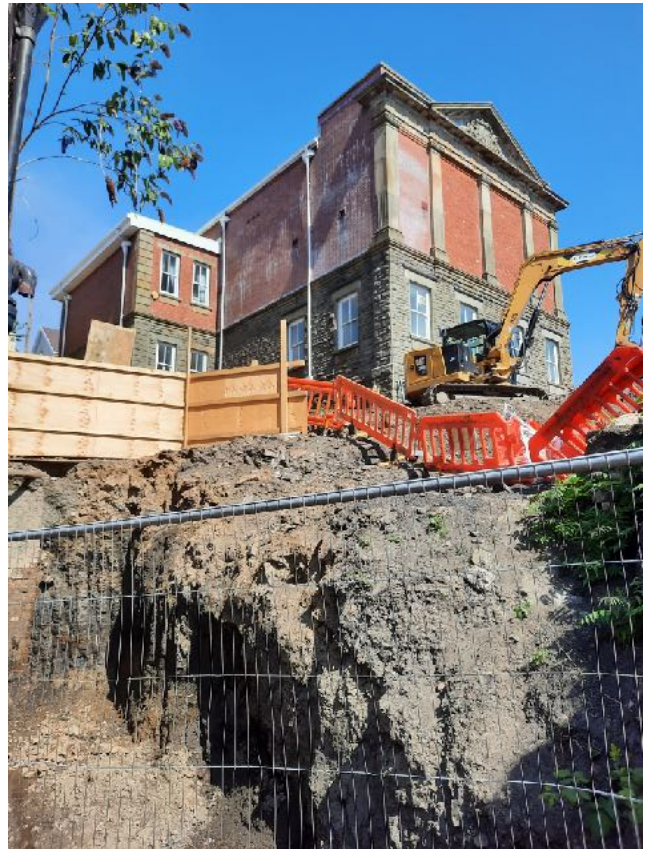
*Above: Photographs indicating the extent of excavation required, with the Masonic Lodge visible in the background, to provide a safe environment for the construction of the replacement retaining wall.*
