## Pandy Farm, Merthyr Tydfil

### Bat Report and Ecology Assessment

Report Ref: 1703 / 04

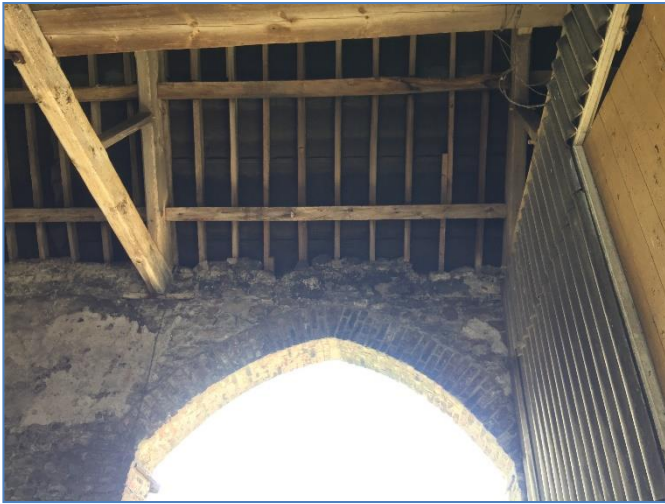
Photograph 5. Building B. The roof structure above the central gated section.

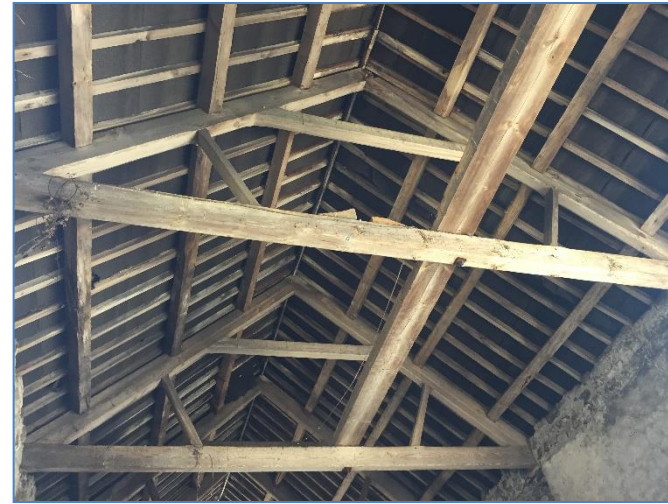
Photograph 6. Building B, eastern section. The tie and collar beam roof construction.

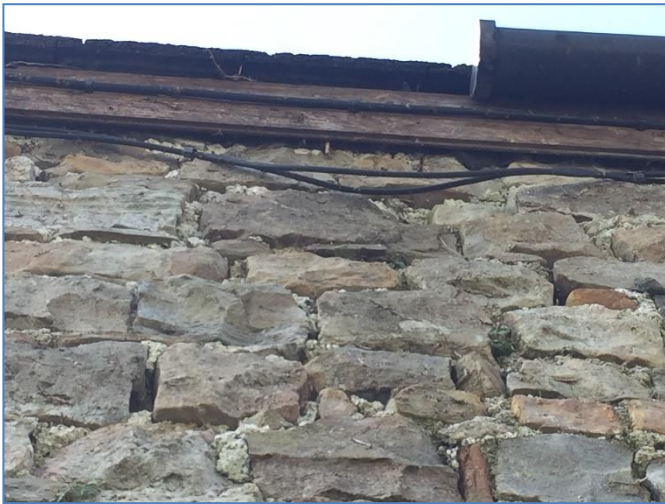
Photograph 7. Building B, eastern section. Gaps beneath fascia boards on the northern elevation.

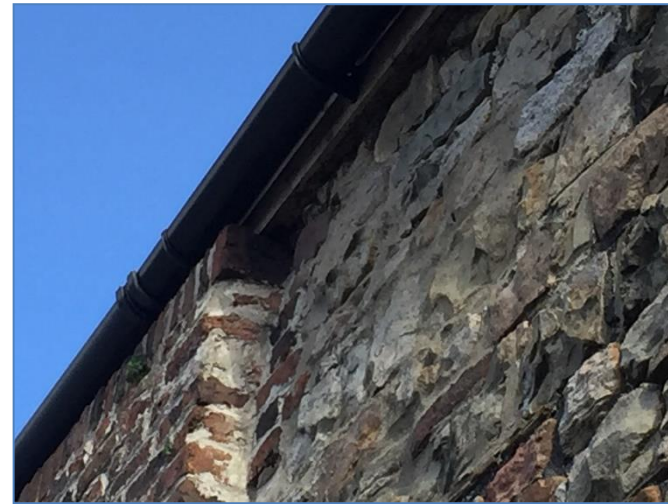
Photograph 8. Building B, eastern section. Further gaps beneath fascia boards.

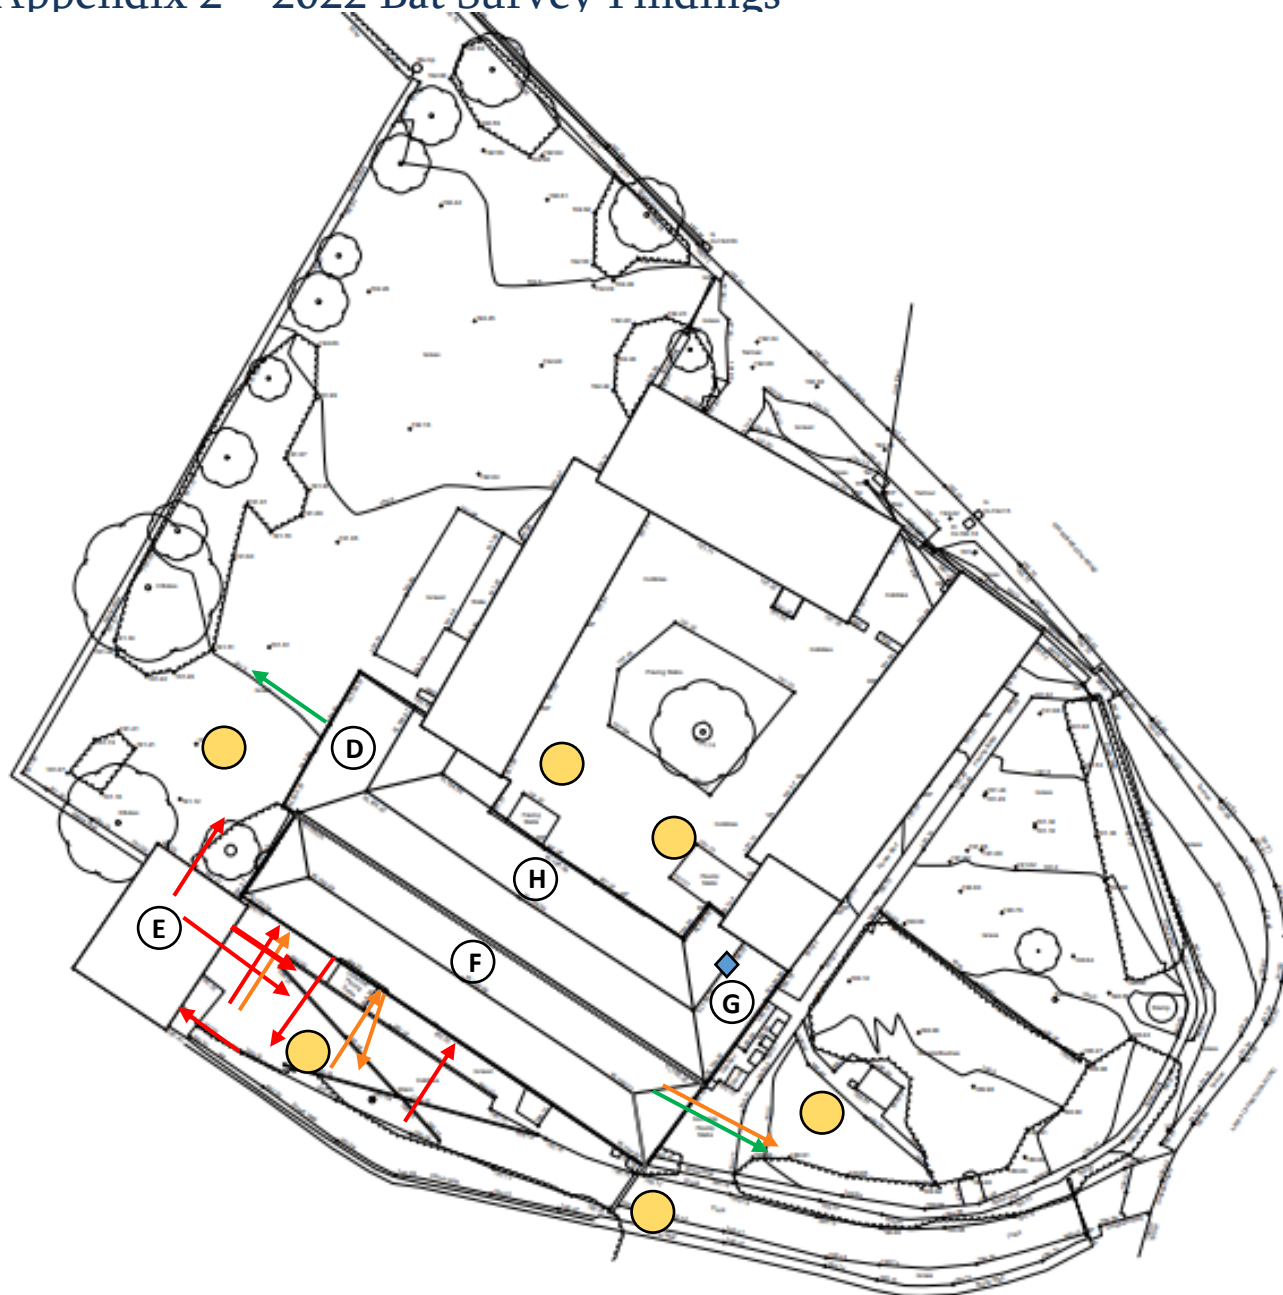
## Appendix 2 – 2022 Bat Survey Findings

- 3.5 Table 3, below, show the findings of 2022 surveys of Buildings D-H recorded the following roosts prior to any renovation works. These are illustrated in **Appendix 2**.
