| Subject | Pandy Farm |
| Reference | Heritage Statement |
| Site address | Pandy Farm<br>Brecon Road<br>Merthyr Tydfil<br>CF47 8PA |

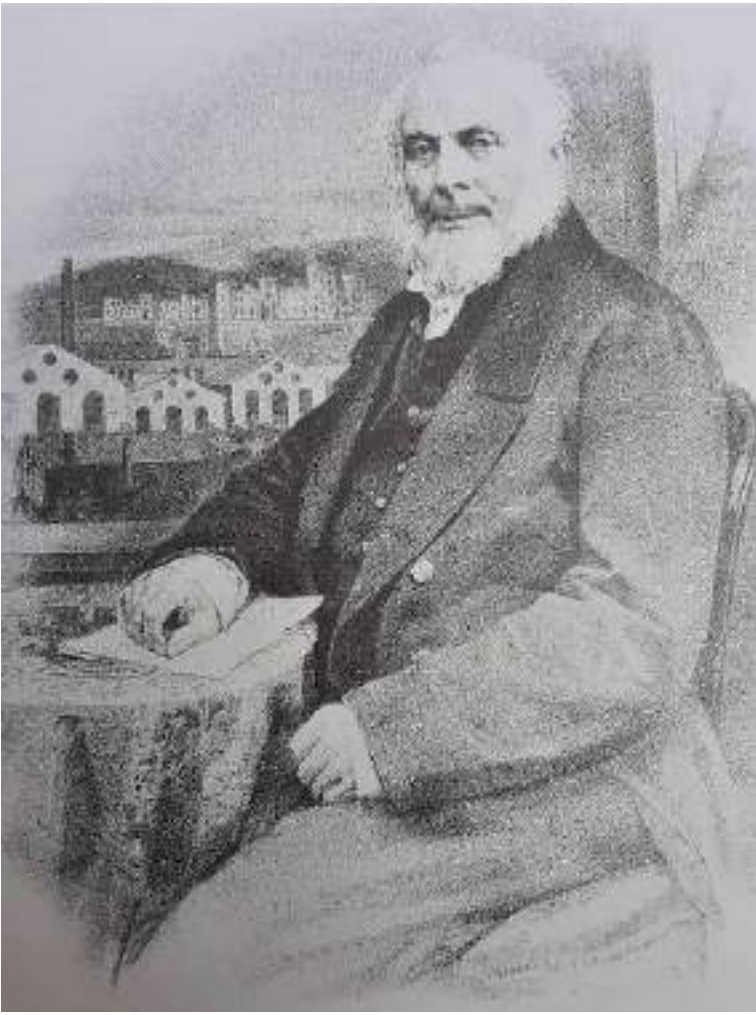
Diagram 02 -William Crawshay II (1788-1867) depicting the ironmaster with his empire of the ironworks, Pandy Farm and Cyfarthfa Castle

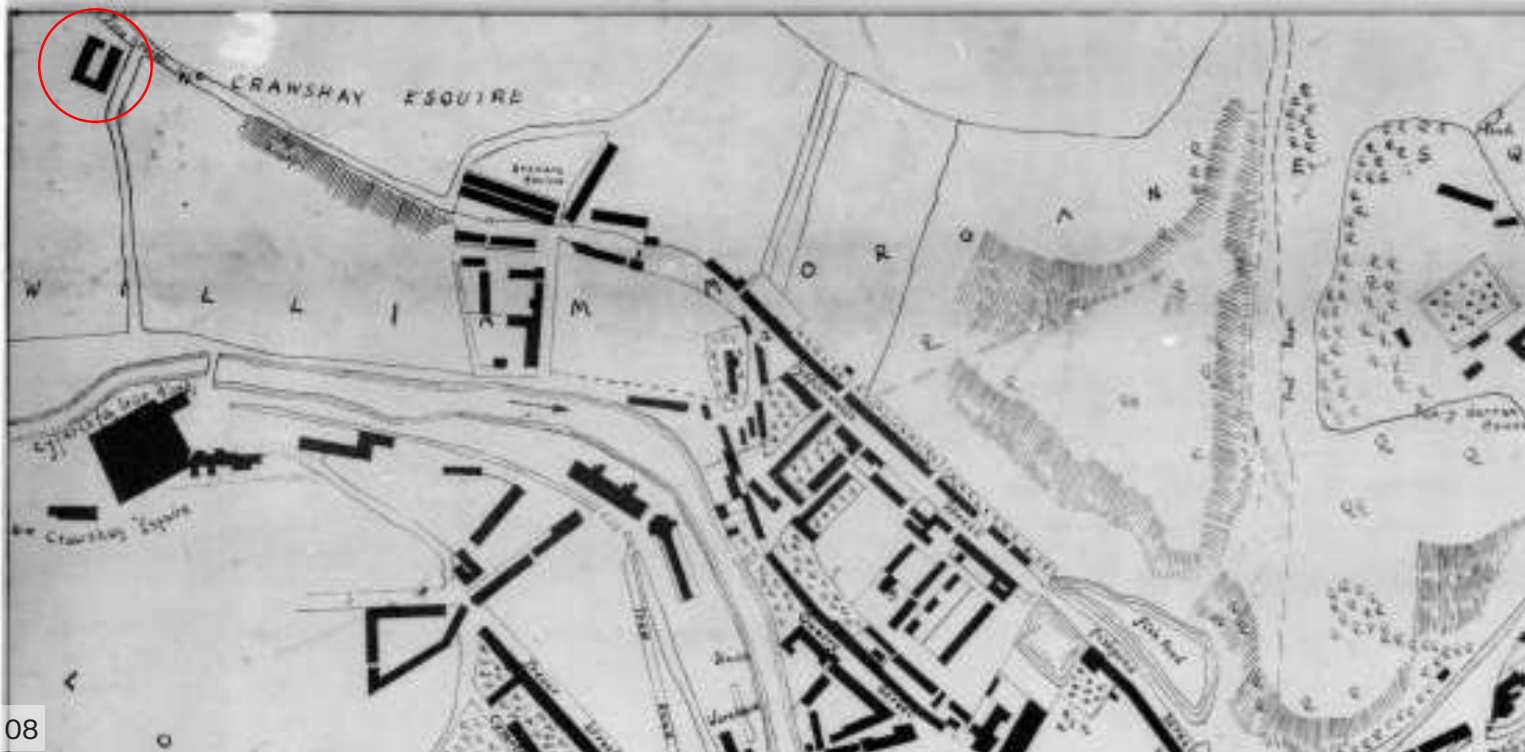
Diagram 06 - George Yates County of Glamorgan 1799, Pandy Farm is not noted  
Diagram 07 - Thomas Budgen Map 1814 – the position of the farm is shown left of the notation Pandy Place. The mapping is not clear enough or of a suitable scale but it does appear to show a U plan courtyard on the south side of Brecon Road - circled in red.  
Diagram 08 - Plan of Merthyr Tydfil from actual survey 1836 John Wood. Pandy Farm circled in red.

The 1836 Plan of Merthyr includes the courtyard plan of Pandy Farm, as shown in diagram 08.

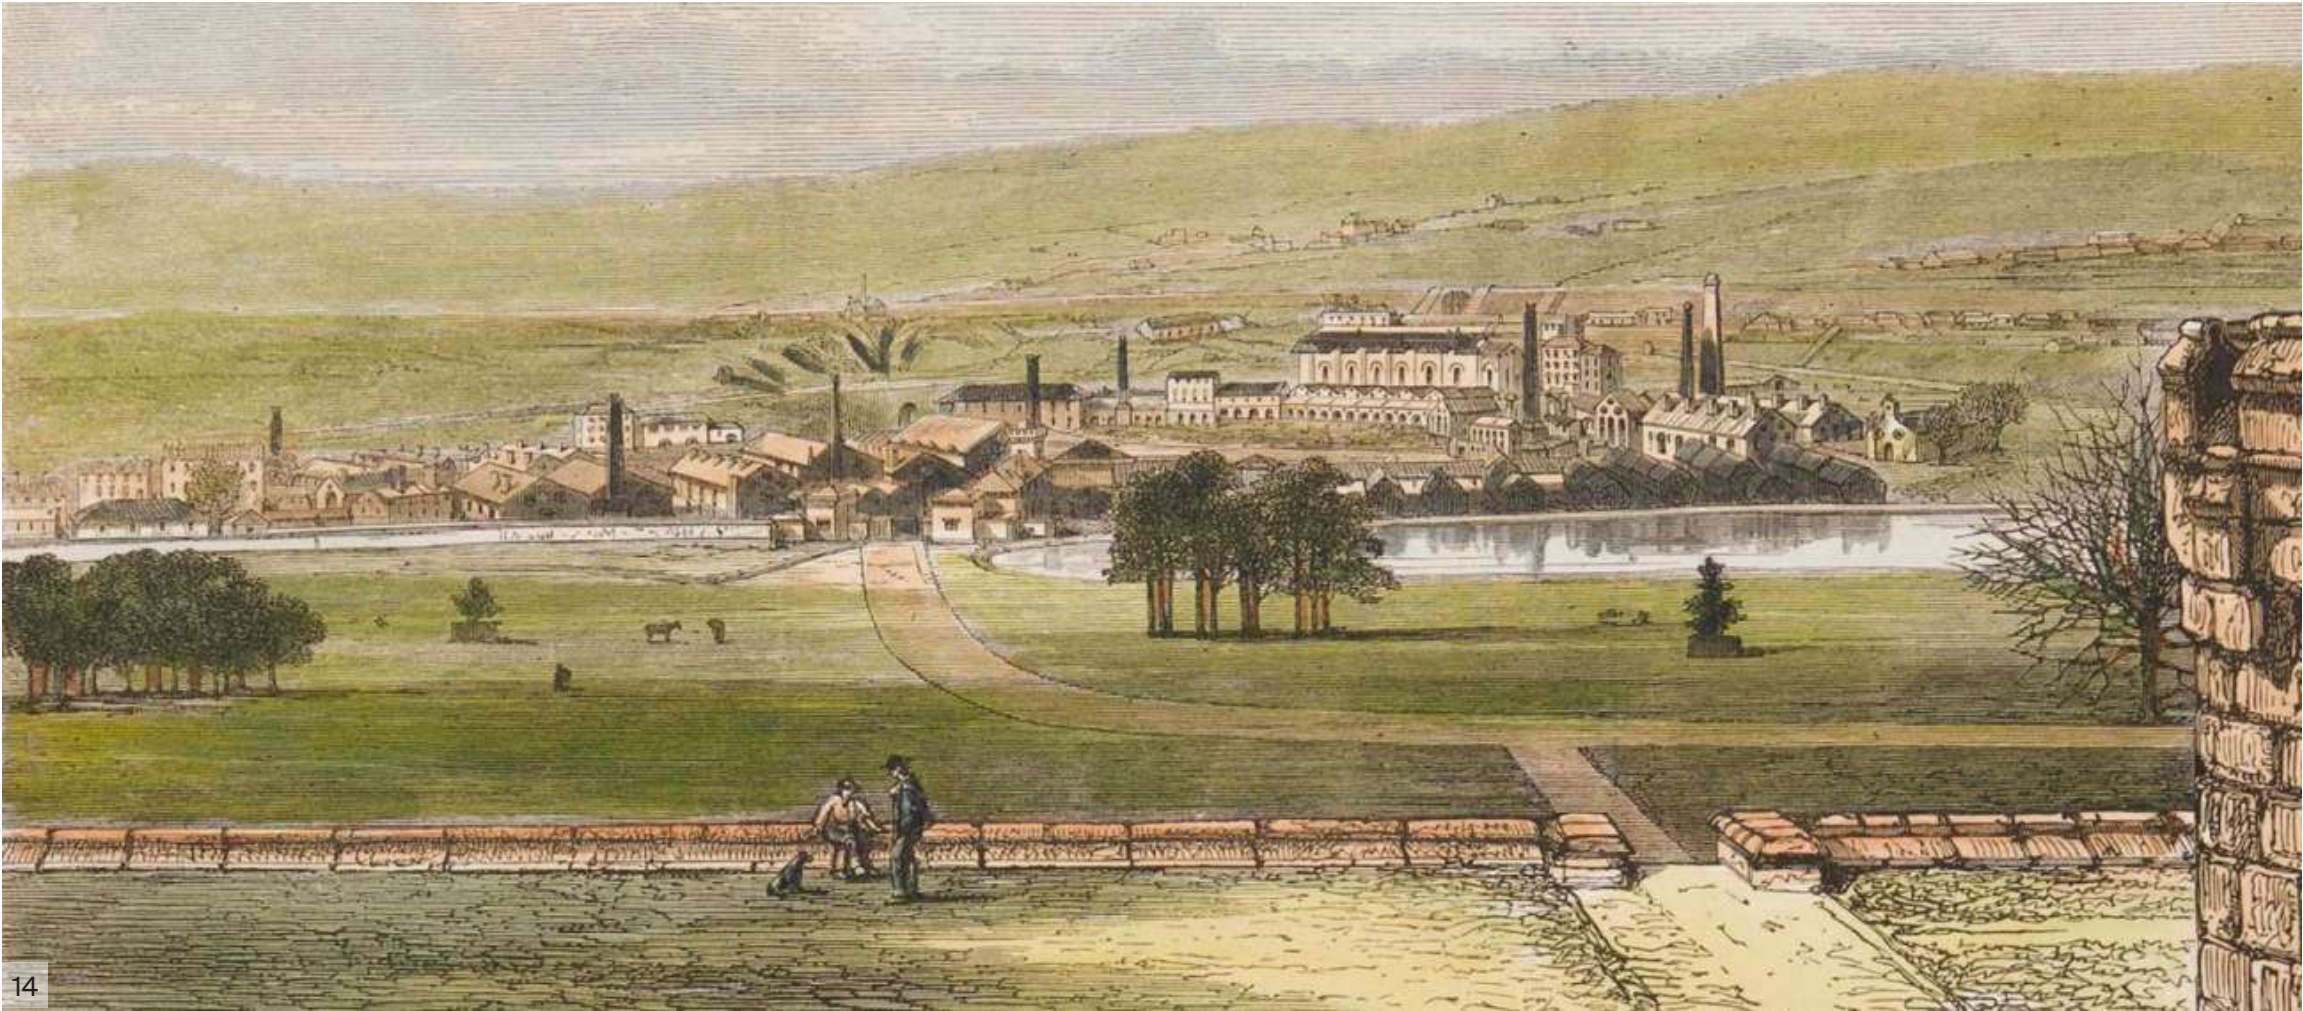
Diagram 14 - The Illustrated London News 1875 – View from the castle to the ironworks. The farmhouse and clock tower can be seen as well as some elements of the farmstead. The massed grey elements reflected in the lake are thatched hay ricks. The hay ricks in the rickyard and beyond were essential for the feeding of the many horses on the estate and used in the ironworks.

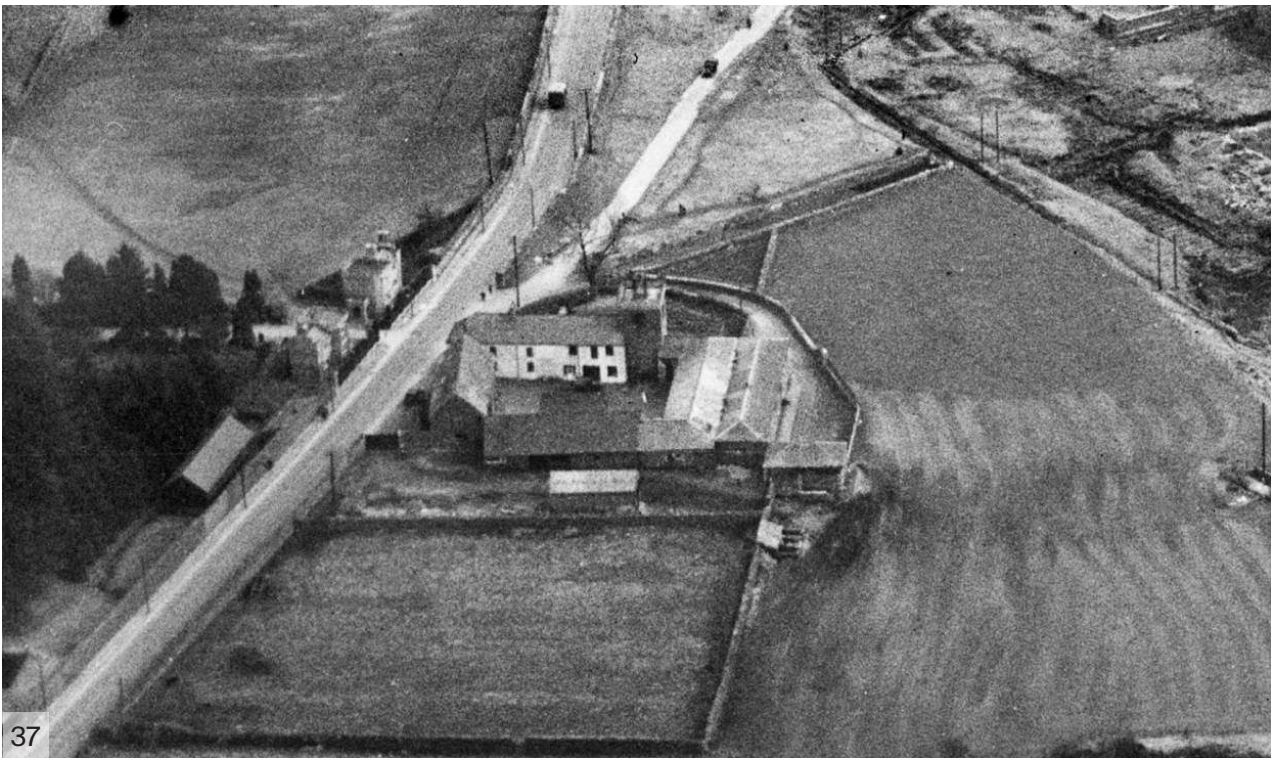
Diagram 37 - Close up of Pandy Farm 1938 showing the limewashed farmhouse, its lower south end in agricultural use with a large ground floor opening. An additional outbuilding west of the L plan range is shown as is a four-pen piggery built into the rickyard wall west of the coach house. The rear west racing range of the courtyard group is still in existence and appears to have a large off centre opening with some windows to the south side.

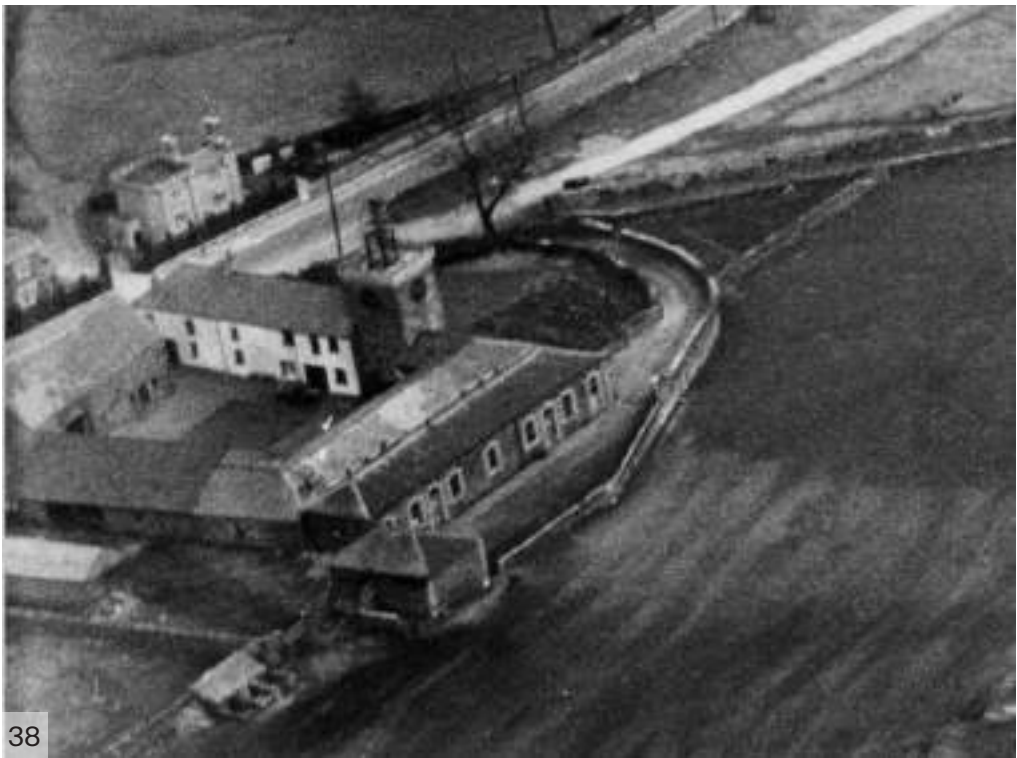
Diagram 38 - Pandy Farm from the south west side 1938. The stables facing south show a rhythm to large window and door openings that are found on many of the iron furnace buildings. The original western door and window arrangement remains intact at this date. A small flue is visible on the south roof slope of the cart shed coinciding with a fireplace that still survives within. The roadside barn has an arrangement with a ground floor door flanked either side by window openings.

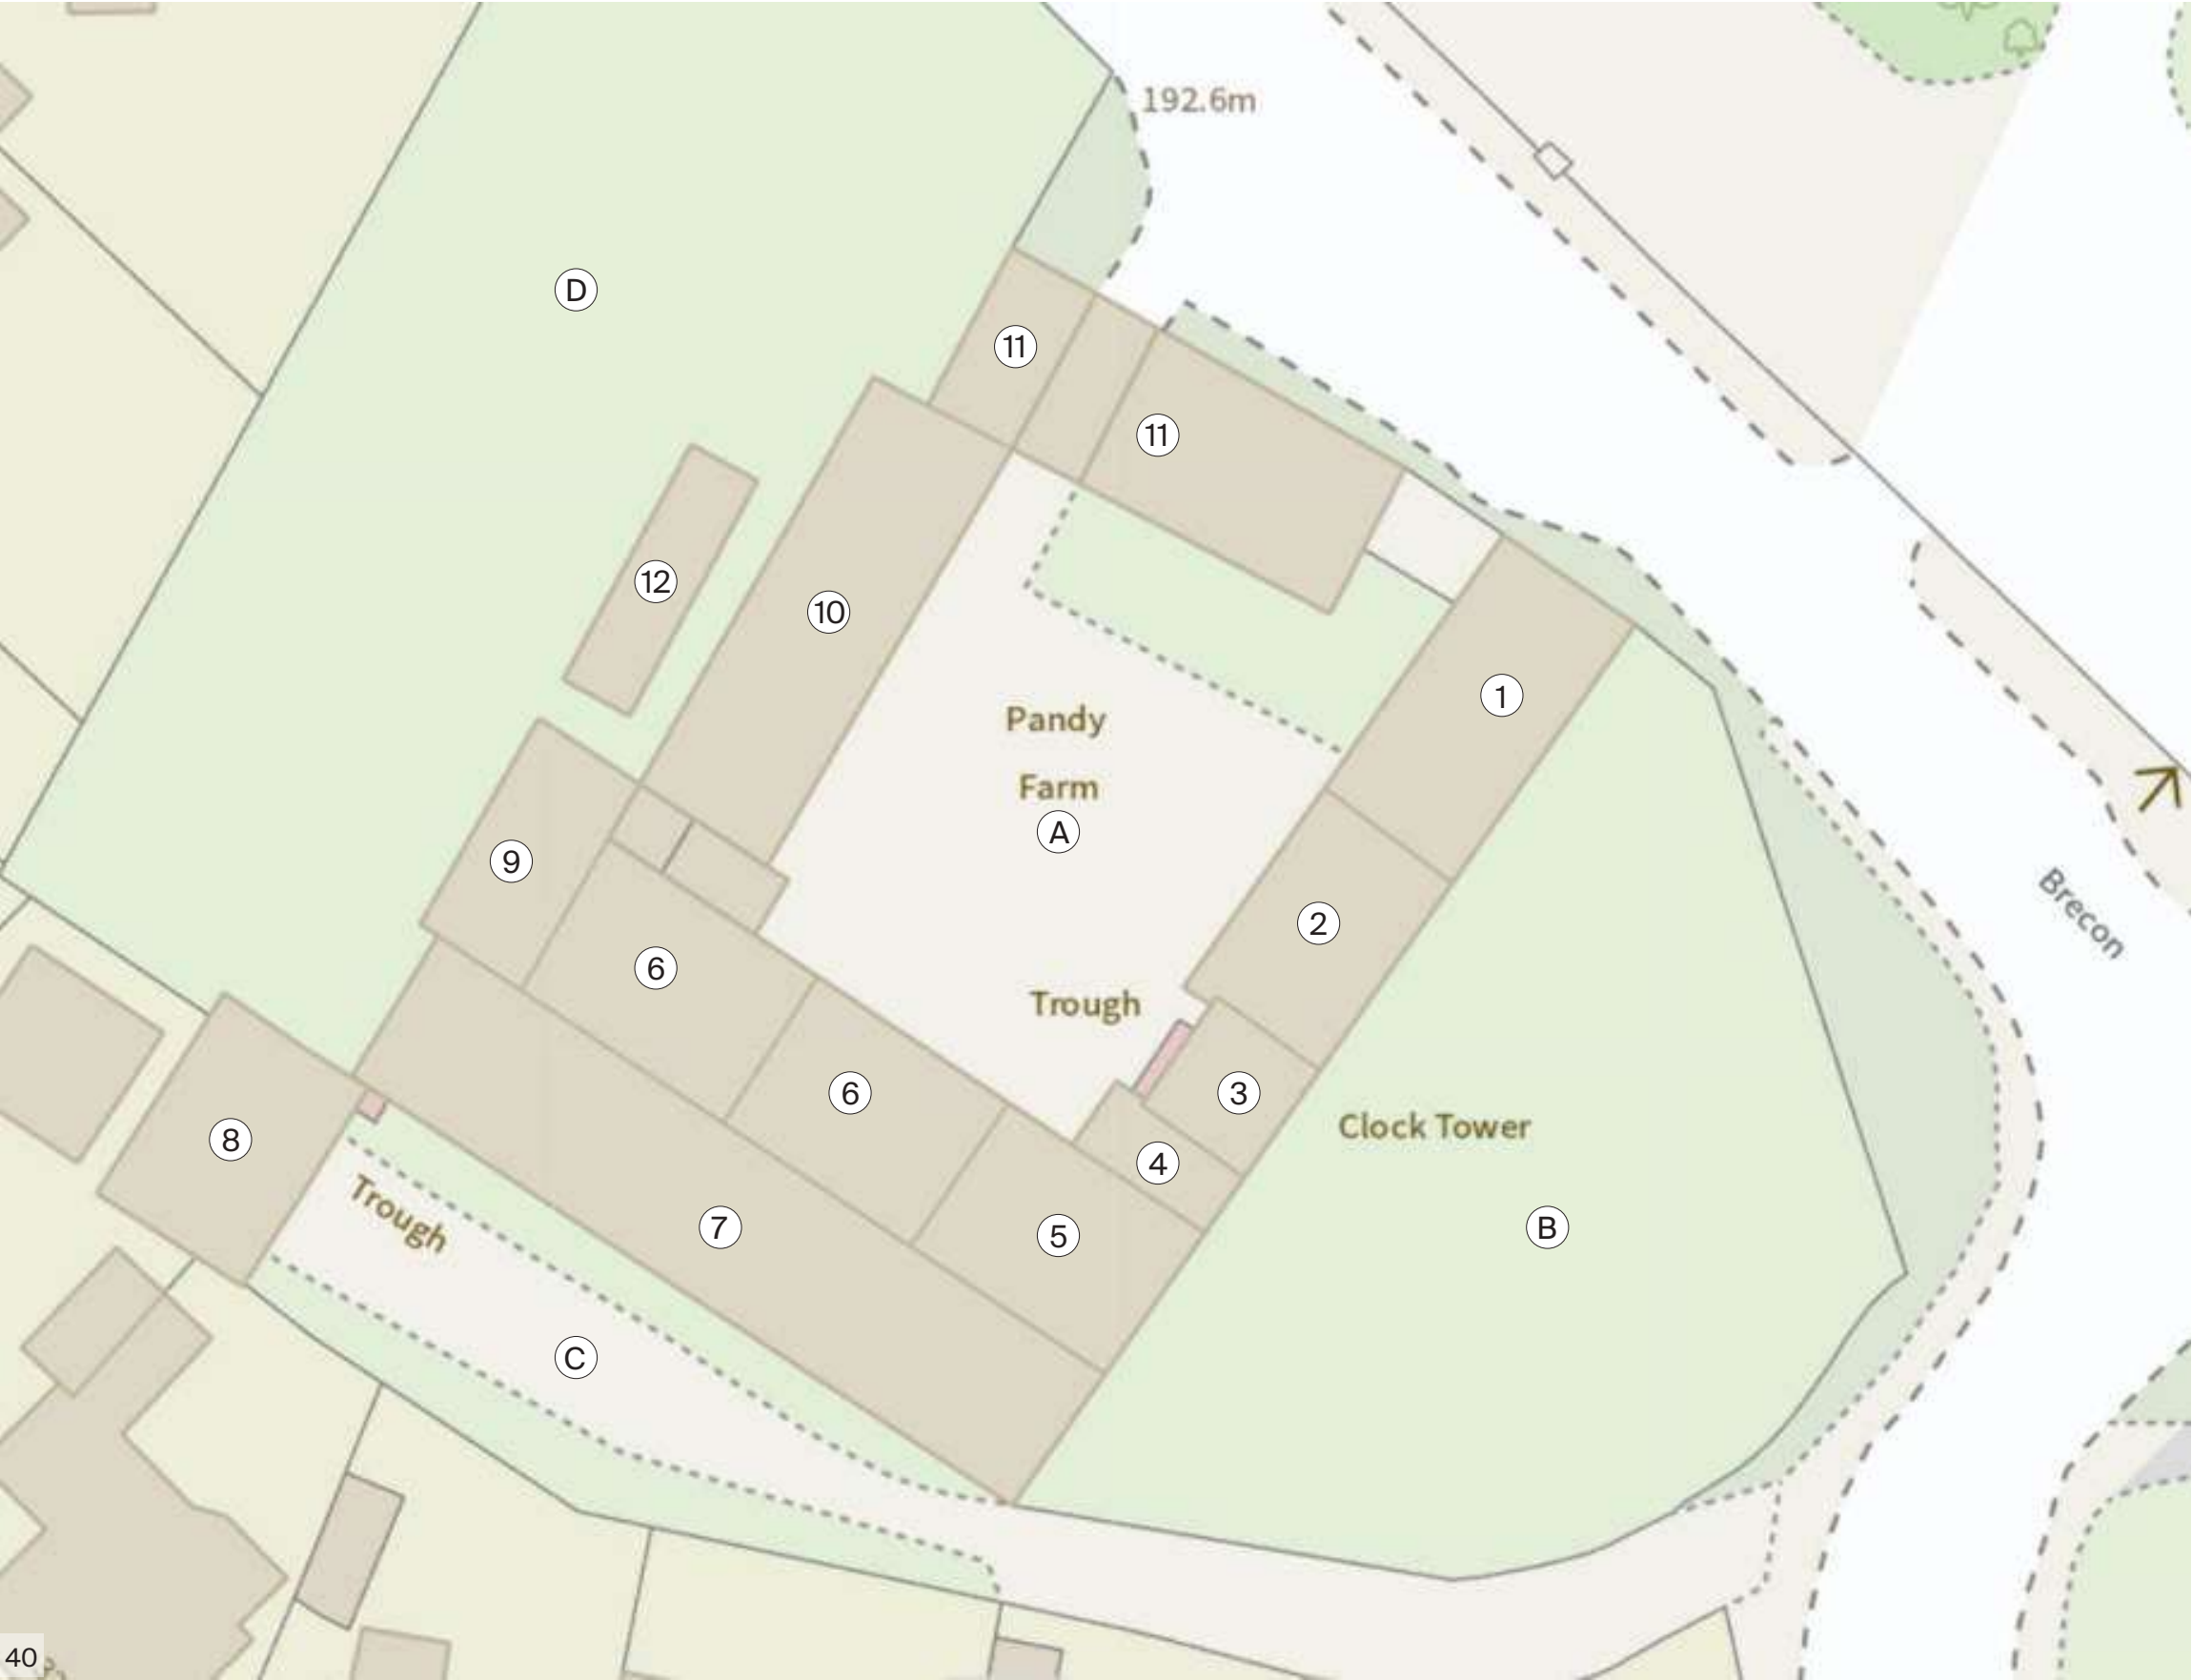
Diagram 40 - Plan showing the arrangement of the farmstead.

- A. Courtyard
- B. Cottage Garden
- C. South Yard
- D. Former Rickyard

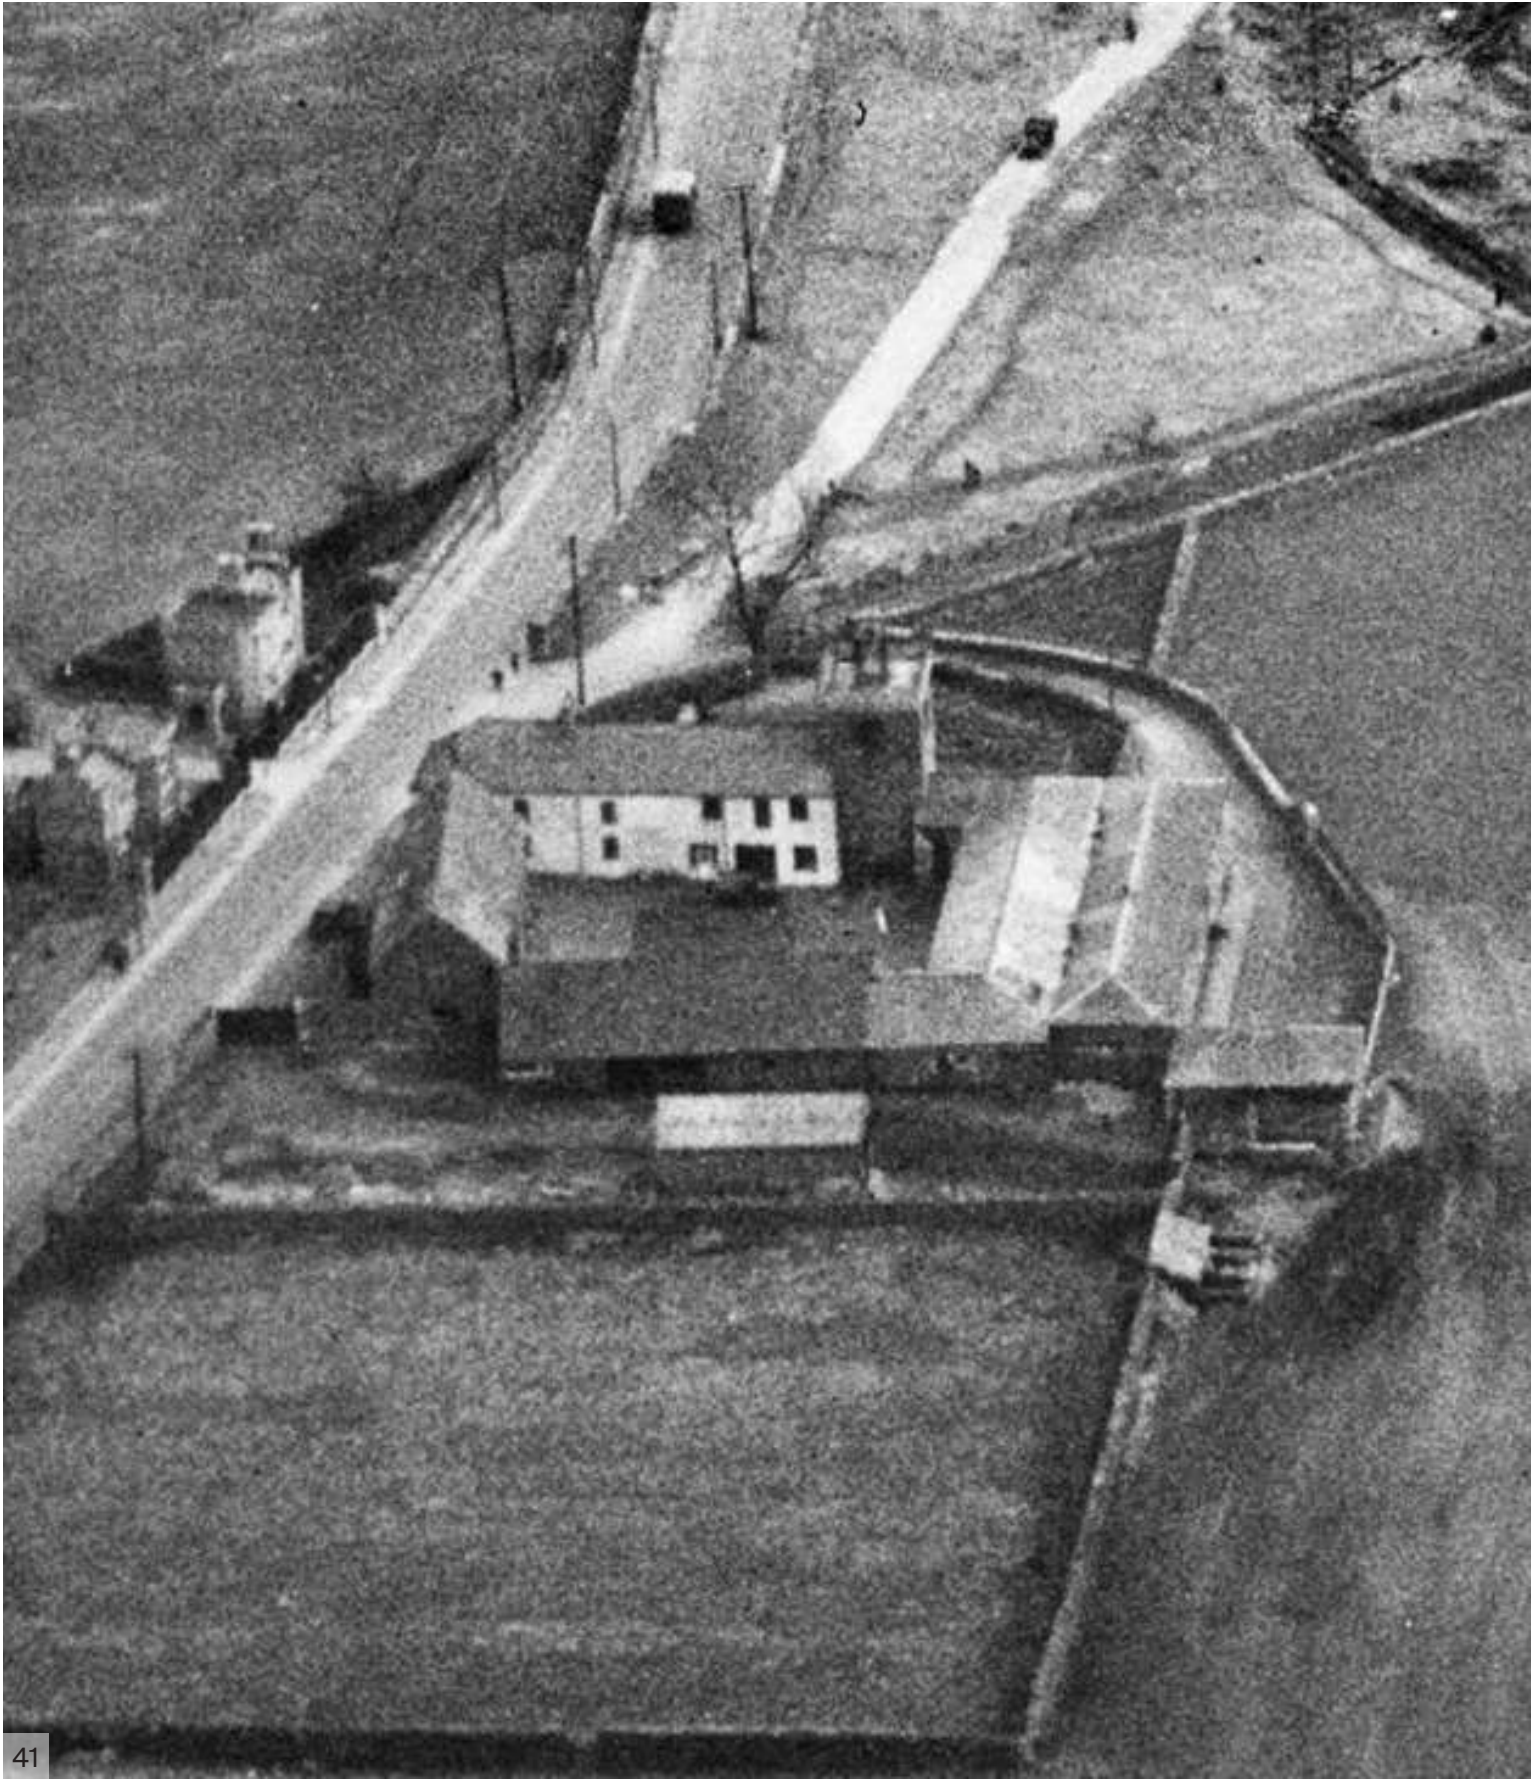
Diagram 41 - Close up of Pandy Farm 1938

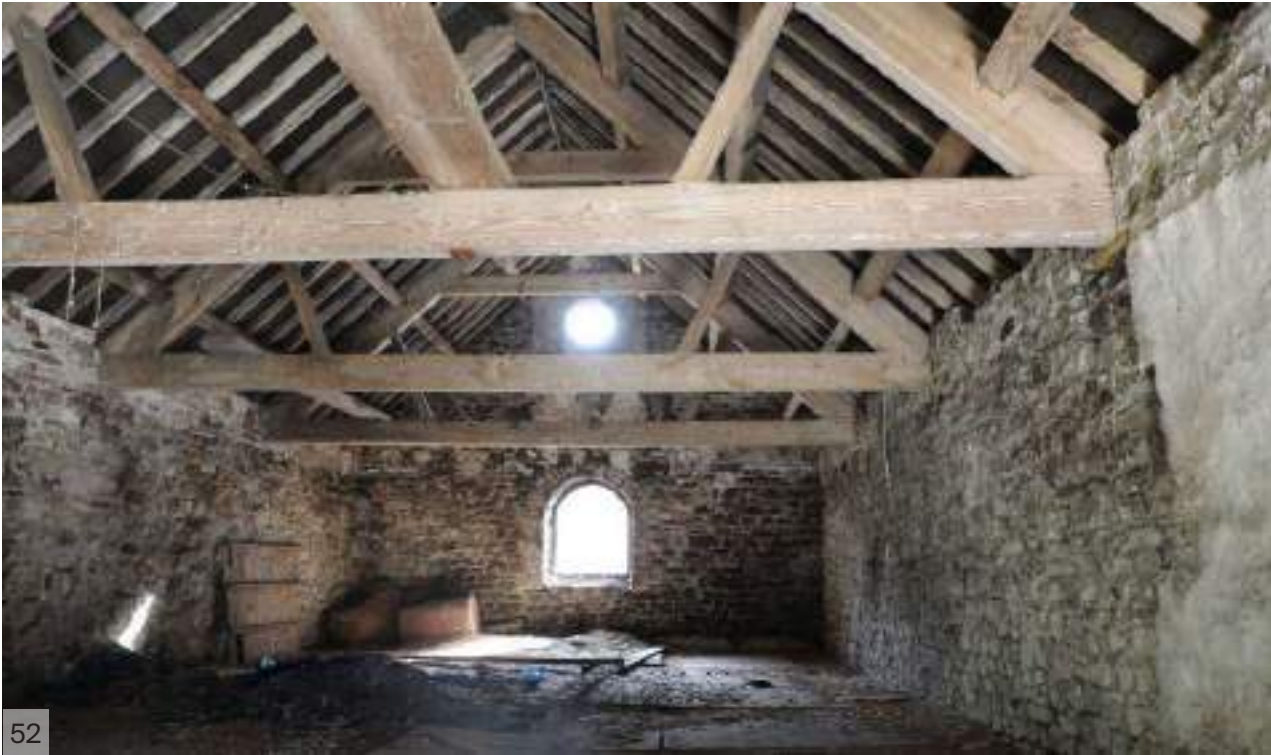
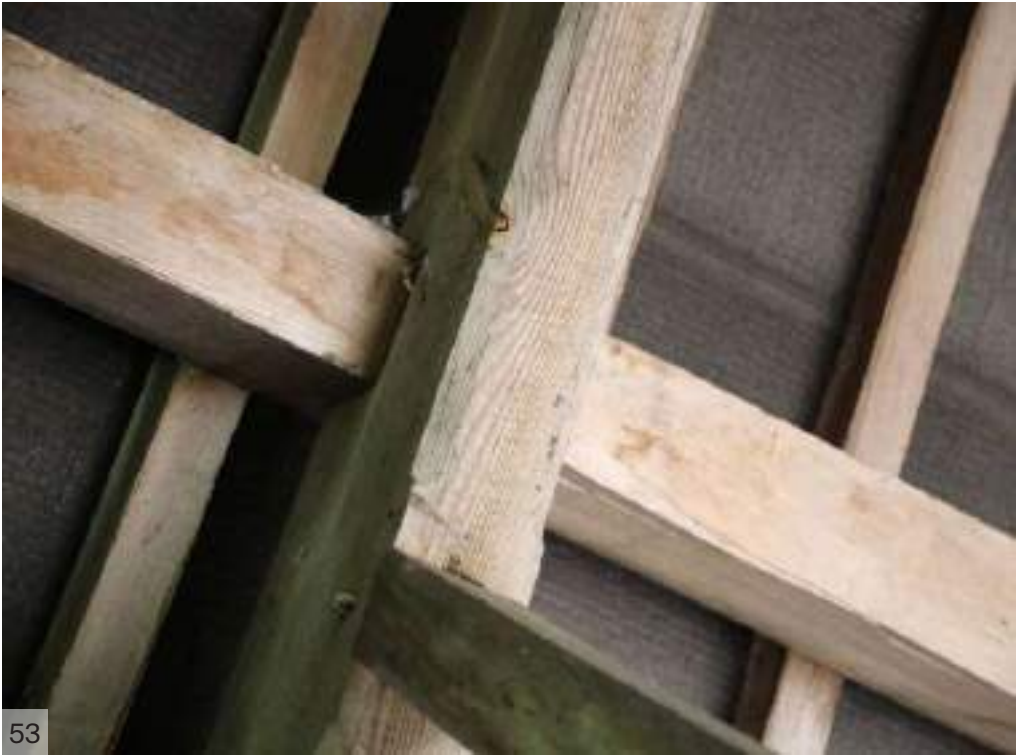
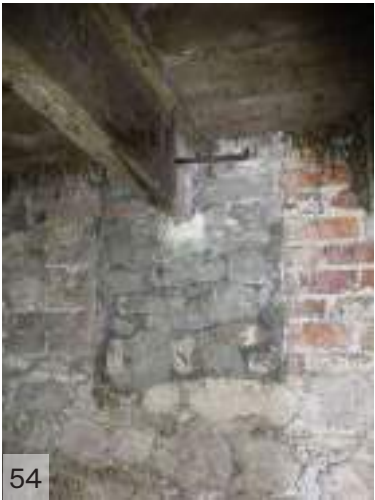
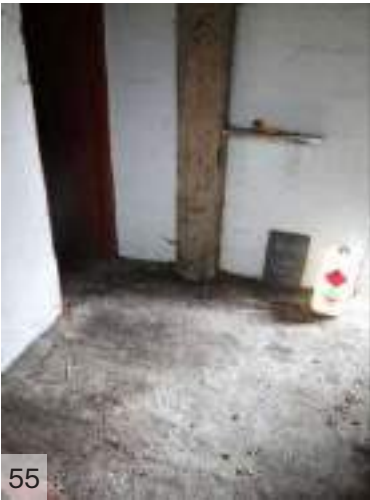
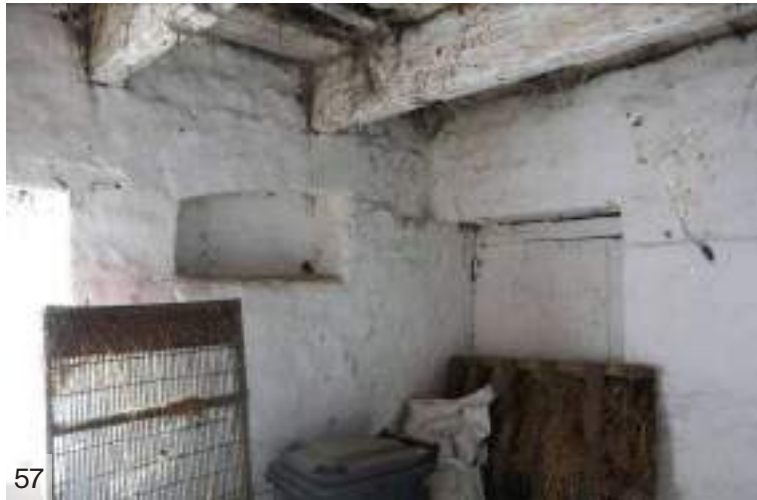
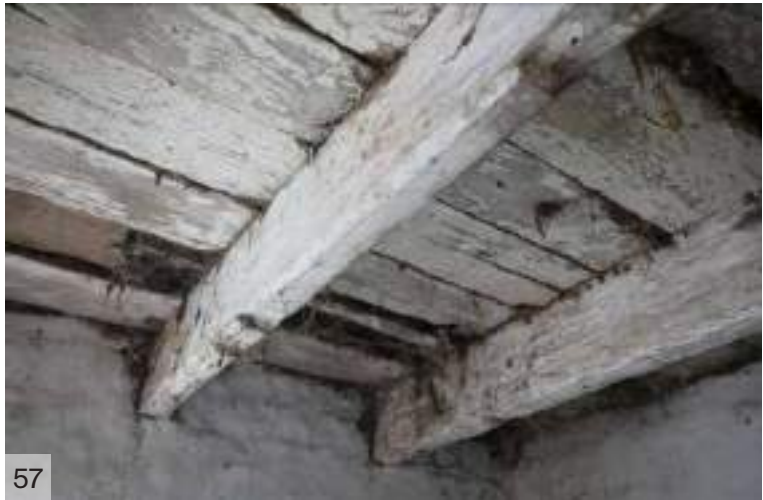
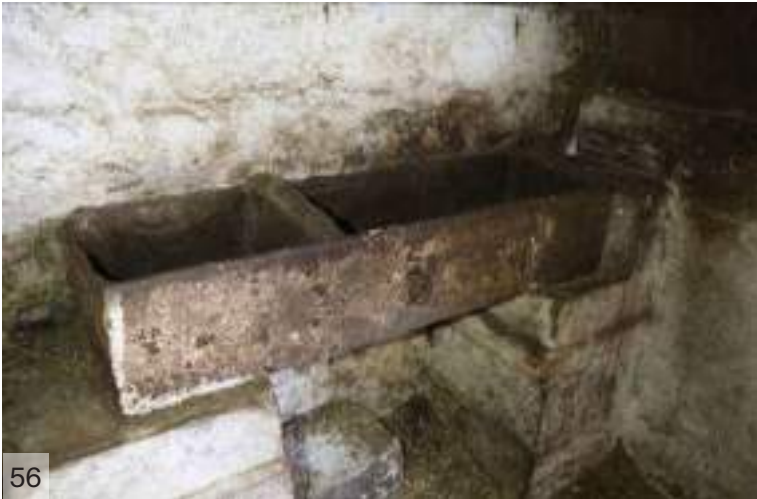
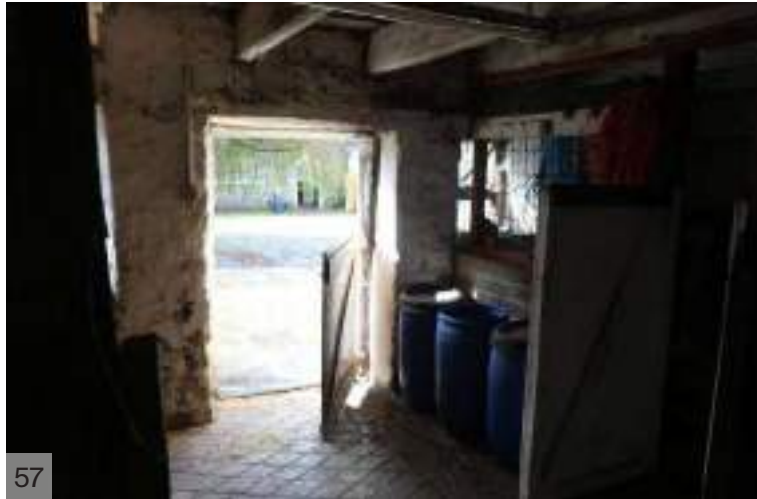
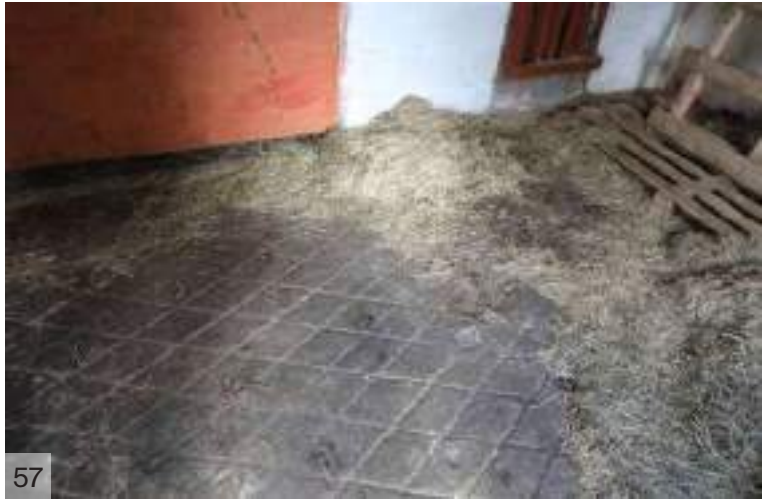
The coursed rubblestone barn is orientated east-west and forms the northern enclosure to the courtyard farmstead. The barn exhibits decorative detailing in the form of arched openings, gable oculus and tall carriage entrance with pointed brick arch. The roof covering is replacement concrete tiles.

Diagram 44 - The carriageway with well-worn stone sett floor, with historic heavyweight iron sockets for the original door still visible, and contemporary linings.

Diagram 48 - The heavyweight iron sockets for the original opening doors found on both sides of the carriageway.

Diagram 52- The simple roof structure of the barn with later off-centre cross timber bolted in place on top of the tie beams. Although the roof is simple it does display some of the hall marks of an estate farmstead in the subtle details for example the principal rafters all have a simple, but elegant stopped chamfer. The interior at first floor must have been divided as noted by the lime plaster visible in sections above the carriageway. Possibly to make the carriage way appear grander than the other sections hidden from public view.

Diagram 56 - A water trough still in situ.

Diagram 57 - general views of the interior condition of the east bay of the barn - noting the floor, walls and ceiling conditions.

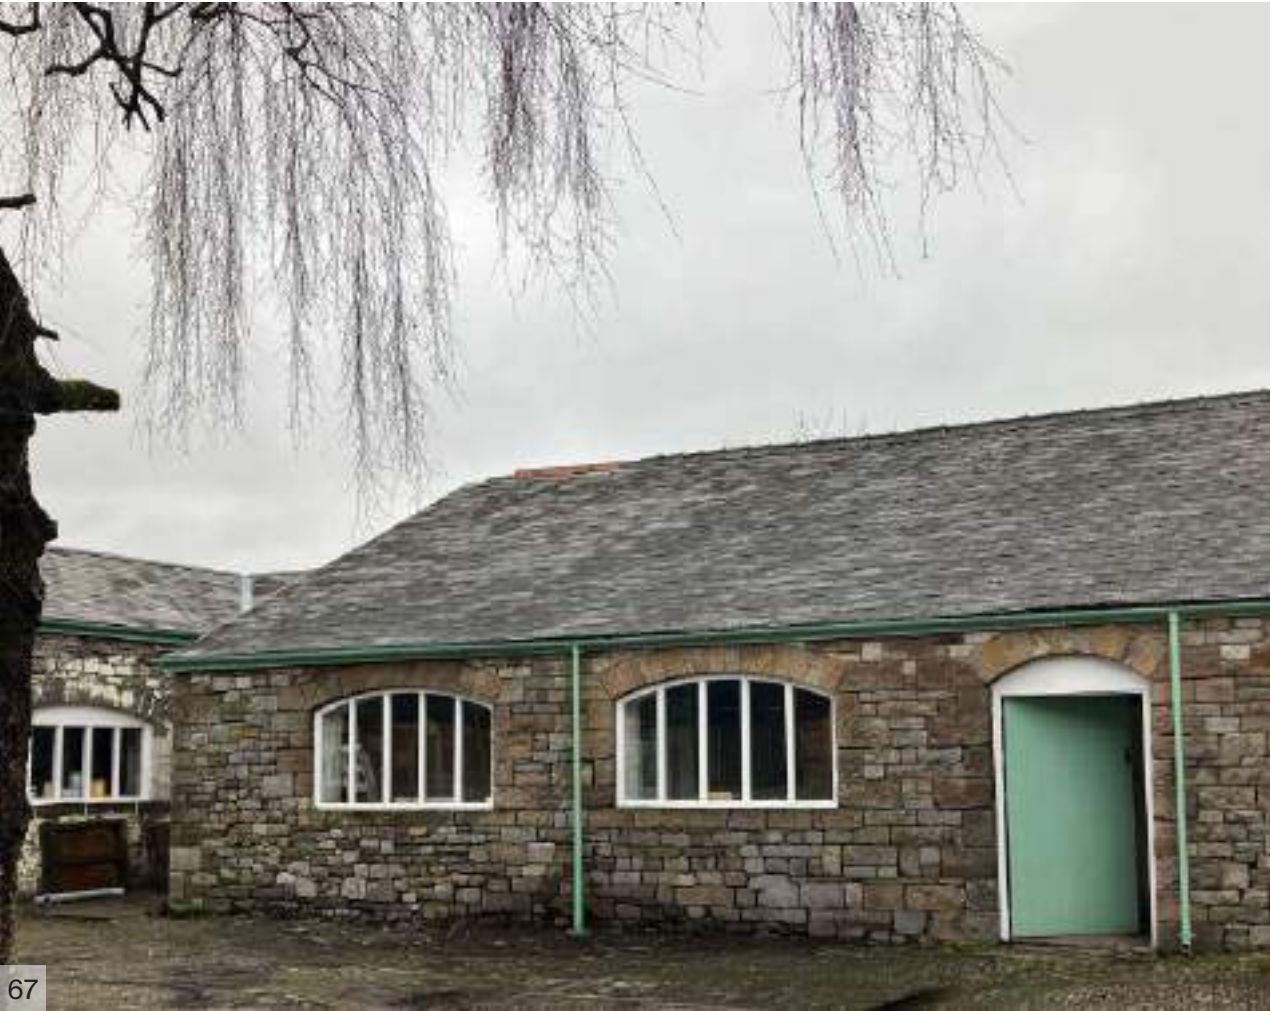
Diagram 72 - Interior of the west cow house range with inserted 20th century horse stalls.

Diagram 73 - View north within the west cow house range above the inserted stabling. The ventilation on the back wall can be seen – this ventilation was a key feature of ‘modern’ thinking in model farms providing a healthier environment for the cows within. The straight joint visible on the north gable is that of the roadside barn showing the cow house range was built after the barn. The roof structure has been reinforced and roof covering renewed in the 20th century – perhaps after the removal of the range on the west side.

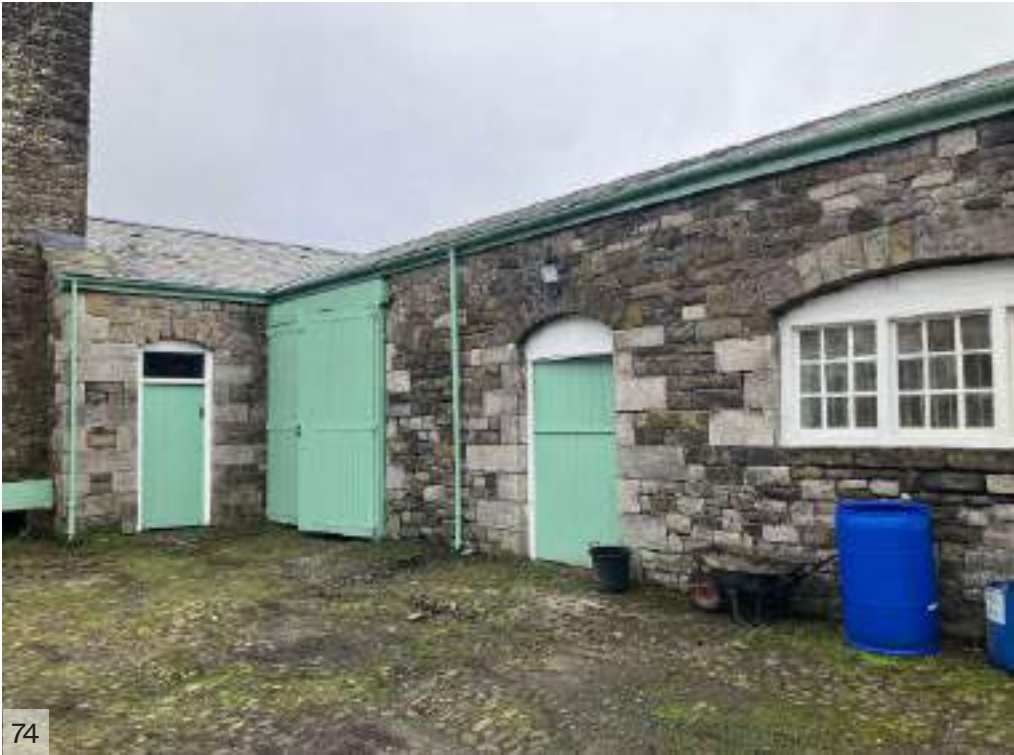
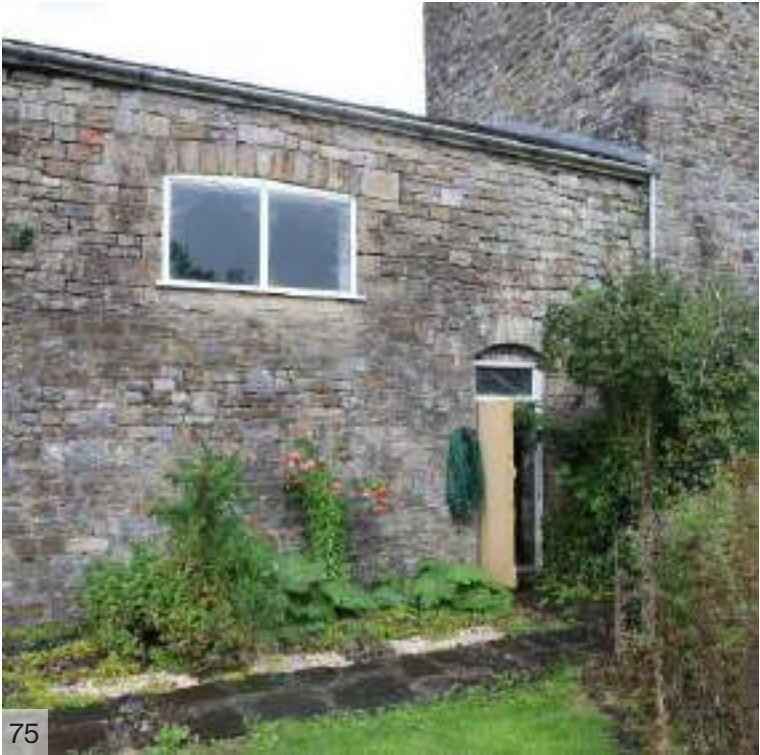
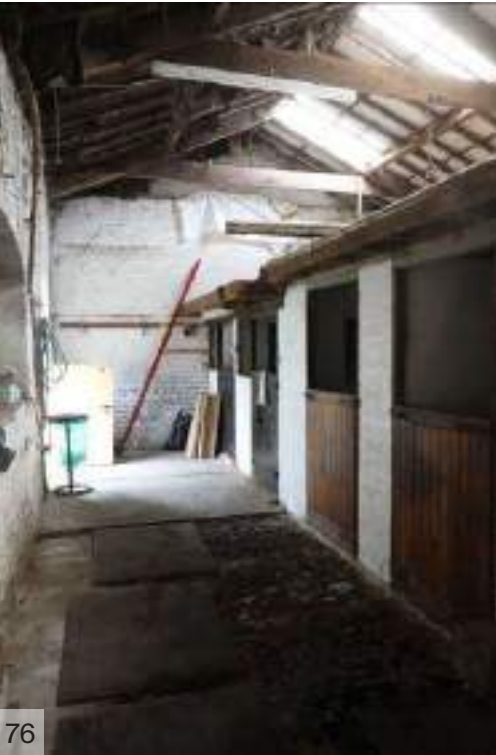
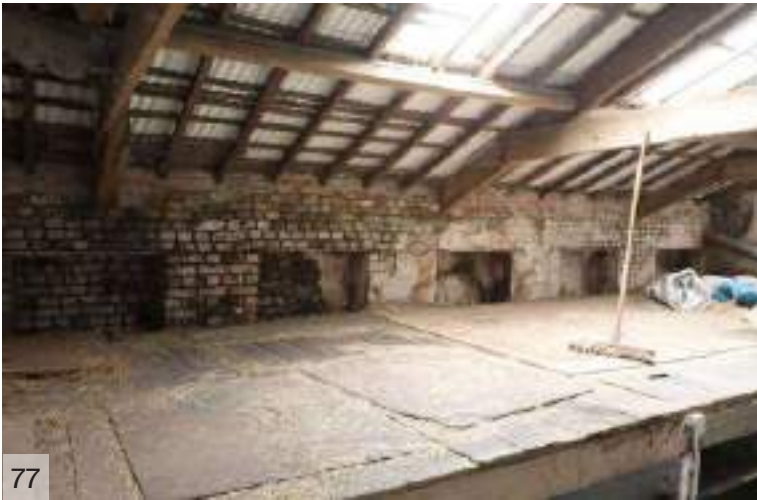
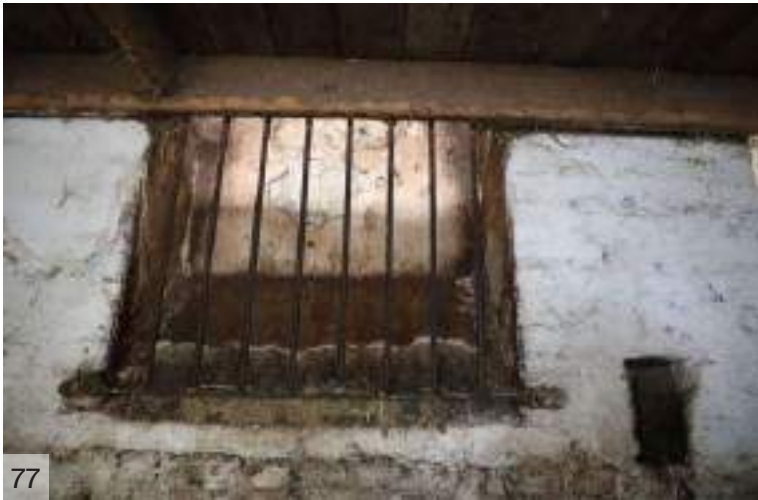
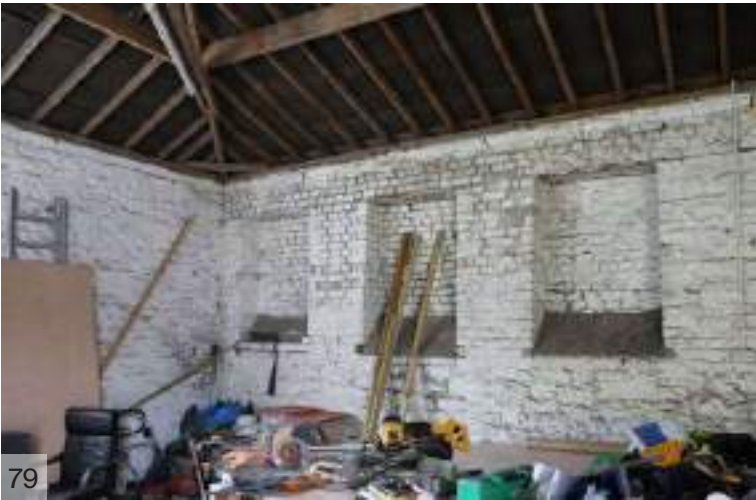
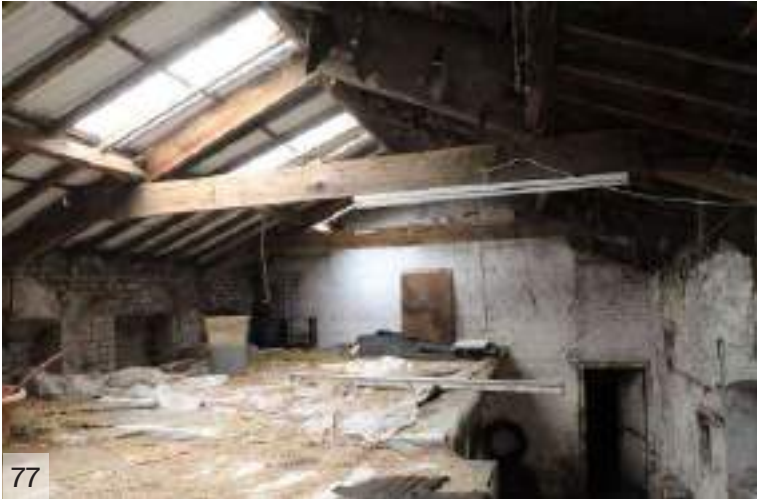
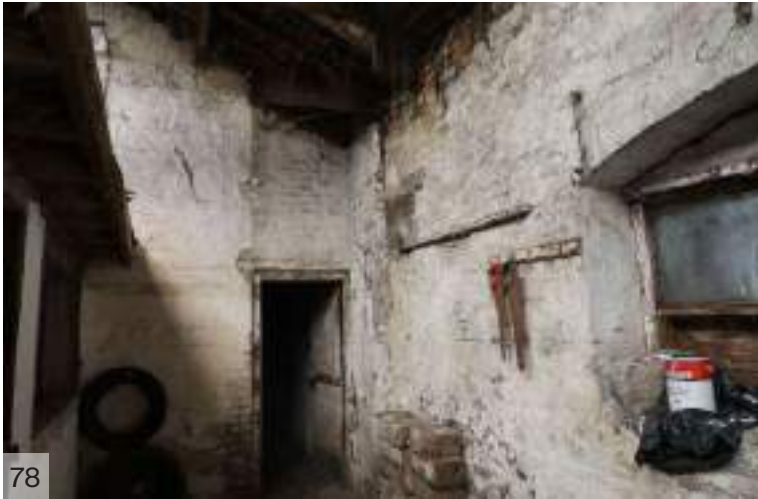
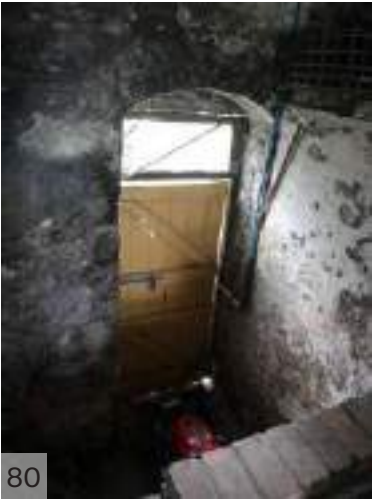
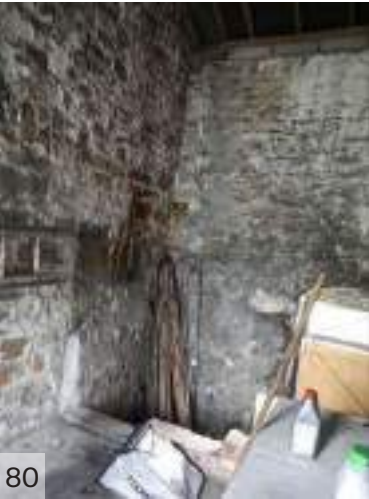
Diagram 79 - South east building accessed via the double garage doors the south wall niches are repeated as per the cow house/stables showing that this was a continuation of the same range. The wall that divides them has straight joints and appears to be an insertion.

Diagram 80 - Linking building between clock tower and south courtyard range with steps down from the courtyard level to the garden level east.
