| Subject | Pandy Farm |
| Reference | Heritage Statement |
| Site address | Pandy Farm<br>Brecon Road<br>Merthyr Tydfil<br>CF47 8PA |

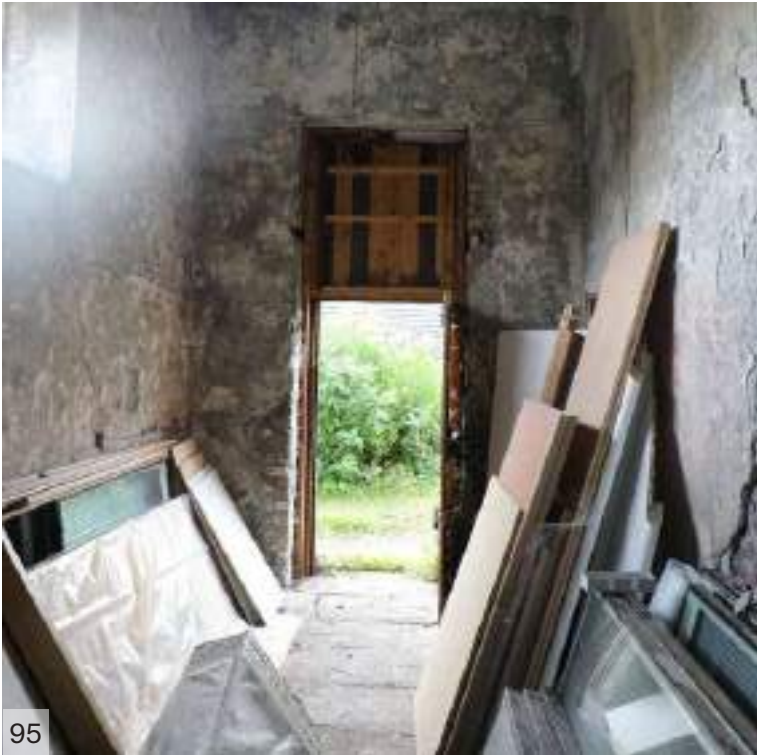
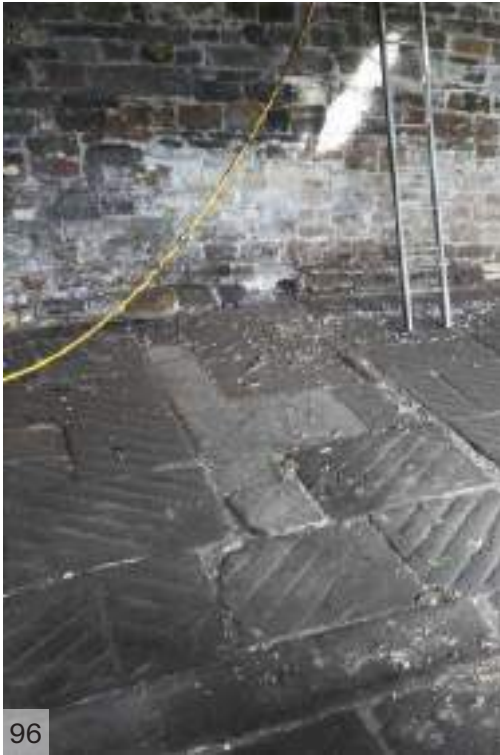
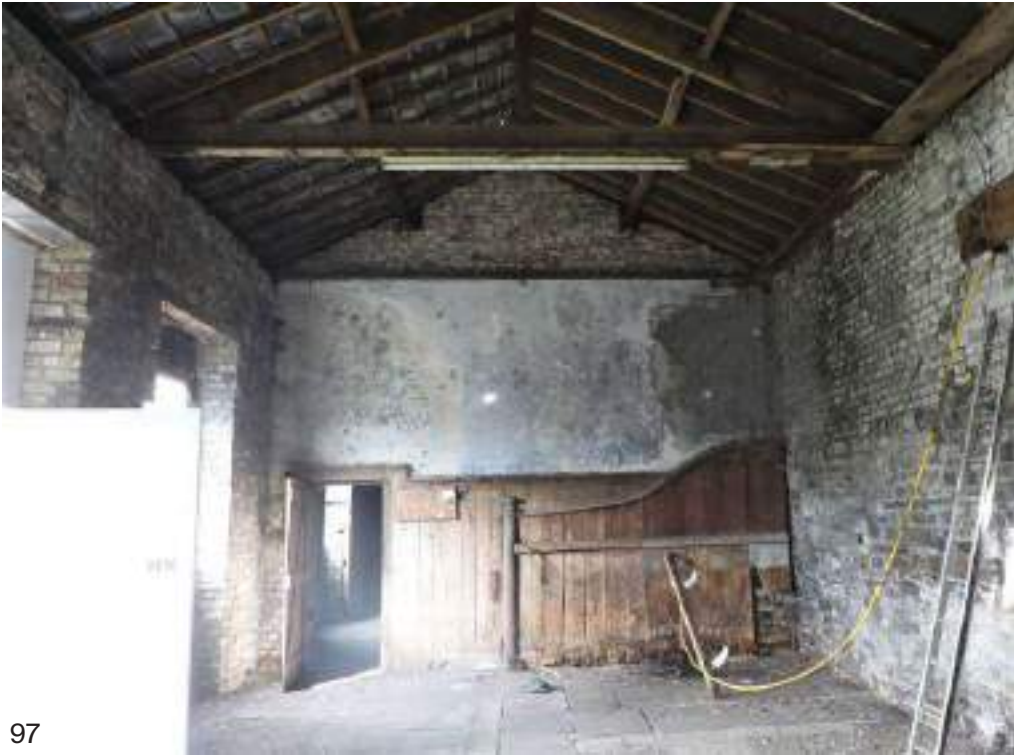
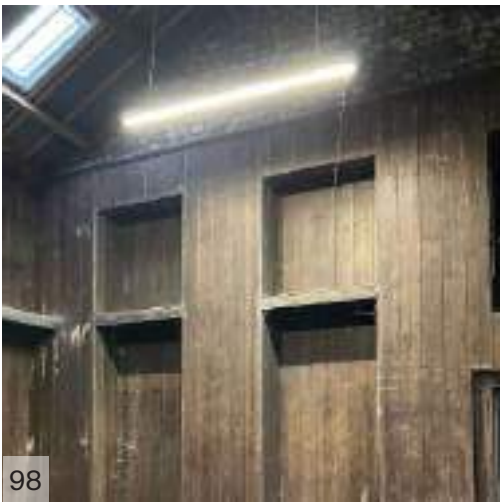
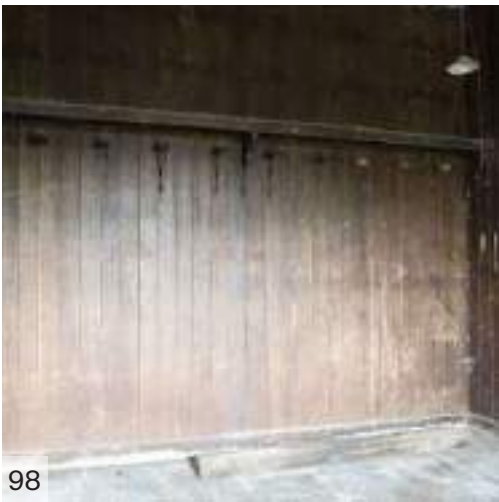
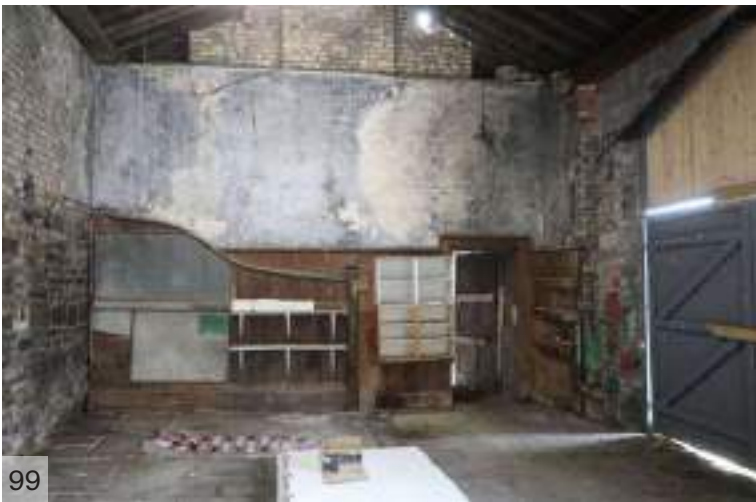
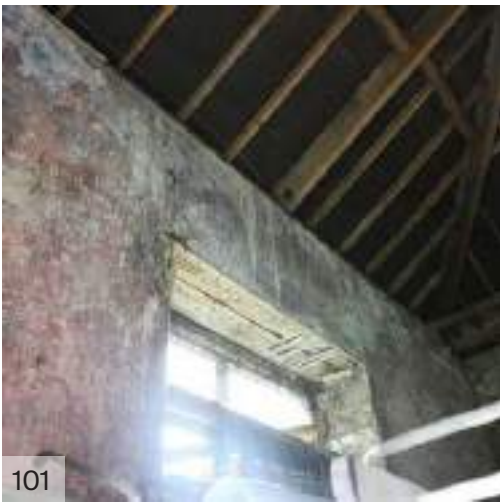
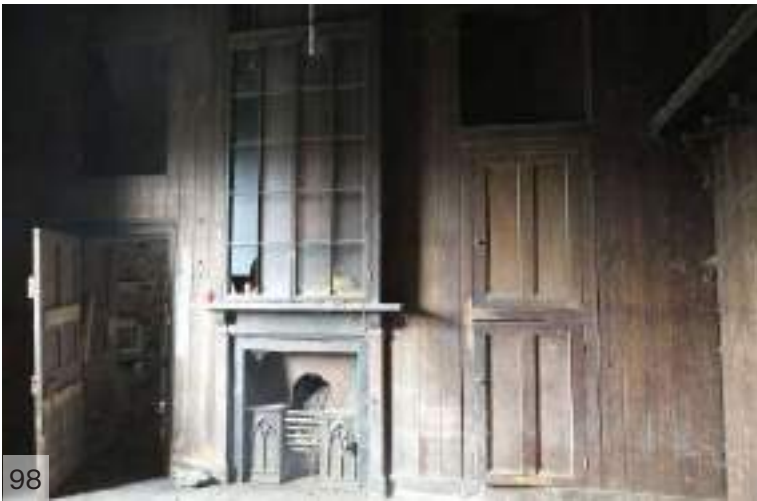
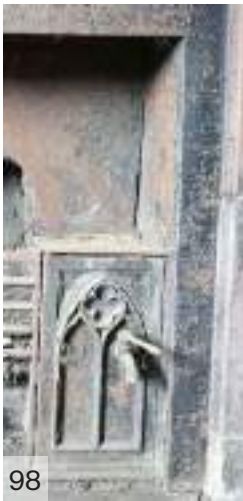
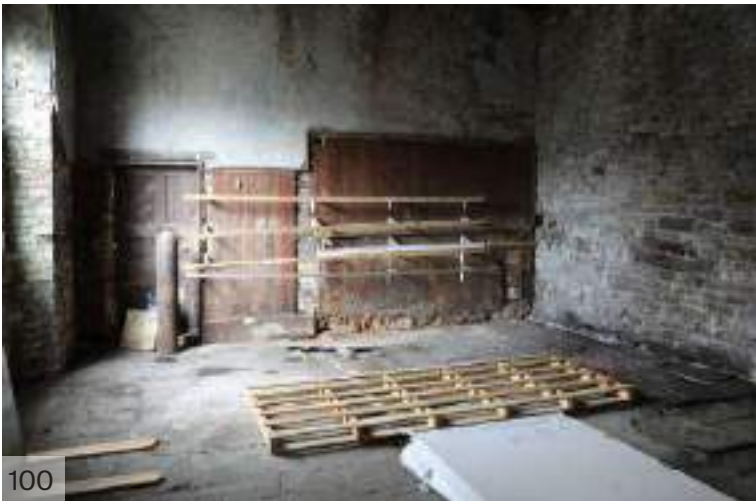
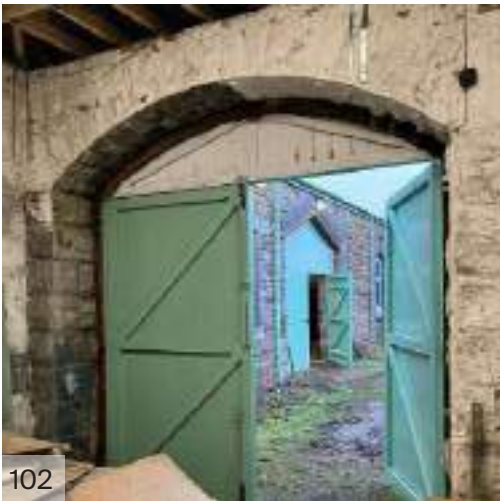
Diagram 90 - The high level window on the west elevation. Here we see the decay within the timber of the window from the poor detail of the window sill.

Diagram 101 - West store room off the stables lit by a high window that faces into the west rickyard. Some lime plaster survives intact, some has been lost to walls and the ceiling has been lost. In the corner there is a straight joint showing that the back wall (the south cow house range of the courtyard) was built first and the gable end of the stables butted up to it.

Diagram 102 - An interior view of the coach house showing the interior condition of the door sets.

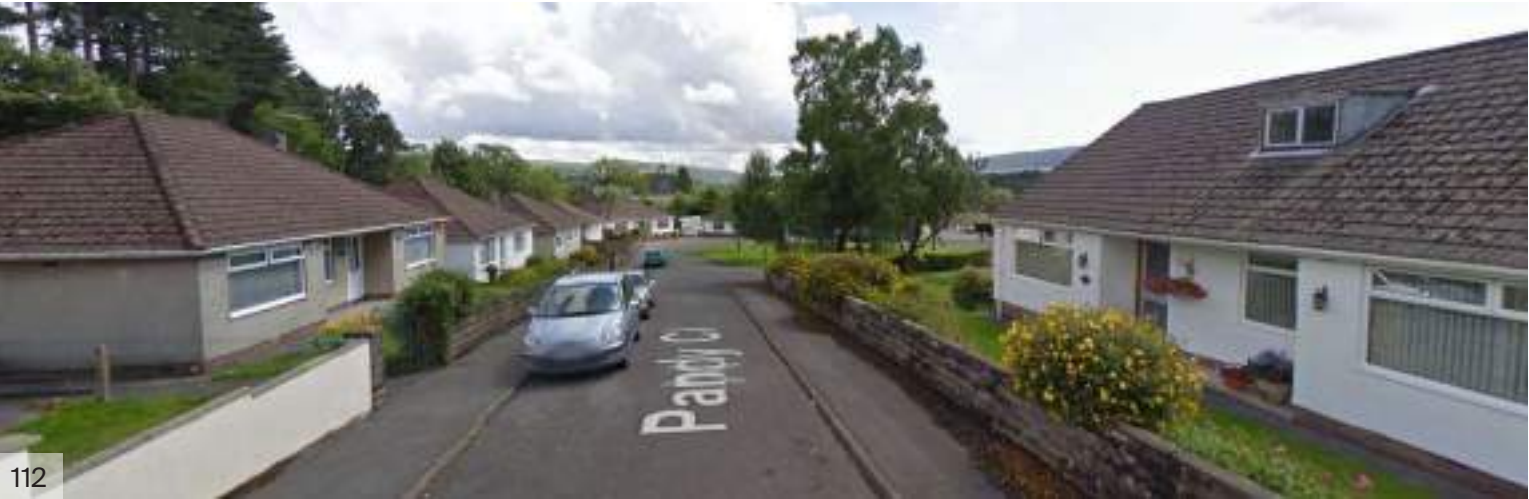
Diagram 112 - View east to the clock tower from within the Pandy Close bungalow development. This was a former rickyard/paddock with stone wall boundary.

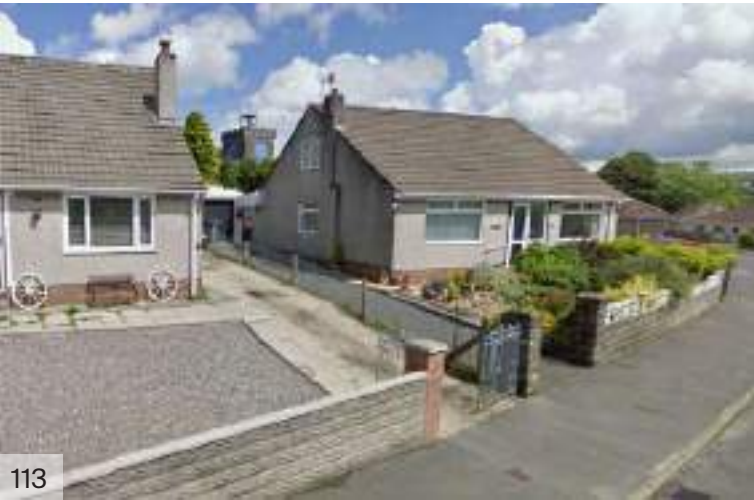
Diagram 113 - Pandy Clock glimpsed north between bungalows on Pandy Close.

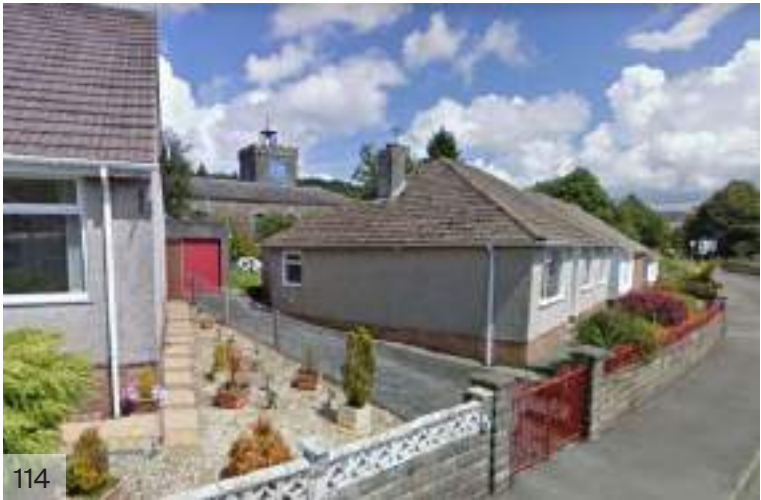
Diagram 114 - At points along Pandy Close the stable range can be seen between buildings.
