*Report No. BC/MB/11.19.04.*

**Site Investigation Report:  
Land at 6 Criccieth Grove, Castle Park Estate,  
Merthyr Tydfil.**

**Eco Valley Homes**

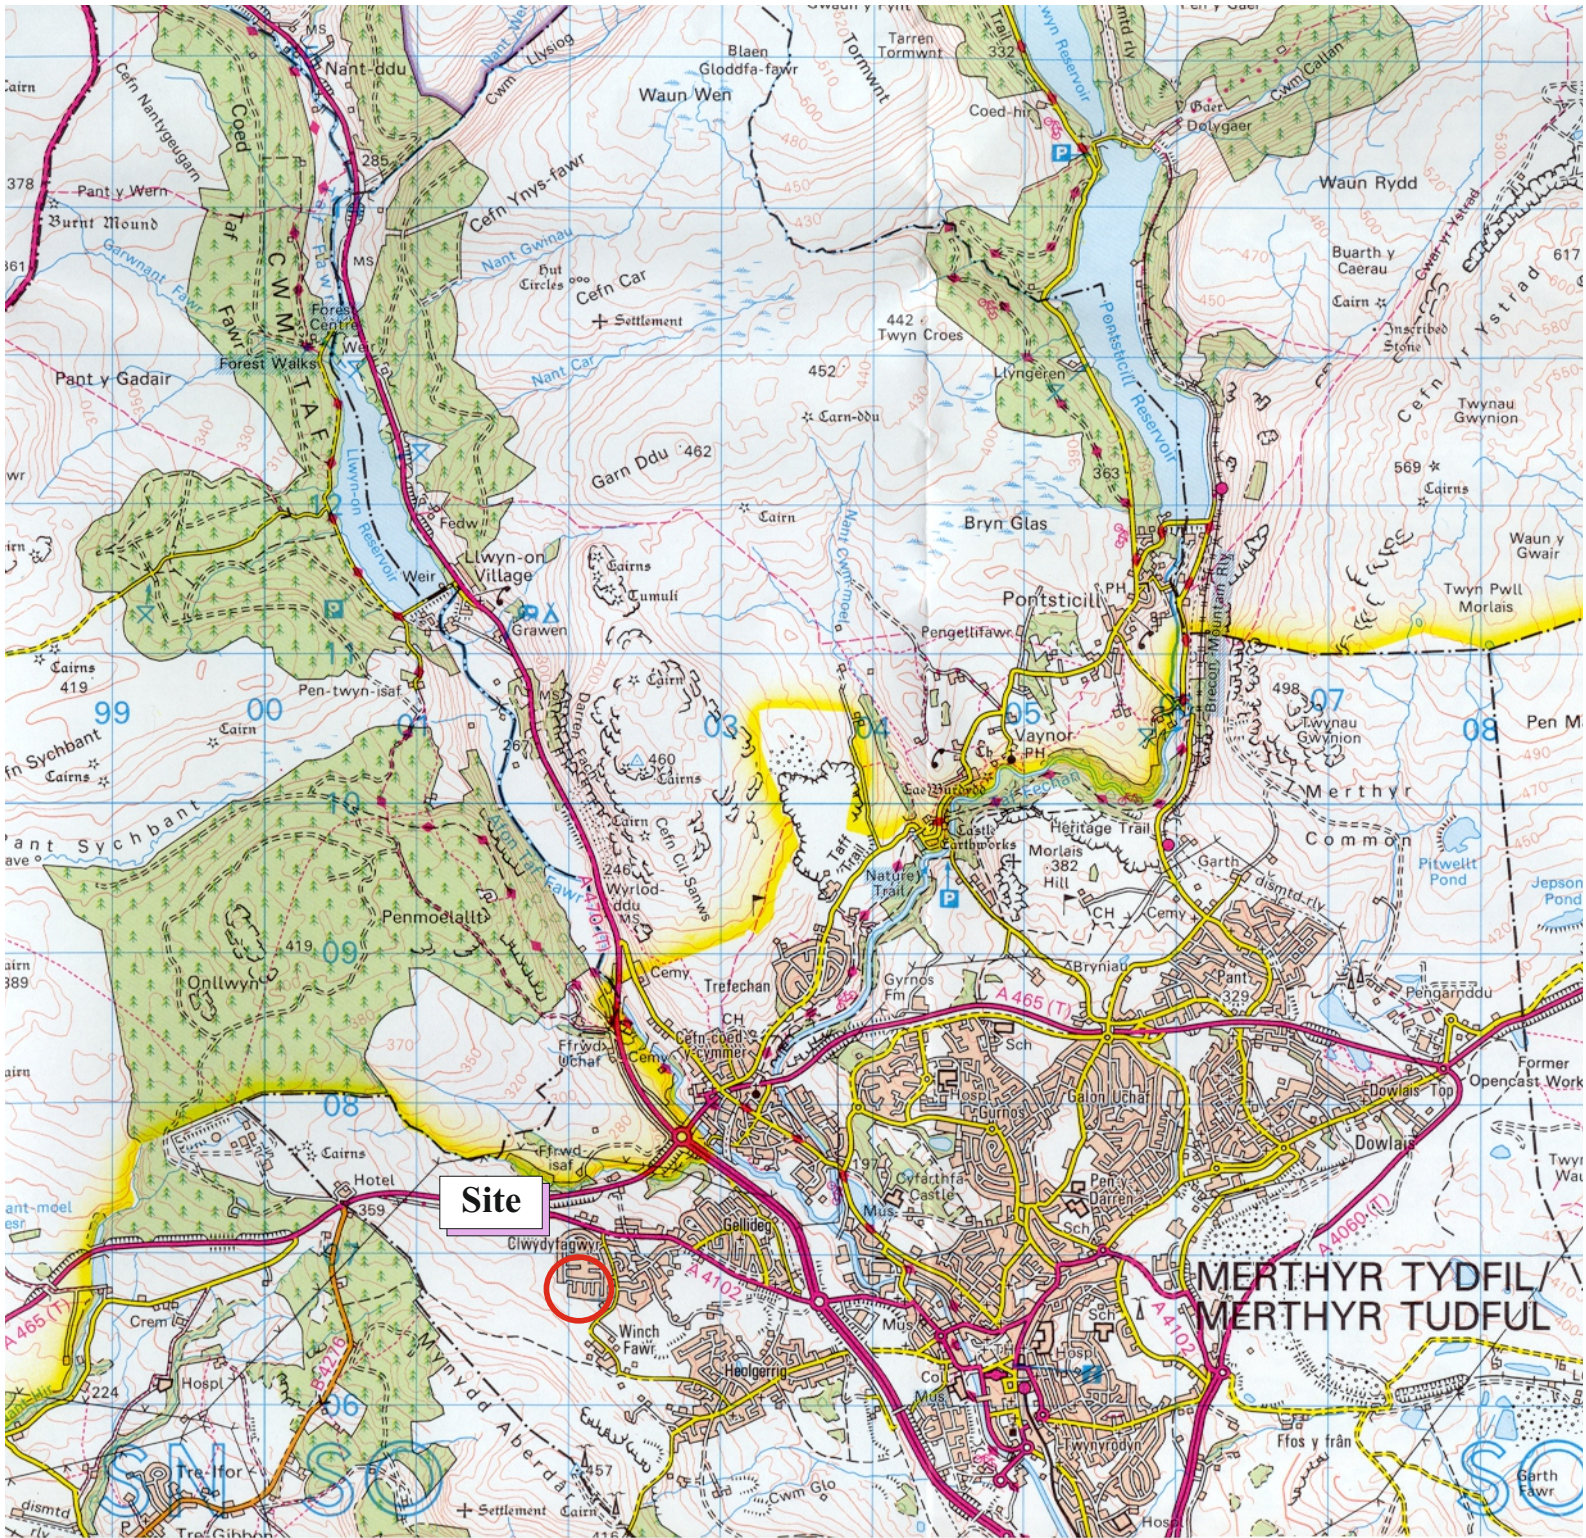
Geology Plan.

The Site is not affected by large faults and is not affected by landslip conditions. The published geological sheet also shows the Site to be covered with glacial deposits of Boulder Clay.
