**THE OLD SAWMILL, COURT STREET, MERTHYR TYDFIL**

**INITIAL BAT INSPECTION SURVEY**

**Bat Survey Report**

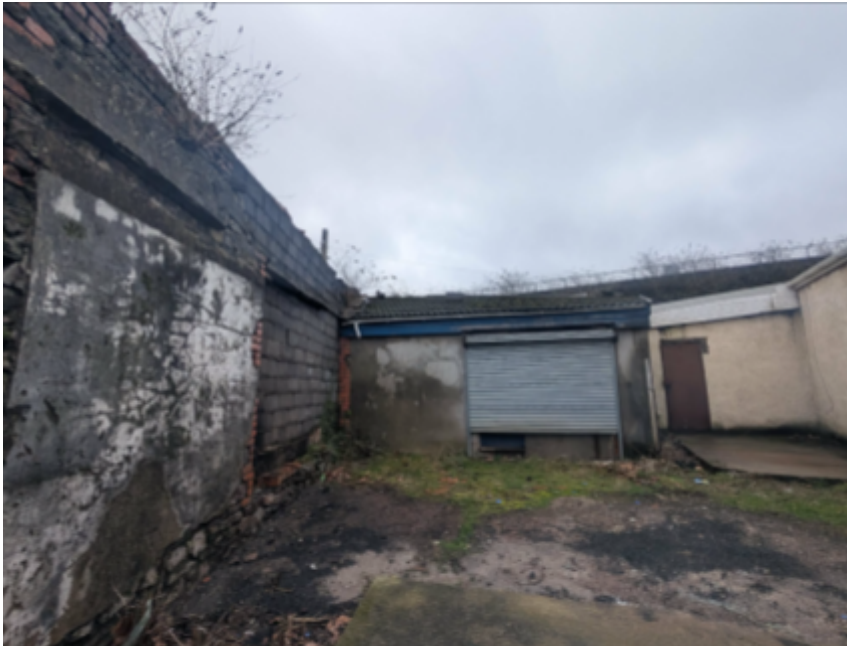
Whilst there are some ridge tiles missing on the small tiled unit, there does not appear to be many gaps into the roof via tiles.

Plate 1- photograph of small tiled roof building

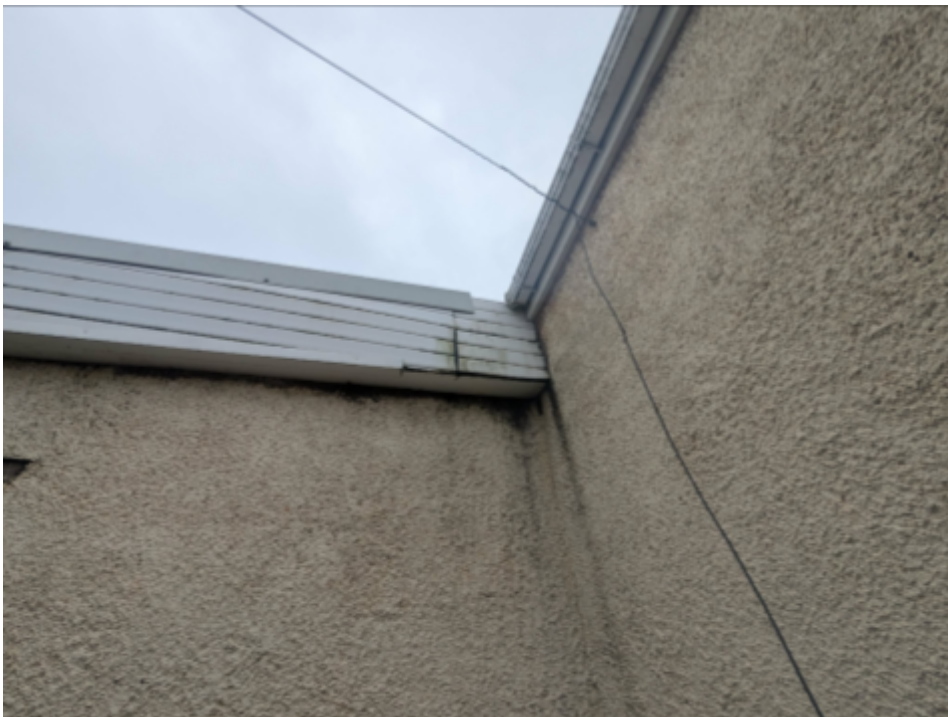
Whilst there are a small number of gaps into the buildings (above shutter doors, beneath metal sheets etc) the wall plates can be viewed. The building is draughty and clean. There is a small amount of ivy present on the rear elevation, however, the ivy is too young to provide appropriate roosting conditions. Generally fascias and soffits do not have gaps beneath them.

Plate 2- photograph of sealed fascias and soffits

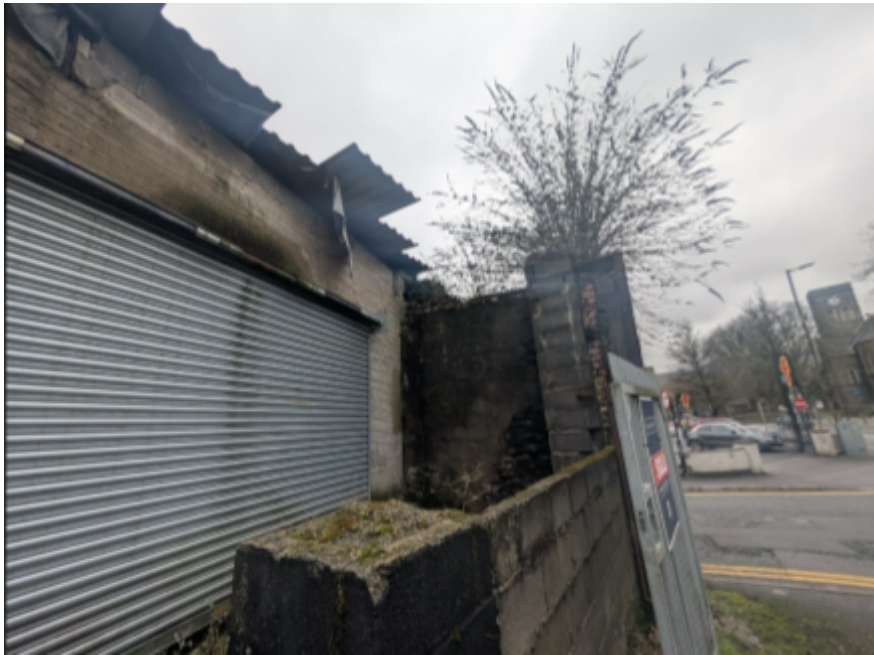
Plate 3- photograph of entrance and front of units

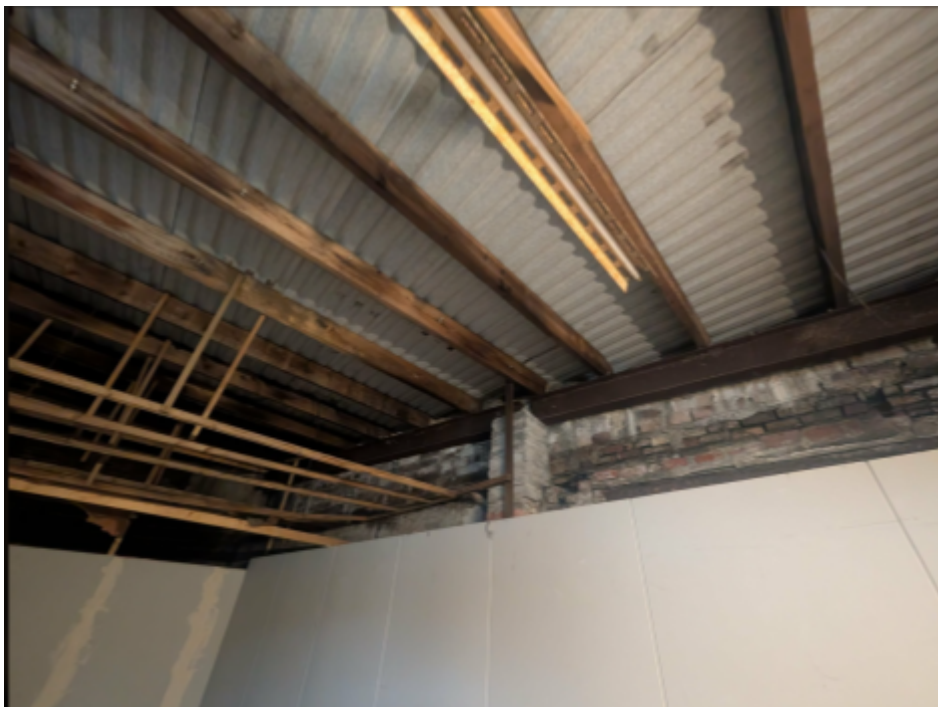
The area to the north east is entirely lined with corrugated metal that is sat on timber joists. There are some gaps to the exterior beneath the metal but the wallplates are exposed and can be viewed.

There are numerous unbroken cobwebs around wall plates. No evidence or potential for bats was found in the interior of the building. No evidence of nesting birds was found within the interior of the building.

Plate 4- interior of units

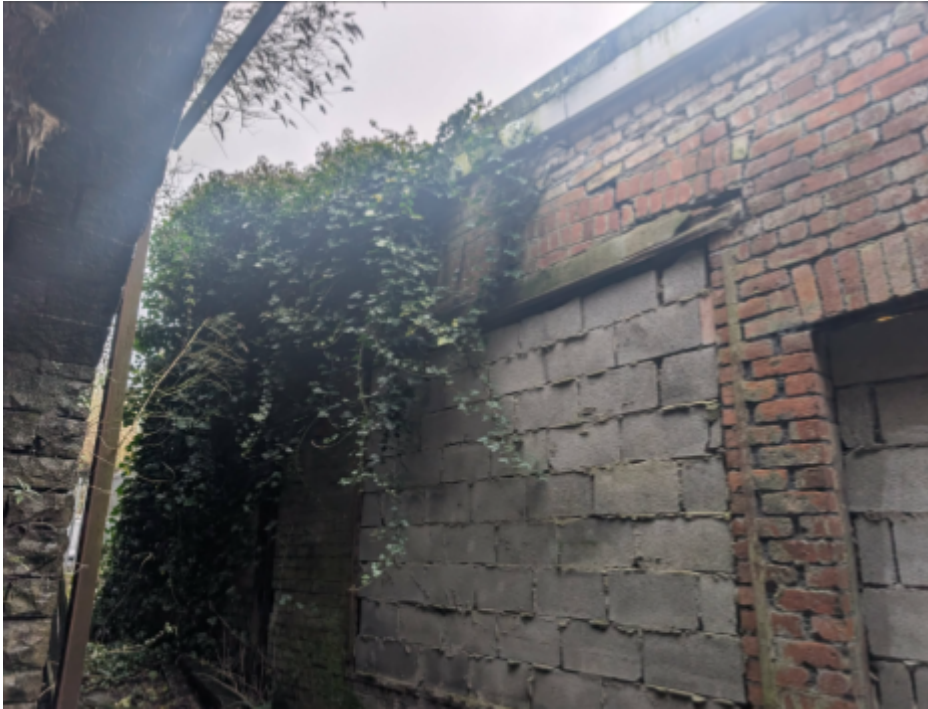
Plate 5- rear of units

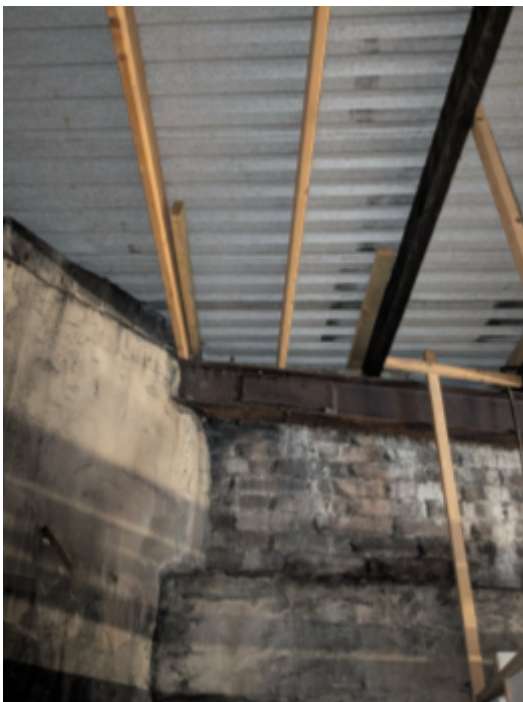
Plate 6- example of interior

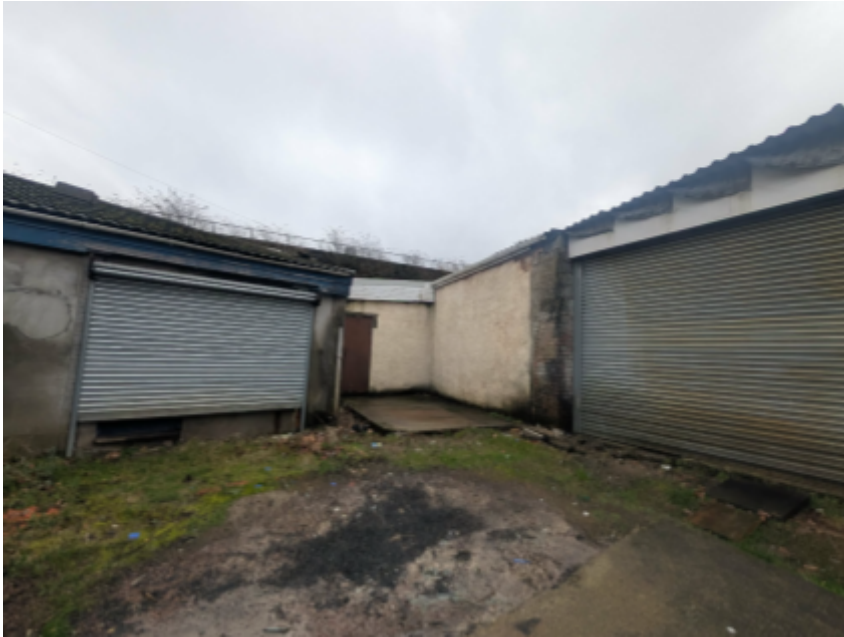
Plate 7- front of property

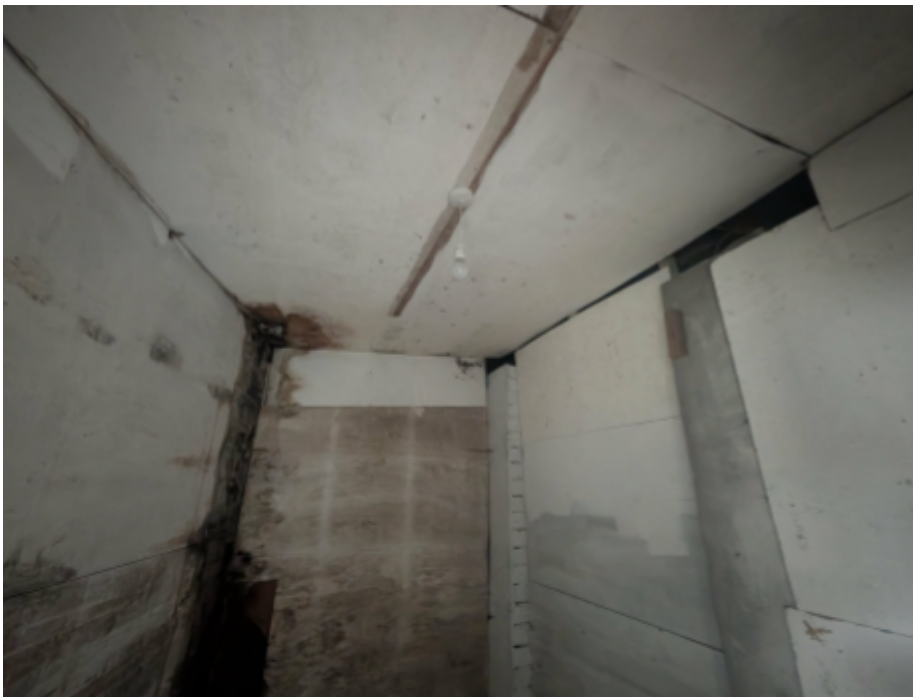
Whilst joined, the buildings are split into separate areas. There is no roof space present within the building with the tile roof. There are no light ingress' within this part of the building at wall plate level.

Plate 8- interior of tiled roof building
