**PROPOSED EXTENSION AT BEDLINOG PRIMARY SCHOOL,  
HYLTON TERRACE, BEDLINOG, TREHARRIS, MERTHYR TYDFIL**

**BAT SURVEY  
ISSUE 1, VERSION B**

**BEDLINOG PRIMARY SCHOOL****Bat Survey Report**

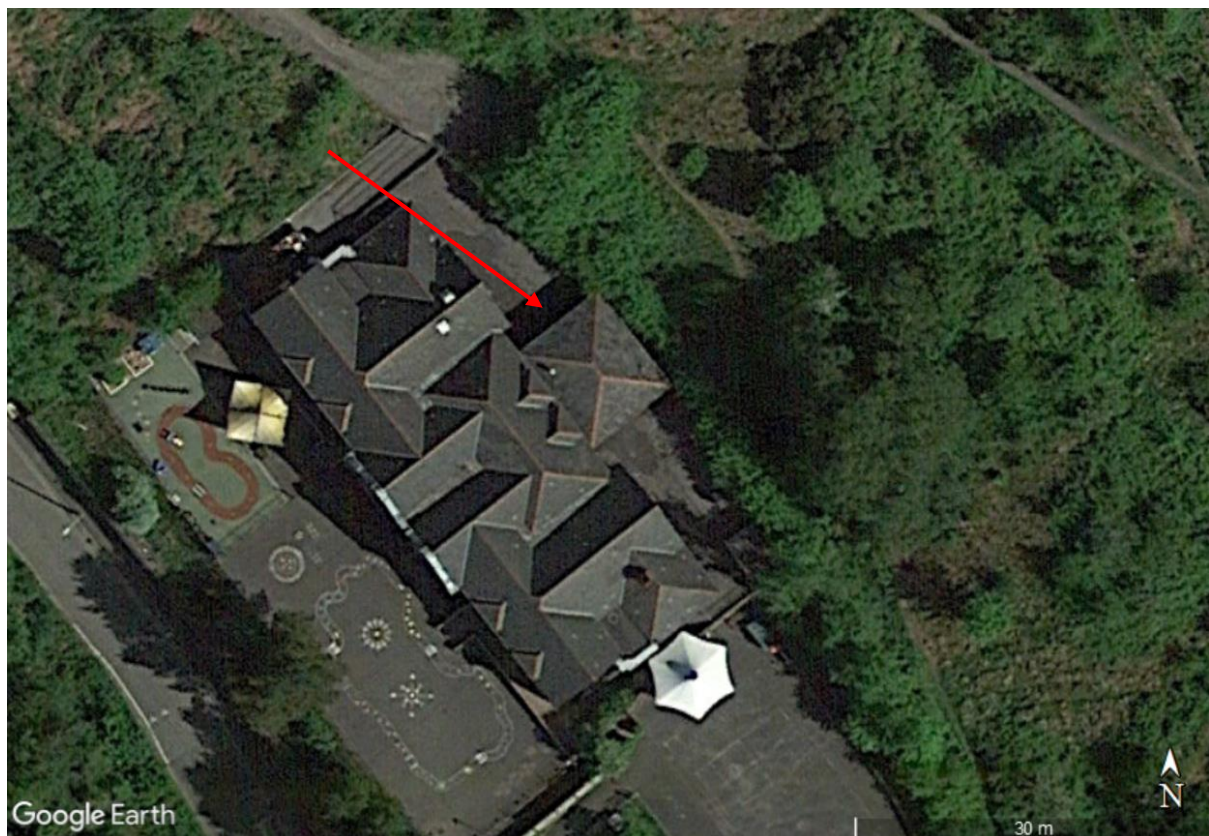
**Figure 1: Detailed view of the school (proposed extension location arrowed red)**

The building has a slate roof, the ridge of which is oriented north west to south east. The roof of the school is complex (figures 1& 2).

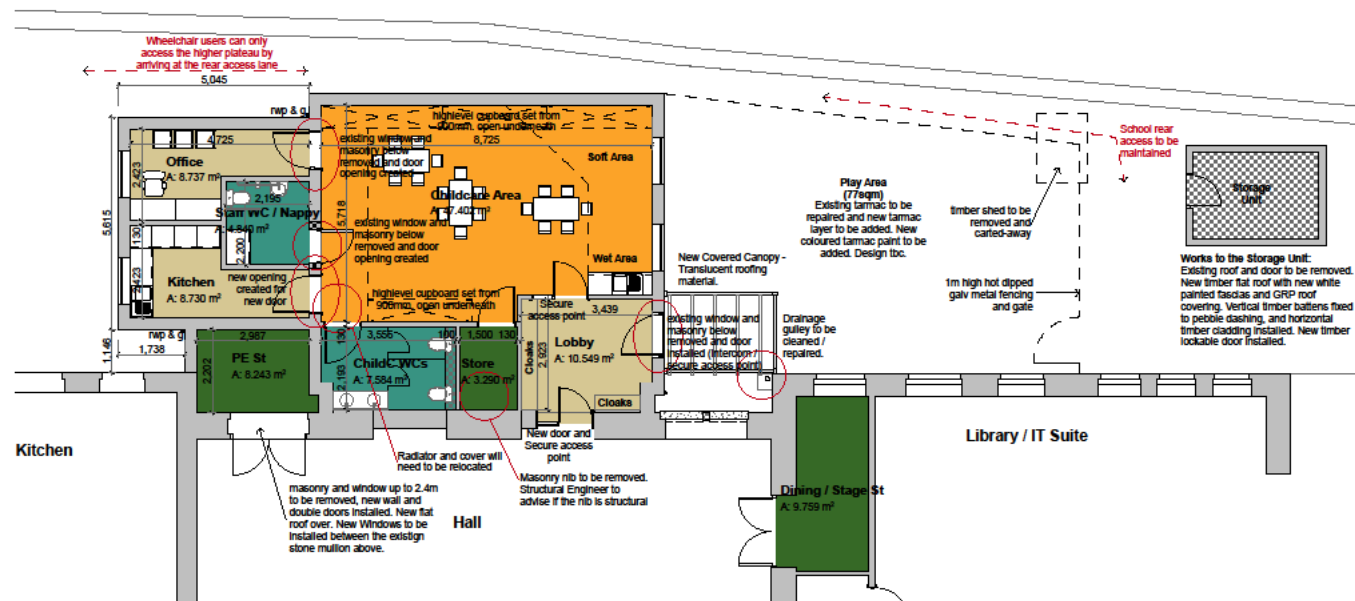
**Bedlinog Primary School Childcare Facility**  
**Proposed Floor Plan**  
Bleanau Gwent County Borough Council  
Community Services

It is proposed to extend the existing extension to the north west to create additional space within the school. In addition to this, it is proposed to remove an existing timber garden shed and re-roof an existing storage unit.

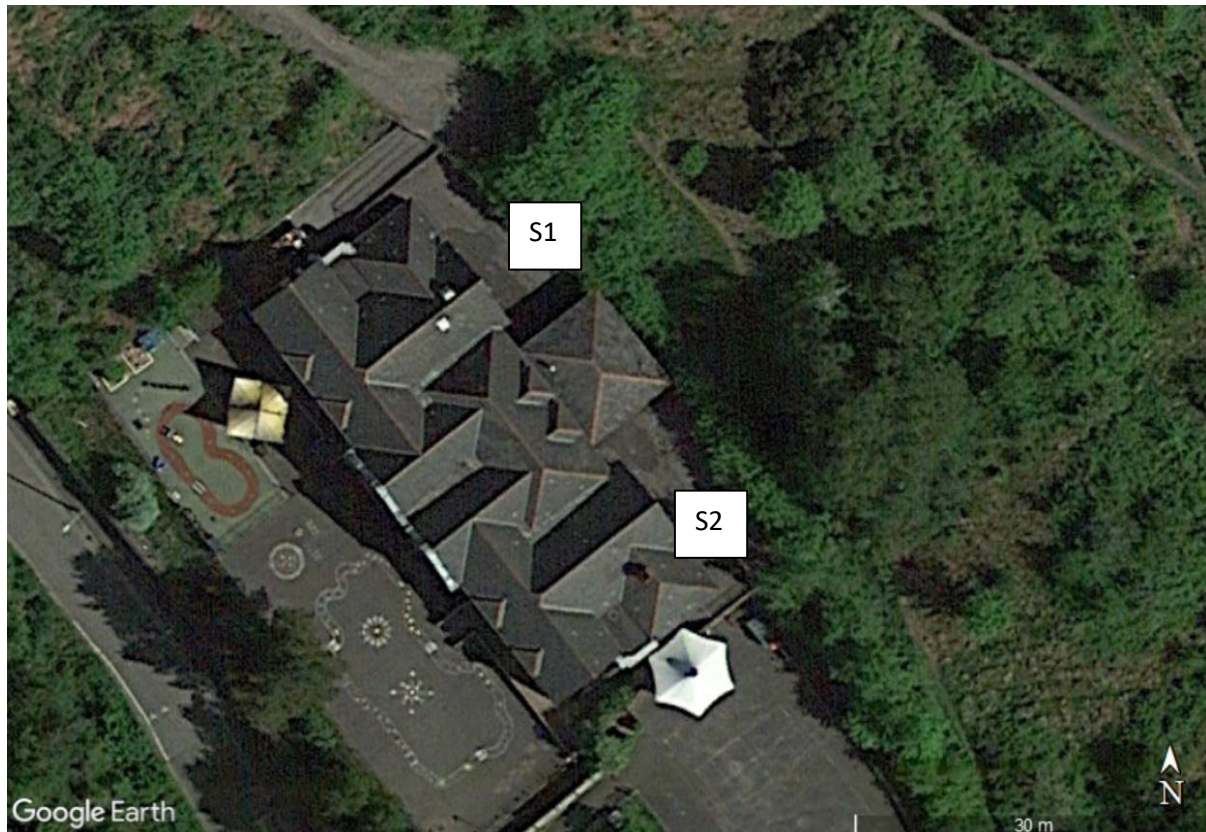
Figure 3: Approximate surveyor locations

A dusk survey was carried out on 22<sup>nd</sup> June using two surveyors, positioned in such a way that as much of the building was visible to surveyors as possible. Surveyors were equipped with Batlogger M detectors.

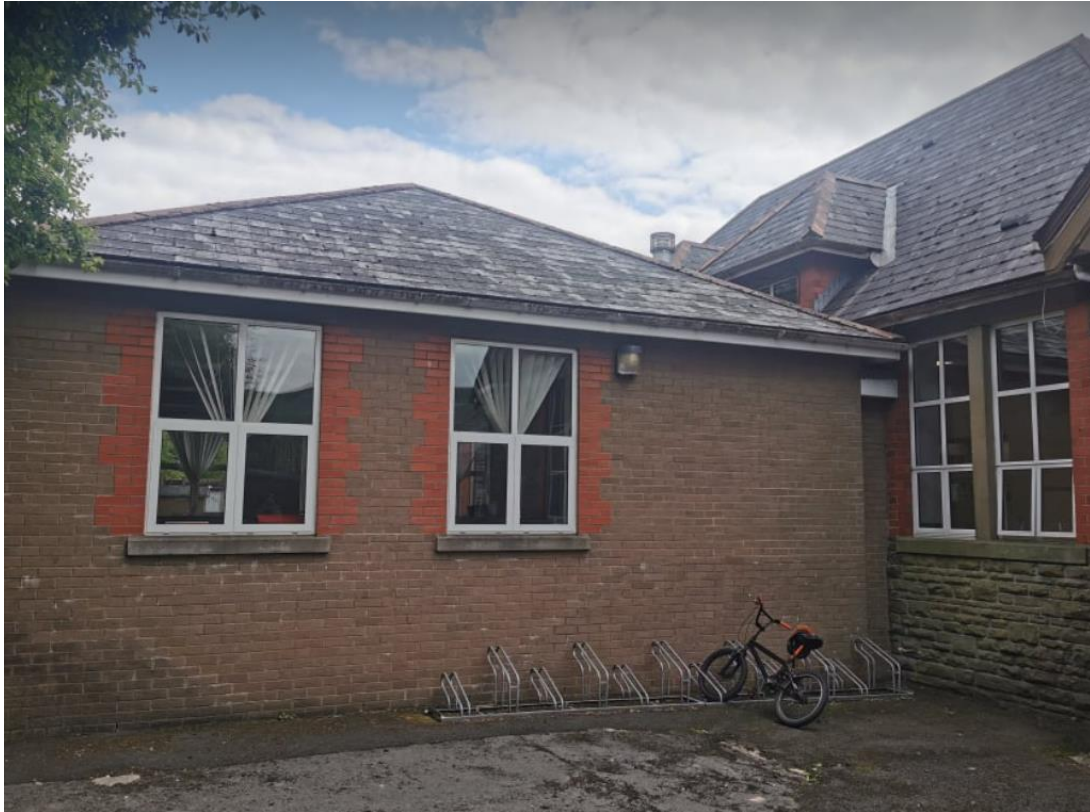
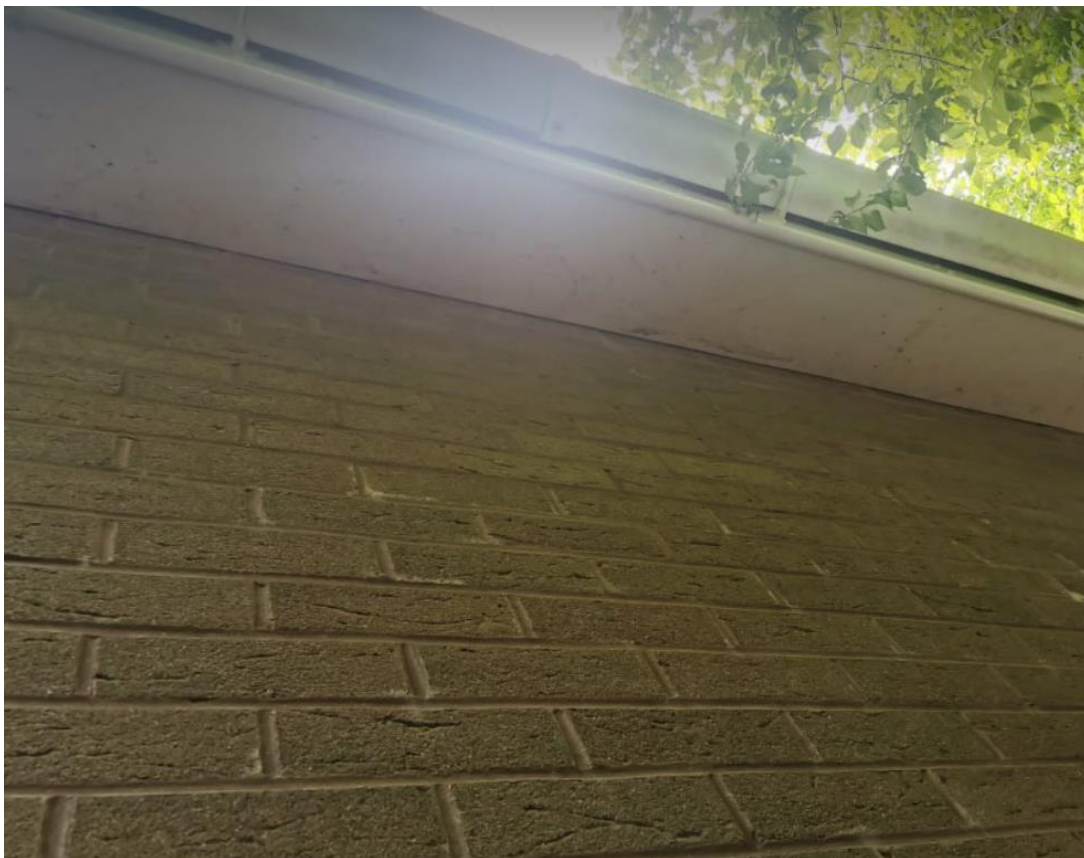
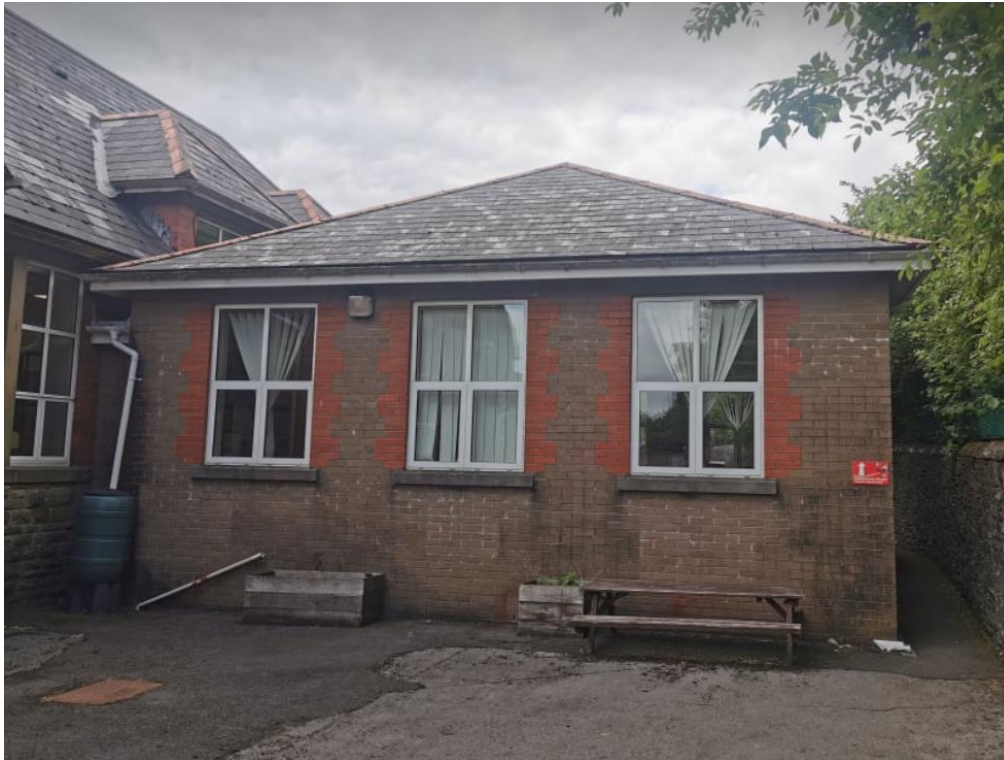
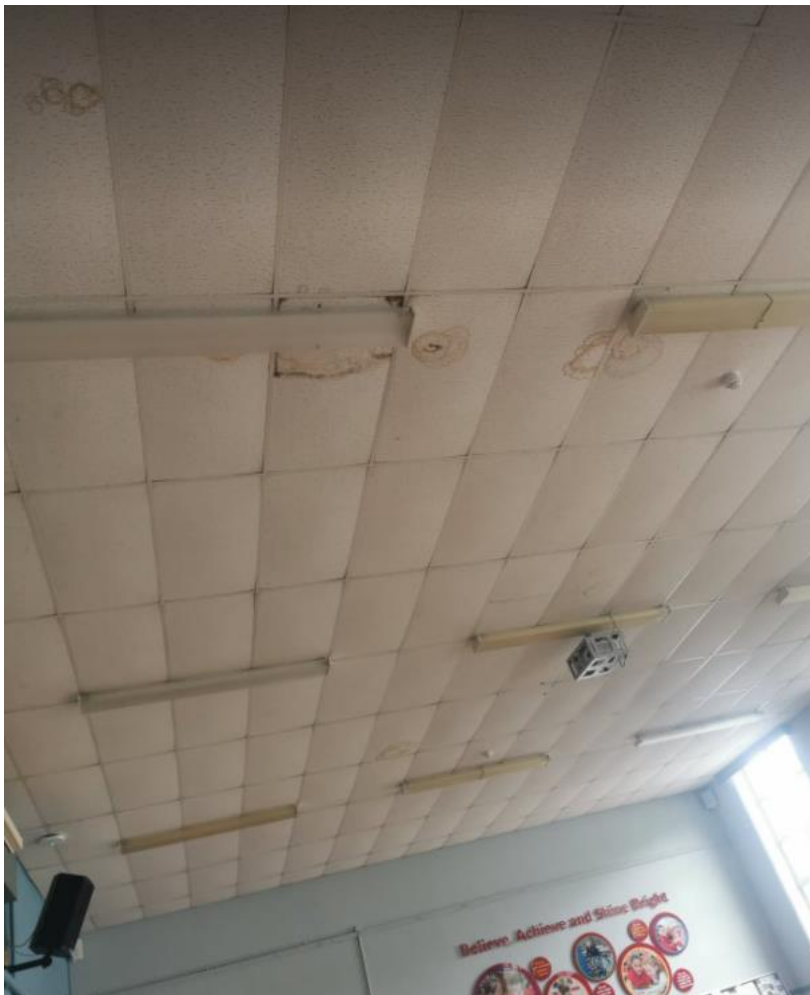
### Existing extension photographs

- A very small gap beneath the fascia on the north east elevation of the extension (debatable as to whether bats could access)
- A small gap beneath the fascia of the south east elevation of the extension (please note, this does not run the full length of the fascia board)

Please see appended plates for photographs of the property exterior. Other than these areas, the building is well sealed with no obvious gaps and no apparent slipped slates on the pitches of the roof. The hip tiles appear to be well cemented.

Supervision for the removal of tiles for the tying in of the extension will be required.

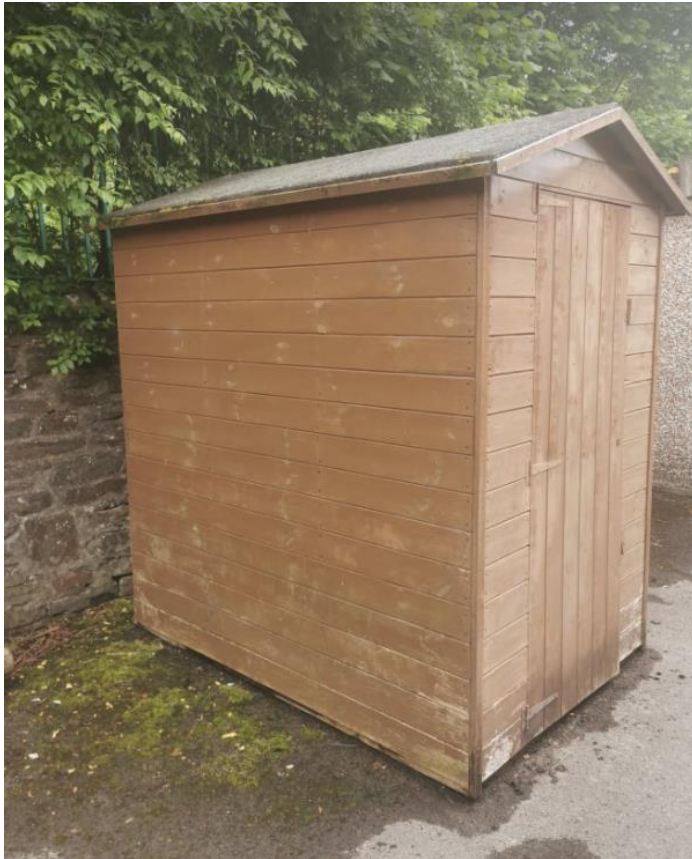
### Garden shed to be removed

The timber shed is a typical single unit garden shed and has no obvious access points for roosting bats.

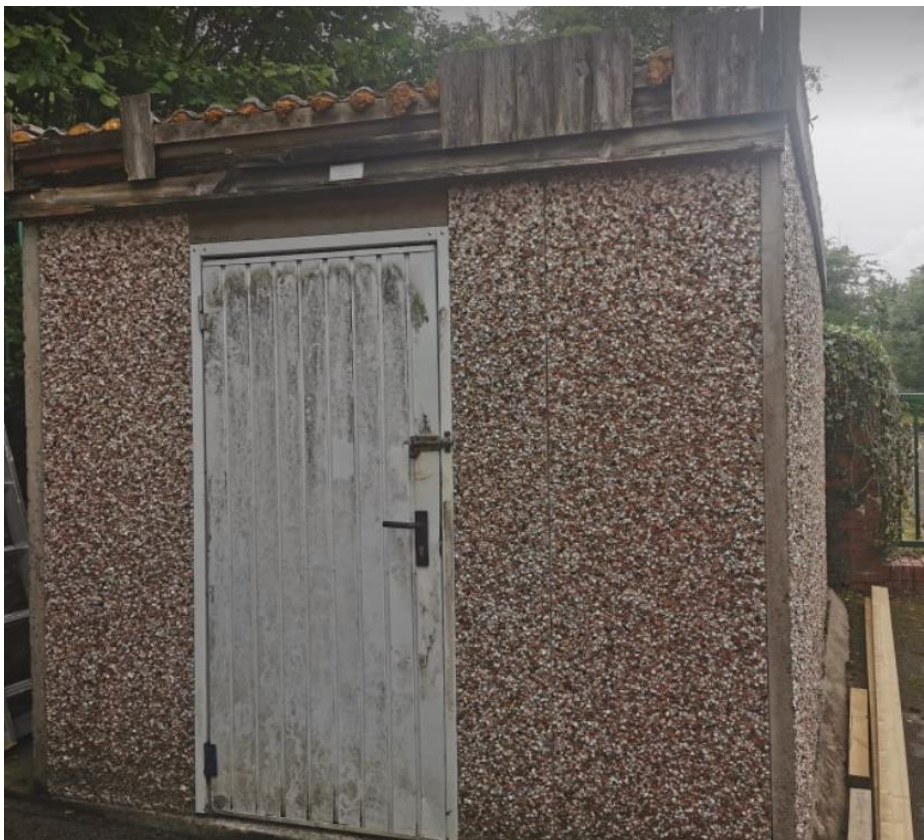
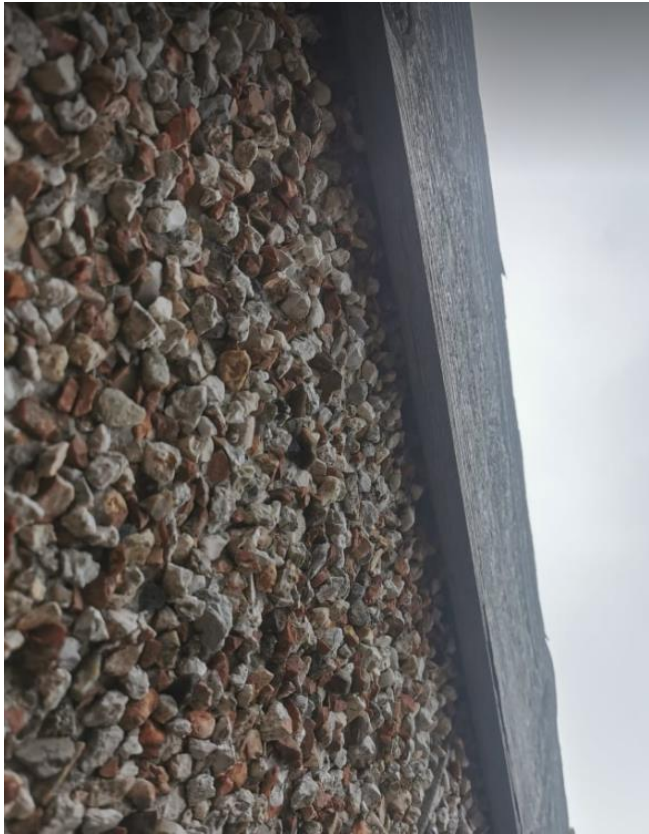
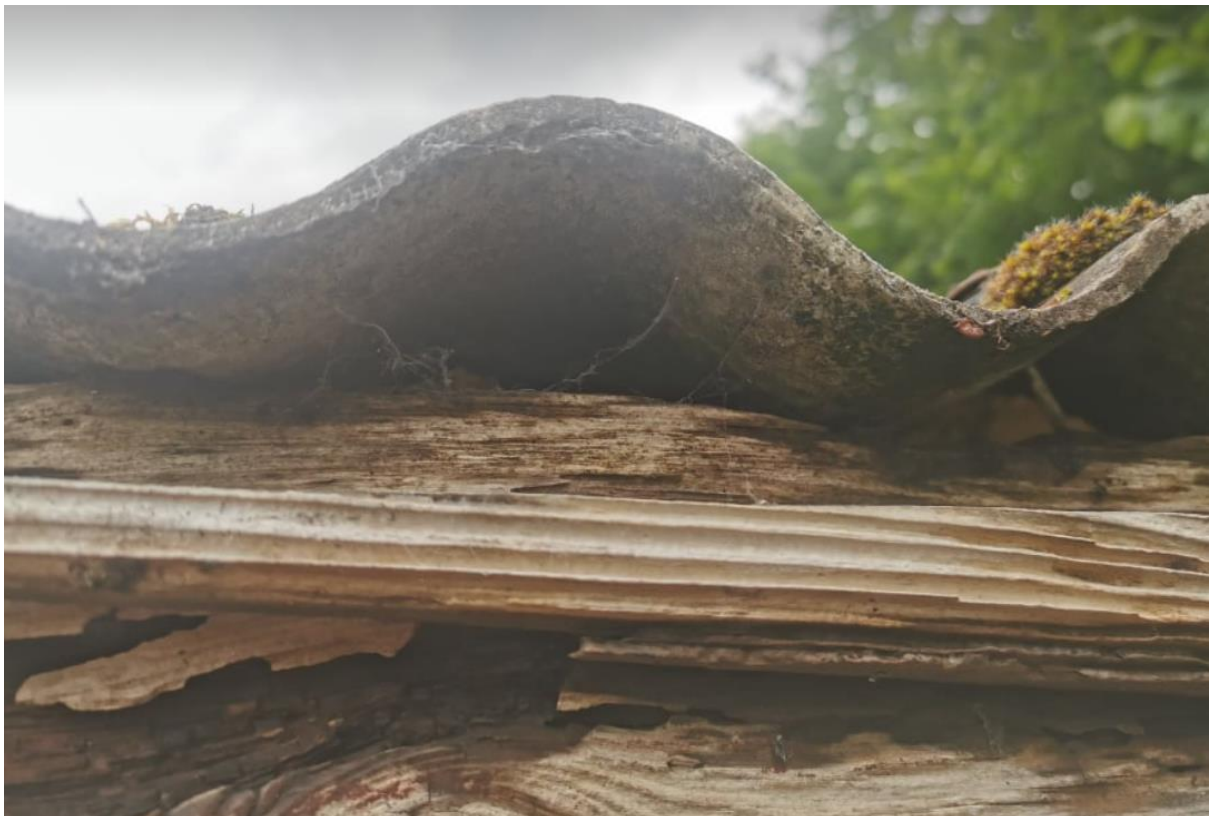
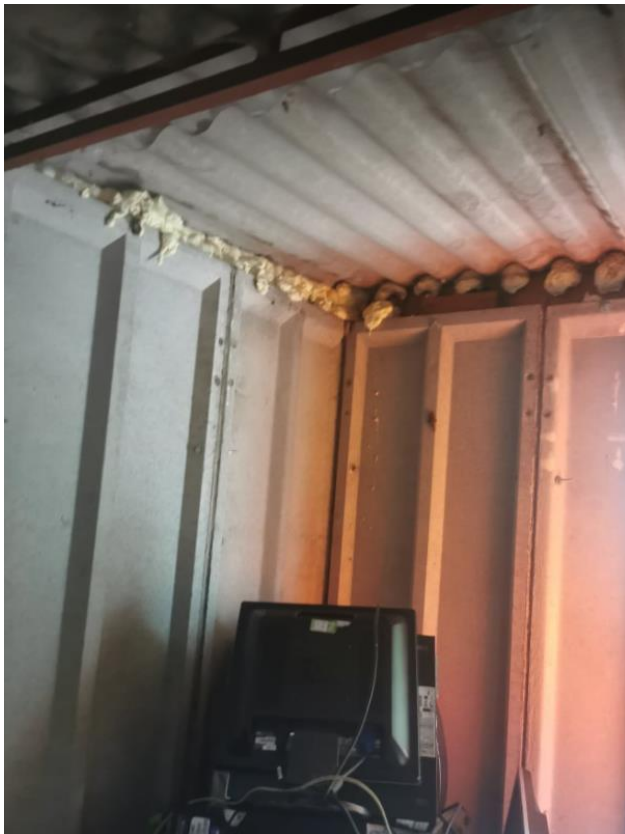
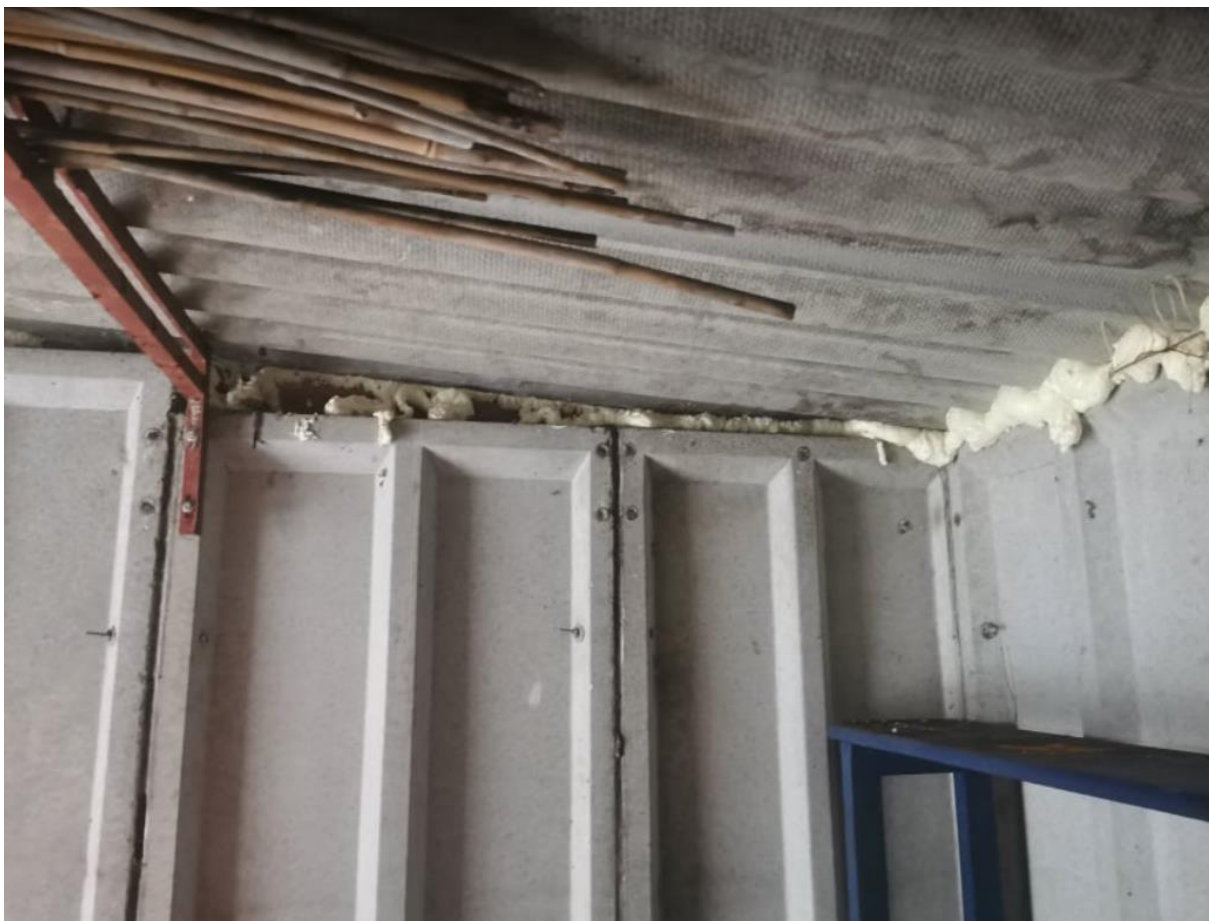
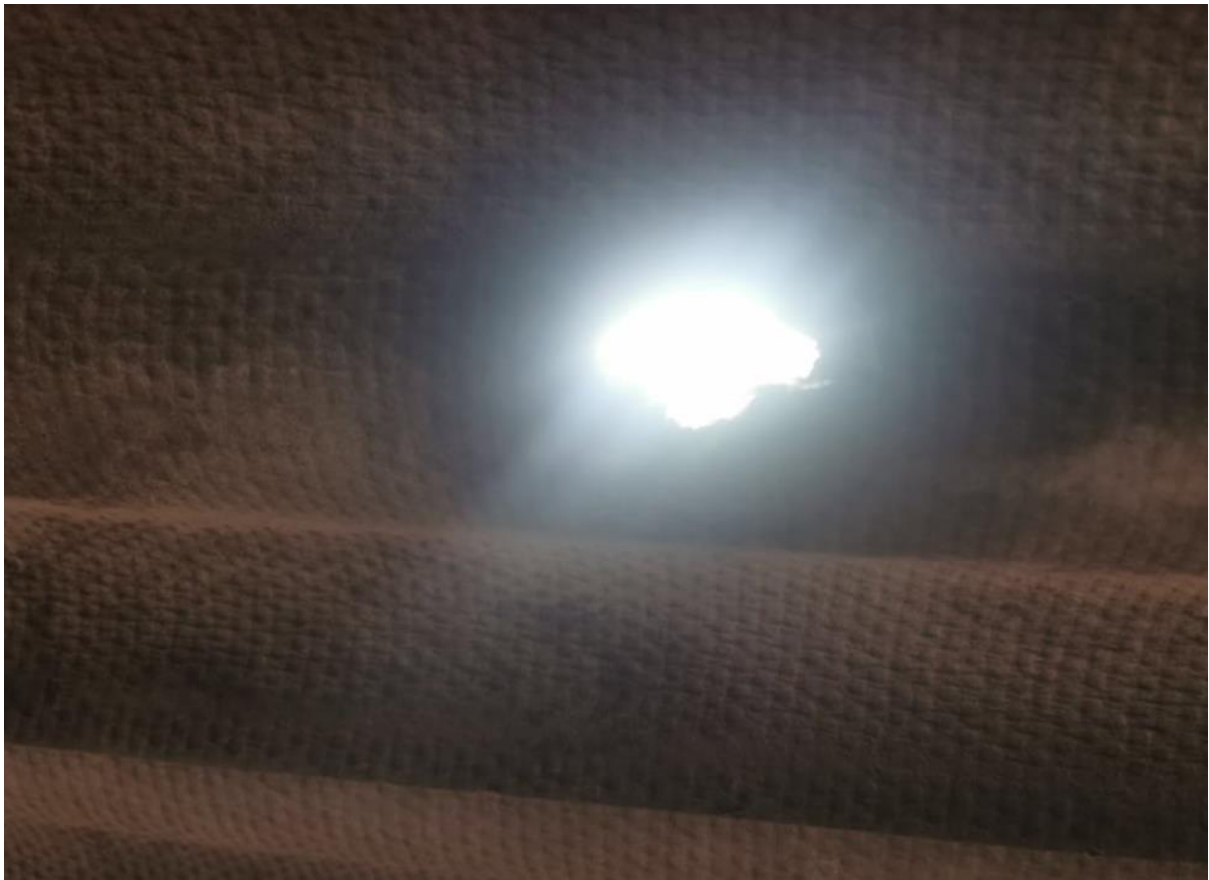
### Storage Unit

The storage unit is in a state of disrepair. There are fascias present, however, they are just rotten pieces of wood that would have been used as decoration at some point. The gap beneath the fascia and the wall can be clearly seen and no bats or evidence of bats were noted at this location. There are gaps at eaves level and beneath the ridges of the asbestos, however all of these gaps have been tightly filled with expanding foam.

The storage unit is made of bare concrete, the roof is unlined and all gaps at eaves level are filled with expanding foam. There is a single small hole in the roof where the asbestos has broken or cracked.

**(please note, lifts in asbestos are filled with expanding foam further in)**

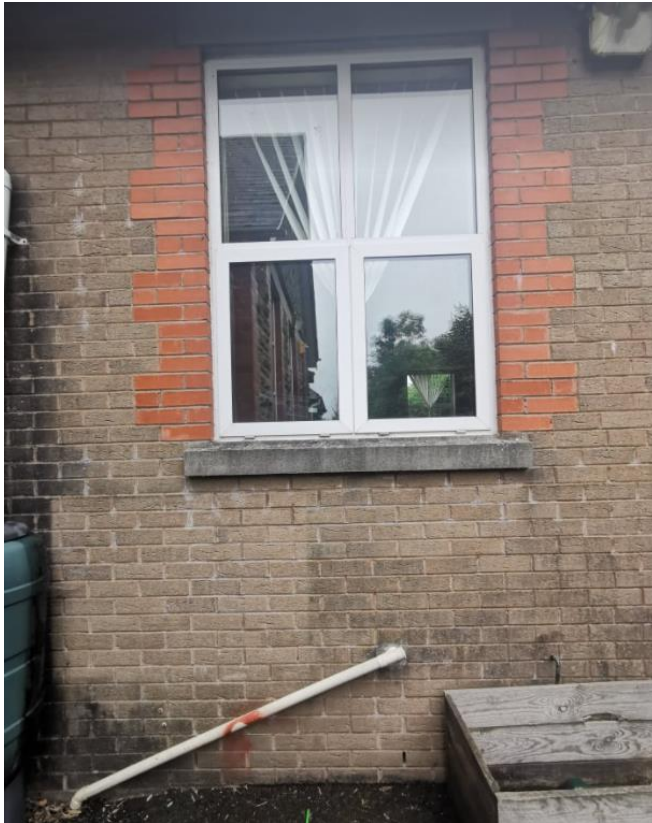
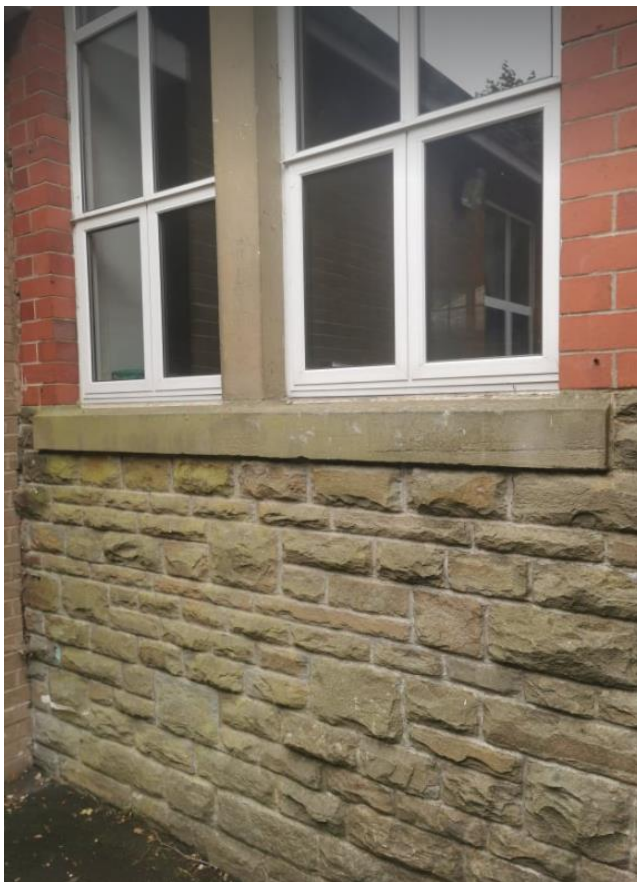
### Windows to be replaced with doors

New doors will be installed in existing windows with only the masonry beneath removed, there are no potential bat access points at these locations with the stone and sills tightly mortared.

New doors will be created in the locations of existing windows, with only the masonry beneath this removed. There are no potential bat access points at these locations.

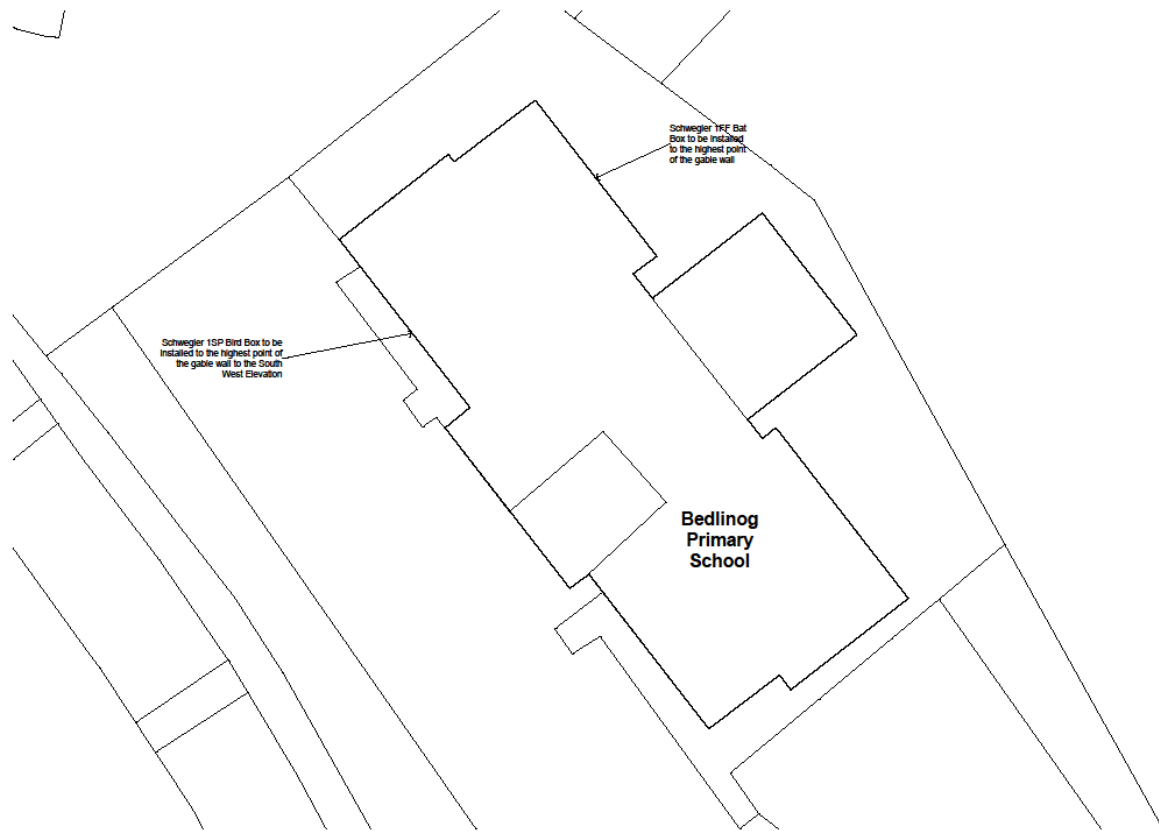
**Bedlinog Primary School Childcare Facility**  
**Bat & Bird Box Locations**  
 Bleanau Gwent County Borough Council  
 Community Services

A Schwegler 1FF bat box will be attached to the north east elevation of the property. Should the 1FF prove difficult to source, an eco bat box (crevice box) <https://www.nhbs.com/title?slug=eco-bat-box> will be installed in its place.

A Schwegler 1SP Sparrow Terrace or the following <https://www.nhbs.com/sparrow-terrace-nest-box> will be attached to the south eastern elevation of the main school.
