CCRW-PUR-01-ZZ-RP-A-0020

# CCTV Installation Guide

## *Visual location schedule*

# CCTV Installation Methodology - Overview

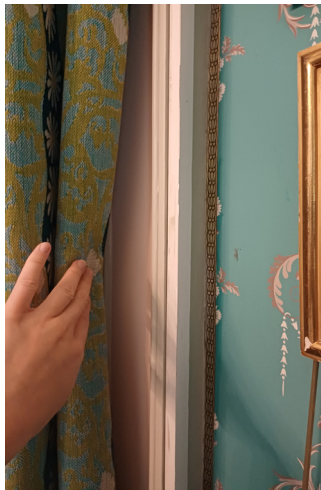
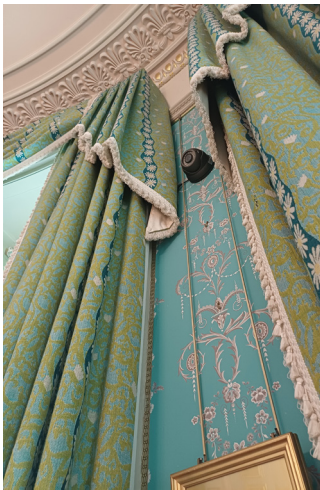
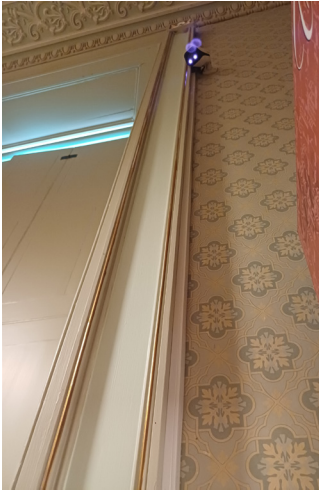
Example of trunking which is installed alongside architraves and concealed behind curtains.

Examples of trunking which is installed alongside architraves resulting in a discrete finish.

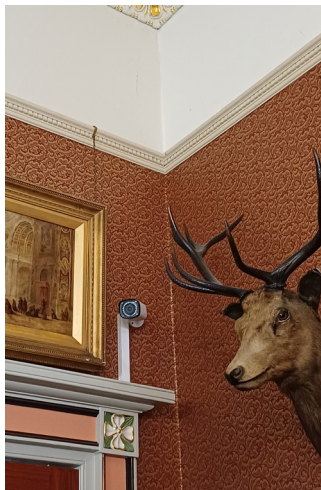
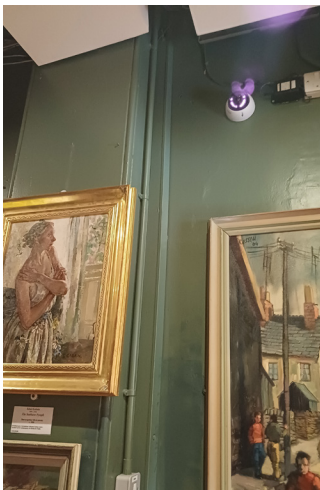
Example of locations where trunking is to be wall mounted. Trunking will be covered with wallpaper or painted in same colour as wall

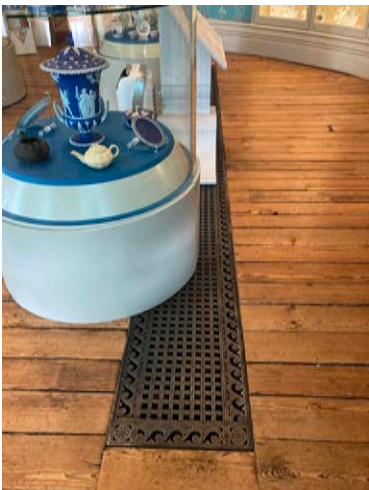
Cabling to be run in floor grilles.

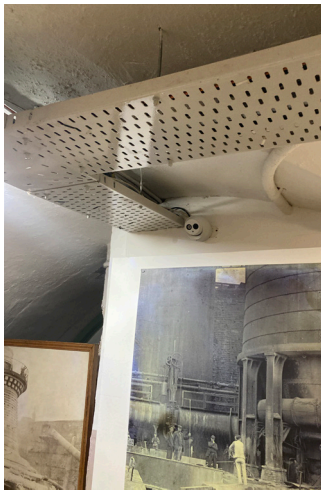
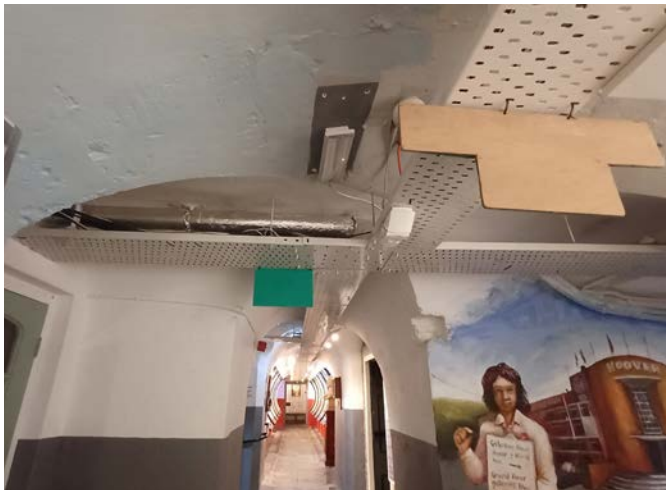
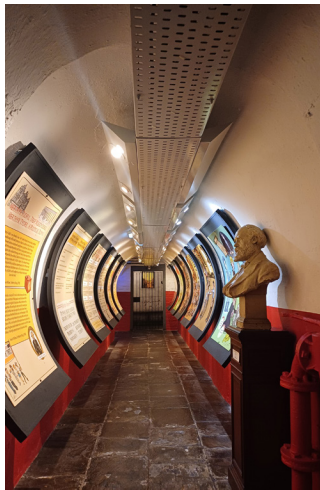
Cable trays run around the majority of the basement spaces to feed existing cameras and will be used for the majority of new camera locations..

- In most of the basement rooms, existing cable trays run around the centre of the room and can be utilised for new cabling.
- In rooms without trays (e.g. B002), new conduits will be installed on the walls and painted to match the decorative scheme, reducing visual intrusion.

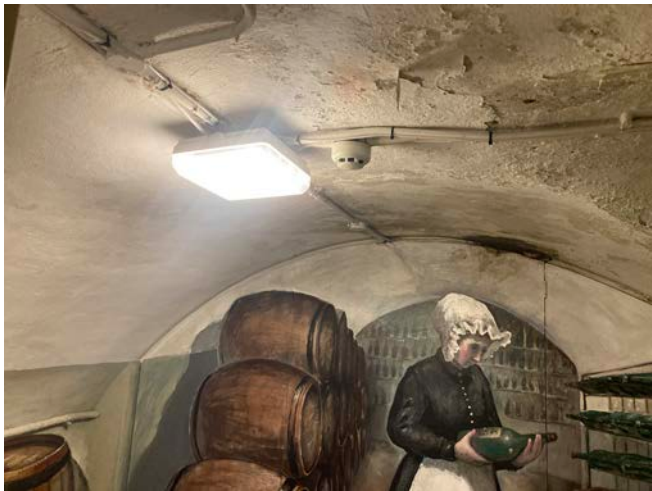
Where cable trays not present, trunking will be surface mounted and painted to match wall / ceiling colour.

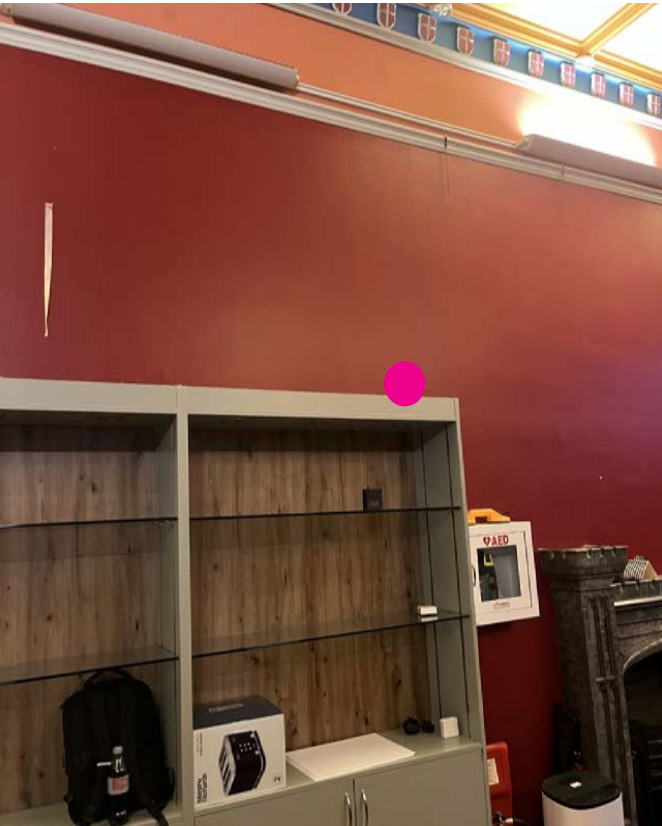
**A1** - New camera and AP location mounted on bookshelf behind reception to remove need to fix into walls. Existing cable route under floor reused.

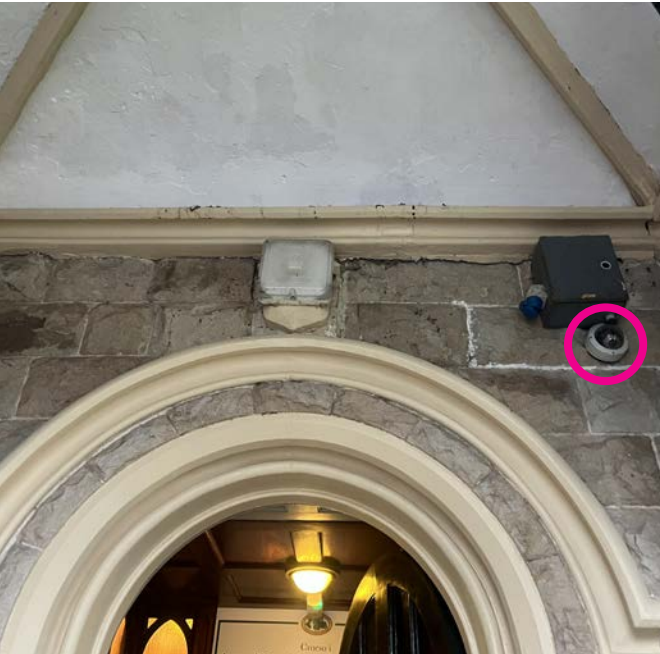
**A2** - New camera to existing location above main entrance door. Location and cabling to match existing

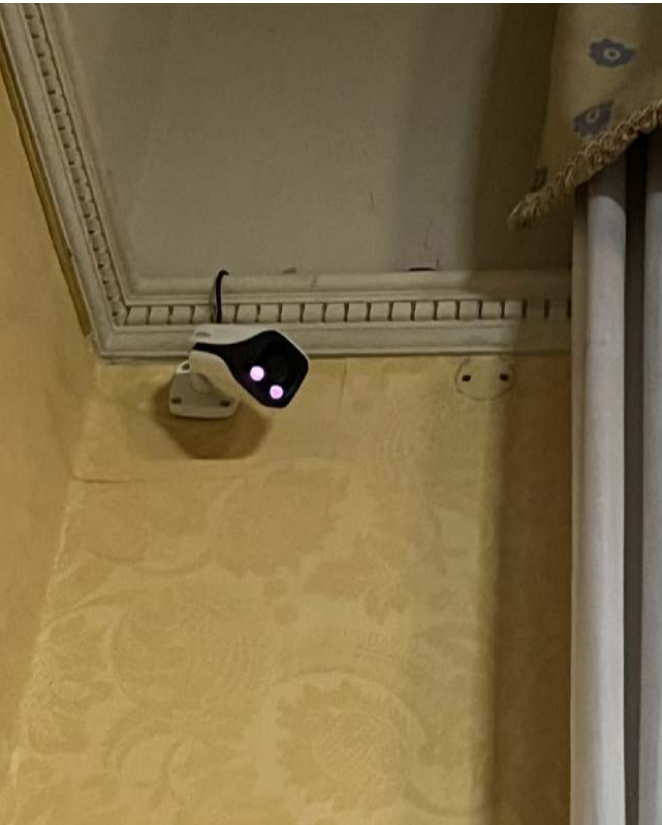
Existing cameras to be removed and all historic fixing locations made good. Cameras to be mounted above picture rail so cabling not exposed

**B1** - Existing camera location with new AP shifted to above door to get full room coverage. Existing painted trunking at window architrave reused to transfer from floor to above picture rail. Cables painted to match architrave when visible. Cabling running above picture rail not visible.

**B2** - Existing camera location shifted to above door to get full room coverage. Existing painted trunking at window architrave reused to transfer from floor to above picture rail.

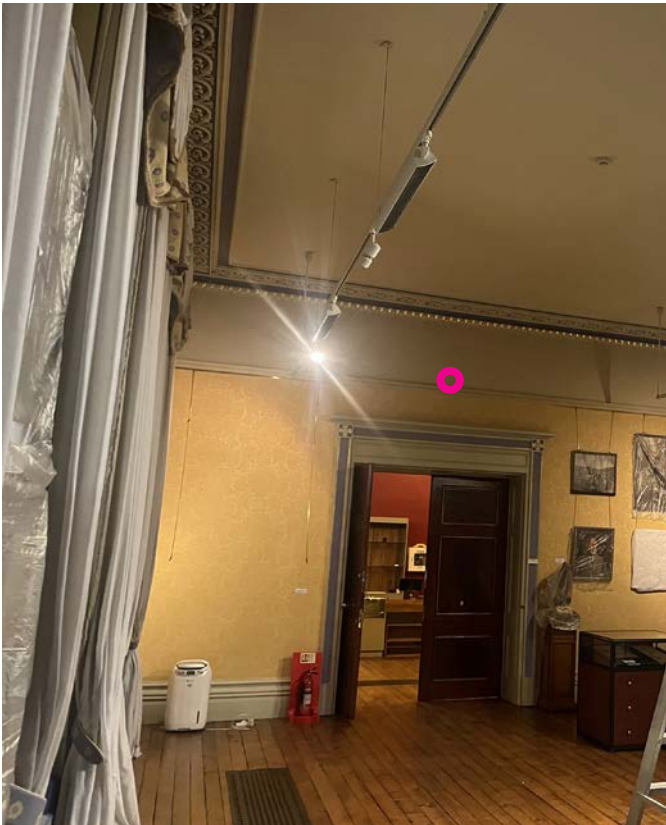
New camera locations above doors and above picture rail to get full coverage of the room. Cabling route not visible above picture rail

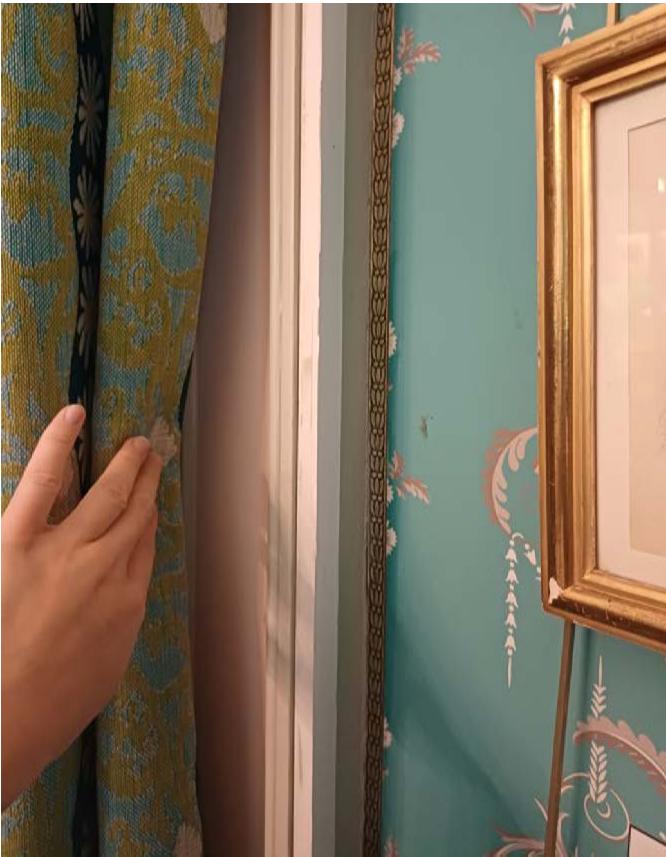
**C1** - New camera to existing location utilizing existing trunking and floor access grilles.

Painted trunking at window architrave to be reused

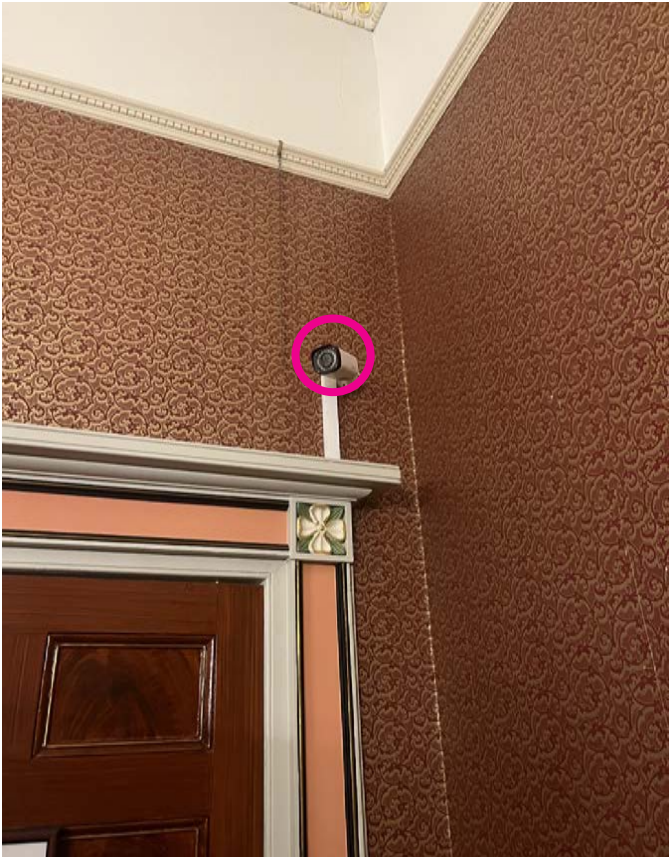
**D1** - Existing camera location and cabling route reused. New Wifi AP paired with camera. Trunking to be covered in matching wall paper to conceal.

Trunking to be wrapped in wallpaper to match wall

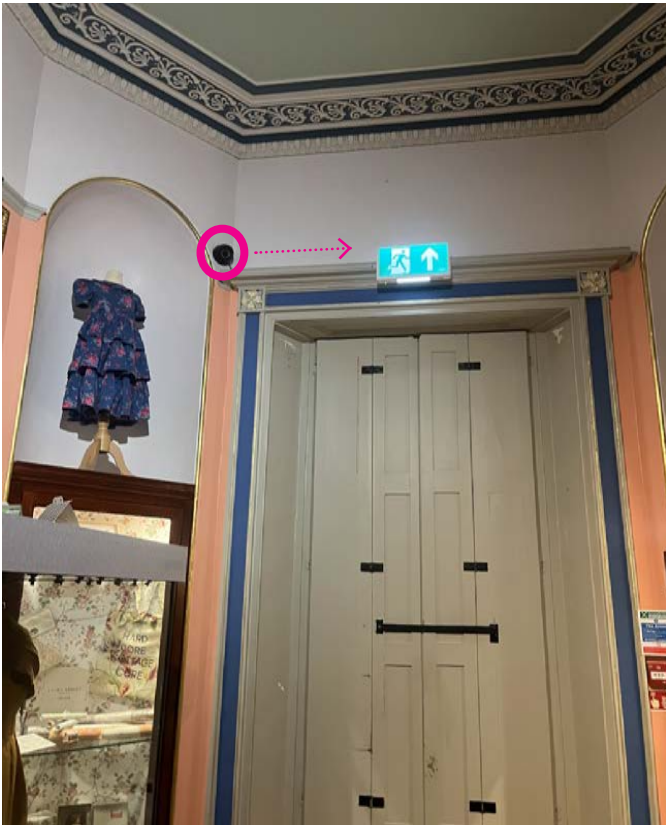
**E1/L1** - Existing camera location shifted to above door. Existing painted trunking reused and cables hidden above door architrave. AP paired with camera.

Trunking to be wrapped in wallpaper to match wall

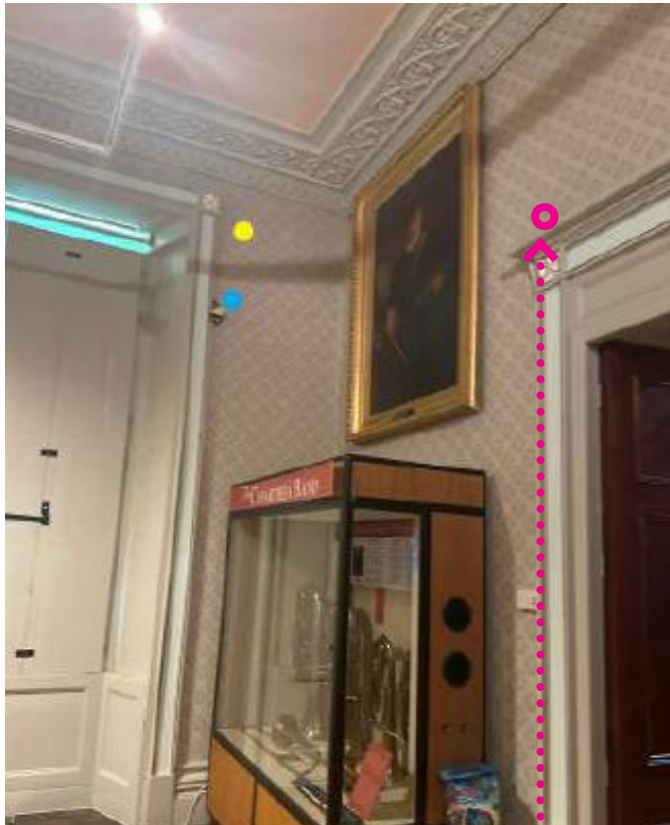
**F1** - Existing camera location shifted to above door to get full coverage. New painted micro trunking mounted on door architrave to transfer from floor to above door. Existing holes in floor utilized for new cabling.

Trunking to be wrapped in wallpaper to match wall

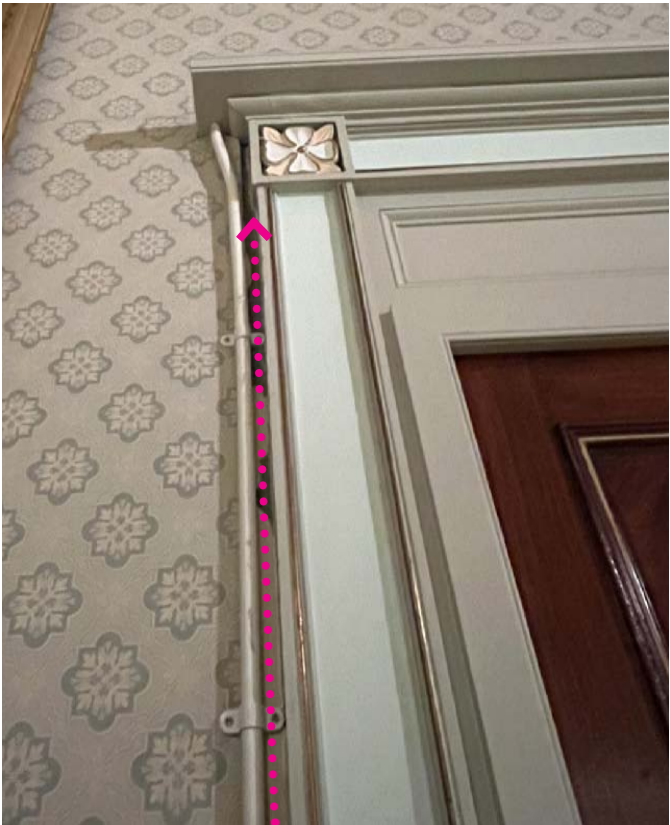
F1 - new micro trunking fits in gap between existing circular trunking and door architrave

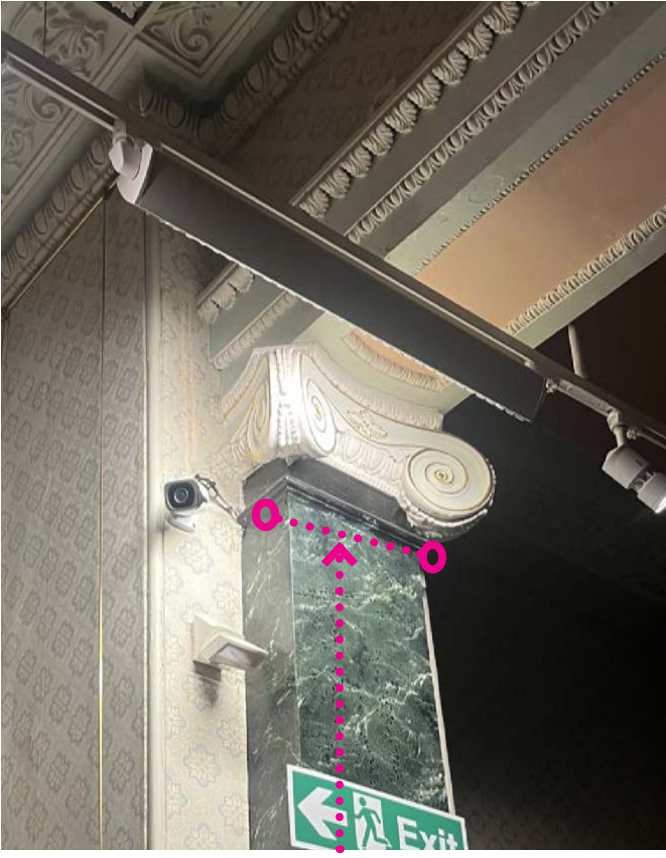
**F2/F3** - Existing camera removed and made good. Two new cameras mounted either side of timber pilaster. Cable route retained within timber pilaster.

F2 & F3 - New drilled hole in pilaster will be required hidden behind camera.

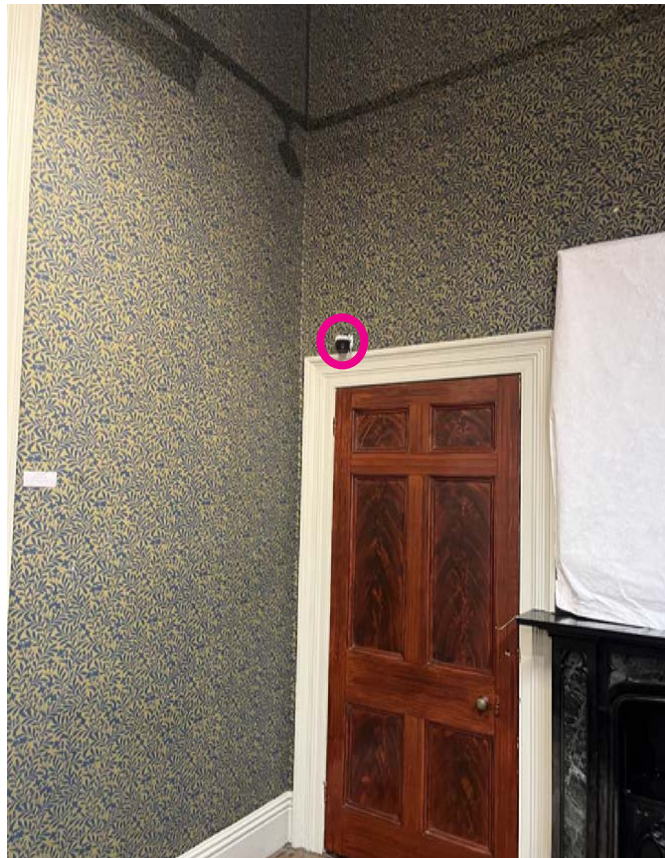
**I1** - Existing camera location and cabling route in cupboard reused. AP to be mounted in cupboard.

Existing camera location to be reused. Trunking to be wrapped in wallpaper to match wall

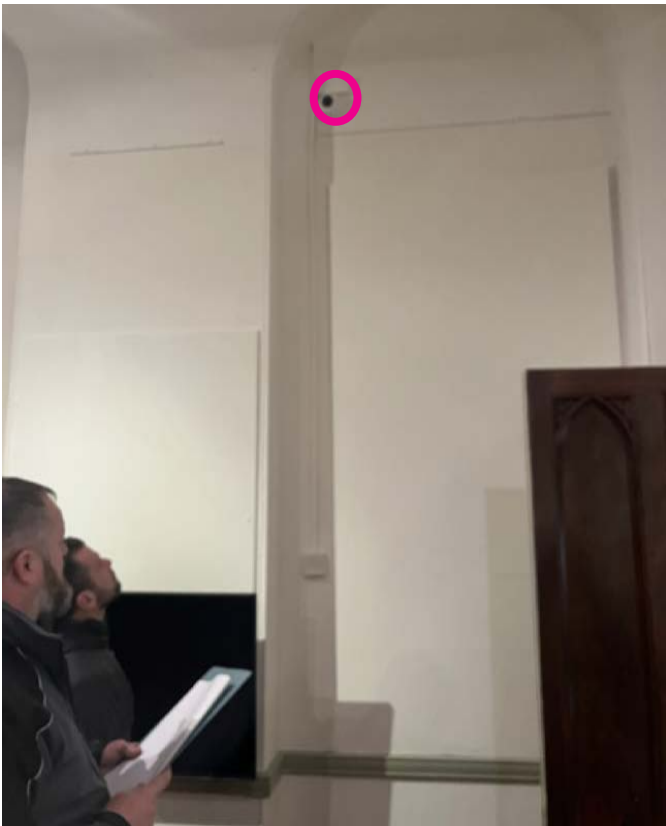
**J1** - Existing camera location and cable route reused. New camera and AP

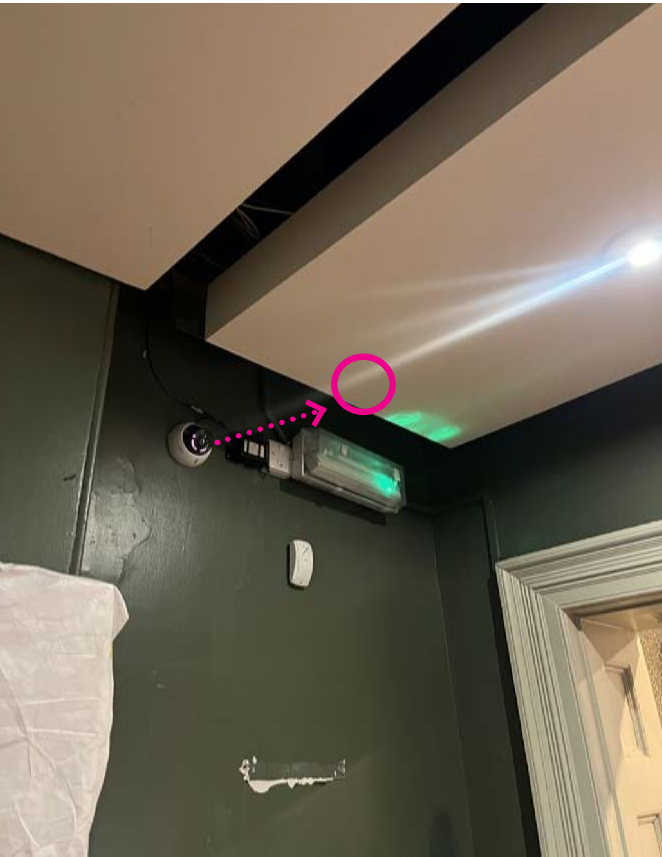
**N1** - New camera moved to underside of suspended ceiling from wall. Cabling routed above ceiling.

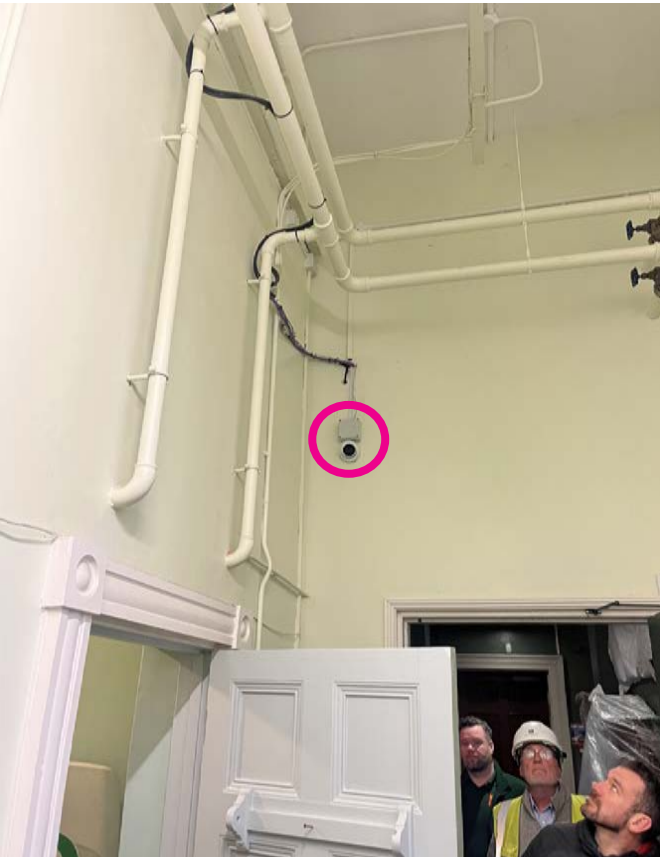
**Q1** - New camera to existing location utilizing existing trunking. Trunking and wiring to be painted to match wall colour

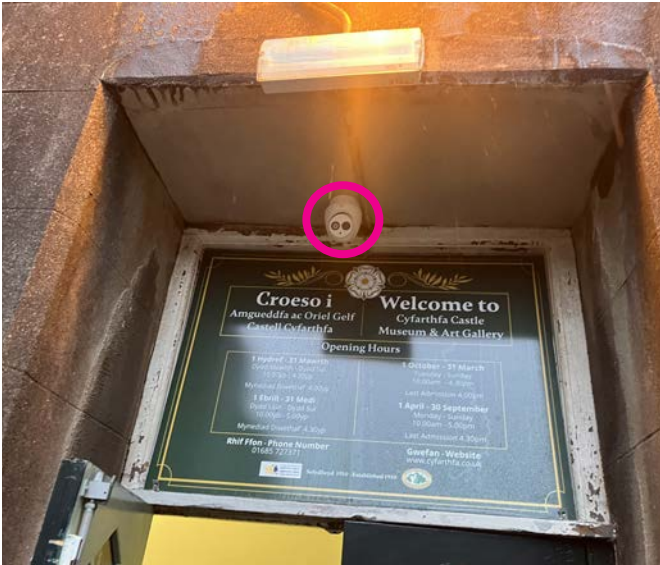
**Q2** - New camera to external door in existing location utilizing existing cable route

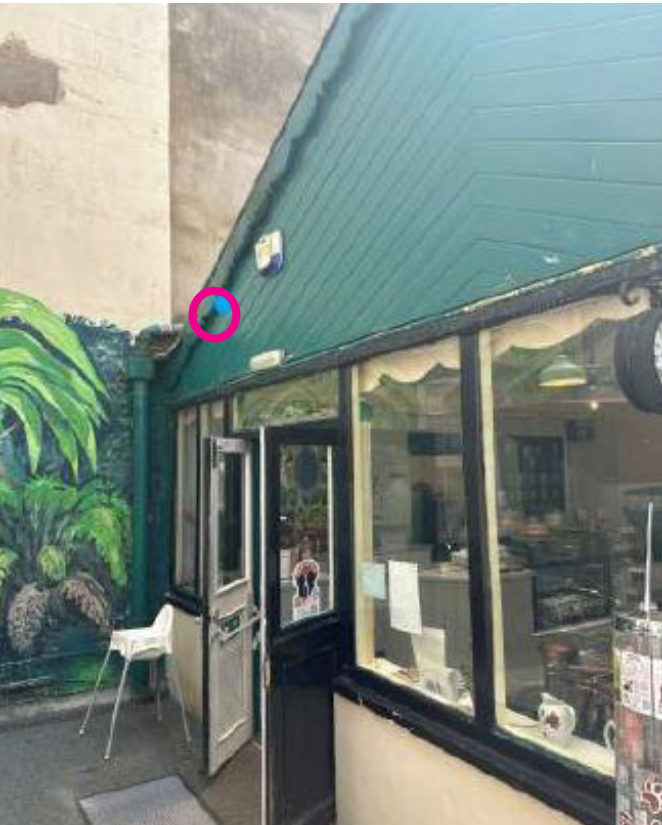
**H1** - New external camera location to cafe courtyard.

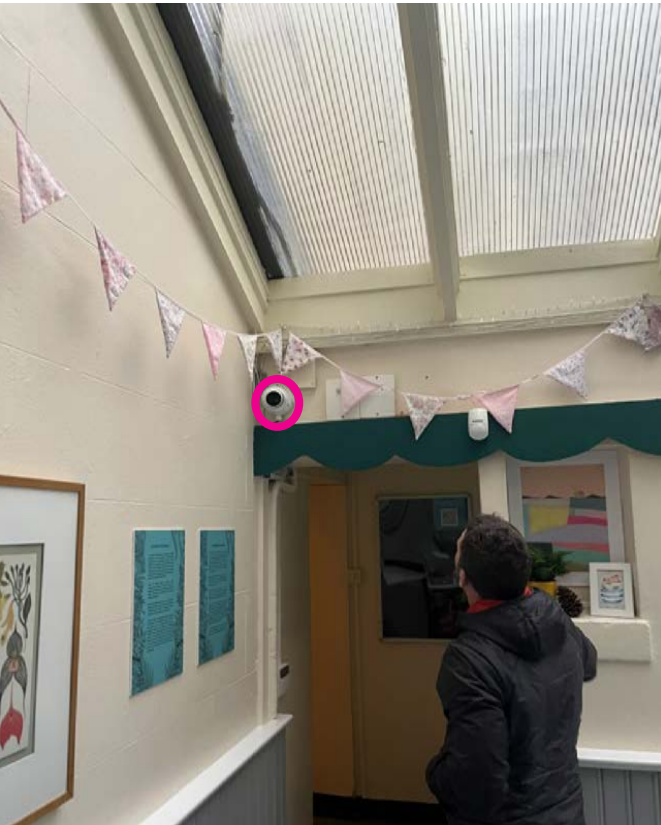
**G1** - New camera and AP in place of existing using existing cabling routes.
