St John's Lodge  
The Grove  
Merthyr Tydfil  
CF48 8YR

A Preliminary Roost  
Assessment (Revision 1)  
(Including Green Infrastructure Scheme)

For  
Mr Udam Singh

January 2024

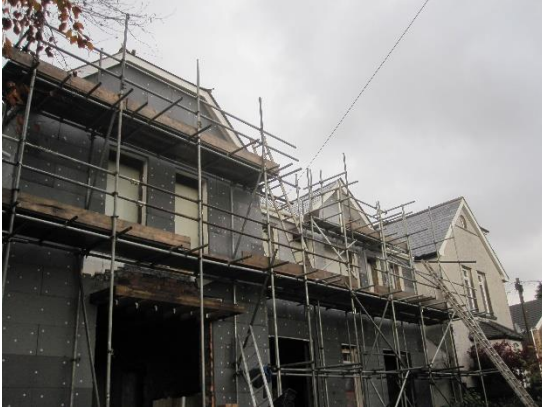
Plate 1: Front, south-eastern aspect of the Lodge (area which has scaffolding in place)

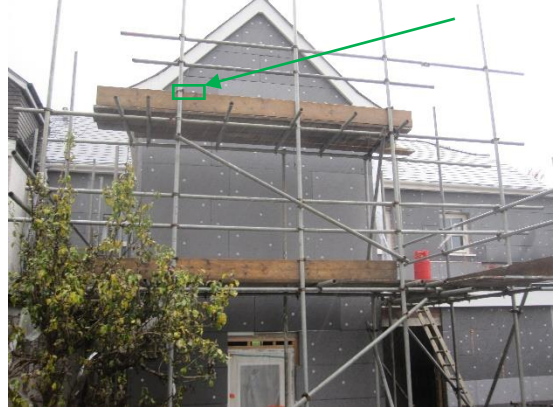
Plate 2: Rear, north western aspect of house, viewed from the back garden to the north, with swift box location marked green

To benefit swifts, a red list species, it is recommended that a Vivara Pro built-in swift nest box is provided, as shown in Plate 19 (see Appendix III). A suitable location is shown in green (see Plate 2), at the rear of the house, where it is away from direct sunlight and prevailing weather. Additionally a hedgehog box is proposed for the south-western part of the property, and it must be sited against the boundary, with appropriate screening for it to blend with its surroundings to avoid interference.

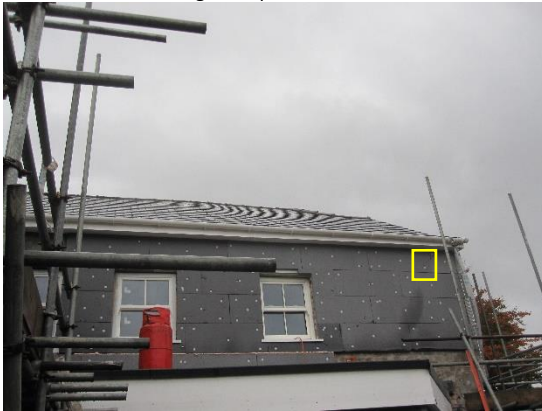
Plate 3: South-western end of house (first floor), which features loft with timber sarking, with possible location for bat box

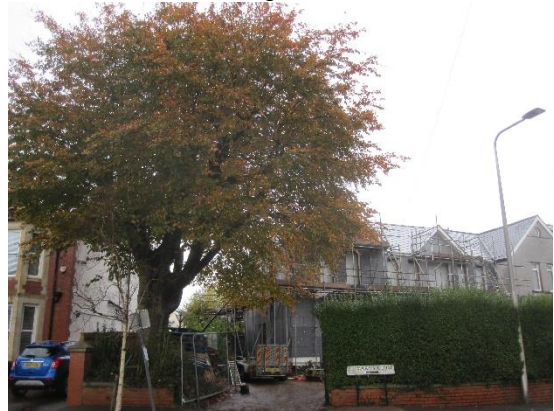
The surveyor considered the features of the garden around the house, which is very narrow to the rear. A semi-mature beech at the entrance to the property was examined, and appeared to be in good health with no obvious openings or damage to the trunk and limbs which might permit bat access. No bird nests were identified.

Plate 4: Frontage of St John's Lodge, with semi-mature beech tree at entrance, and box hedge

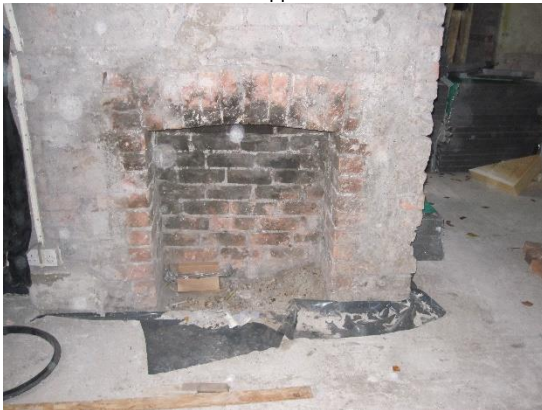
Several open fireplaces on this floor were subject to detailed inspection. All of the original chimneys had been capped, but the chimneys, and open fireplaces were still present. Lesser horseshoe bats were known to be in the wider vicinity, and this species will often use chimneys if they can gain access to the interior of a building. Chimneys were searched (some having flues fitted), and the cap at the top could be seen. No bat or evidence of bats was found.

Plate 5: One of several internal fireplaces, the chimneys for which have been capped

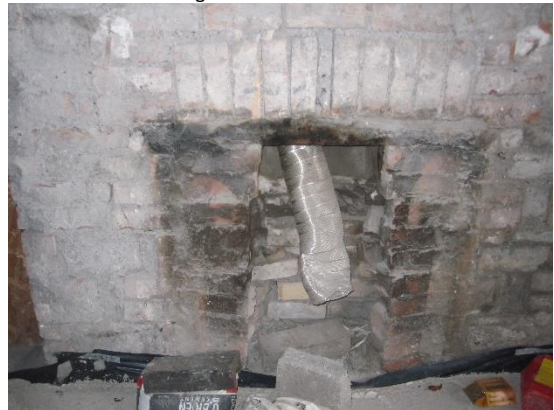
Plate 6: Some fireplaces feature flues, suggesting previous fitment of gas fires

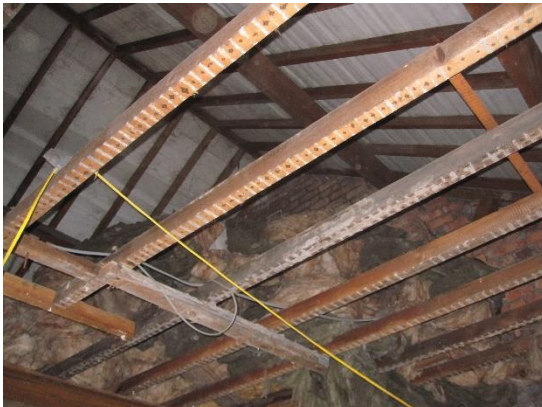
The surveyor noted that the ceiling beneath the main loft had been stripped out/removed. The remnants of these ceiling had been taken away, and most of the glass-fibre insulation too. Some of the insulation remained in place, but most of this was hanging down into the upper rooms. It was possible to view the inside of the roof, and note the presence of a white breathable membrane, lining all of the areas which could be seen. Close inspection was possible from floor level of the ridge areas, and edges of the wall plates. No bats were visible and there was no evidence in the form of bat droppings, or evident fur staining.

Plate 7: Main loft area, illustrating absence of ceilings and fitment of breathable membrane

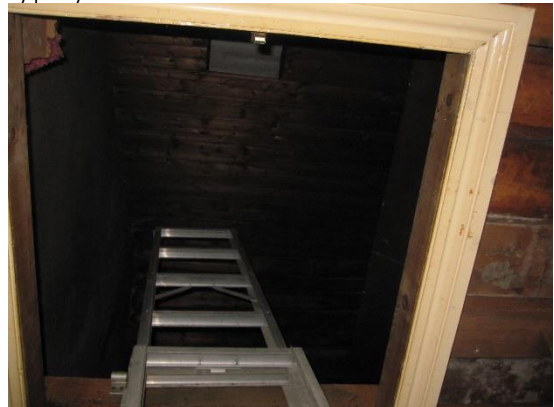
Plate 8: Western loft with timber sarking, entrance obstructed by partly fixed ladder

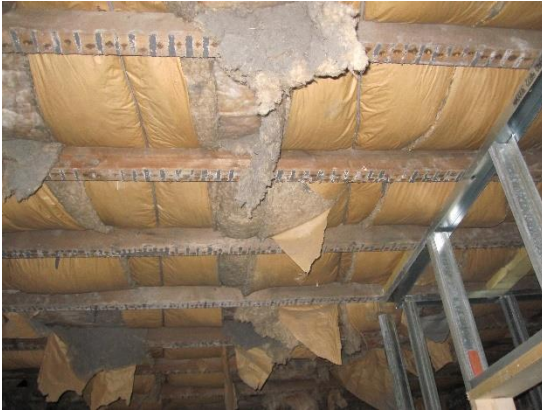
Plate 9: Insulation in rear loft, where ceiling has been removed

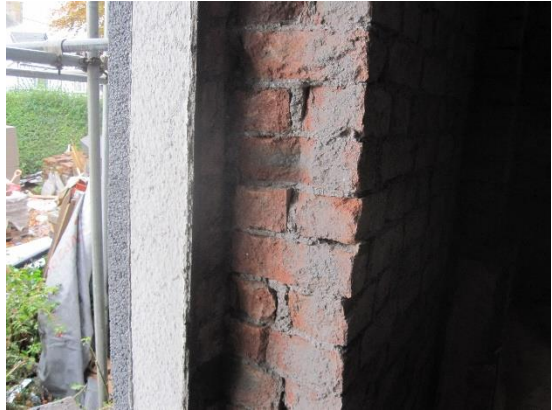
Survey continued with the ground floor area. Whilst some windows and doors had clearly recently been put in place, some of the ground floor openings were still open to the elements. Again the surveyor examined any open chimney/fireplace, door and window openings, particularly lintels, and any internal gaps in brickwork. The window openings, where no frames were in-situ, were subject to a particularly close inspection. All were found to be bricked up (see Plate 10), effectively sealing the cavity. Window frames therefore seat into the walls, against the outer brick course, thus affording bats or other creatures, no means to enter the cavities. No evidence of bat presence was found.

Plate 10: Some ground floor windows are still to be replaced, but no access to the cavities is evident

It is recommended that the work to complete fitting the windows and doors in the building are completed as soon as possible, and must be completed before the end of February 2024. This ensures the work to enclose the building is done at a time of year when bats are largely inactive – depending on weather conditions.

However, the risk is acknowledged, and therefore, the owner must engage a suitably experienced and licenced Ecological Clerk of Works (ECW), to undertake an inspection of each opening before the builder/carpenter physically fits each unit, to ensure no bat is located against the inside of the outer brick course. If a bat, or evidence of bats is noted, then the guidance below must be followed.

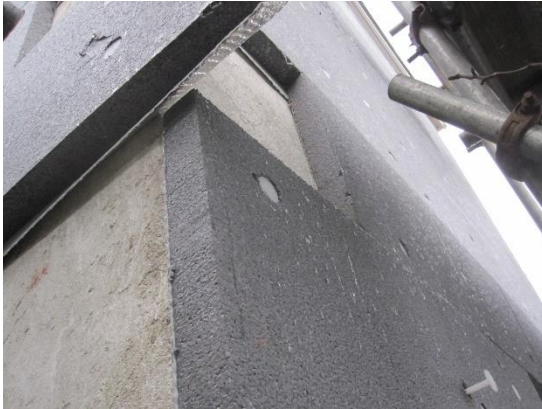
Plate 11: Fitment of external insulation

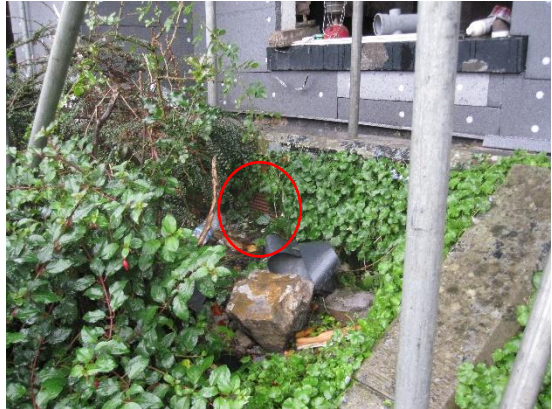
Hibernation potential around the house was considered, with air vents being noted in several places around the exterior, at ground level. Most of these vents were tight fitting, and narrow.

Plate 12: External air vents (circled red)

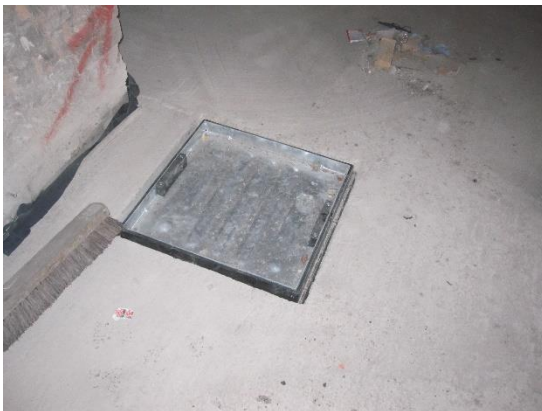
Whilst examining the openings for doors and windows, the surveyor sought signs of potential access points to the wall cavities; none were found. An access hatch to an underground chamber was noted, but access was not possible without appropriate tools. Inspection may not have been possible, as a potential confined space, even if access had been possible.

Plate 13: Internal access hatch to underground chamber

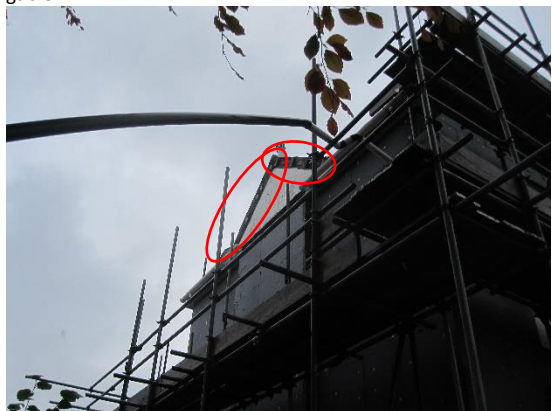
Only at the south-western (semi-hip) gable end, where the work to replace the barge boards and soffit boxes remained incomplete, was there the possibility of bat or bird access. The purlins on that part of the roof, and wall plate were exposed, allowing possible access. Elsewhere on the exterior, openings were evident where the remaining windows/doors and frames had not yet been fitted, and some of the lintels were still also uncovered, or not boxed in. These were examined as closely as possible for signs of bats and birds. No evidence for presence was noted.

Plate 14: Last barge boards still to be replaced, and south-western gable

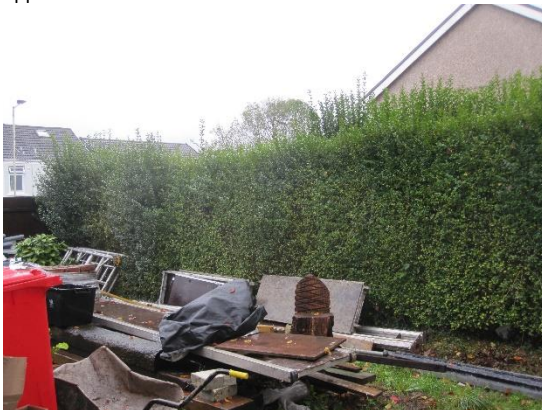
A box (*Buxus sempervirens*) hedge was noted at the front of the property, which together with the boundary wall, provides a degree of privacy between the house and The Grove. Otherwise any garden plants were generally buried below a multitude of bricks, blocks, and other building materials strewn across the front garden, which examination of satellite images, has previously been a car parking area.

Plate 15: Road side box hedge in front garden, affords nesting opportunities for birds

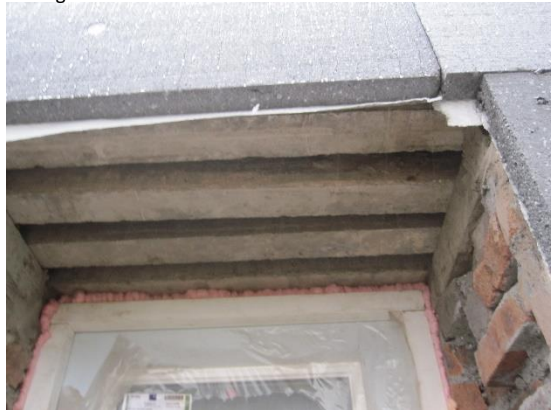
Plate 16: Gaps at exposed lintels, where care must be taken when sealing them off

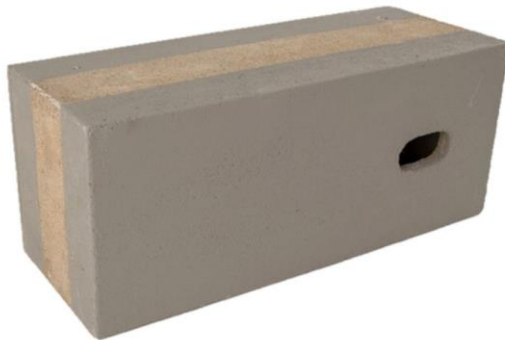
Plate 19: Vivara-pro built-in swift nest box
