# MERTHYR VALLEY HOMES

## PROPOSED ROOFING REPAIRS AND IMPROVEMENTS, PROPERTIES AT COUNCIL STREET AND URBAN STREET MERTHYR TYDFIL

### BAT ACTIVITY SURVEY - ADDENDUM REPORT

DOCUMENT REF: E22108101/Doc 02. SEPTEMBER 2022

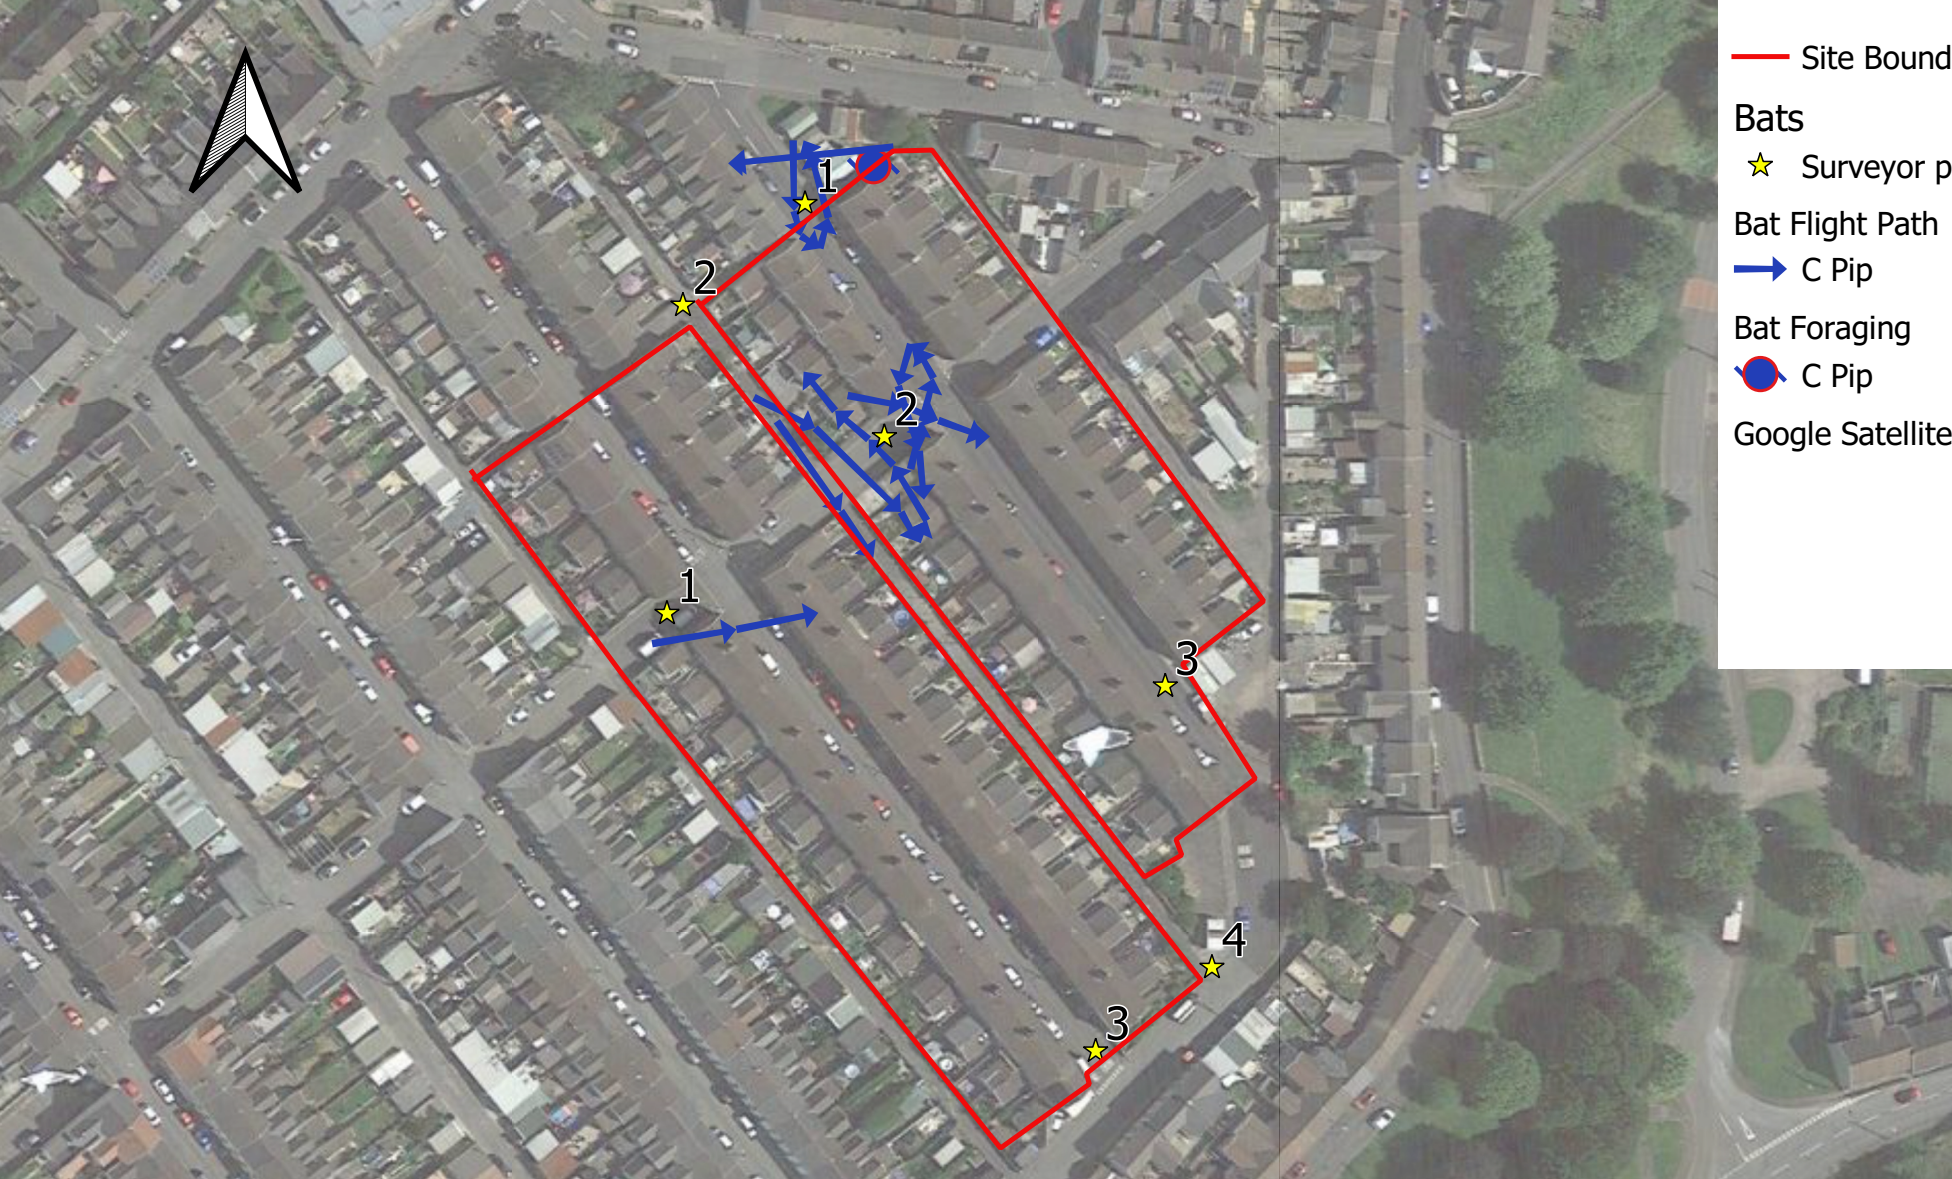
**APPENDIX I     SURVEYOR LOCATION & RESULTS PLAN**

2.2 One dusk activity survey was undertaken on each street by a team of 4 (Council Street) or 3 (Urban Street) surveyors and commenced 15 minutes before sunset. Surveys were conducted using broad-band bat detectors (Peersonic, EM Touch & Bat Box Duet) and suitable recording equipment. All calls were recorded and bat species either identified in the field or using computer-based sonogram analysis software (e.g. Analook or Kaleidoscope). Surveyors were positioned so as to afford views along the frontage or rear of properties and gable ends where PRF features had been identified (see plan in Appendix I).

- 3.1 A summary of findings are given below and further details of bat flight lines can be found in Appendix I. No bats were seen to emerge over the course of the surveys and levels of activity by foraging/commuting bats were low with some surveyors not recording any bat activity. A total of three bat species were recorded over the course of the surveys including Common and Soprano Pipistrelle *Pipistrellus pipistrellus*/*P. pygmaeus* and Noctule *Nyctalus noctula*.
