ALL ENHANCEMENT MEASURES IN LINE WITH LITTLE WING ECOLOGY REPORT

Thespian House,  
Penydarren Rd, Merthyr  
Tydfil, CF47 0LJ

| 907.19A | proposed enhancement to building B | | |

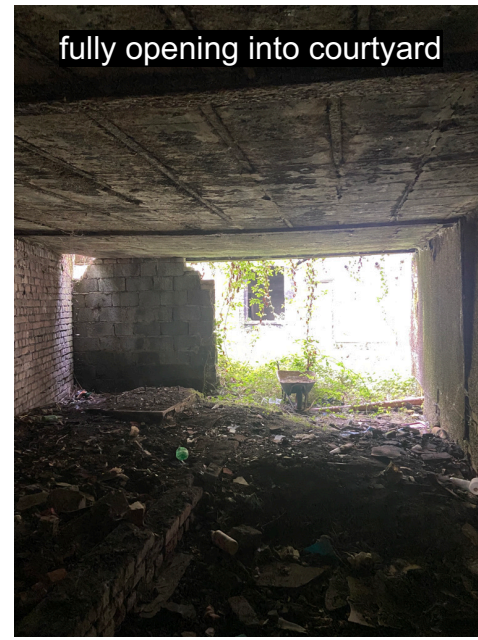
block built baffles to opening see Little Wing Ecology report for detail

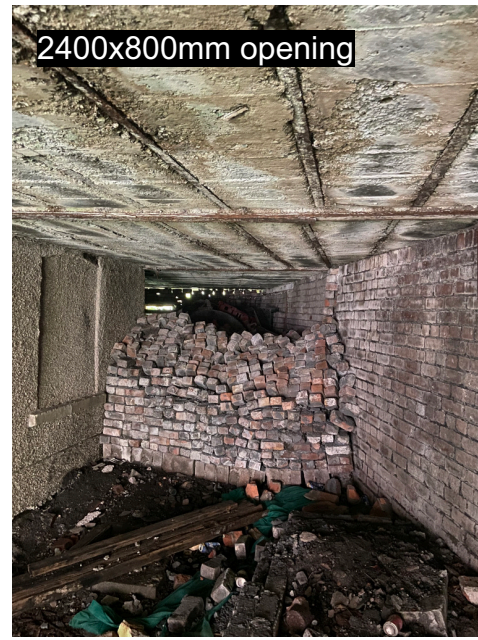
opening to remain.

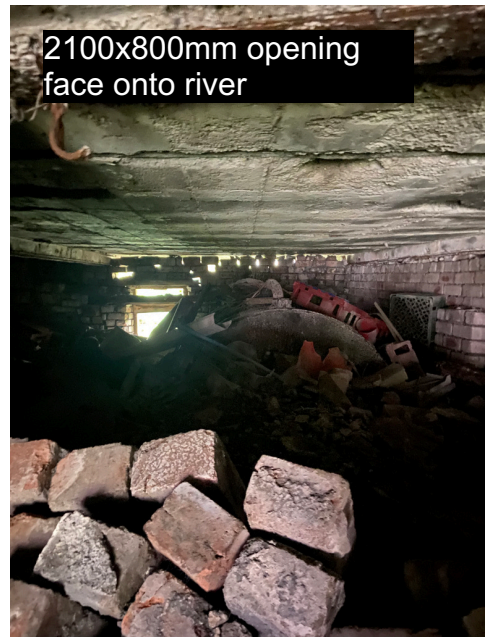
opening to be blocked off, access door added - see Little Wing Ecology report for detail

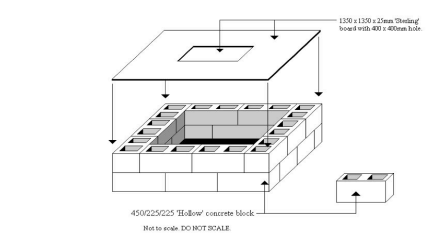
### COOL TOWER AS BELOW

Fig 1 BASE. The floor/ground need to be flat and level. Sterling board has been suggested as it has a 'rough' surface, enabling lesser horseshoe bats to grip. In my original 'tower' I fixed nylon netting to the underside of the boarding.

Fig 2 CENTRAL SECTION. 400x 400mm holes cut centrally through boarding.

Fig 3. UPPER SECTION. Showing 'missing' block to allow bats access.

Fig 4. FULL TOWER. Insulation can be increased by filling the hollow sections and covering the roof with suitable material, i.e. earth.

As part of a managing vegetative growth, inspections will take place every month to ensure that the entrance to the new 'cave' roost (facing the adjacent stream at the eastern elevation) is not blocked
