**A Preliminary Roost Assessment**  
**On behalf of**

**Ross Perriman**  
**for**  
**Standard Upholstery**  
**Pontmorlais**  
**Merthyr Tydfil**  
**CF47 8UT**

**April 2023**

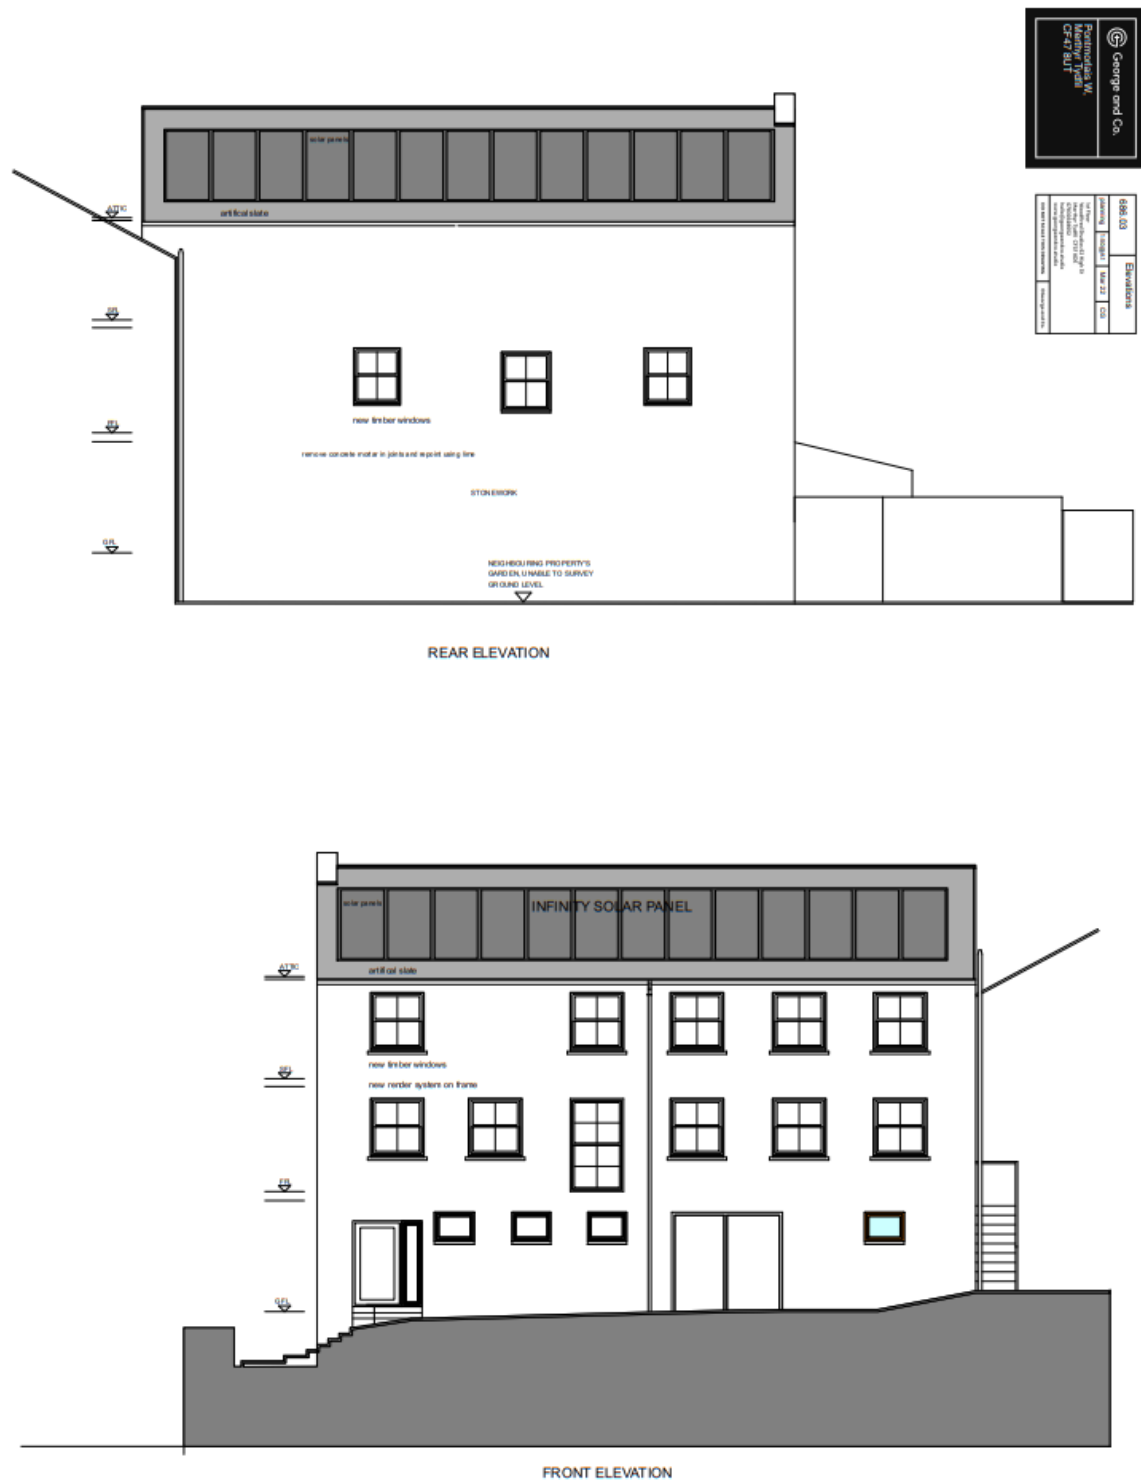
Figure 3: Proposed Development

- 1.2.1 Planning permission is sought for the conversion of a former industrial building.
- 1.2.2 Building A is unoccupied.
- 1.2.3 New solar panels are planned for the roof, the proposed development will impact all elevations (Figure 3).

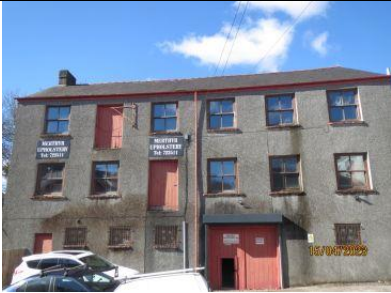
| Photographs | Description |
|---|---|
| | <p><b>Photograph 1:</b></p> <p><b>North-eastern Elevation:</b></p> <p>Building A – The frontage of the structure facing a small, enclosed courtyard next to the Nant Morlais.</p> <p>Taken from the north-east looking south-west.</p> |

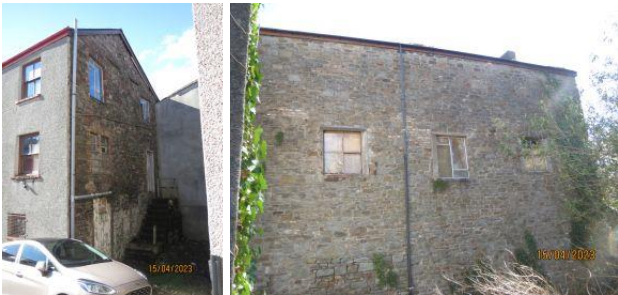
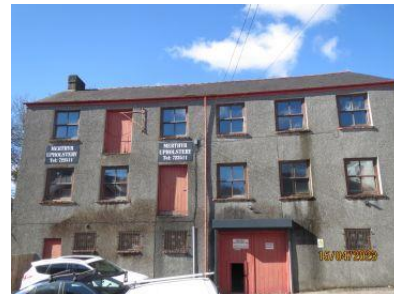
| Structure | Potential Nest and Roost Assessment | Evidence | Assessment | |
|---|---|---|---|---|
| <p><b>Building A</b></p> <p><b>Standard Upholstery</b></p> <p>An unoccupied Structure</p> <p>A three-storey stone and slate, traditionally built Victorian warehouse with a cement render to the front elevation, slated roof, and a breathable roofing membrane.</p> | <p><b>Exterior Elevations</b></p> <p>Several gaps were recorded between the bargeboard and wall plate. The roof is relatively new and materials are in good order. No areas of flashing were recorded around the chimney, but all elevations of the chimney were not visible from a ground observation (i.e., the western elevation).</p> <p>Gaps were recorded around exterior doors and around windows. Some windows were broken providing access to the interior space.</p> | <p>No evidence recorded of roosting bats.</p> <p>Two jackdaws (<i>Corvus monedula</i>) were observed nest building at the chimney entrance.</p> | <p>Moderate (Bats)</p> <p>High (birds)</p> | |

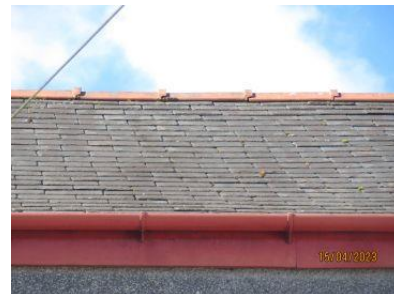
| Structure | Potential Nest and Roost Assessment | Evidence | Assessment | |
|---|---|---|---|---|
| <p><b>Building A</b></p> <p><b>Standard Upholstery</b></p> <p>An unoccupied Structure</p> <p>A three-storey stone and slate, traditionally built Victorian warehouse with a cement render to the front elevation, slated roof, and a breathable roofing membrane.</p> | <p><b>Exterior - Roof Structure (Slates/Tiles)</b></p> <p>No damaged or slipped roof tiles were observed. All observed materials were in good condition and well fitted. Not all the roof was visible from a ground level examination, the western elevation was largely obscured from view.</p> <p>The roof was later found to be lined with a breathable membrane and the client confirmed that the building had been re-roofed at some point in its recent history.</p> | <p>No evidence recorded of nesting birds or roosting bats.</p> | <p>Low (Bats)</p> <p>Negligible (birds)</p> | |

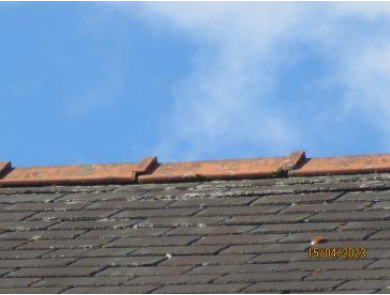
| <p><b><u>Building A</u></b></p> <p><b><u>Standard Upholstery</u></b></p> <p>An unoccupied Structure</p> <p>A three-storey stone and slate, traditionally built Victorian warehouse with a cement render to the front elevation, slated roof, and a breathable roofing membrane.</p> | <p><b><u>Exterior - Roof Structure (Ridge Tiles)</u></b></p> <p>No significant gaps were recorded along the ridge tiles. The materials were in good conditional and well fitted. A good record was made of the condition of the ridge from the eastern elevation, but direct observation was not possible from the west.</p> | <p>No evidence recorded of nesting birds or roosting bats.</p> | <p>Negligible (Bats)</p> <p>Negligible (birds)</p> | |

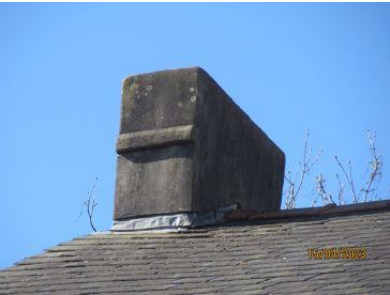
| <p><b><u>Building A</u></b></p> <p><b><u>Standard Upholstery</u></b></p> <p>An unoccupied Structure</p> <p>A three-storey stone and slate, traditionally built Victorian warehouse with a cement render to the front elevation, slated roof, and a breathable roofing membrane.</p> | <p><b><u>Exterior - Chimneys/Flue</u></b></p> <p>Where observation was possible, both the flashing and tiles around the chimney were well fitted and in good condition. A good record was made of the condition of the chimney from the eastern elevation, but direct observation was not possible from the west.</p> <p>Two jackdaws (<i>Corvus monedula</i>) were observed nest building at the chimney entrance.</p> | <p>No evidence recorded of nesting birds or roosting bats.</p> | <p>Negligible/low (Bats)</p> <p>High (birds)</p> | |

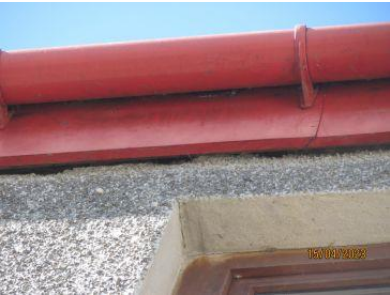
| <p><b><u>Building A</u></b></p> <p><b><u>Standard Upholstery</u></b></p> <p>An unoccupied Structure</p> <p>A three-storey stone and slate, traditionally built Victorian warehouse with a cement render to the front elevation, slated roof, and a breathable roofing membrane.</p> | <p><b><u>Exterior - Bargeboards</u></b></p> <p>Several gaps of various sizes were recorded between the timber bargeboard and the wall plate. Large gaps were recorded on the northern elevation.</p> <div data-bbox="450 1015 768 1254"> </div> <div data-bbox="775 1015 1093 1254"> </div> | <p>No evidence recorded of nesting birds or roosting bats.</p> | <p>High (Bats)</p> <p>Moderate (birds)</p> | |

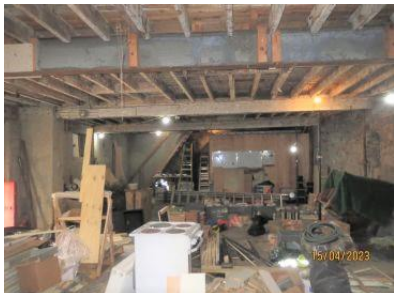
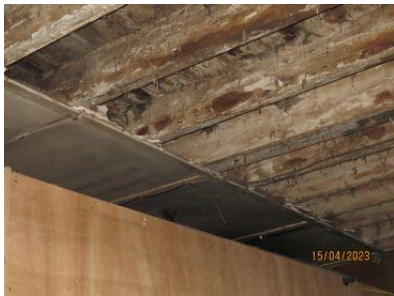
| <p><b><u>Building A</u></b></p> <p><b><u>Standard Upholstery</u></b></p> <p>An unoccupied Structure</p> <p>A three-storey stone and slate, traditionally built Victorian warehouse with a cement render to the front elevation, slated roof, and a breathable roofing membrane.</p> | <p><b><u>Interior – Ground Floor</u></b></p> <p>The interior of Building A has recently been stripped out and no ceilings are present. This is a dark space with access to the upper two storeys. Several gaps were recorded between the floor joist (in the ceiling) and the exterior stone wall. On the eastern elevation these form dark spaces which offer potential for crevice dwelling bat species. Along the western elevation there is light penetration between the floor joists and the exterior stone wall, and the 1<sup>st</sup> storey is visible in several places. These spaces offer much less potential. Within the exterior stone walls there are several gaps in the mortar providing access to small cavities. A small corner of the ground floor has been boarded off to provide a secure store room. The ceiling boards are still in place above this feature and the gap between the ceiling board and the floorboards is open to the interior of the main room (photo left – below). This offers opportunities for roosting and a dark space.</p> | <p>No evidence recorded of nesting birds or roosting bats.</p> | <p>Moderate (Bats)</p> <p>Negligible (birds)</p> |

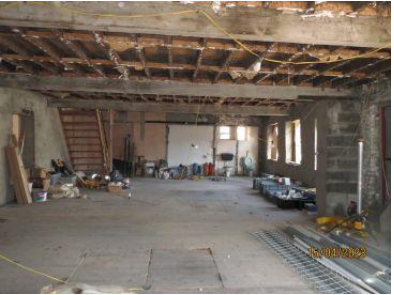
| <p><b><u>Building A</u></b></p> <p><b><u>Standard Upholstery</u></b></p> <p>An unoccupied Structure</p> <p>A three-storey stone and slate, traditionally built Victorian warehouse with a cement render to the front elevation, slated roof, and a breathable roofing membrane.</p> | <p><b><u>Interior – 1st Floor</u></b></p> <p>The interior of the first storey has recently been stripped out and no ceilings are present. This is a relatively light space with widows to all elevations. Several gaps were recorded between the floor joist (in the ceiling) and the exterior stone wall. On the eastern elevation these form dark spaces which offer some potential for crevice dwelling bat species. Along the western elevation there is light penetration between the floor joists and the exterior stone wall, and the 1<sup>st</sup> storey is visible in several places. These spaces offer much less potential.</p> <p>A single bat dropping of a pipistrelle type was recorded at the south eastern windowsill and feeding remains (small tortoiseshell - <i>Agla urticae</i>) at the north western windowsill; characteristic of brown long eared bat (<i>Plecotus auritus</i>) or lesser horseshoe (<i>Rhinolophus hipposideros</i>), both of which are recorded roosting locally (&lt;50m).</p> <p>A smashed window provides access to the exterior.</p> <p>The light levels at these locations suggest that both represent a night roost/feeding roost.</p> <p>Disused jackdaw nesting material had been swept up into one corner.</p> | <p>Bat droppings (s) and feeding debris.</p> <p>Remains of a jackdaw nest.</p> | <p>High (Bats)</p> <p>High (birds)</p> | |

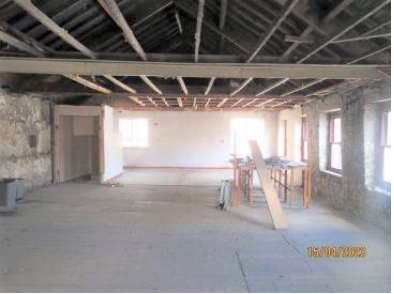
| <p><b><u>Building A</u></b></p> <p><b><u>Standard Upholstery</u></b></p> <p>An unoccupied Structure</p> <p>A three-storey stone and slate, traditionally built Victorian warehouse with a cement render to the front elevation, slated roof, and a breathable roofing membrane.</p> | <p><b><u>Interior – 2nd Floor (Including Roof Space)</u></b></p> <p>The interior of the second storey has recently been stripped out and no ceilings are present. The roof space is exposed to the roofing felt. No light penetration was recorded at roof level.</p> <p>Remains of original timber cladding remain in situ along the interior southern gable. Each of these provided a internal cavity of unknown proportions and a potential roosting site for crevice dwelling species.</p> | <p>No evidence recorded roosting bats.</p> <p>An inactive jackdaw nest (<i>Corvus Monedula</i>) was recorded in the roof space at the north west corner.</p> | <p>Moderate (Bats)</p> <p>High (birds)</p> | |

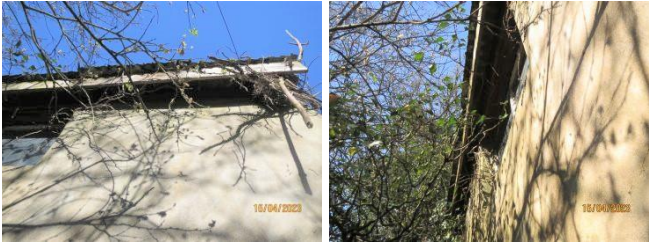
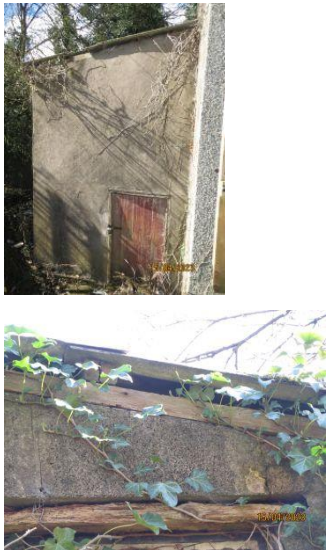
| <p><b><u>Building B</u></b></p> <p>A single storey, block built outhouse adjoining the southern gable of Building A.</p> | <p><b><u>Exterior – Building B</u></b></p> <p>A small structure (Building B) adjoins the southern gable of Building A. This was locked and inaccessible. Much of this structure was covered in vegetation and only a partial exterior examination was possible.</p> | <p>No evidence recorded of nesting birds or roosting bats.</p> | <p>Cautionary (Bats)</p> <p>Low (birds)</p> | |

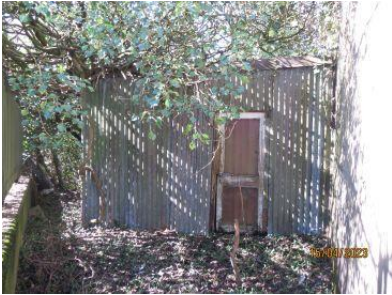
| <b><u>Roofless Corrugated Lean-to</u></b> | <b><u>Exterior – Remains of a Lean to - Building B</u></b><br><br>Previously a smaller structure had been attached to the southern elevation of Building B and while access to the interior was not available it was recorded that the roof of this structure was no longer in place and this structure represents the remains of the exterior walls (mostly corrugated sheet metal). | No evidence recorded of nesting birds or roosting bats. | Negligible (Bats)<br><br>Low (birds) | |

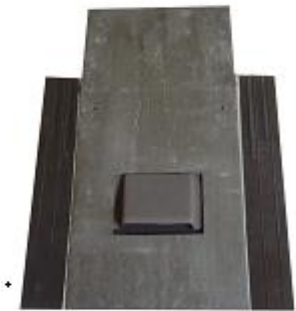
Figure 5.1: Enhancement Features for Net Gain Biodiversity

| Enhancement Feature(s) | Information |
|---|---|
| | <p><b><u>Bat Access Tiles</u></b></p> <p>Beddoes Products<br/> Accessed 01/03/2023.<br/> Available at: <a href="https://beddoesproducts.com/">https://beddoesproducts.com/</a><br/> N.B. this is given as an example only. Many other suitable products are available.</p> |
