# Cefn Fforest Farm Treharris

## Bat Activity Survey Report

August 2026 | Issue 2VB

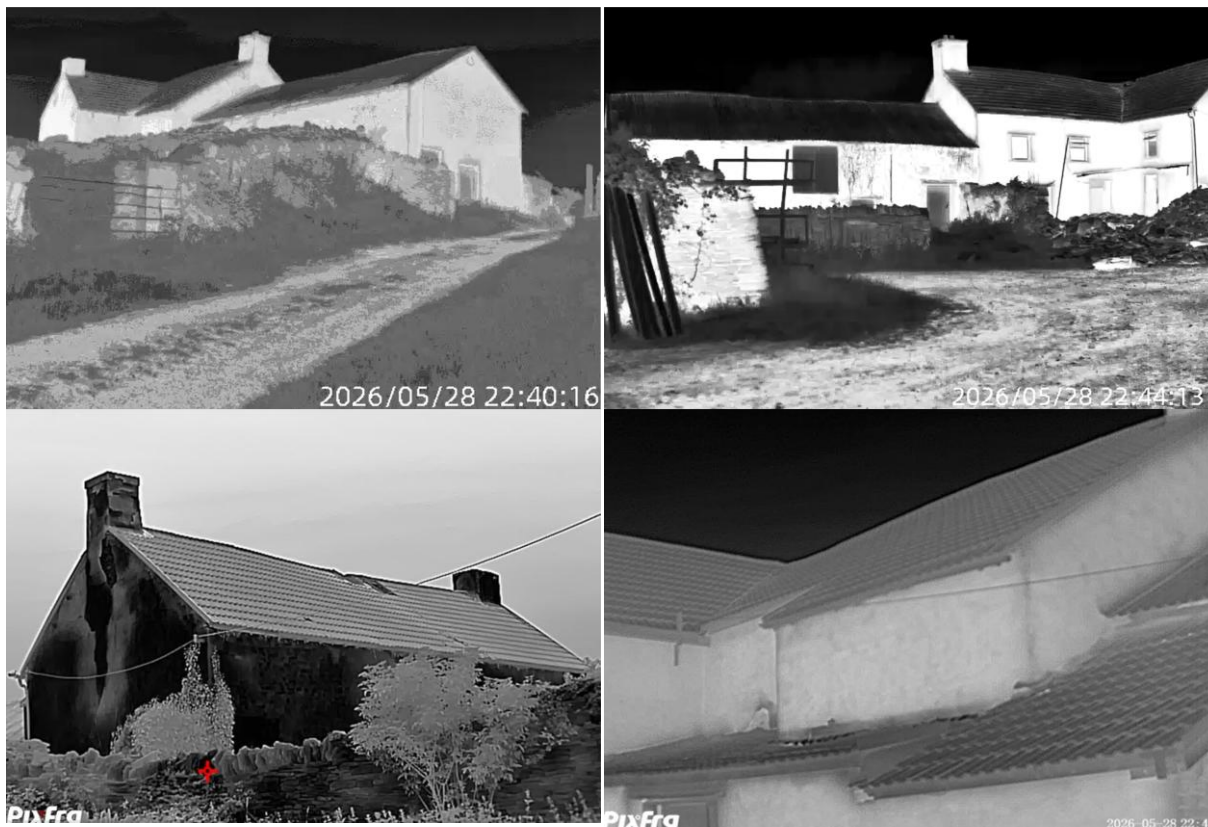
A dusk emergence survey was undertaken on 28th May 2026 with surveyors/cameras positioned to maintain visibility of all elevations of both buildings.

Bat activity on this date was little and intermittent.

The first bat heard was a common pipistrelle at 23 minutes post sunrise. The bat was seen flying high from east to west above the property. A small number of passes by common pipistrelle and soprano pipistrelle were recorded foraging and commuting in the vicinity of the buildings. No bats were observed emerging from, or interacting with, either building.

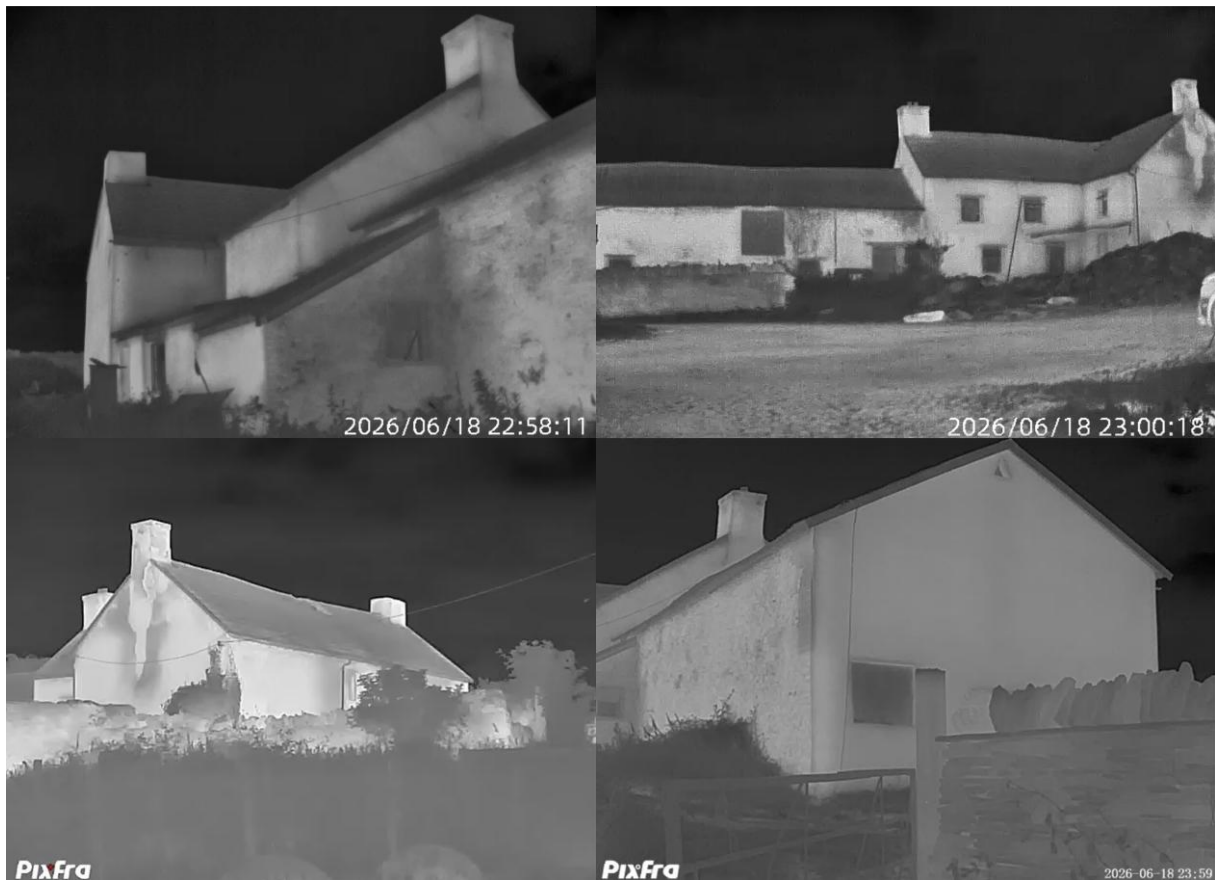
A dusk emergence survey was undertaken on 18th June 2026 by the same surveyors and using the same equipment (as above).

Bat activity was markedly higher than on the first survey. Approximately six bats (common and soprano pipistrelles) were recorded foraging around the buildings and grounds throughout the survey.

Species recorded included common pipistrelle, soprano pipistrelle, noctule and *Myotis* sp., foraging and commuting across the site.

Despite this level of activity, no bats were observed emerging from, or returning to, either building.

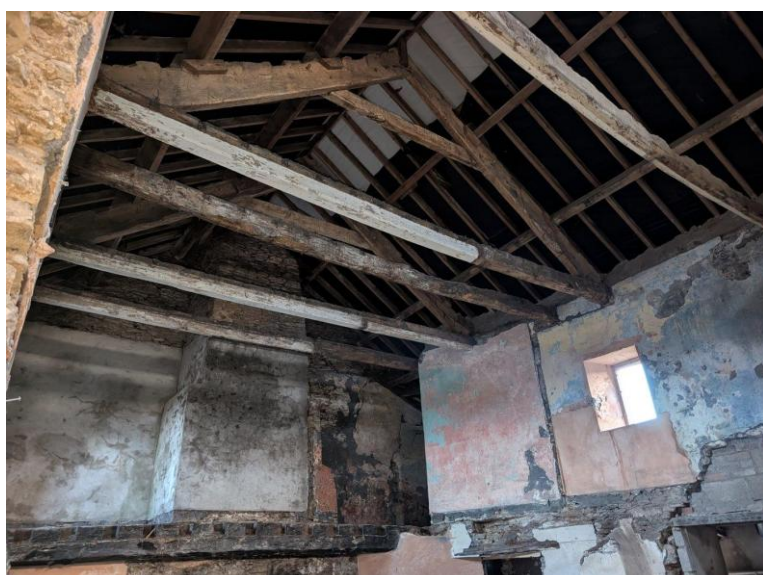
*Plate 2 - Farmhouse roof structure viewed from below, showing exposed pitched roof timbers and rafters over degraded plaster and bare stone walls, with a small square window opening to the gable.*

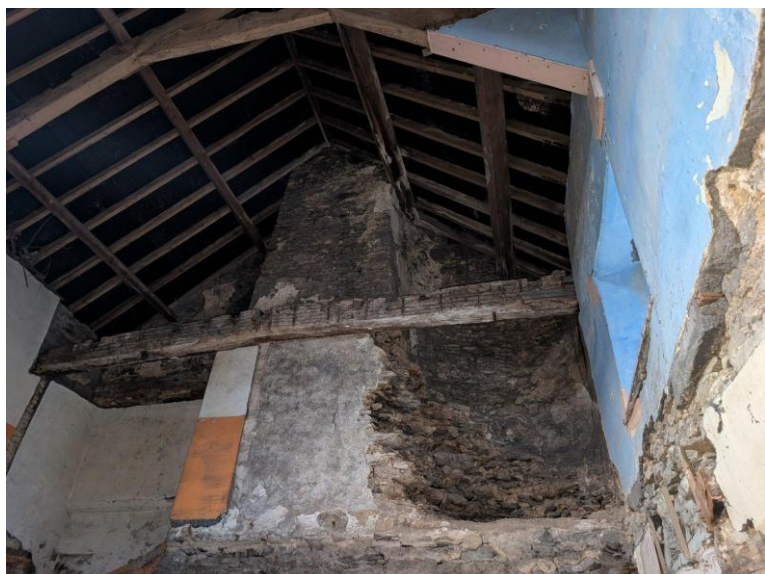
*Plate 3 - Internal corner showing exposed roof timbers meeting a stone chimney breast,*

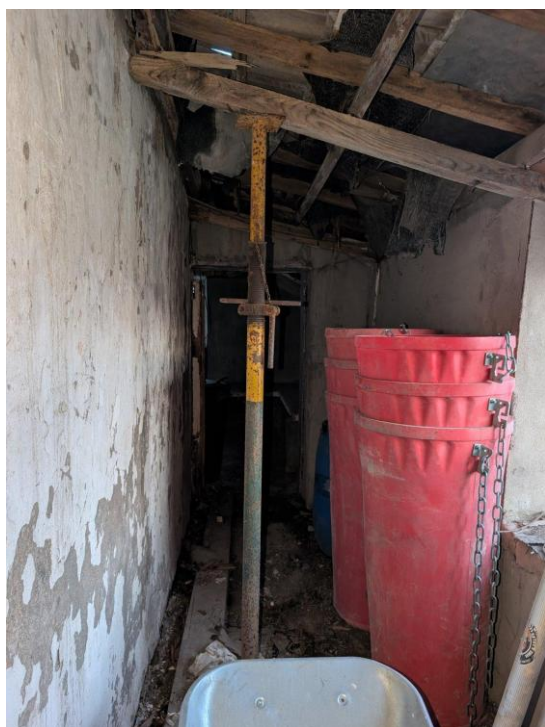
*Plate 4 - Derelict internal area with peeling plastered walls, exposed ceiling timbers, an acrow prop and stored materials*

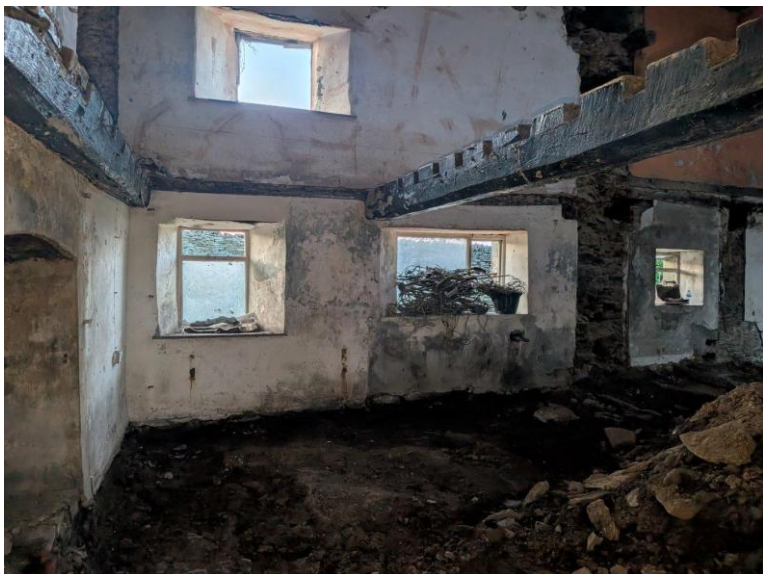
*Plate 5 - Gutted ground-floor room showing multiple small window openings, exposed bressummer/ceiling beams and a bare earth and rubble floor.*

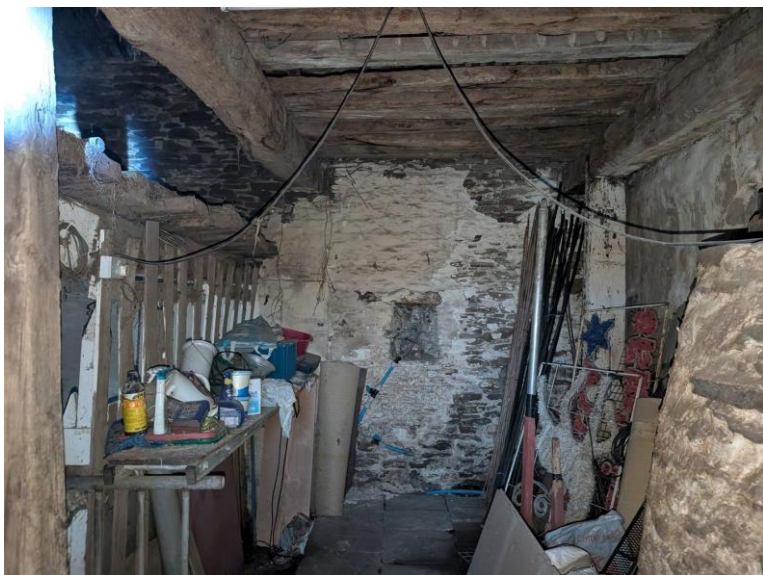
*Plate 6 - Internal storage room with degraded plaster over stone walls, exposed ceiling beams, stored tools and materials and a blocked former opening.*

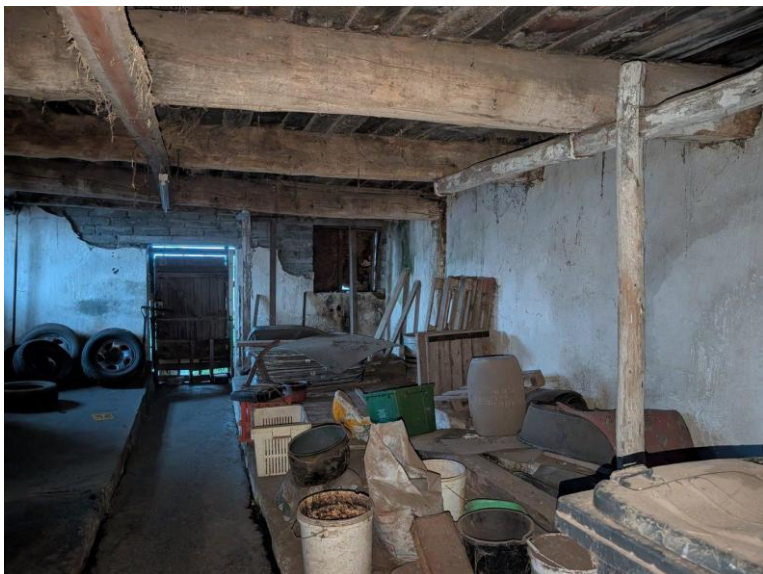
*Plate 7 - Barn interior used for storage beneath exposed ceiling beams and timber roof structure, with an open doorway and stored materials*

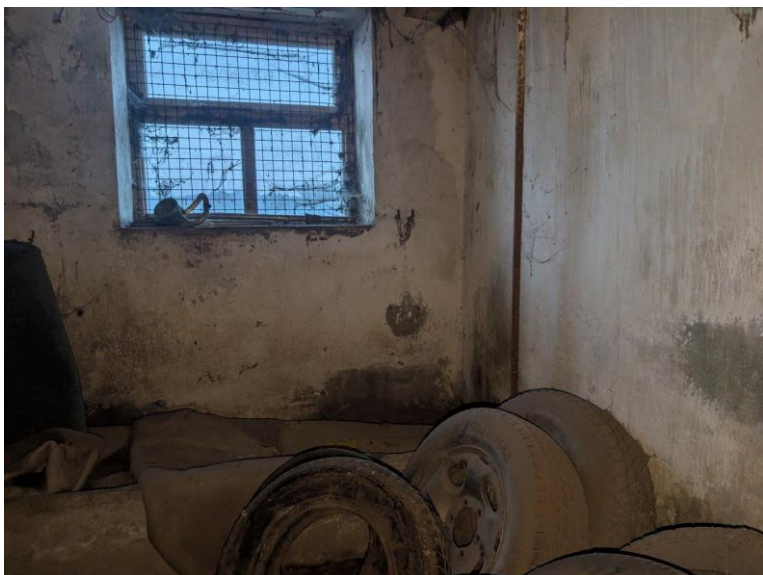
*Plate 8 - Barn/store corner showing a mesh-covered window*

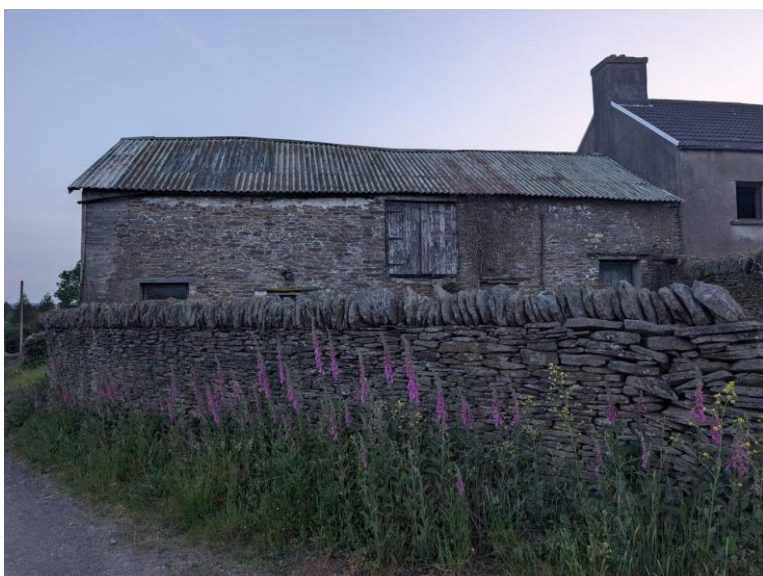
*Plate 9 - External elevation of the stone-built barn with corrugated metal roof and boarded loft opening*

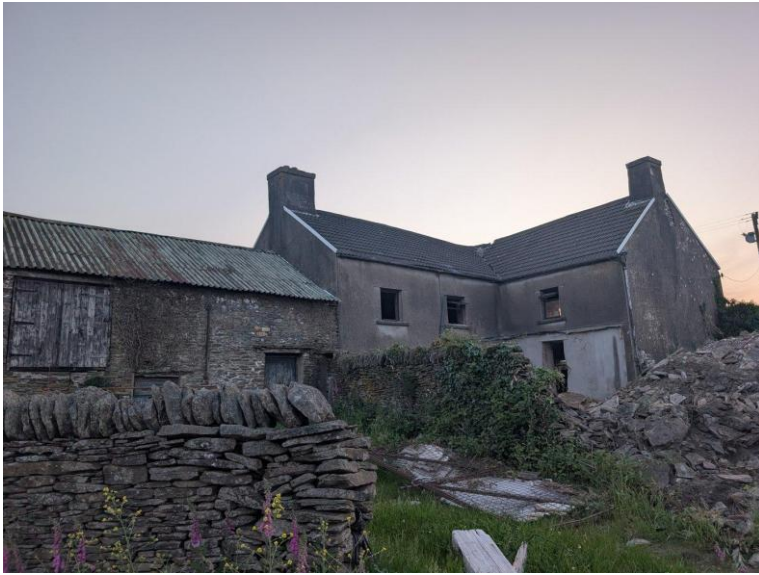
*Plate 10 - Site context: the farmhouse and attached barn range viewed from the rear, showing tiled and corrugated roofs, chimney stack.*
