**LAND AT SIX BELLS ESTATE, HEOLGERRIG,  
MERTHYR TYDFIL  
GREEN INFRASTRUCTURE STATEMENT 2025**

| <b>Form completed by:</b> | Rebecca Sheahan-East (East Ecology) |
| <b>Address of site:</b> | Land at corner of Six Bells Estate, Heolgerrig, Merthyr Tydfil |
| <b>Description of Proposal:</b> | Development of small plot for a single dwelling with attached annex, off street parking and gardens |

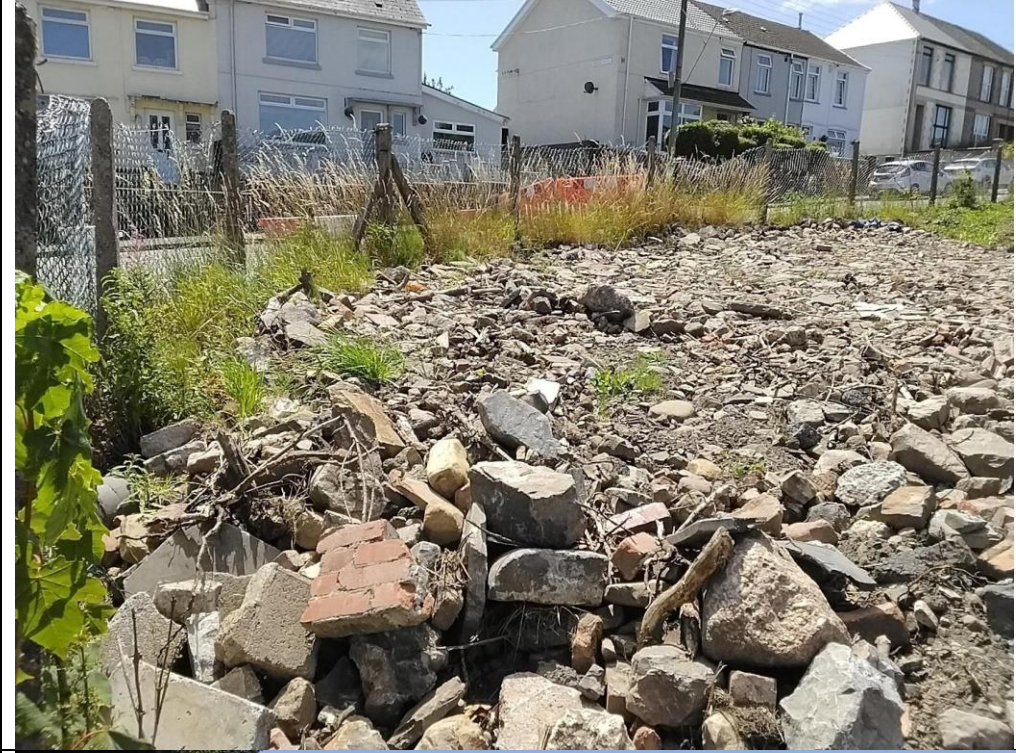
| A photograph showing a large pile of rubble and debris, including bricks and stones, next to a wire fence. In the background, there are residential houses and a clear sky. | <p>Bare ground and wire boundary fence</p> |

Climbing plants will be planted on the fencing structures along boundary 1 and 2. These will be a native variety with viable pollen such as honeysuckle *Lonicera periclimenum*, ivy *Hedera helix* and dog rose *Rosa canina*

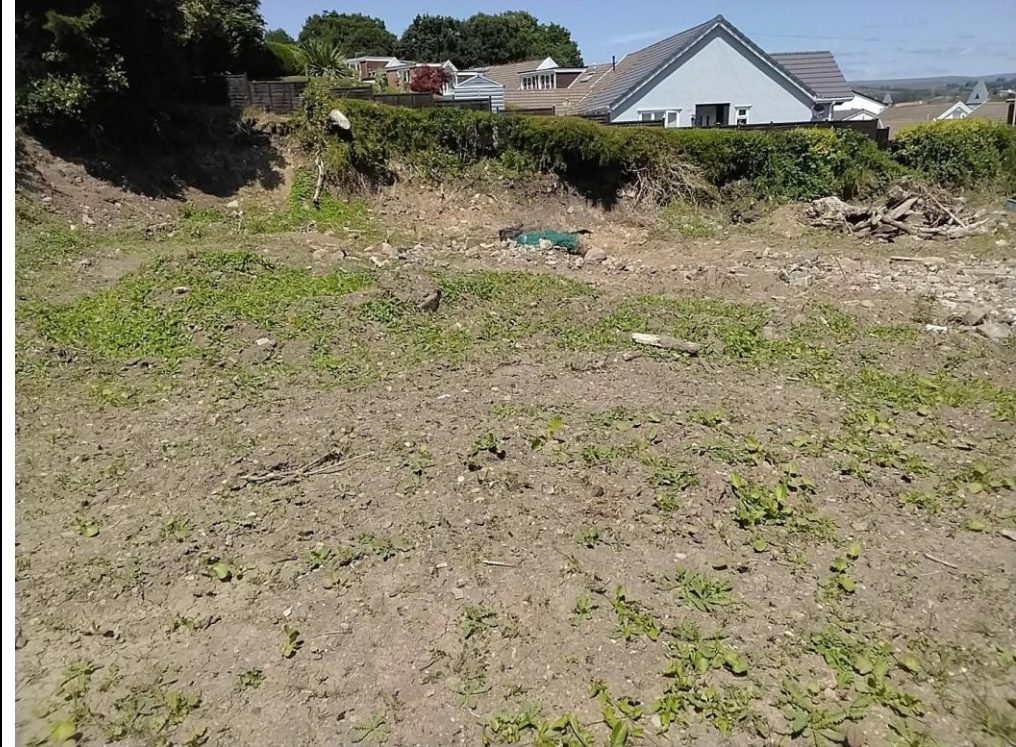
| A photograph showing a view of bare ground in the center and west of the plot. In the background, there is a house with a gabled roof and a hedge. The ground is covered with sparse vegetation and some debris. | <p>Bare ground in the centre and west of the plot</p> |

| <b>Within the plot</b> | Garden space will be utilised for growing food plants in line with permaculture practice |

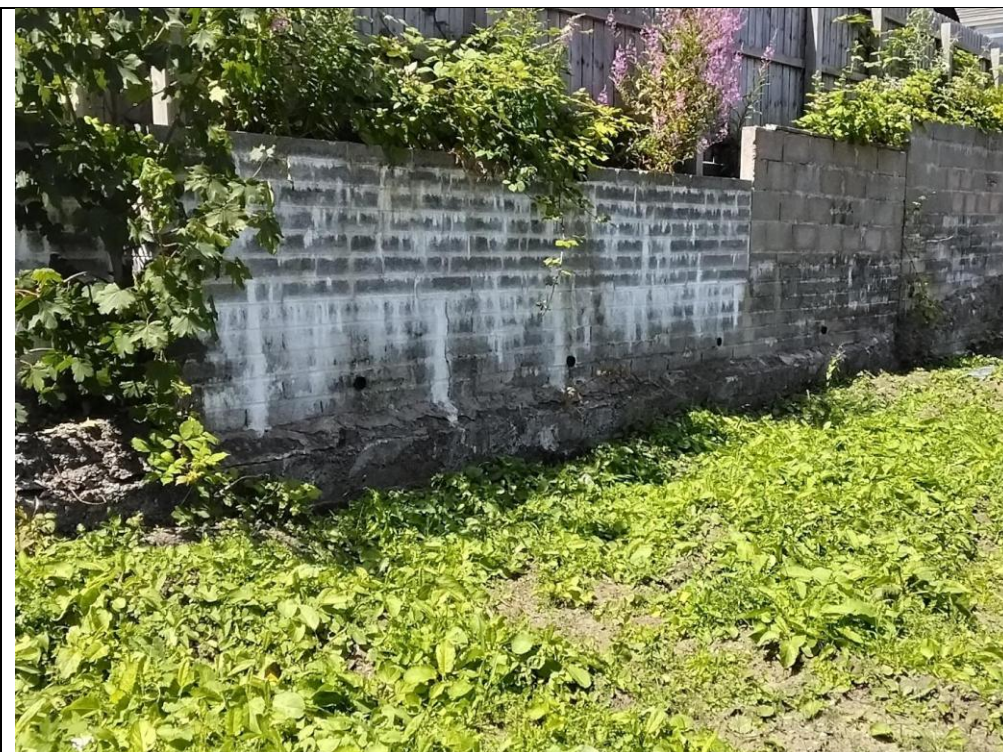
| <b>Boundary 4:</b> | A block retaining wall makes up the western boundary |

East  
boundary,  
block wall

| <b>Boundary 4</b> | Vertical geocell or similar will be used and planted with native shrubs or edible fruiting shrubs |

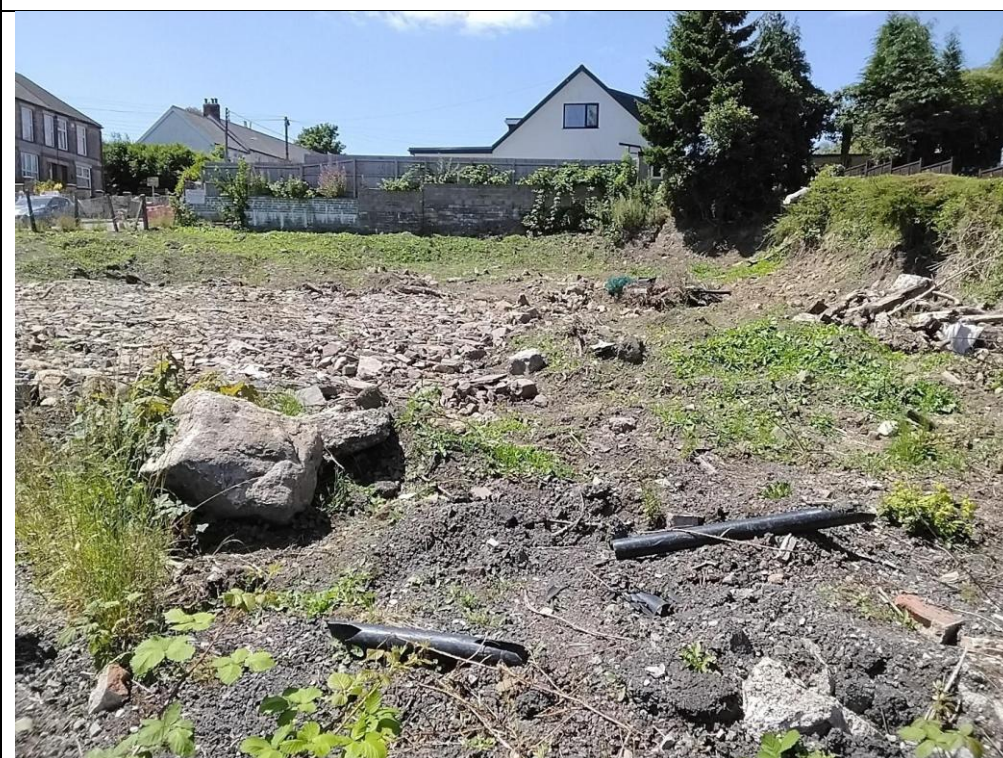
View  
across the  
plot east  
to west

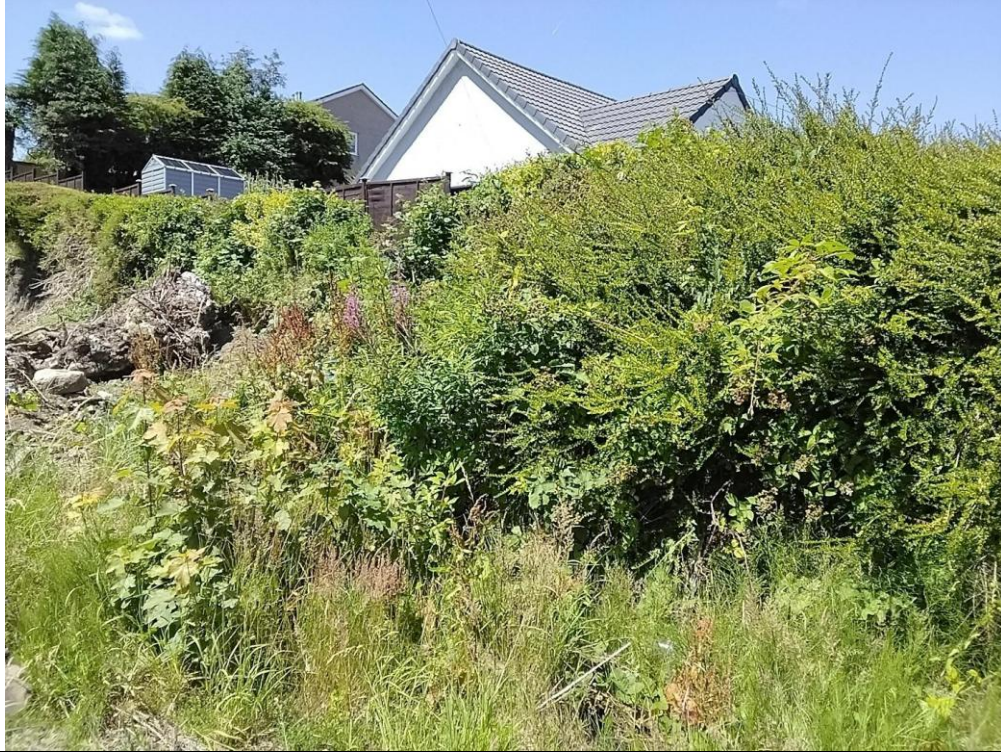
| <b>Boundary 3:</b> | Northern boundary is a clipped hedge of non-native species with gaps |

| <b>Boundary 3</b> | The clipped hedge plants are likely to be lost as the made-ground bank and loose material is removed to create a new retaining wall. |

| <b>Boundary 3:</b> | Cannot be retained to accommodate the building away from an underground culvert |

North  
boundary  
non-native  
hedge

| <b>Boundary 3</b> | Vertical geocell or similar will be used and planted with native shrubs or edible fruiting shrubs |

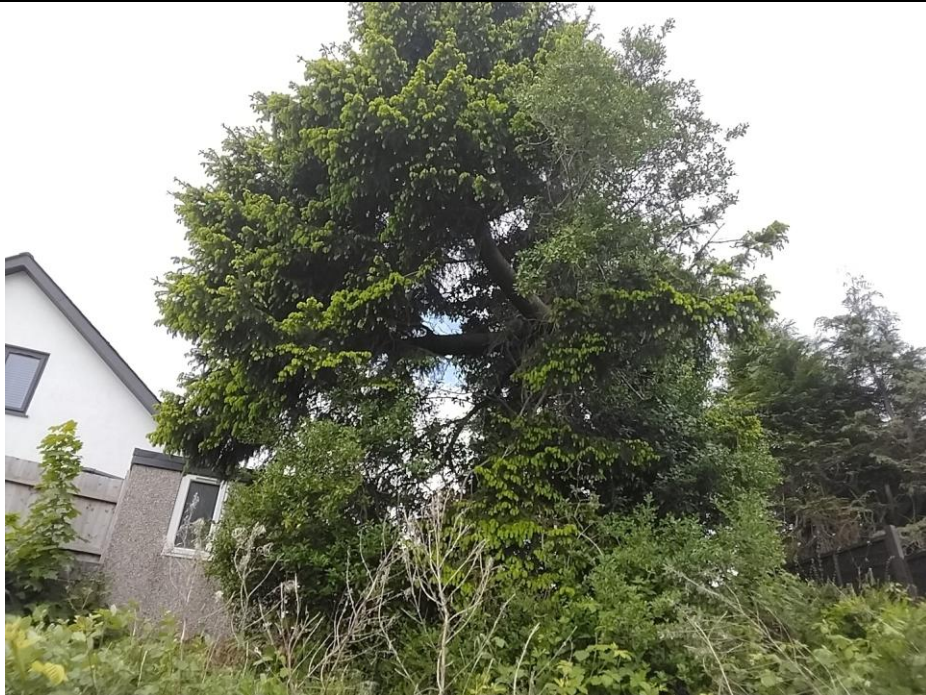
| <b>Within the site</b> | A mature but deformed spruce tree is in the northwest corner. One small willow shrub near to gate |

| <b>Within the Site:</b> | The spruce tree is growing on made ground and will become unstable when loose material is removed to create a new retaining wall. The tree has had the top removed in the past and has regrown in an unstable shape. |

| <b>Within the plot</b> | Cannot be retained |

Single  
spruce  
tree to be  
removed
